NELSON POINT TUG PEN REMEDIATION

PORT HEDLAND, WA

MAINTENANCE - BLAST & PAINT

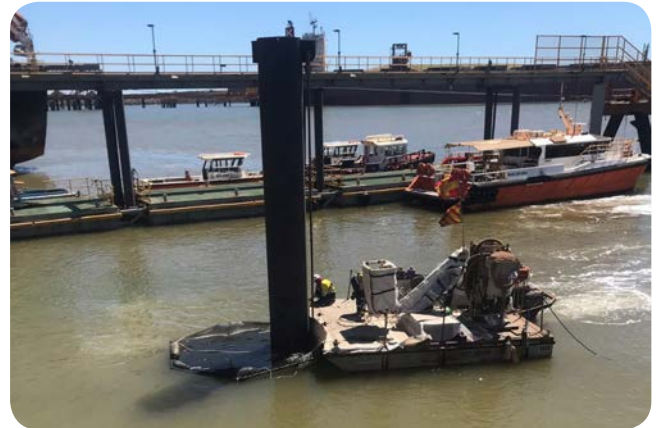
- ▶ Use of custom made recovery for falling paint debris.
 - ▶ Accessing top sections of piles from barge EWP.
- ▶ 100% dust free operation as a result of fully automated blasting and vacuum start/stop sequence.

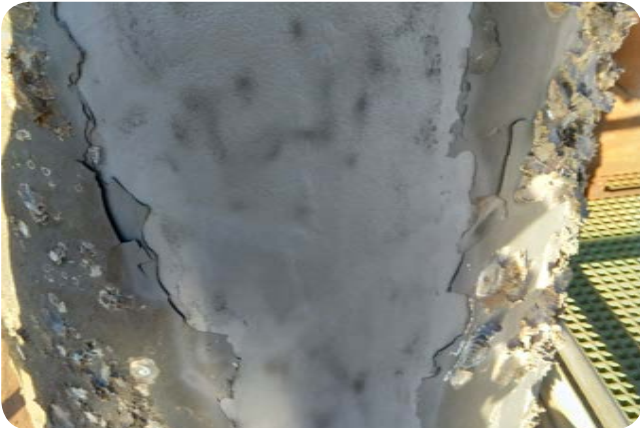
- ▶ Corrosion on piles.
- ▶ Scaffold over water for pontoon deck
- ▶ Pontoon 13 mooring piles completed.

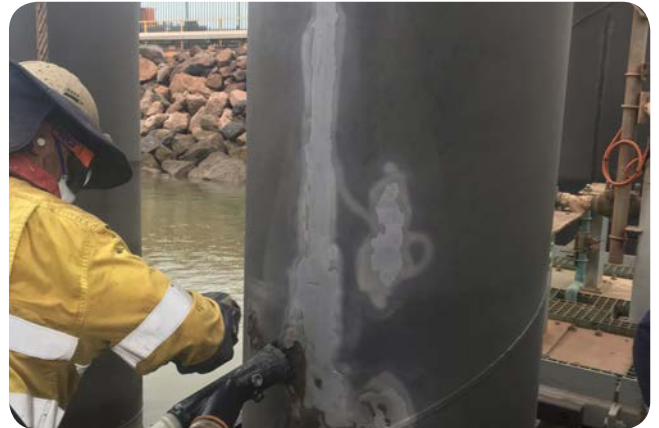
- ▶ Vacuum blasting of corroded areas.
- ▶ Coating inline with tide from deck access.
- ▶ Pontoon 14 mooring piles completed.
