Domestic Wastewater Management Plan 2019

MANNINGHAM

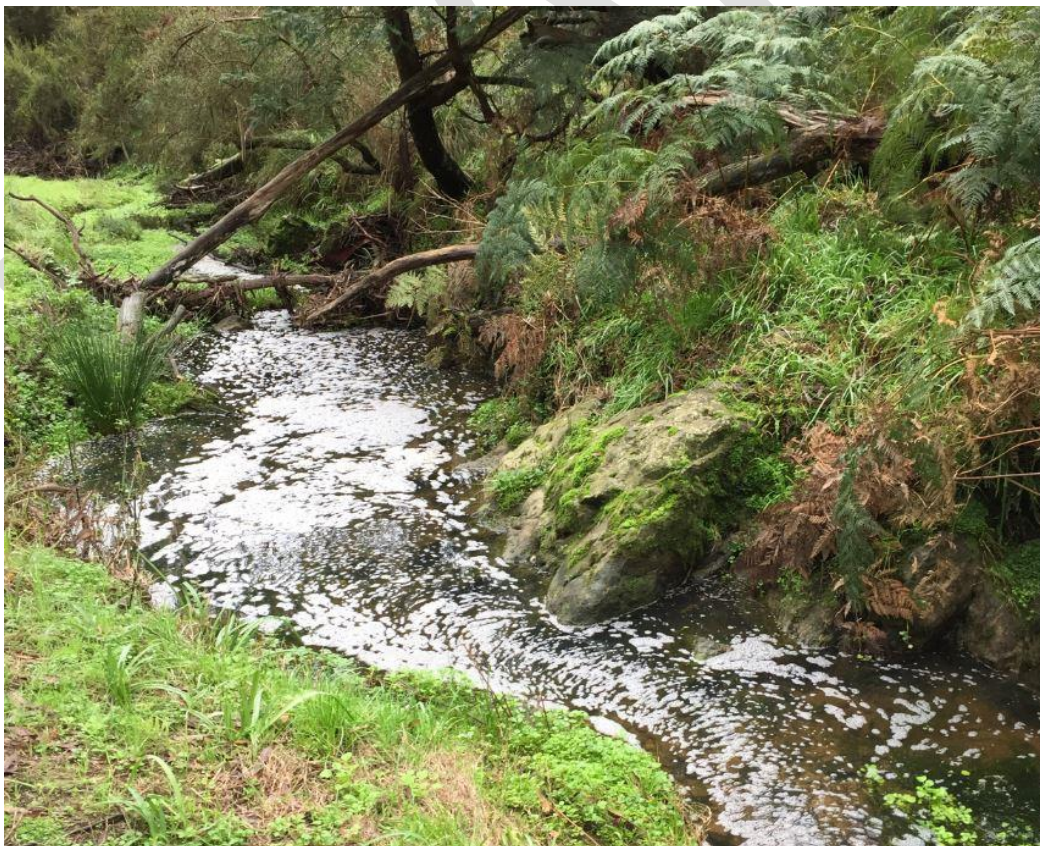
Figure 1: Soapy discharge entering Andersons Creek (May 2018)

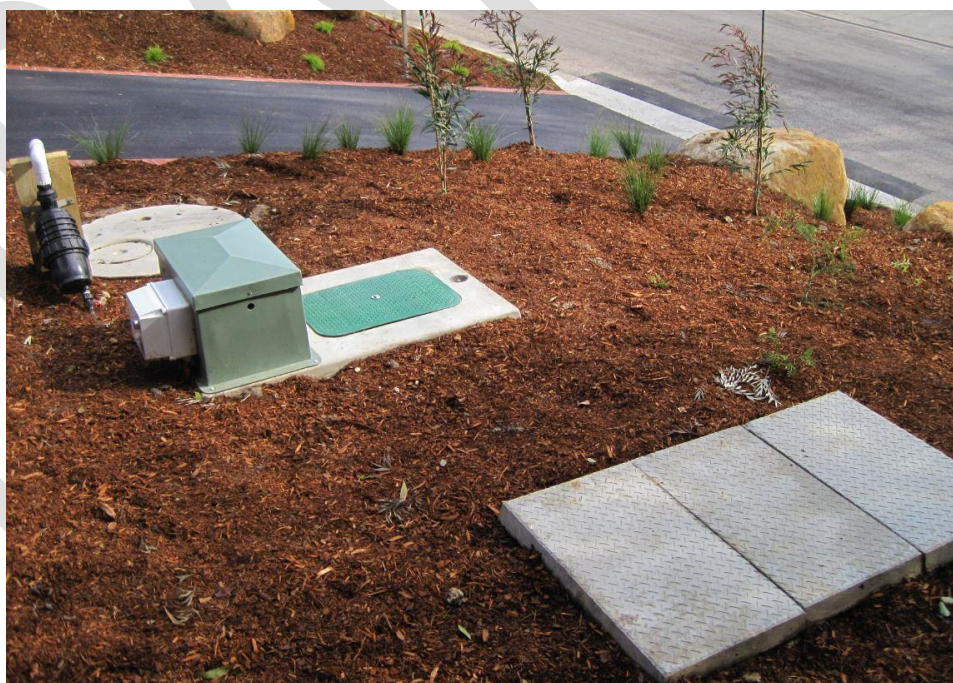
Figure 2: Treatment Plant with sub-surface irrigation

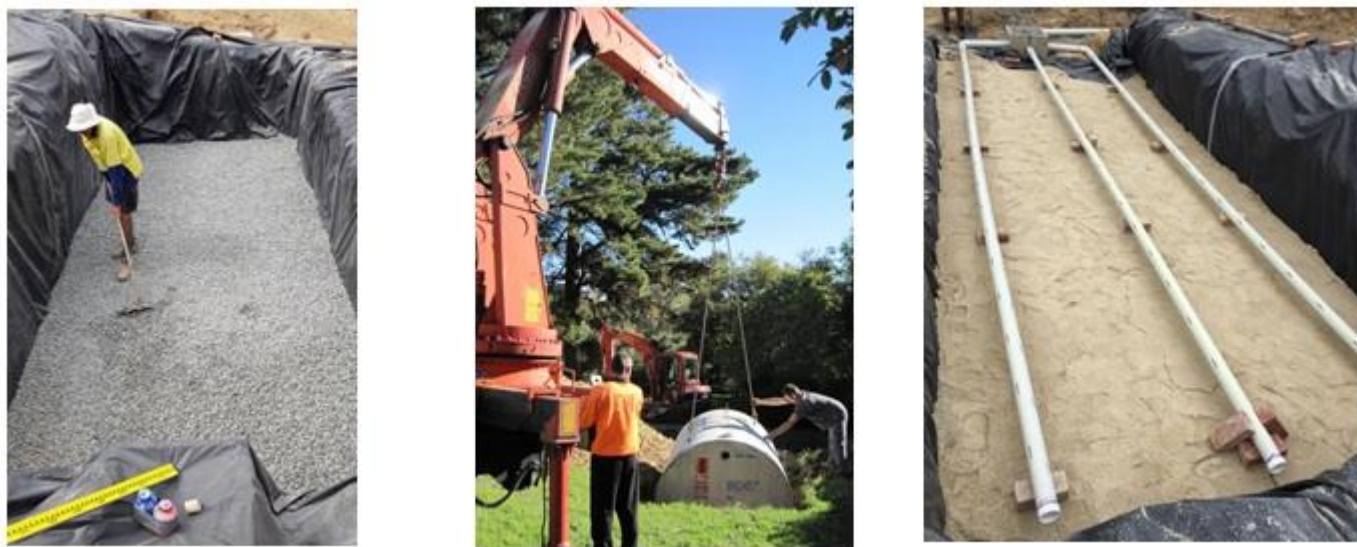
Figure 3: *Septic system components in various stage of construction/installation*

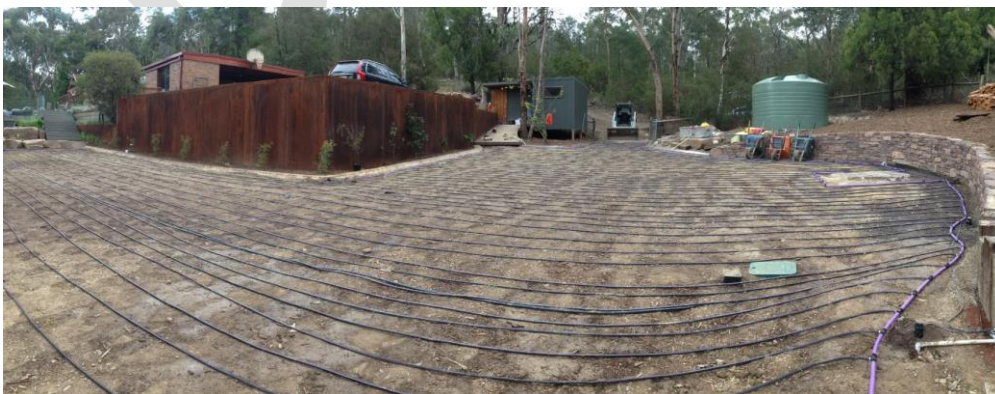
Figure 4: Lay-down of sub-surface irrigation

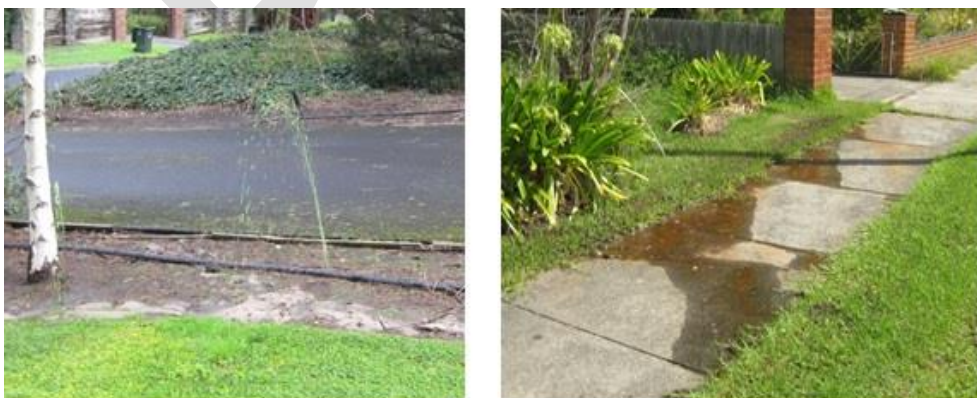
Figure 6: Burst dripper line and septic effluent flowing over footpath

- Sand filter blockages from tree roots (general maintenance required)
- Treatment plants not being serviced as no service contract in place
- Properties failing to desludge the septic tank every 3 years
- Redirected / bypassed irrigation systems offsite.
- Flush valves and inline cartridge filters being tampered with.

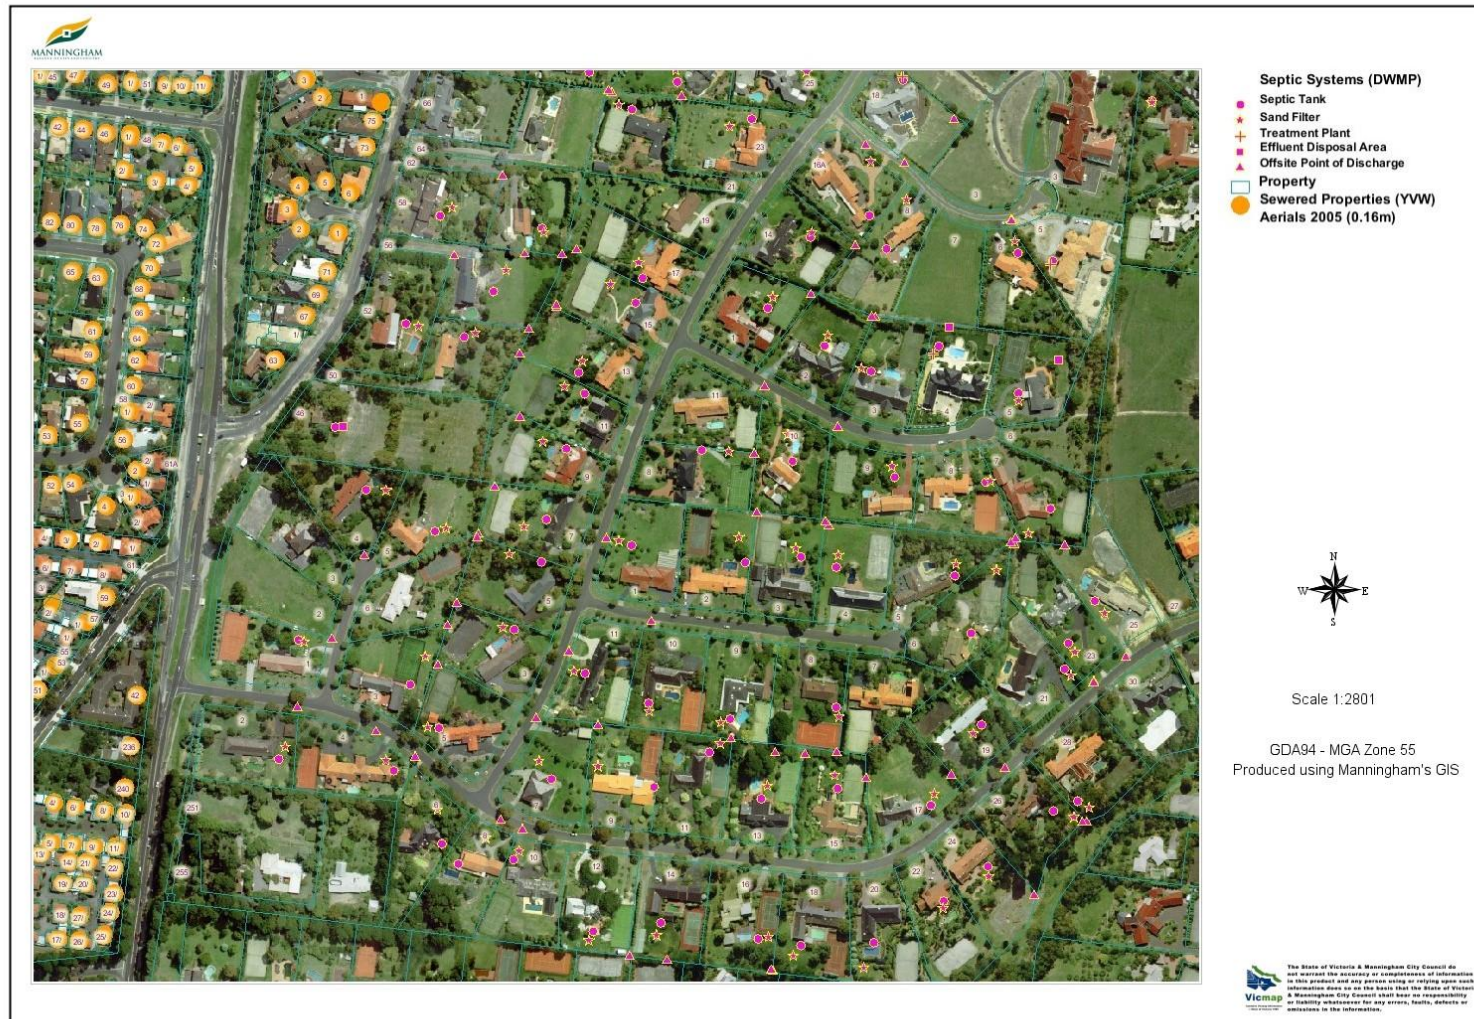
The image below shows Councils GIS overlay of septic systems in use. GPS is used to capture the exact location of system components (indicated by various pink symbols). The orange circles represent properties connected to sewer.

Figure 10: GIS overlay of septic system components in use (Donvale RA0041A)

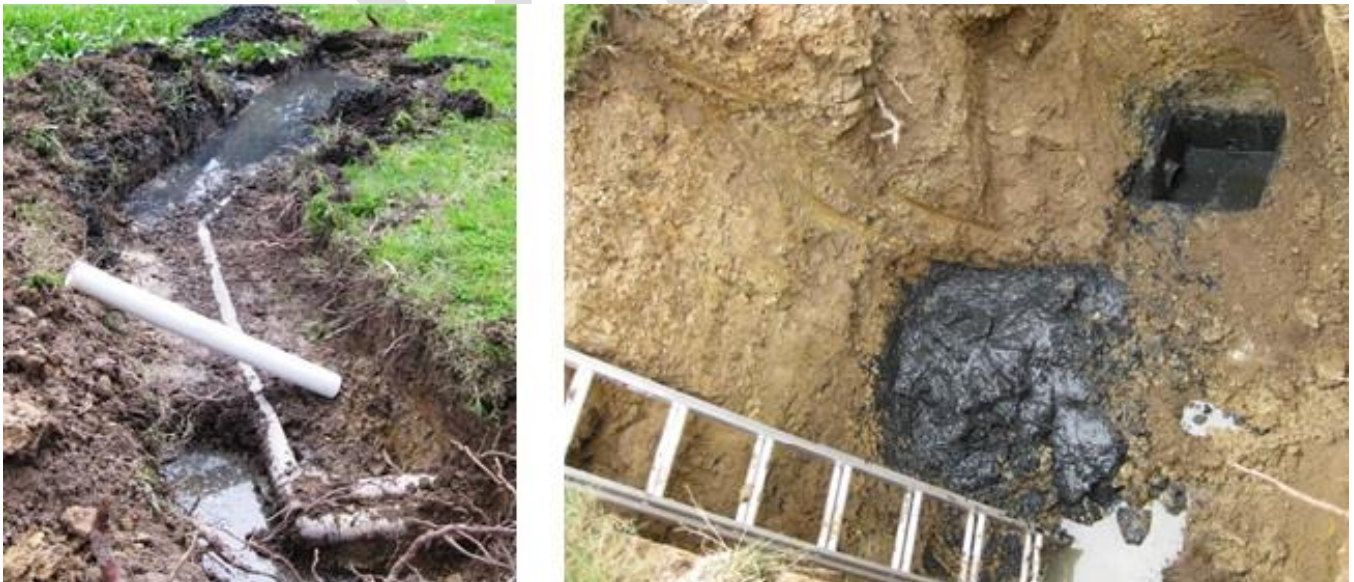
Figure 11: Flooded irrigation field and a deeply buried distribution pit (legacy system)

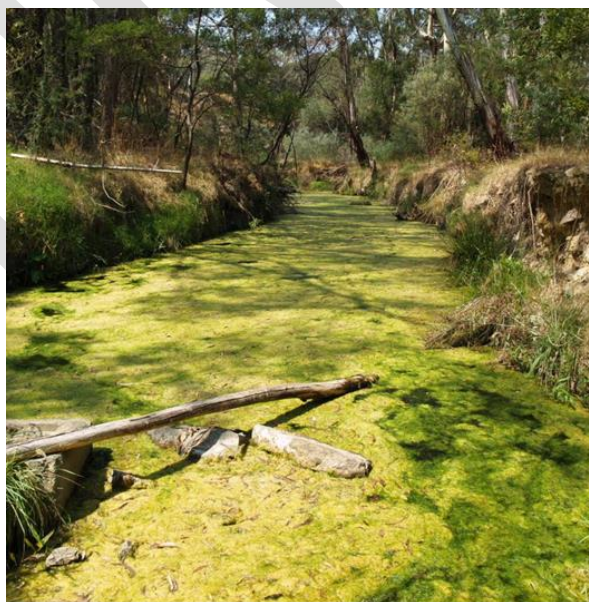
Figure 13: Algal bloom, Andersons Creek

Waterwatch monitoring in Andersons Creek indicates that the creek is being impacted by highly polluted stormwater discharging from the majority of the stormwater drains. The continuous nature of the stormwater discharge, even outside of rainfall, and the associated milky white colour, strong sewer-like odour and foamy consistency suggests that the discharge is likely to have originated as household waste water. Measurements of Ortho-phosphorus, electrical conductivity and ammonium, particularly in the upper parts of the catchment, are measured as highly degraded and can regularly exceed the limits of the Waterwatch equipment. Waterwatch data indicates that the creek is at its most polluted at the top of the catchment and improves with ground water dilution as the creek flows through the Warrandyte State Park.

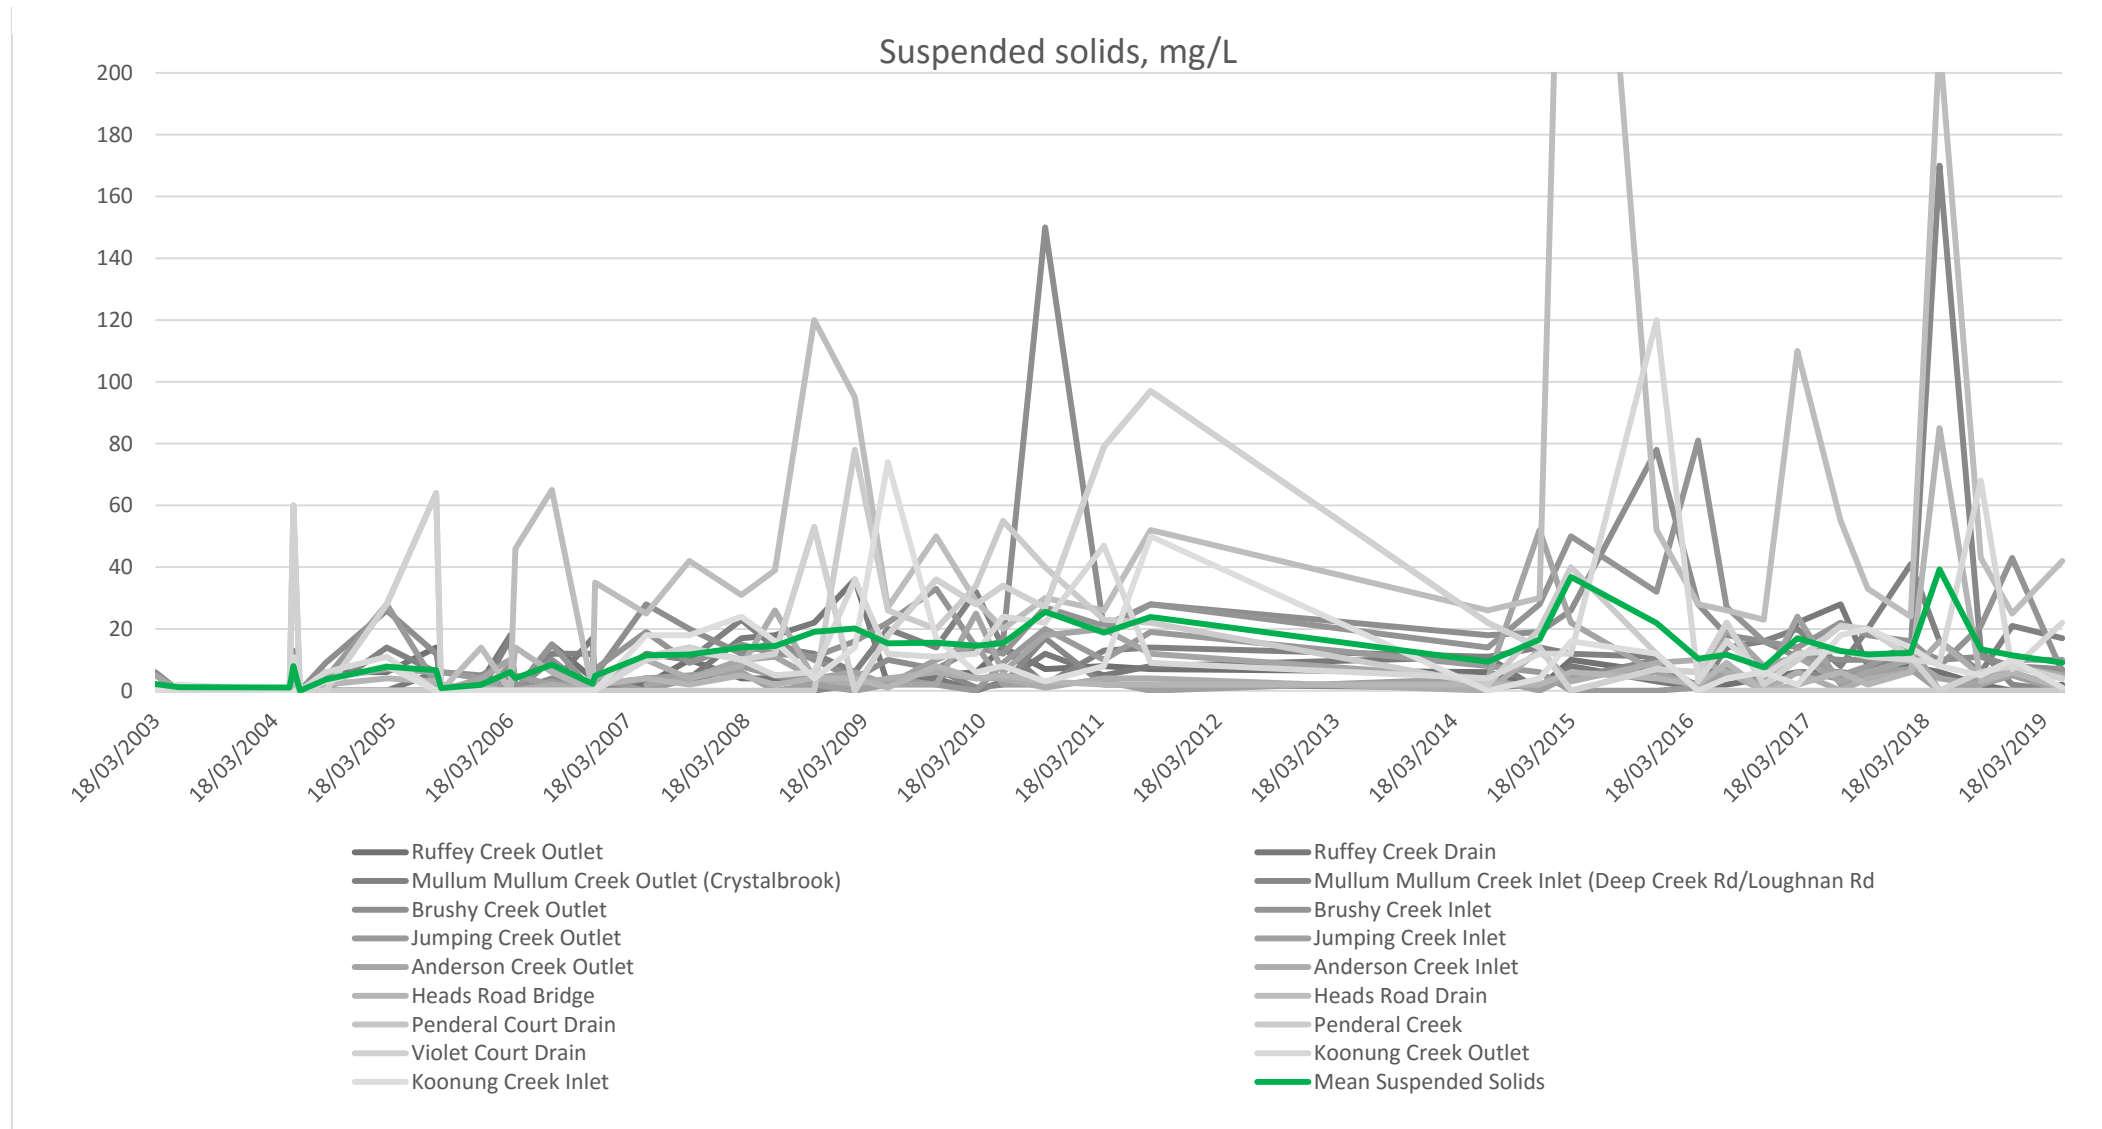
Figure 16: Suspended Solids by date and location

Water sampling has been conducted by the DWMP team since 2003 at several locations along creeks running throughout Manningham. Samples were taken 30cm below the surface to obtain a consistent sample representative of the water quality in that area. The table below indicates high levels of E.coli present in Manningham's creeks and is indicative of faecal contamination. In some instances, levels were considerably higher than those levels recommended for swimming.
