Tahmoor Mine: washery rejects disposal and emplacements management plan.

Prepared by: R.W. Corkery & Co Pty Limited.

Mining, Rehabilitation and Environmental Management Plan for the

Sheahan-Grants Gold Mine Annual Report 1989

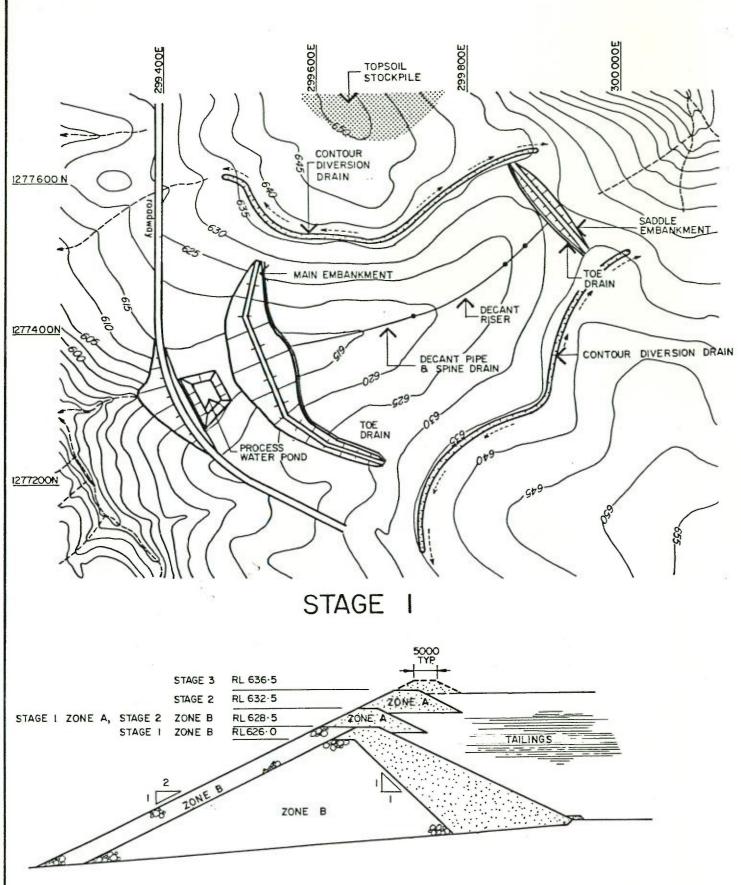
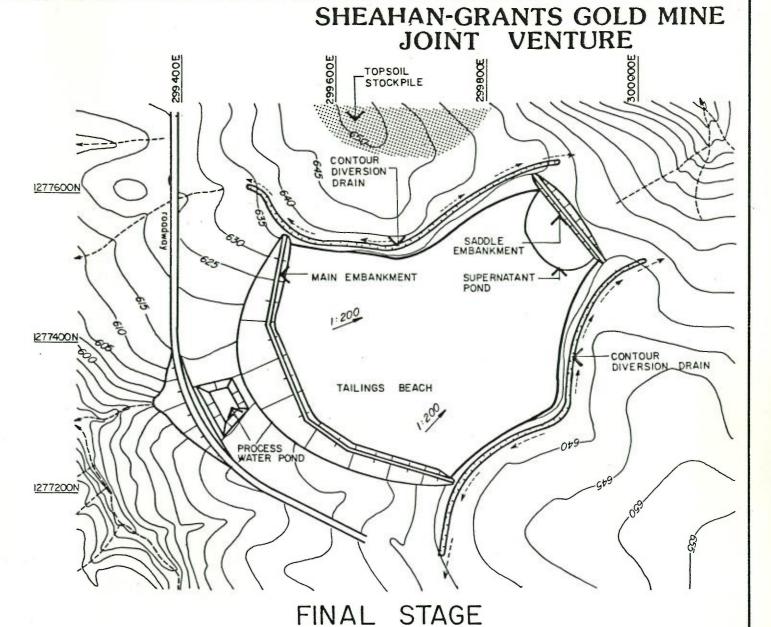
Plan 15A - MAY 1989
TAILINGS DAM
MAIN WALL
CONSTRUCTION DETAIL

STAGE CONSTRUCTION OF EMBANKMENT - SECTION

ZONE A: Selected weathered waste rock placed in 300 mm layers.

Moisture conditioned and compacted. Oversize rock raked into Zone B.

ZONE B: Weathered to fresh waste rock placed in 600 mm layers and compacted. Moisture conditioning generally not required. Oversize rock raked onto downstream slope.

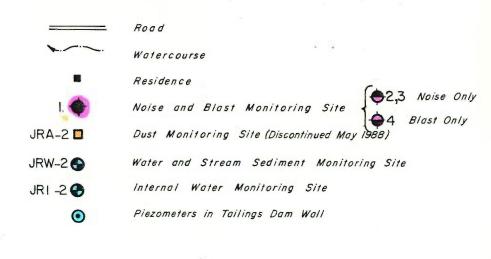
PLAN 19

NOTE: Water monitoring at upstream sites (JRW-I, JRW-2, JRW-3) discontinued April 1989.

Internal water monitoring site JRI-6 (at silt trap $N^{\circ}3$) has been added, May 1989.

ENVIRONMENTAL MONITORING

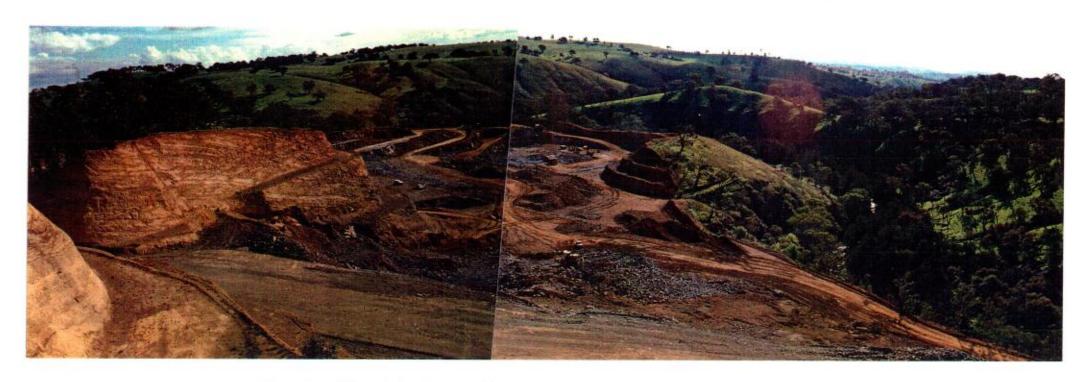
Plate 1: View of the pit and mining activity, looking west (May 1989). (Ref: 127K/12,13)

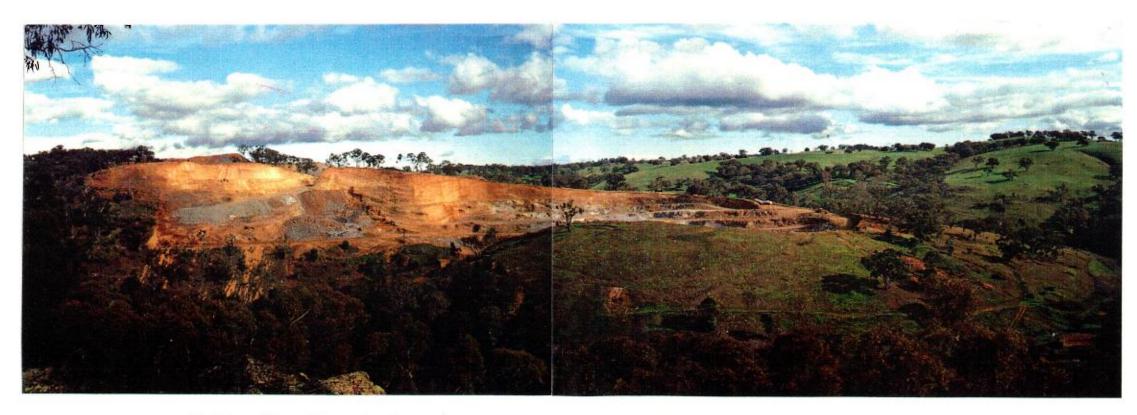
Plate 2: View of the pit looking south from the Junction Reefs recreation reserve. Note tree planting programme on the northern and northwestern slope (white specks are tree seedling guards) (May 1989). (Ref: 127K/21,22)

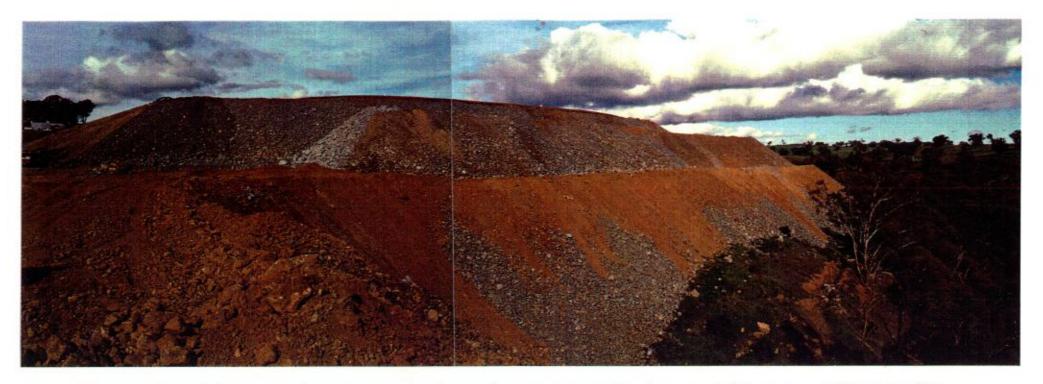
Plate 3: View of the waste rock emplacement looking southeast. Note level 610 m berm, level 624 m berm and final level 635 m (May 1989). (Ref: 127K/19,20)

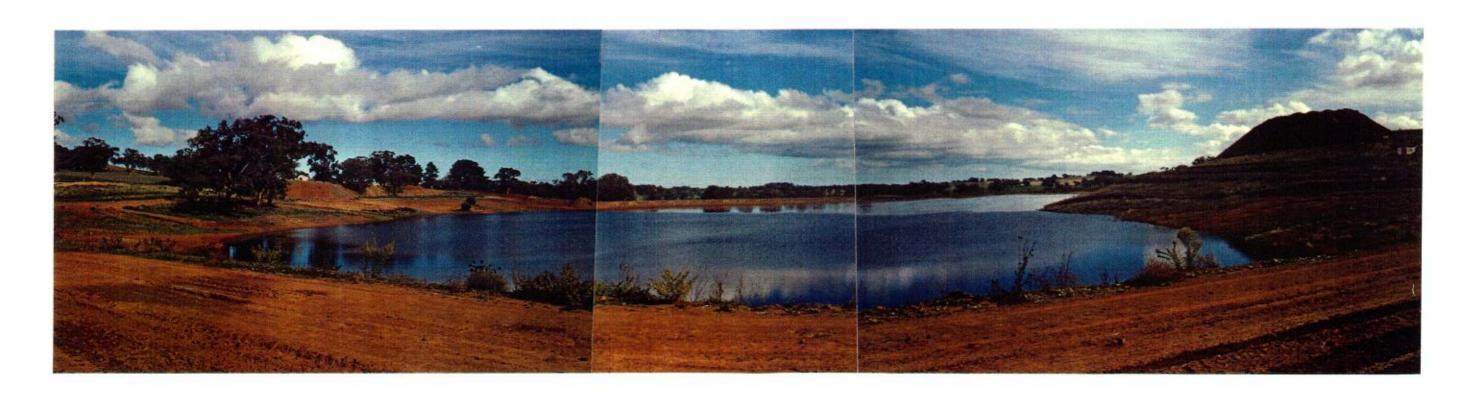
Plate 4: View of the tailings disposal facility looking southwest from the saddle dam. Waste rock stockpiled for later spreading during rehabilitation, is evident to the north and south (May 1989). (Ref: 127K/5,6,7)

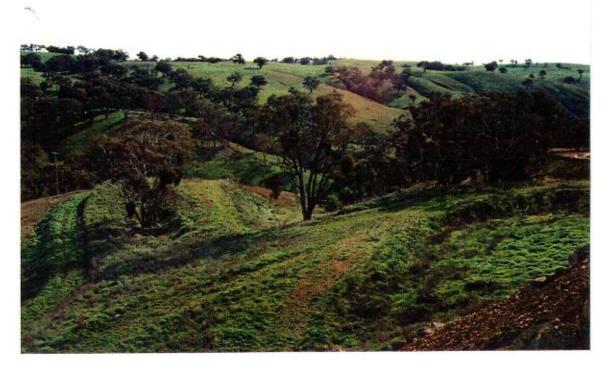
Plate 5: Stable grass cover established on soil stockpile no. 3 south of the pit (May 1989). (Ref: 127K/18)

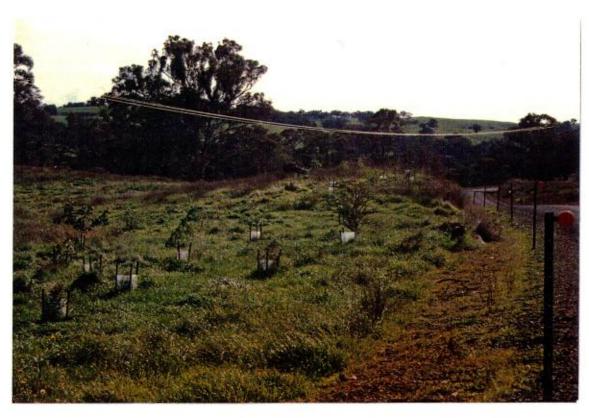
Plate 6: Good tree and shrub growth along the access to the mine. Planted in Autumn 1988 (May 1989). (Ref: 127K/10)

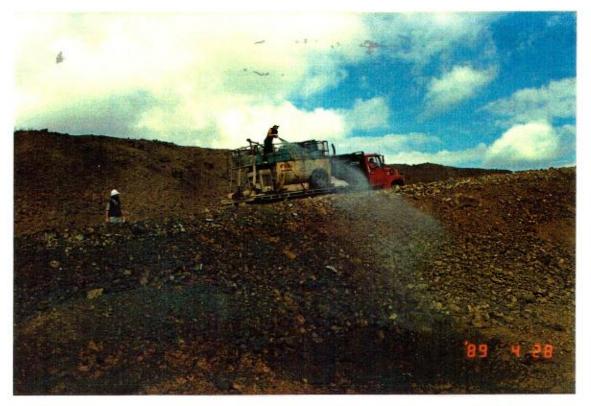
Plate 8: Hydromulching (native shrub seed and wood pulp) trial on exposed waste rock batter (April 1989). (Ref: 127J/18)

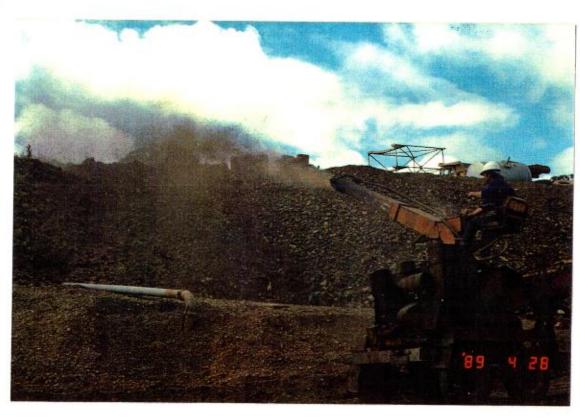
Plate 9: Hydromulching (straw and grass seed) trial on exposed waste rock batter (April 1989). (Ref: 127J/21)

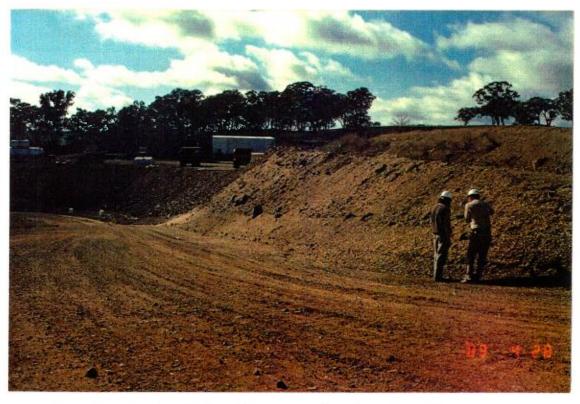
Plate 10: Hydromulching trials were undertaken using either native shrubs or grasses on the more visually exposed waste rock batters (April 1989). (Ref: 127J/10)
