Development application : proposed sand extraction and
agricultural land rehabilitation at Lot 3 DP 567166, Old Northern
Road, Maroota, Shire of Hornsby

DEVELOPMENT APPLICATION
PROPOSED EXTENSION OF SAND EXTRACTION
AND
AGRICULTURAL LAND REHABILITATION
AT
LOT 3, D.P. 567166 OLD NORTHERN ROAD
MAROOTA
SHIRE OF HORNSBY
VOLUME 2

Prepared by: Collin C Dongés & Associates Pty Limited

November, 1994

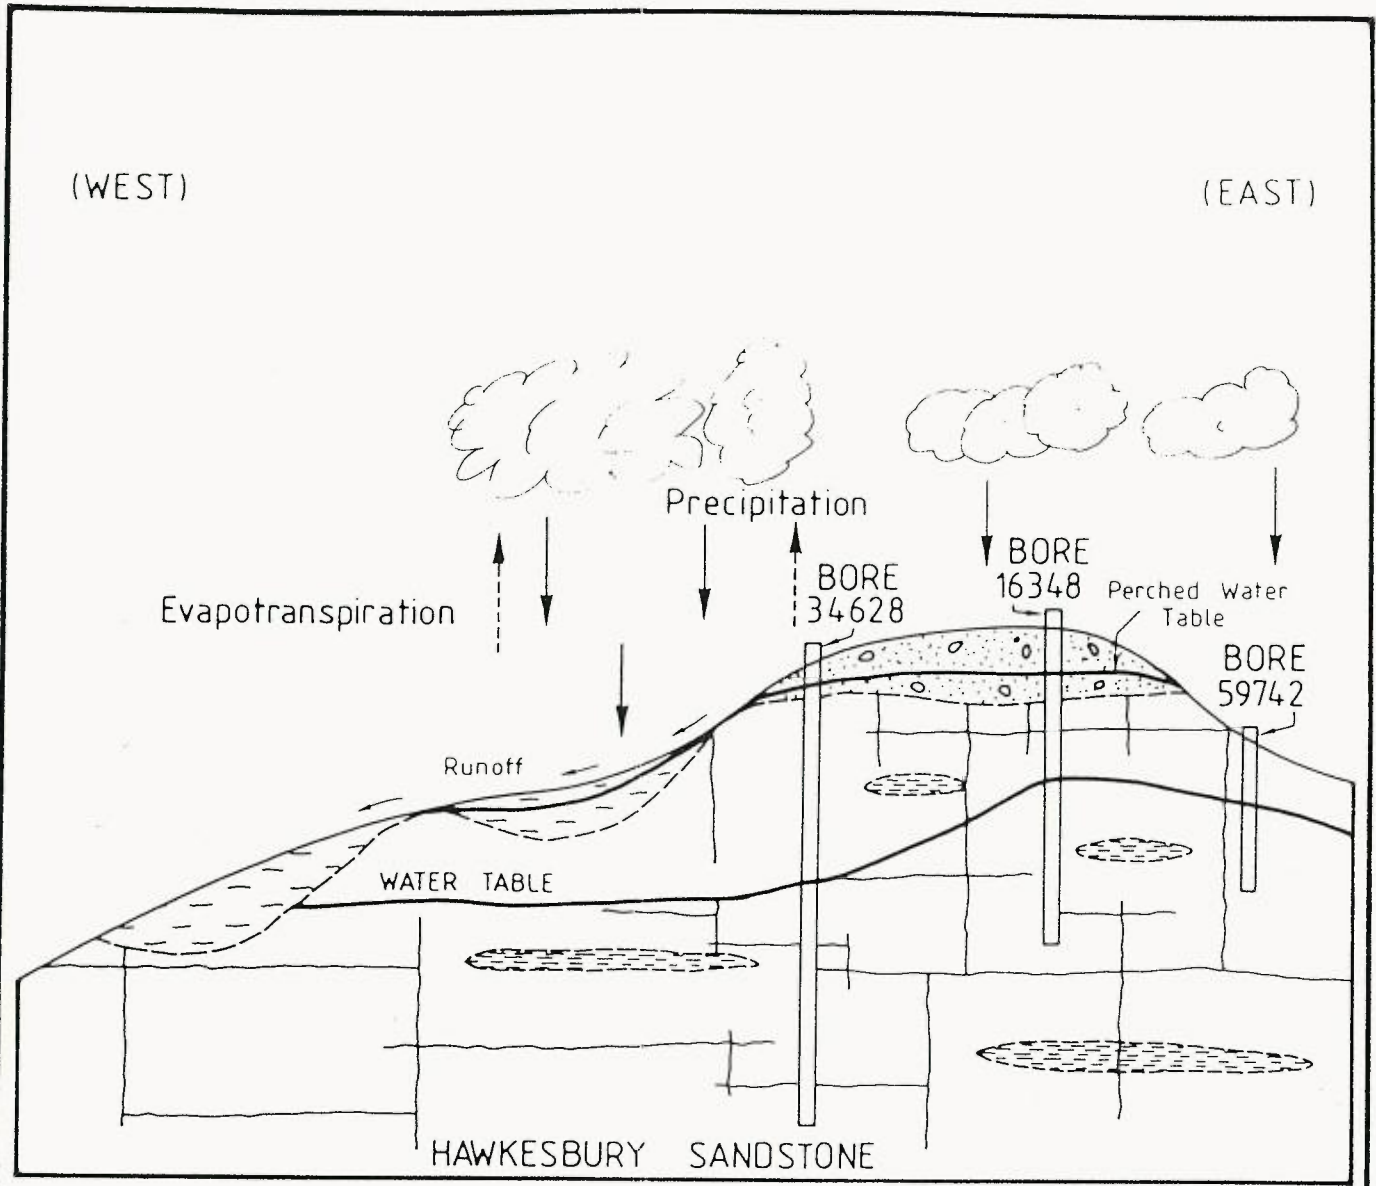
Figure 9 HYDROLOGICAL SECTION AT NORTH MAROOTA

Joints and groundwater flow paths through rock

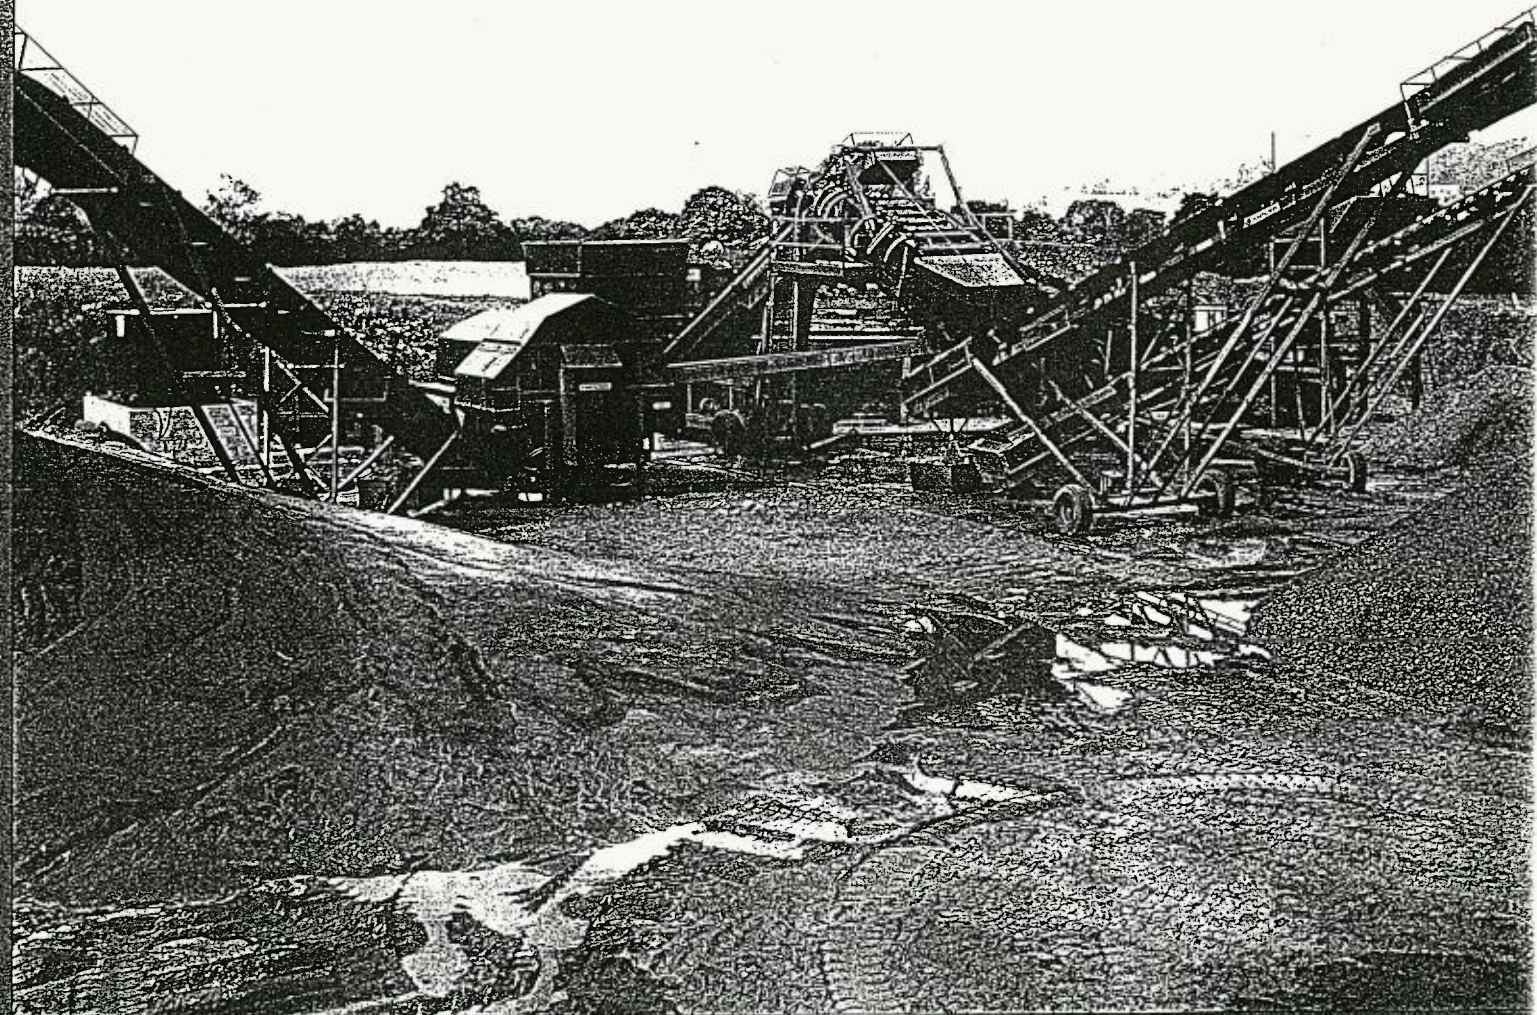
FIGURE 12a

THE COMMANDER

WASHBOX
A washbox complete with spray pipe fitted with 7 off high output spray nozzles is fitted in front of the main conveyor head drum to feed moistened raw material evenly onto the screen unit top deck.

MAIN SUPPLY PIPE
All spray pipes are fed from a 4 ins main supply pipe and water flow requirements are 800 gals/min. at the recommended minimum of 20 PSI rising to 900 gals/min. at 25 PSI and so on.

CENTRAL CONTROL PANEL
Conveniently located, the panel gives on hand control of the hydraulic circuits and engine functions including feed and screen angle adjustments.

CATCHBOX
The screen unit is fitted with a catchbox to direct sand, silt and water which pass through the bottom screen mesh via troughs or pipes to the dewaterer. Either one grade or two grades of sand can be produced.

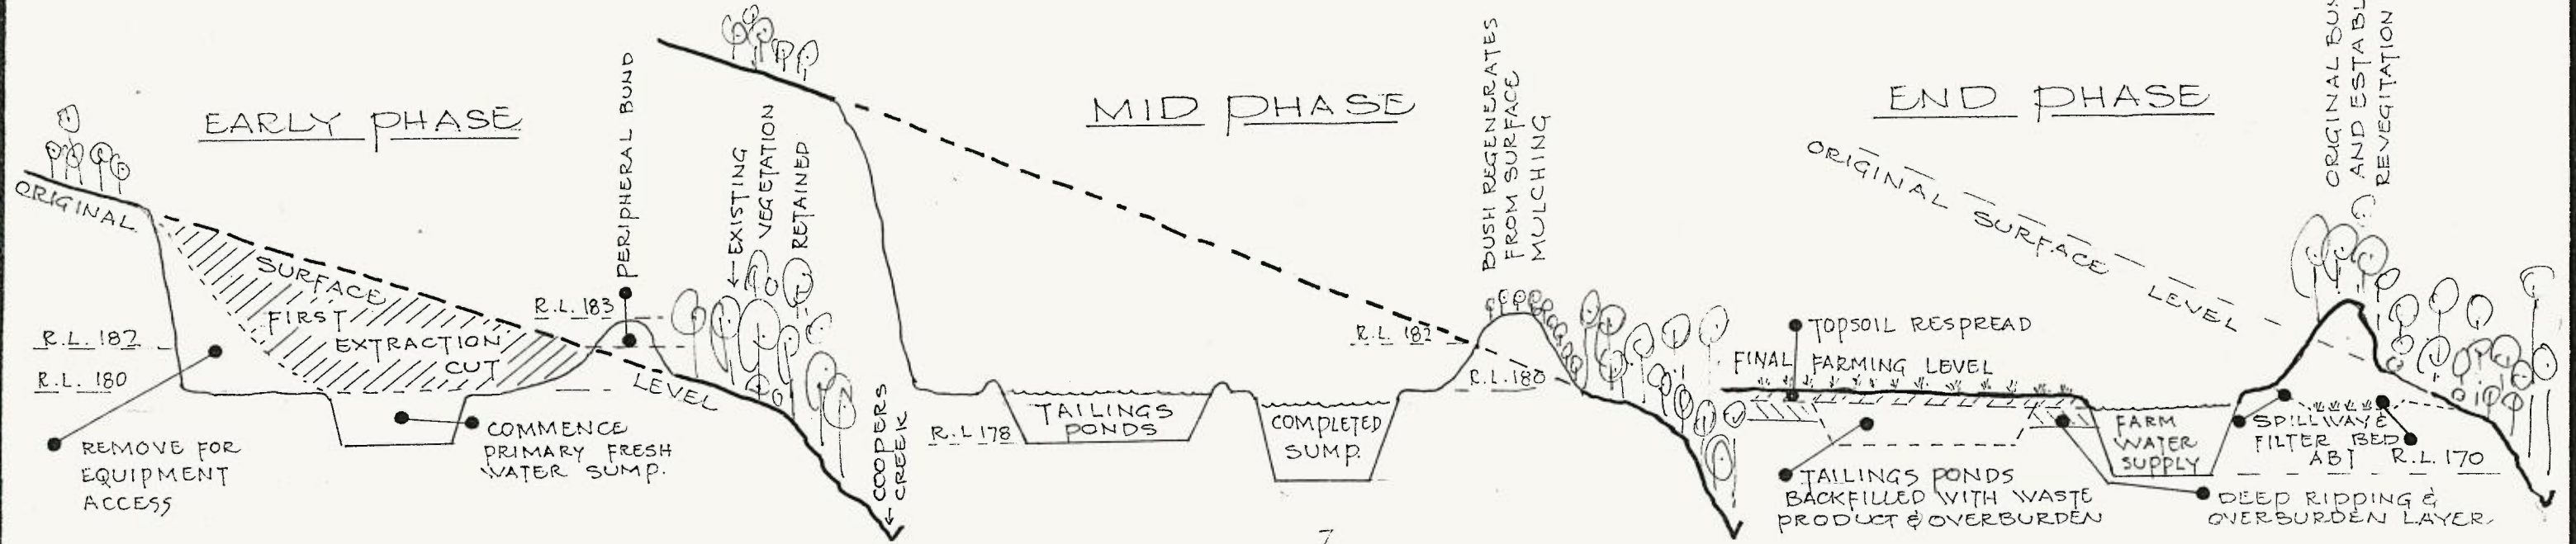
FIGURE 16

STAGE 1

STAGE 2

SCHEMATIC CROSS SECTIONS

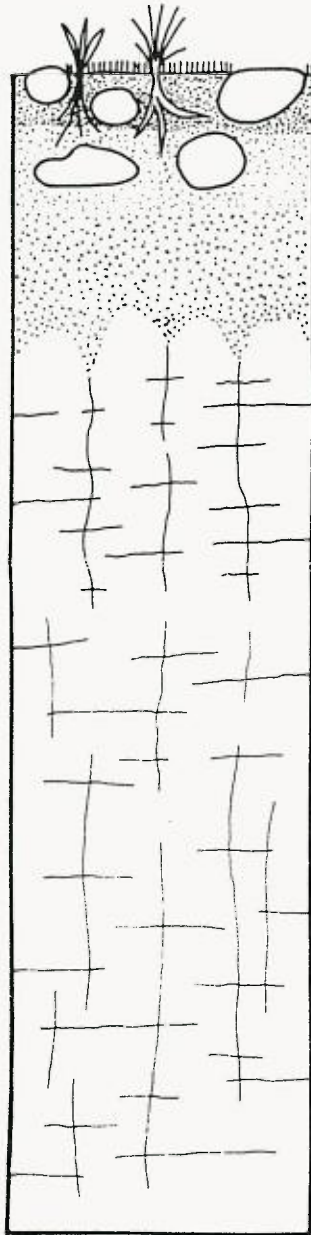
TYPICAL NATURAL SOIL PROFILE ON SITE

0 - 300 mm. 'A HORIZON'
SANDY DISCONTINUOUS
TOPSOIL, NUMEROUS
STONES, WEAK STRUCTURE.

'B HORIZON'
VARIABLE DEPTH UP TO 1 m.
STRONGLY WEATHERED,
IRON STAINED CLAYEY
SANDSTONE. WATER TABLE
OFTEN PERCHED ON OR
IN THIS UNIT.

1.3 m. - WEATHERED HAWKESBURY
SANDSTONE
(Eluvial Sand).

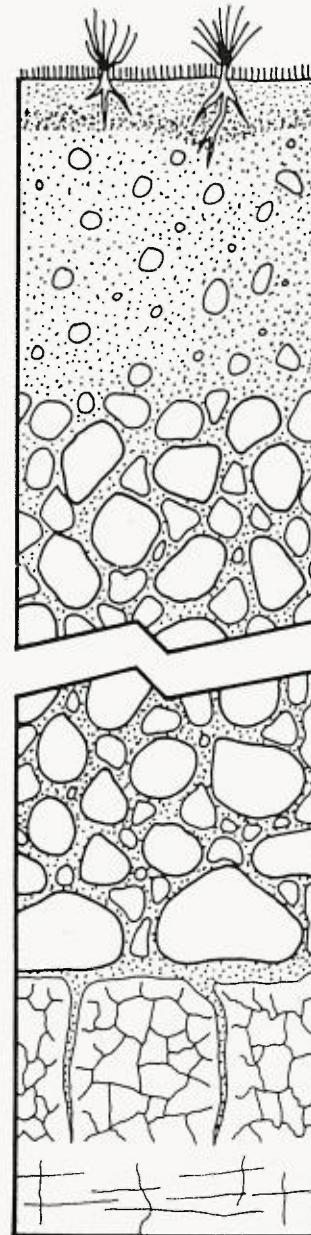
TYPICAL REHABILITATED SOIL PROFILE

0 - 100 mm. REPLACED ORIGINAL TOPSOIL,
EVENLY SPREAD, FERTILISED
AND MULCHED.

100 mm. - 500 mm.
SANDY OVERBURDEN AND FINE
MINING REJECTS COMPACTED
AND CONTOUR RIPPED

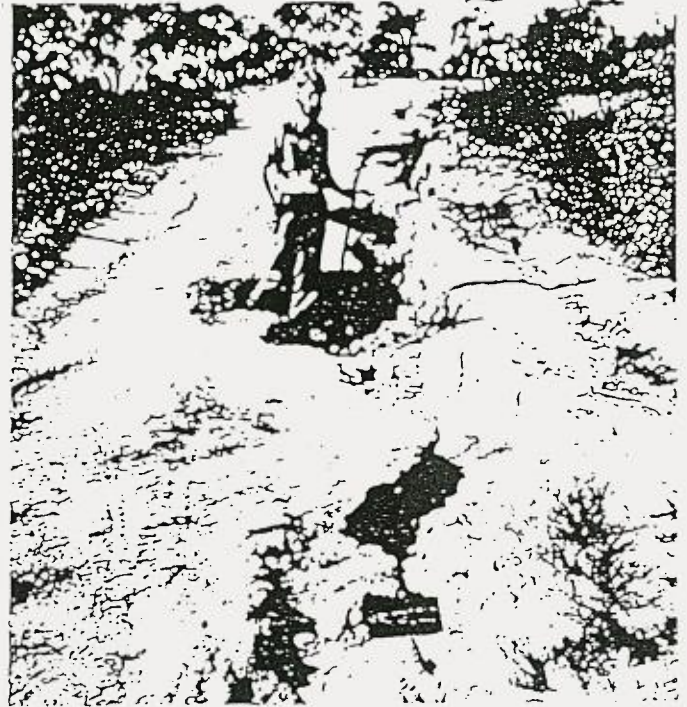
Figure 1 Trafficability is seriously impaired when undrained low standard roads become eroded.

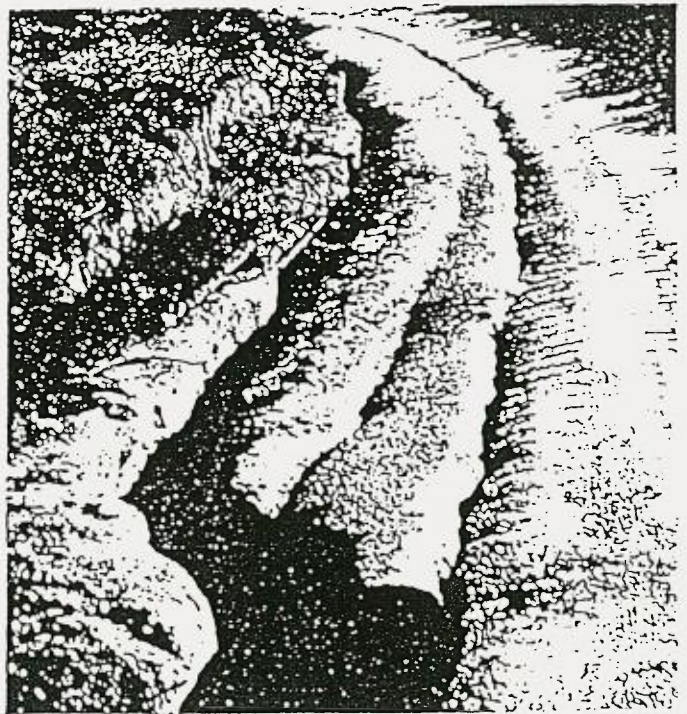
Figure 2 Deep rill erosion caused by inadequate drainage
