Exeter Quarry extension : environmental impact statement

1999. Specialist consultant studies Vol 1 Pts 1-9

**EVALUATION OF THE CHARACTERISTICS
AND QUALITY OF EXETER BASALTS**

EVALUATION OF THE CHARACTERISTICS AND QUALITY OF EXETER BASALTS

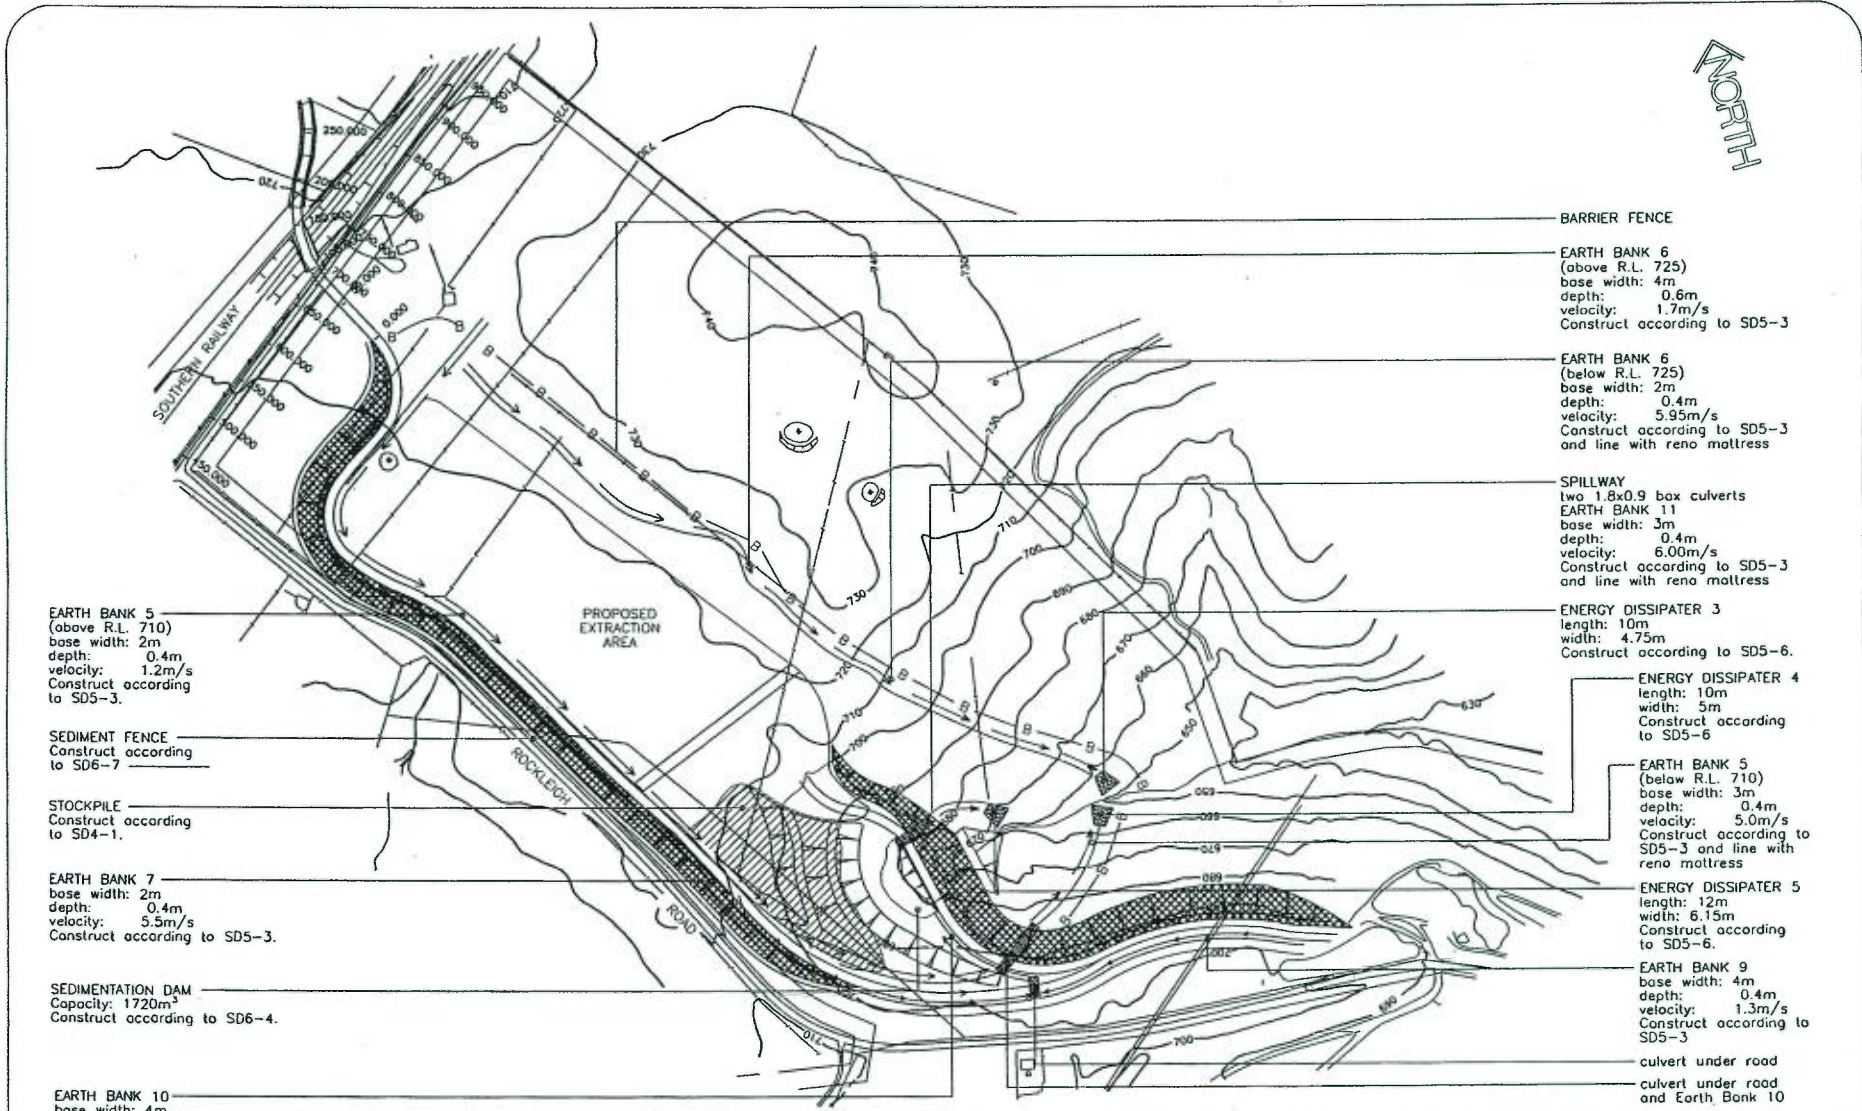
- EARTH BANK 5
(above R.L. 710)
base width: 2m
depth: 0.4m
velocity: 1.2m/s
Construct according to SD5-3.
- SEDIMENT FENCE
Construct according to SD6-7
- STOCKPILE
Construct according to SD4-1.
- EARTH BANK 7
base width: 2m
depth: 0.4m
velocity: 5.5m/s
Construct according to SD5-3.
- SEDIMENTATION DAM
Capacity: 1720m³
Construct according to SD6-4.
- EARTH BANK 10
base width: 4m
depth: 0.3m
velocity: 3.4m/s
Construct according to SD5-3

- BARRIER FENCE
- EARTH BANK 6
(above R.L. 725)
base width: 4m
depth: 0.6m
velocity: 1.7m/s
Construct according to SD5-3
- EARTH BANK 6
(below R.L. 725)
base width: 2m
depth: 0.4m
velocity: 5.95m/s
Construct according to SD5-3
and line with reno mattress

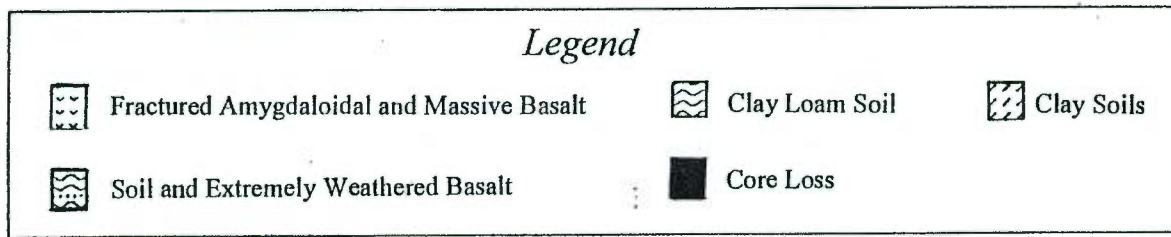
Cross-section Through MB/BH4-1 and Spring 7

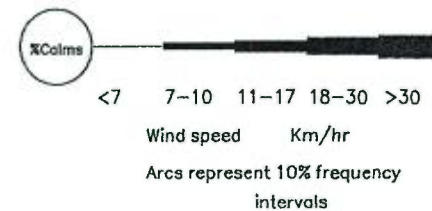
WIND ROSES : EXETER
 SUMMER 1998

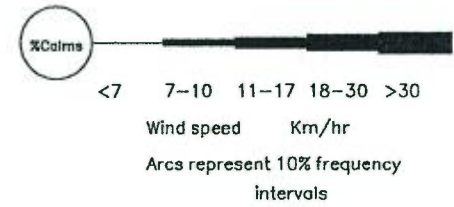
WIND ROSES : EXETER
JANUARY 1998

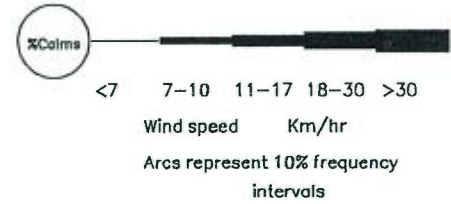
WIND ROSES : EXETER
MARCH 1998

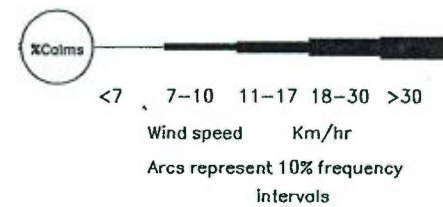
WIND ROSES : EXETER
APRIL 1998

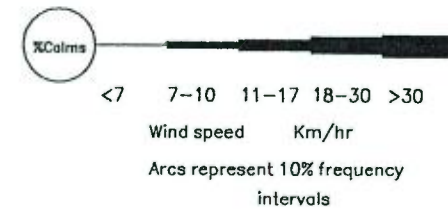
WIND ROSES : EXETER
 AUGUST 1998

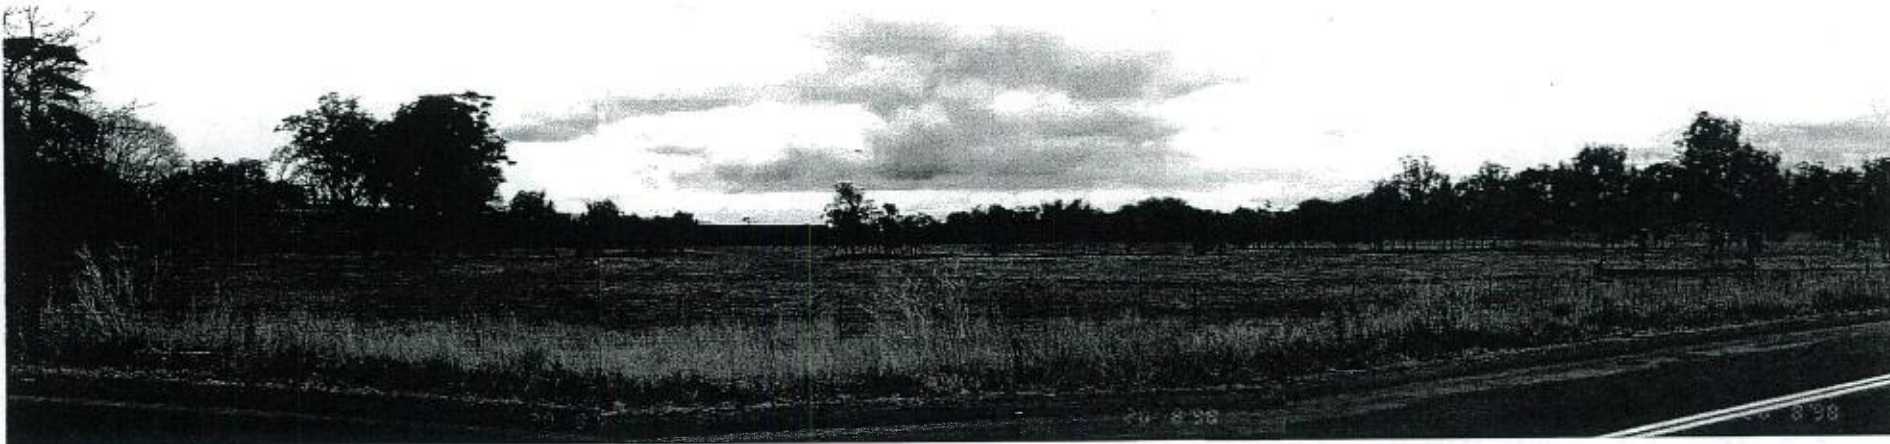
Figure 5a: Photomontage – Werai Road frontage after 2 years

Road frontage closest to Weraí Road. The reason for this is so that the site will not be hidden behind a "wall" of vegetation, but will appear to blend with the character of the more open, partially wooded land which presently surrounds it (Figure 5a). On the remainder of the Rockleigh Road frontage, the plantings will generally be selectively thinned to provide groups of dense vegetation interspersed with open areas, as is common on road verges in other parts of the eastern margins of the Southern Highlands where blackwood wattle is a conspicuous species. The Acacias will remain in place to provide screening to bunds in important view lines, such as the view from Willowbank (Figure 5c) and Merry Hill, where the view composition is similar.

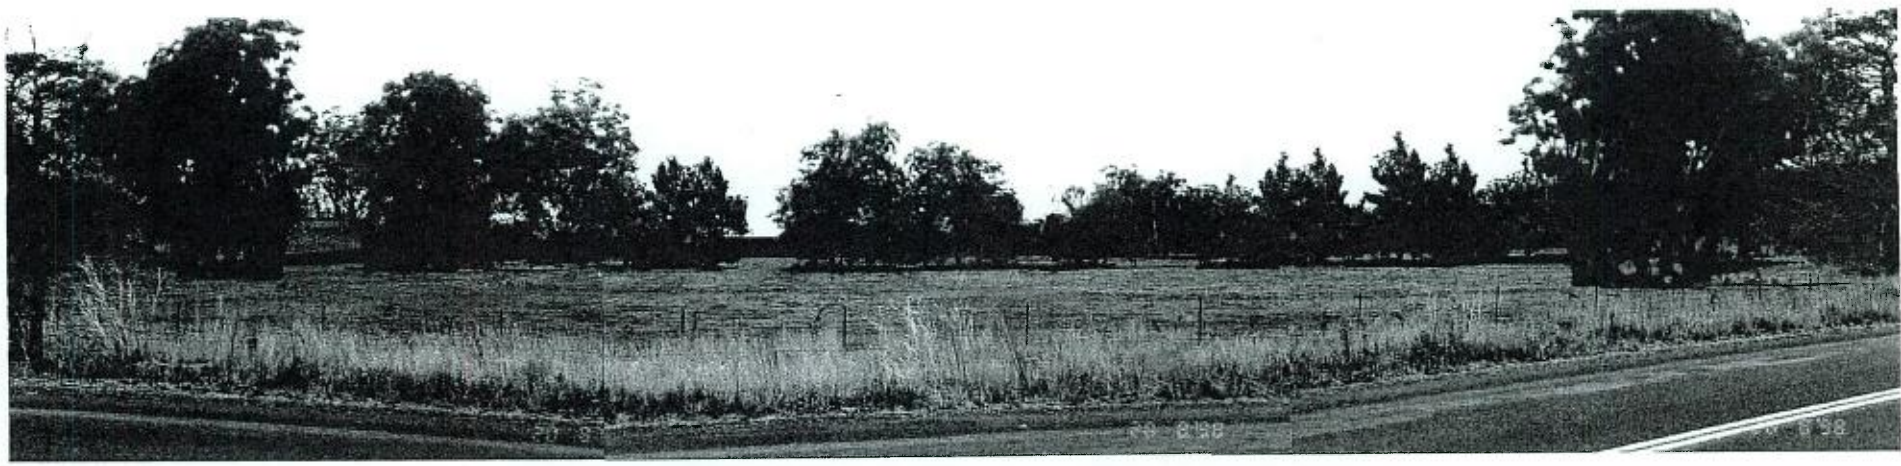
Figure 5b: Photomontage – Werai Road frontage final appearance

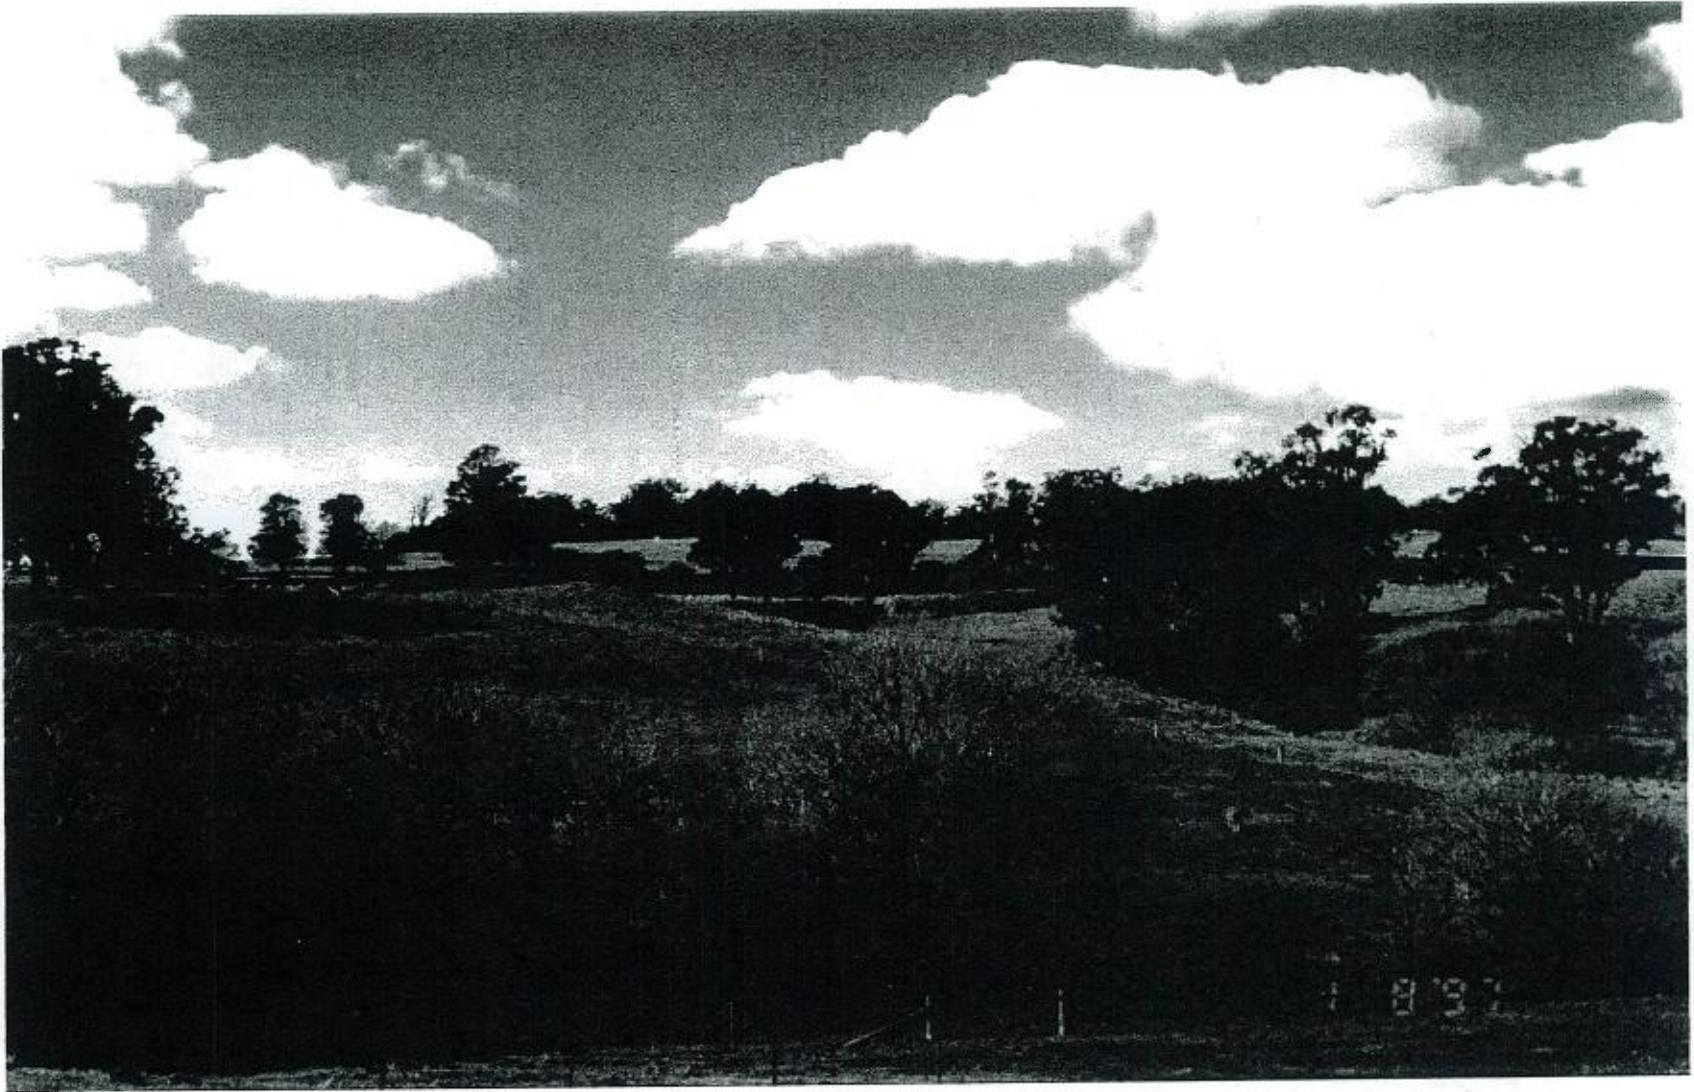
Figure 5c: Photomontage – Rockleigh Road frontage

A similar bund wall would be used on the Rockleigh Road side of the proposed extraction area, planted to merge with existing planting on the road and within the site. The typical details of this are shown in Figures 4c-4d. It would be varied in height and slope to decrease its visual presence and to prevent views into the site from the few locations identified as affected to the south of the site. Part of this perimeter bund wall would be surmounted by a fence for acoustic purposes, that would be removed at the end of extraction. The fence, which is shown in Figures 4c-4d, which would not be erected until about Year 4 of the extraction process, would be disguised by planting on the bund surface, new plantings between it and the site fence and by existing vegetation on the boundary. The bund walls and vegetation would be in place and sufficiently mature so that the fence, by the time it was necessary to be constructed, would not be visible. The final appearance of the proposed extraction area when viewed from Willowbank is depicted in a photomontage, Figure 5c.

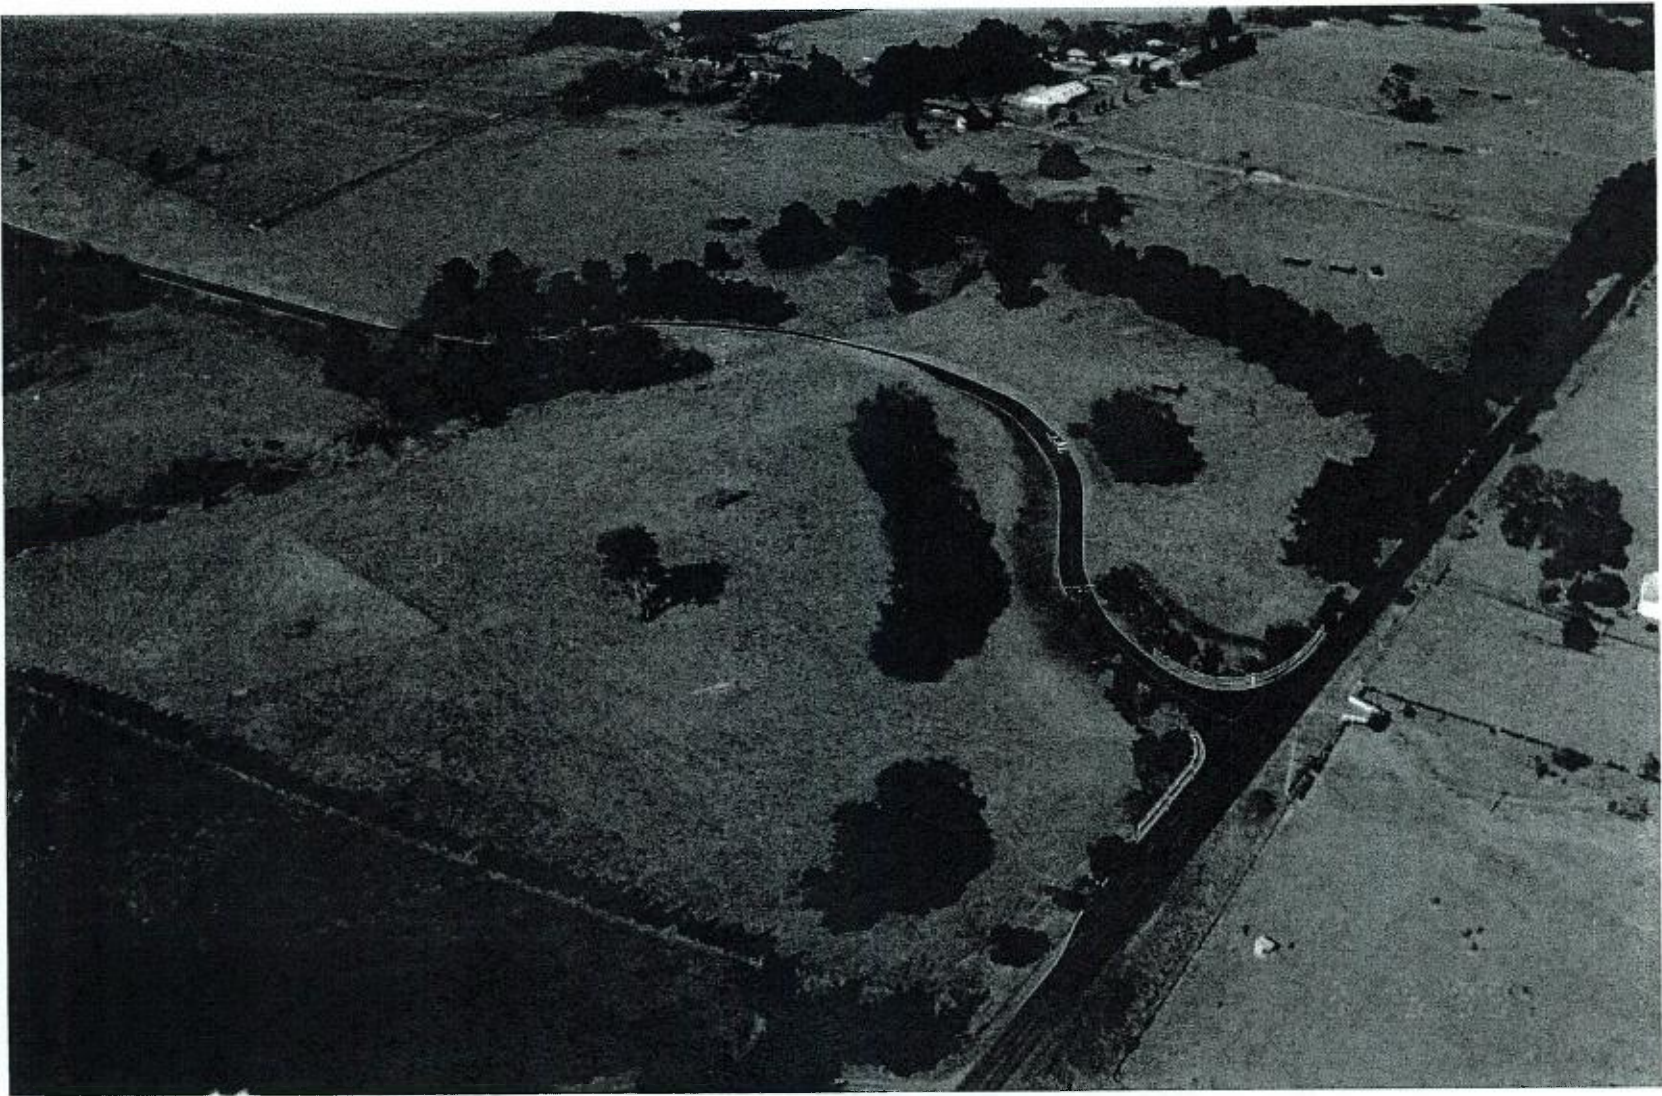
Figure 5d: Photomontage – Exeter Bypass

The Bypass road would generally not be visible from the surrounding landscape, but evidence of it in the form of a grassed bund would be able to be seen from nearby rural properties to the north. When seen from these, it would not be intrinsically out of character in the landscape, even though truck movements would be seen. Rural roads and access ways and the movement of traffic are a familiar feature of the landscapes of the area and have relatively little visual impact, once established. There are many other linear features that contribute to the character of the area, such as windrows, fences, other roads and tracks, railway embankments etc. The Bypass would be seen, from the limited locations indicated above, within that context.

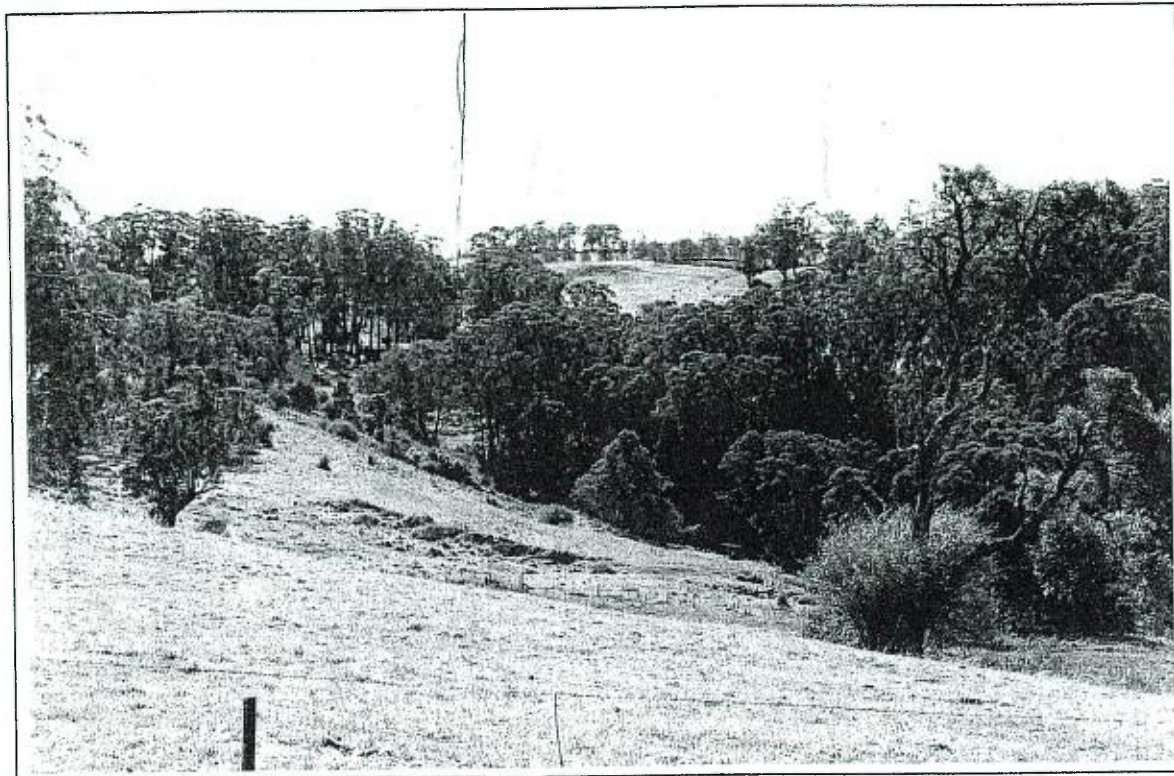
Figure 1. View toward the proposed extraction area from near “Boeing Park” residence. The northern boundary of the extraction area is barely visible. Rockleigh Road is in the middle distance but obscured by trees in the foreground. Vegetation screening and bund walls would remove any visual exposure of the extraction activity.

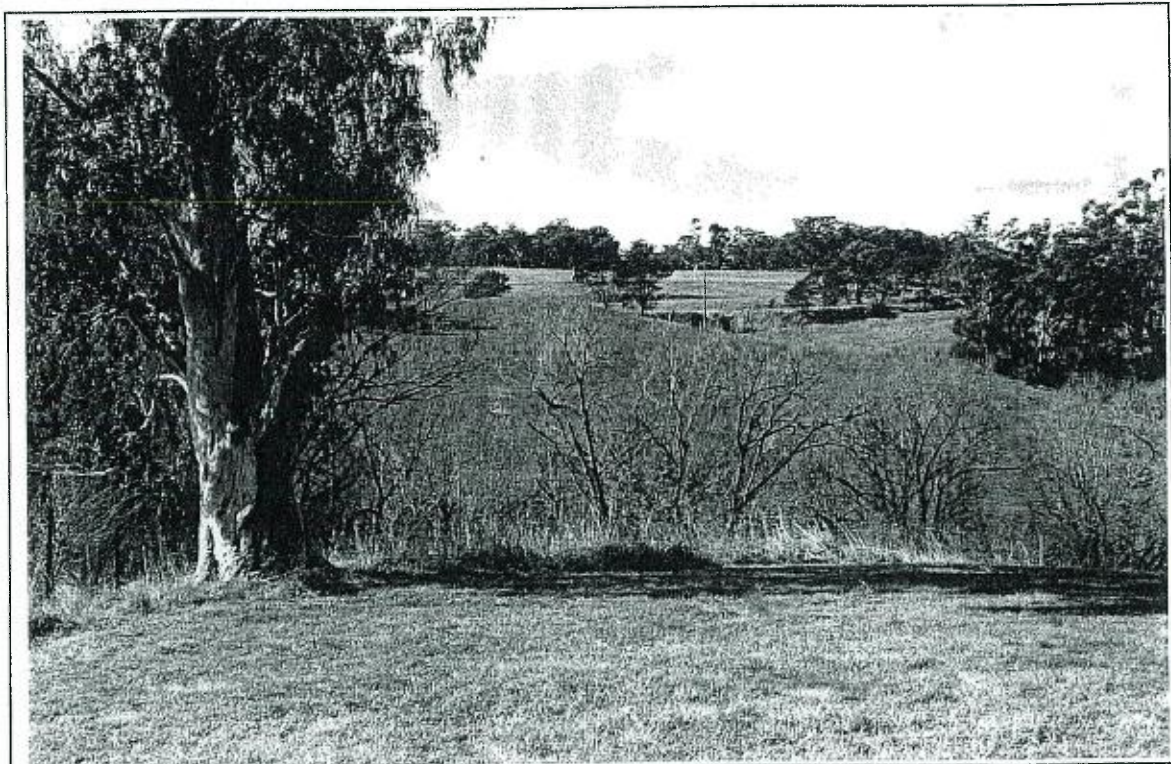
Figure 4. View toward the proposed extraction area from near the residence "Willowbank", (winter view).

The existing visibility of the extraction area is minimal. The bund wall beyond Rockleigh Road, in the middle distance, plus its tree screening vegetation, would remove any visual access to the site. By the time the acoustic fence was constructed in this view line, the vegetation would have grown sufficiently to reduce its visibility to a negligible level.

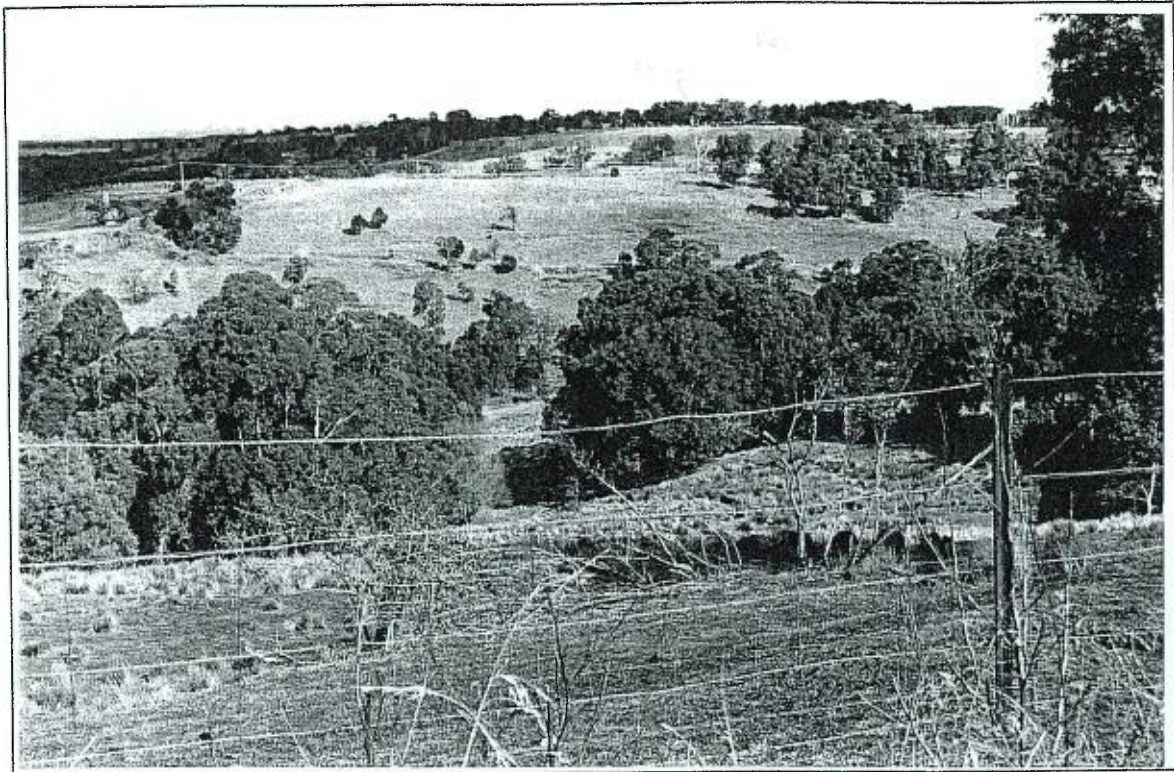
Figure 5. View toward the existing operations from "Rockleigh Cottage".

The view shows the existing crushing and screening plant (left) and existing extraction area (right centre). The foreground would be unaffected by the proposal. The internal product transportation route would be visible near the mid-ground horizon, but difficult to visually distinguish from the existing Rockleigh Road or to differentiate from another road that crosses the centre of the view. The visual exposure of both road and crushing plant will be reduced by an ongoing program of landscape construction and planting work that is presently being implemented.

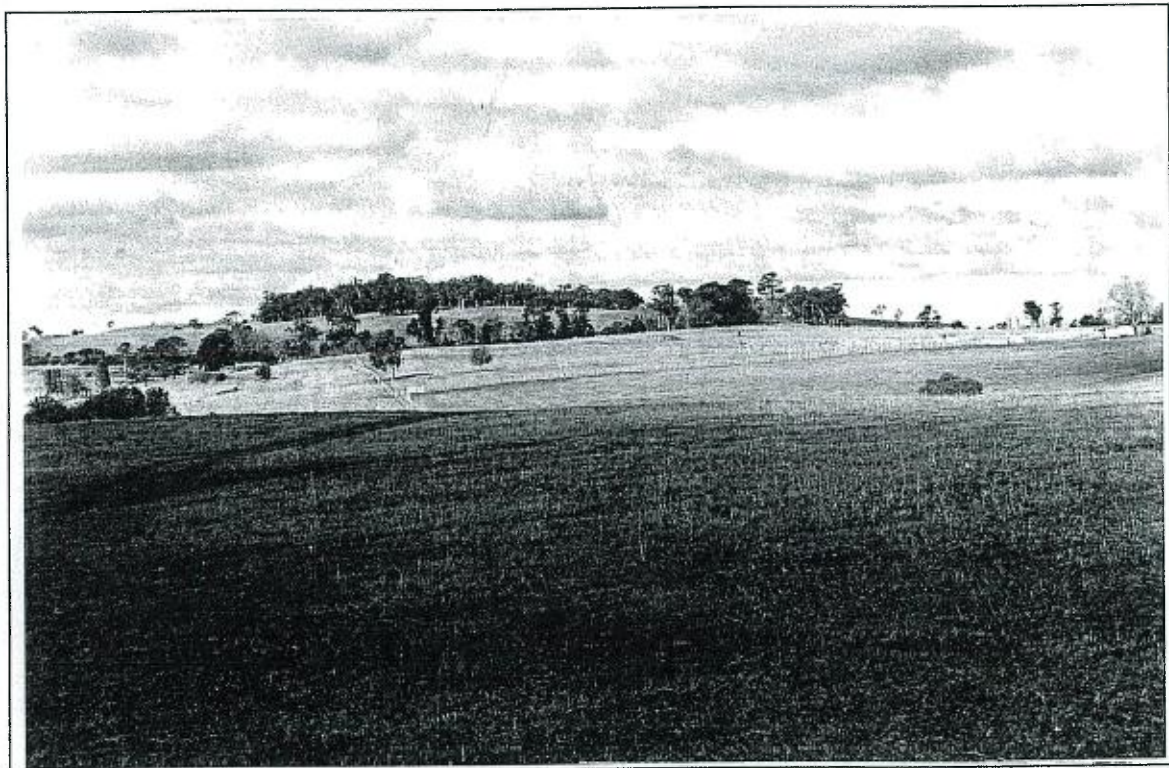
Figure 12. View toward the proposed extraction area from Exeter Road near the entrance to "Tralee".

The extraction area is effectively out of sight from here and its minimal visibility would be further reduced by bund construction and planting. The Exeter Bypass route would be visible crossing the middle ground toward the viewer on the left of the picture. Its alignment would be screened by carefully located groups of trees, as would the closer part of the road and entrance.

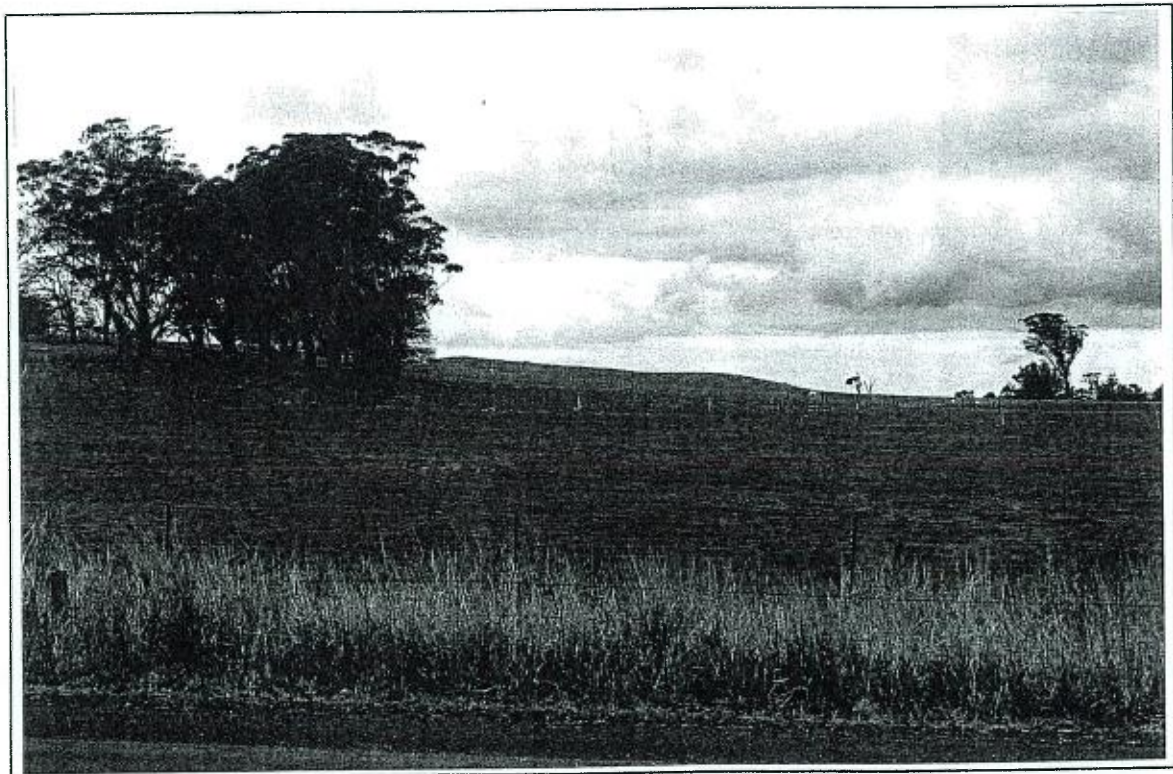
Figure 14. View of the north western margin of the proposed extraction area, from Werai Road.

The extraction area is set back approximately 130m from the road. The area between the road and the extraction area will be screened by foreground planting (to remain until other vegetation is established) and groups of native trees that continue the appearance of the remnant stand on the left, while filtering and screening views toward the bund wall that contains the extraction area. The open grassy character would largely be retained. None of the extraction or transportation of material would be visible.
