ENVIRONMENTAL IMPACT STATEMENT FOR A PROPOSED EXTRACTIVE INDUSTRY AND LANDFILL AT MARSDEN PARK, NSW

VOLUME 2

APPENDICES

May 1998

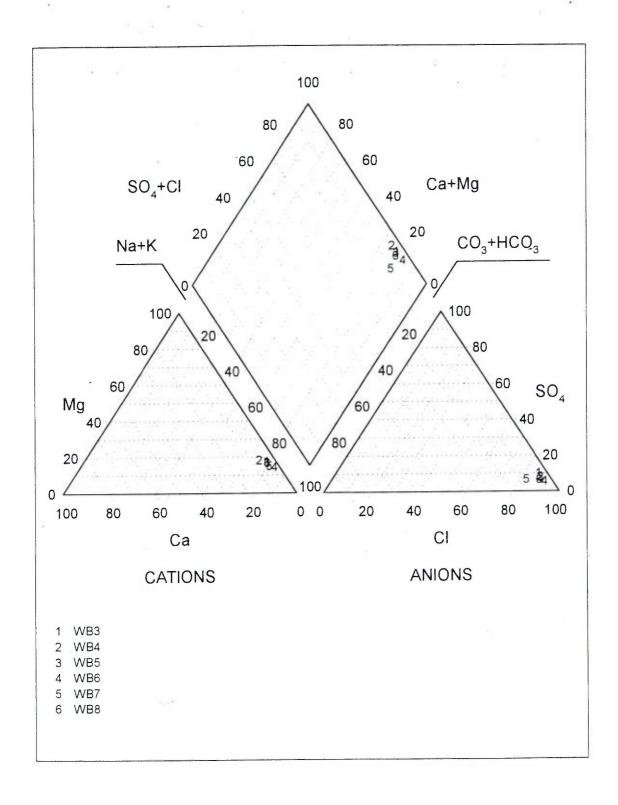
Figure 1 - Piper Diagram Showing Ionic Concentration Percentages in Groundwater Bores from Marsden Park

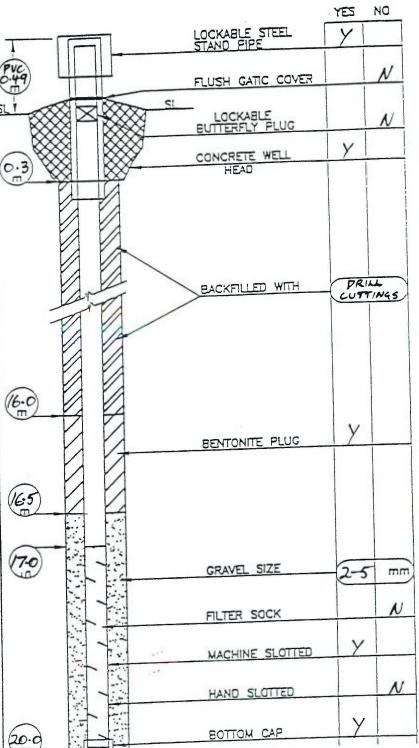
Bore No. : WB3

DRILLING METHODS
FROM TO

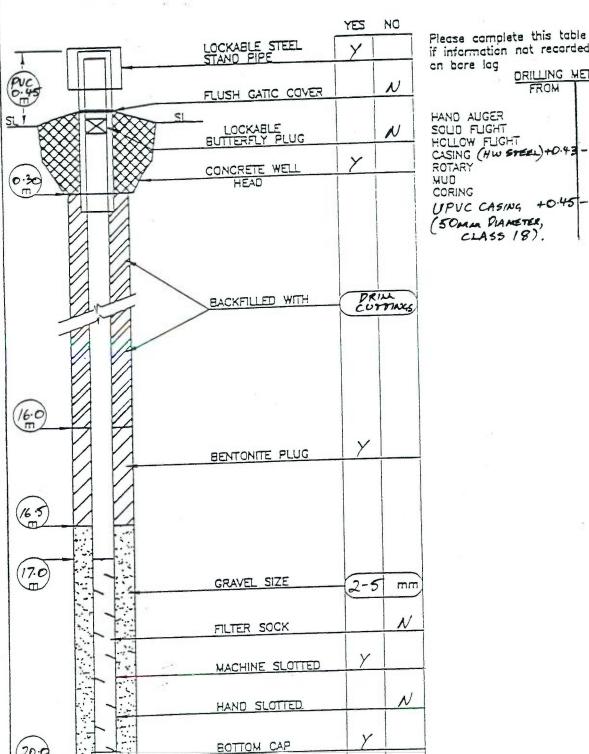
Bore No. : WB7_

if information not recorded on bore log DRILLING METHODS FROM HAND AUGER SOUD FLIGHT HOLLOW FLIGHT CASING (HW STEEL)+0.43-0.5% ROTARY MUD CORING UPUC CASING +0.45-20-02 (50 MM PLAMETER, CLASS 18).

WAS ANY GROUNDWATER NOTED: NO - BORE PRIMED WITH WATER

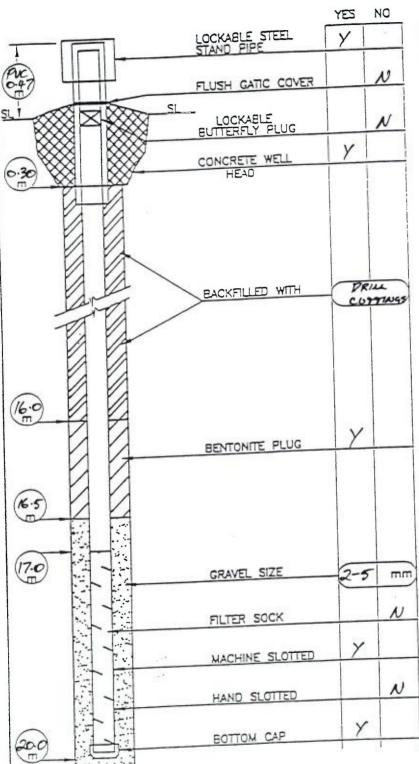
WB8

Please camplete this table if information not recorded on bore log DRILLING METHODS FROM HAND AUGER SOUD FLIGHT HOLLOW FLIGHT CASING (HW STEEL)+0.45 -0.55 ROTARY MUD CORING UPVC CASING +0.47 -20.00 (50mm DIAMETER, CLASS 18).

NO -BORE PRILLED WITH WATER. WAS ANY GROUNDWATER NOTED:

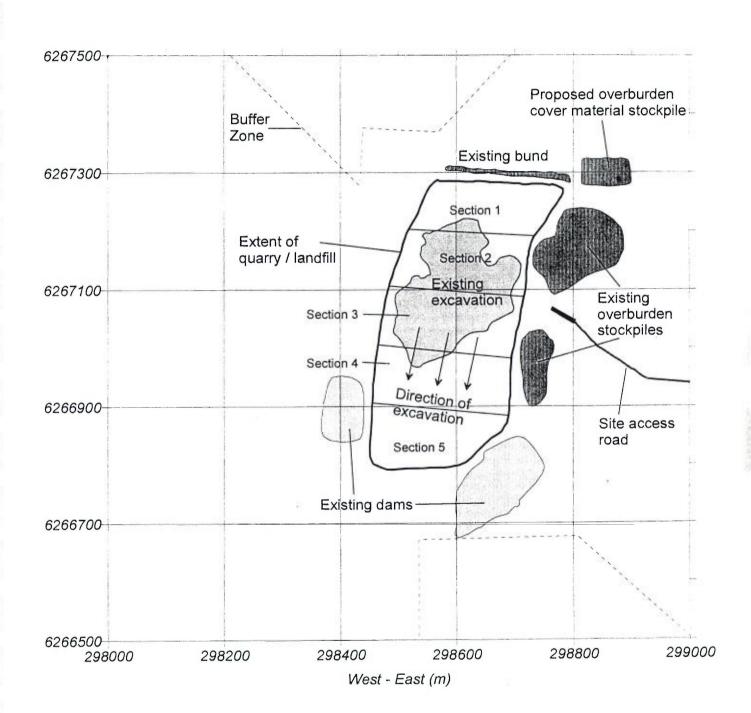
LAYOUT OF PROPOSED SITE

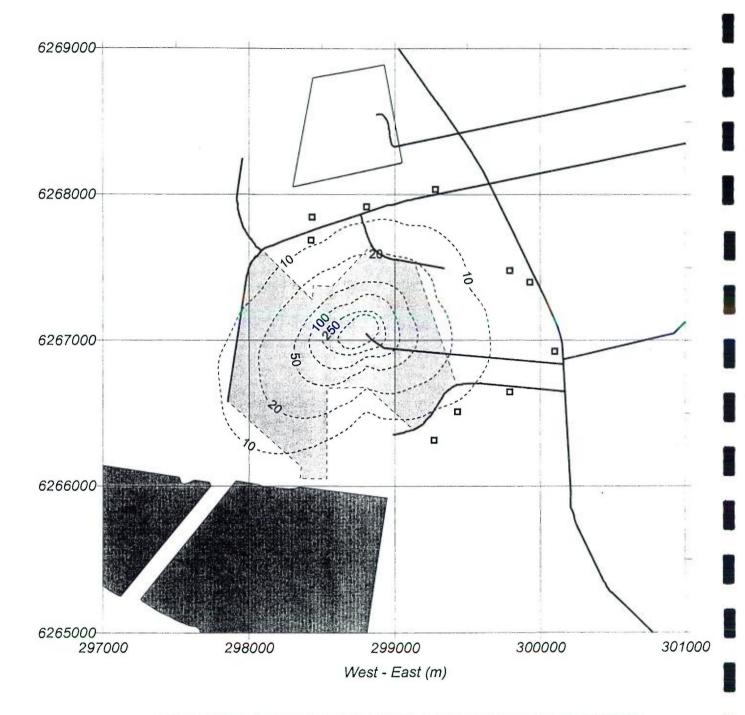
PREDICTED ANNUAL AVERAGE TSP CONCENTRATION DUE TO QUARRY OPERATIONS AT MARSDEN PARK - $\mu g/m^3$

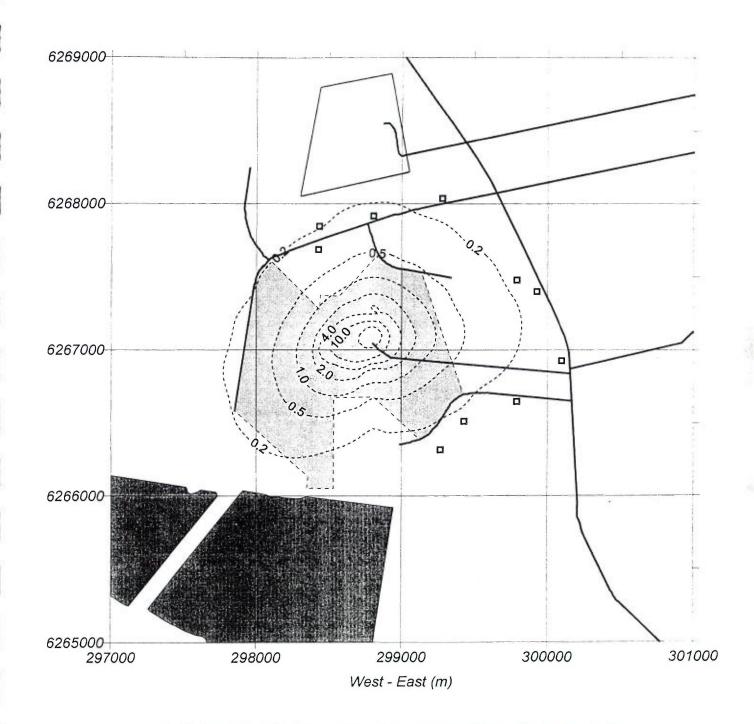
PREDICTED ANNUAL AVERAGE DUST DEPOSITION DUE TO QUARRY OPERATIONS AT MARSDEN PARK - g/m²/month

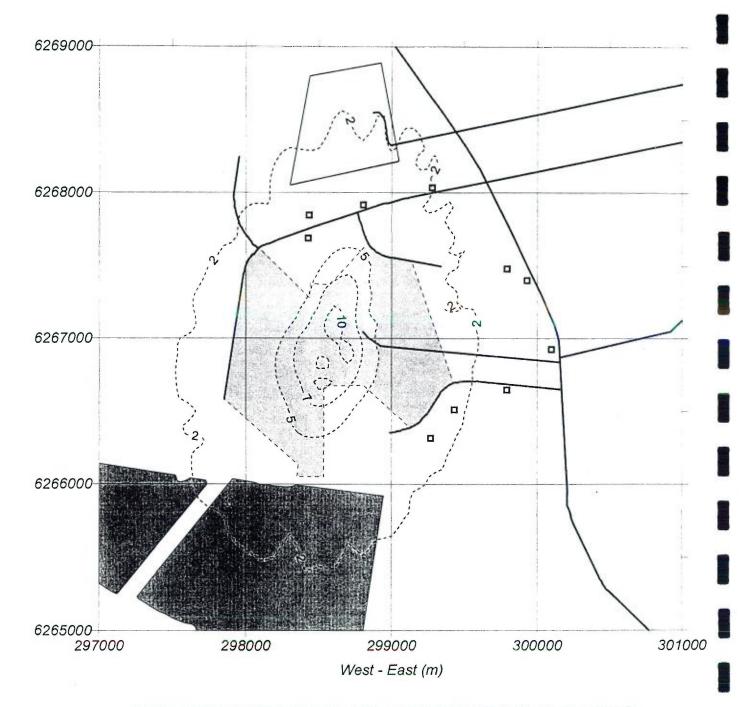
PREDICTED MAXIMUM 3-MINUTE AVERAGE ODOUR (NEAR FIELD) CONCENTRATIONS DUE TO LANDFIILL OVER THE WHOLE SITE AT MARSDEN PARK (odour units)

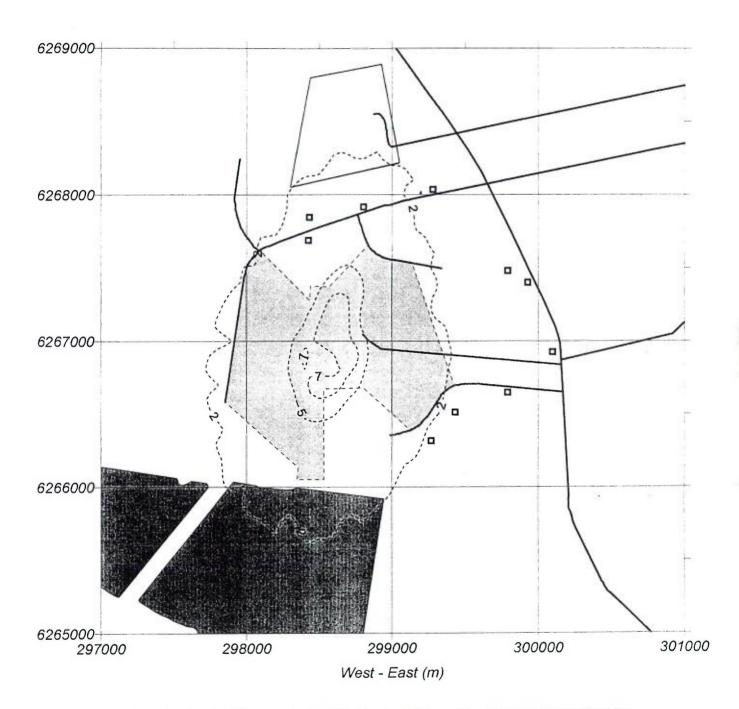
PREDICTED MAXIMUM 3-MINUTE AVERAGE ODOUR (FAR FIELD) CONCENTRATIONS DUE TO LANDFIILL OVER THE WHOLE SITE AT MARSDEN PARK (odour units)

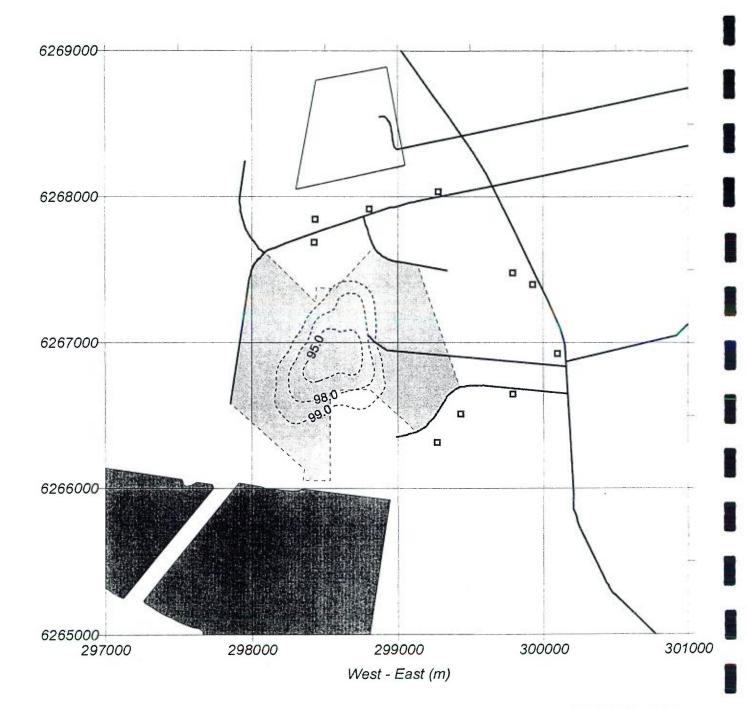
PERCENTAGE COMPLIANCE WITH THE 2 ODOUR UNIT URBAN GOAL ASSUMING THE LANDFILL IS COMPLETE

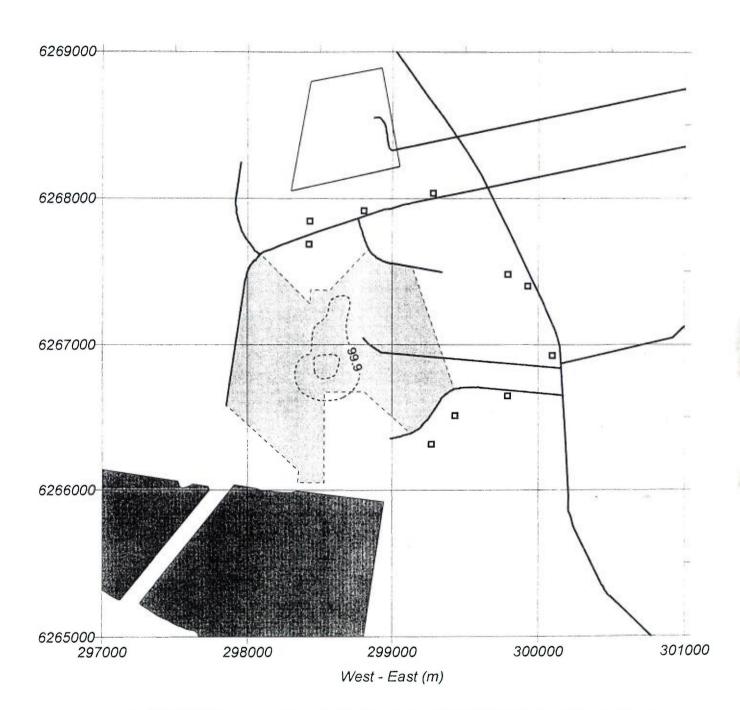
PERCENTAGE COMPLIANCE WITH THE 7 ODOUR UNIT RURAL GOAL ASSUMING THE LANDFILL IS COMPLETE

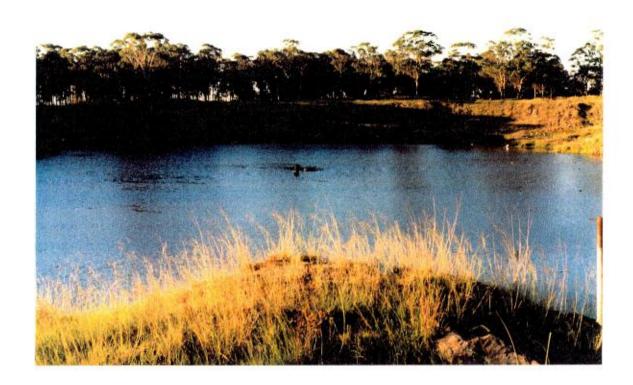
PLATES 1 & 2 The existing quarry contains water and provides some limited resources for native fauna, including waterbirds. The artificial nature of the quarry and the lack of riparian or aquatic vegetation substantially reduces its quality as a resource for native fauna. The majority of the woodland in Plate 1 is to be retained, whilst some of the trees in the background of Plate 2 will require removal.

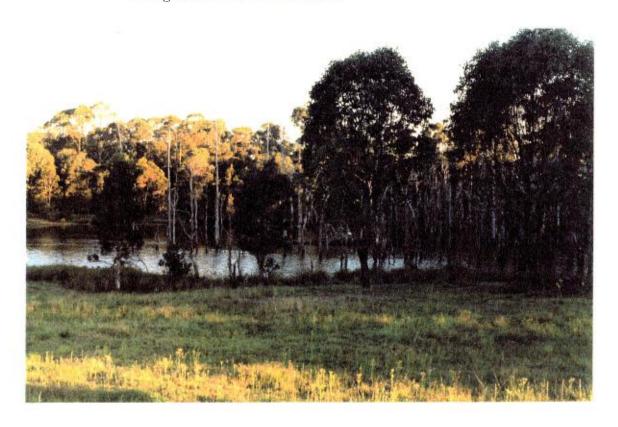
PLATE 4 The artificial wetland to the south of the existing quarry provides an array of resources for native fauna, particularly waterbirds which roost in the dead trees. Reeds, sedges and mudflats provide foraging and shelter resources for native fauna. This wetland is to be avoided and conserved.

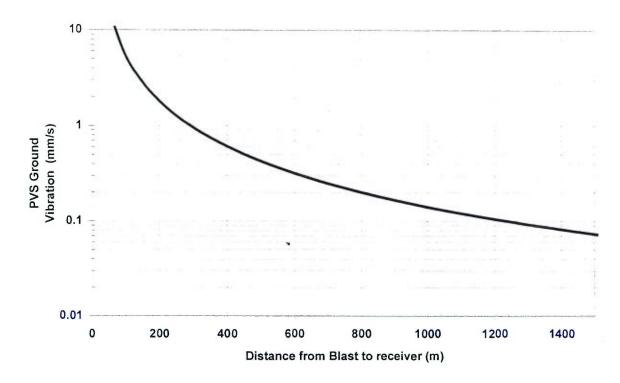
Figure 9.1.1 Peak Vector Sum Ground Vibration

The relationship between distance and the peak vector sum (PVS) ground vibration and peak airblast from blasting on the subject site are presented in **Figure 9.1.1** and **Figure 9.1.2** respectively, for a maximum instantaneous charge weight of 13 kg.

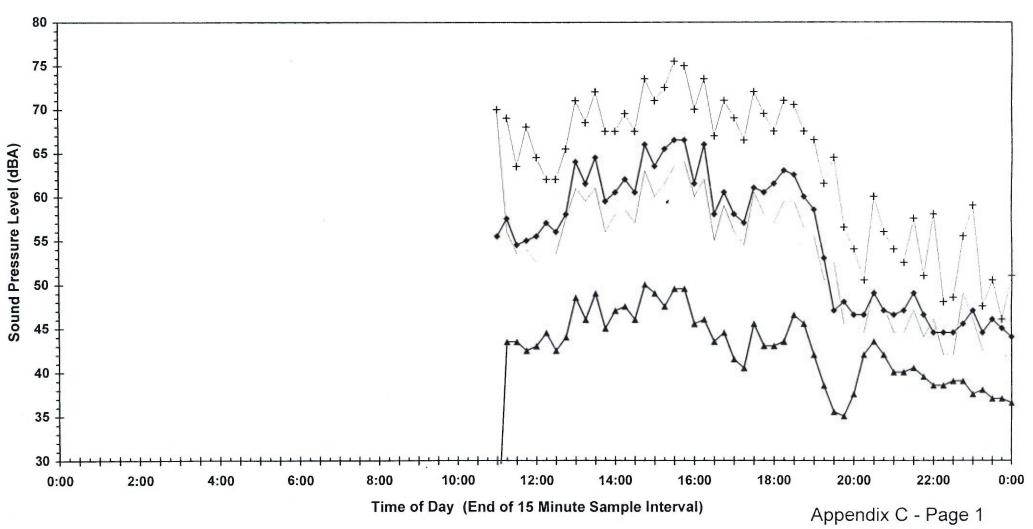
Statistical Ambient Noise Levels Noise Monitoring Location A, 311 South Street - Friday 14 November 1997

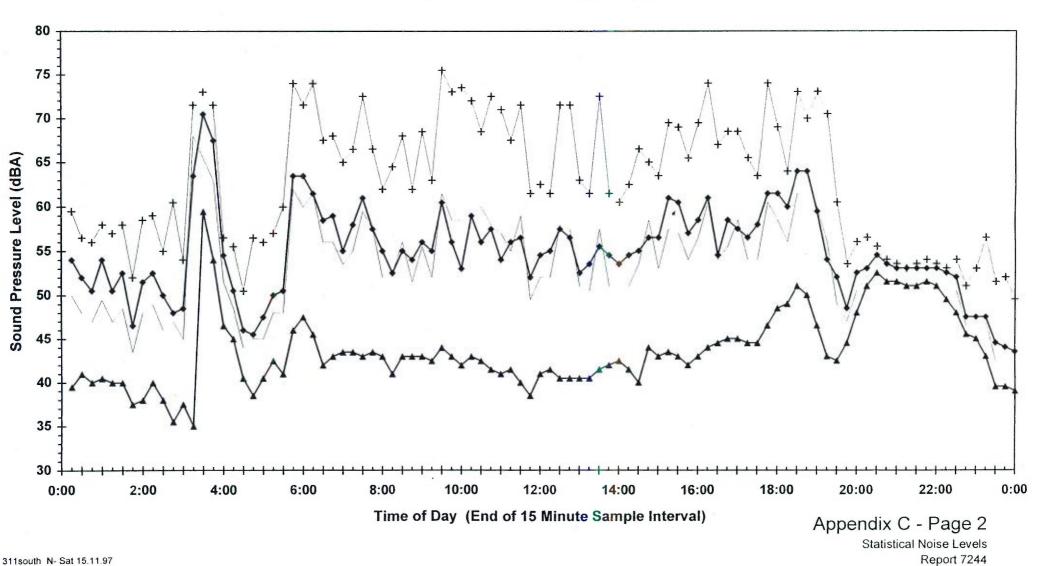
Statistical Ambient Noise Levels Noise Monitoring Location A, 311 South Street - Saturday 15 November 1997

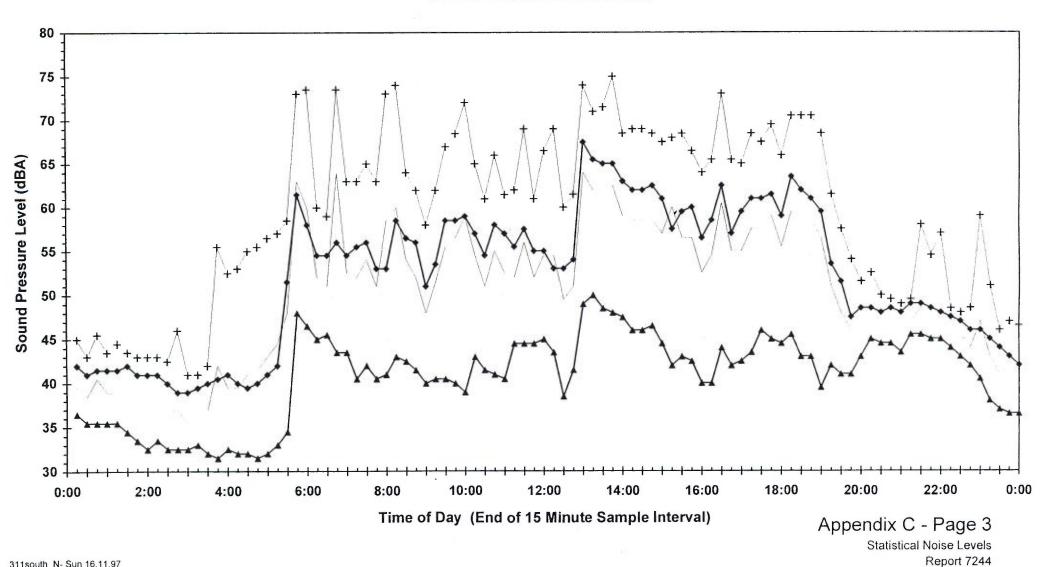
Statistical Ambient Noise Levels Noise Monitoring Location A, 311 South Street - Sunday 16 November 1997

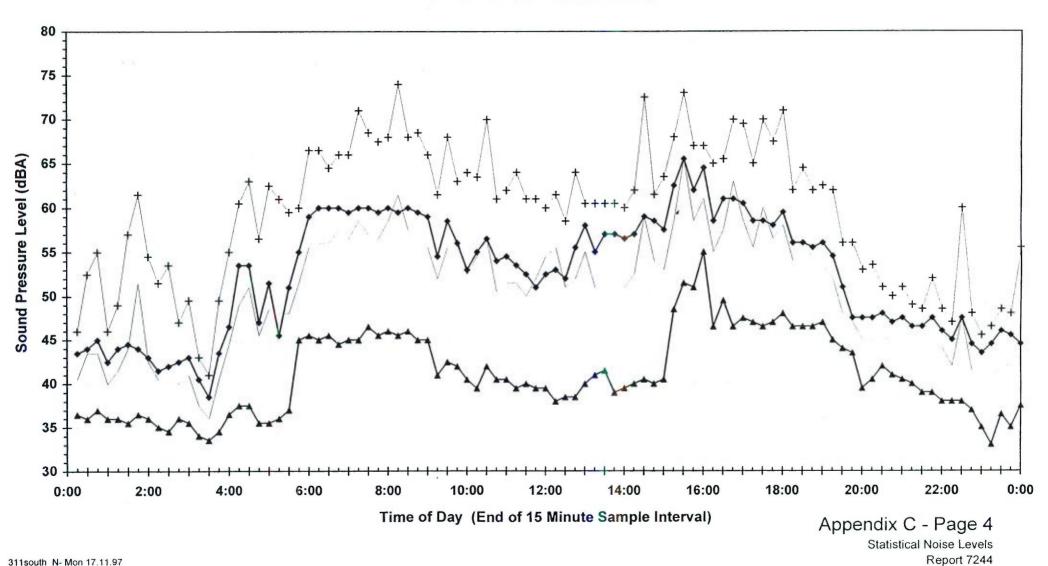
Statistical Ambient Noise Levels Noise Monitoring Location A, 311 South Street - Monday 17 November 1997
