Environmental investigations and rehabilitation considerations  
at the Ottery Mine, Emmaville, N.S.W.

NSW DEPT PRIMARY INDUSTRIES

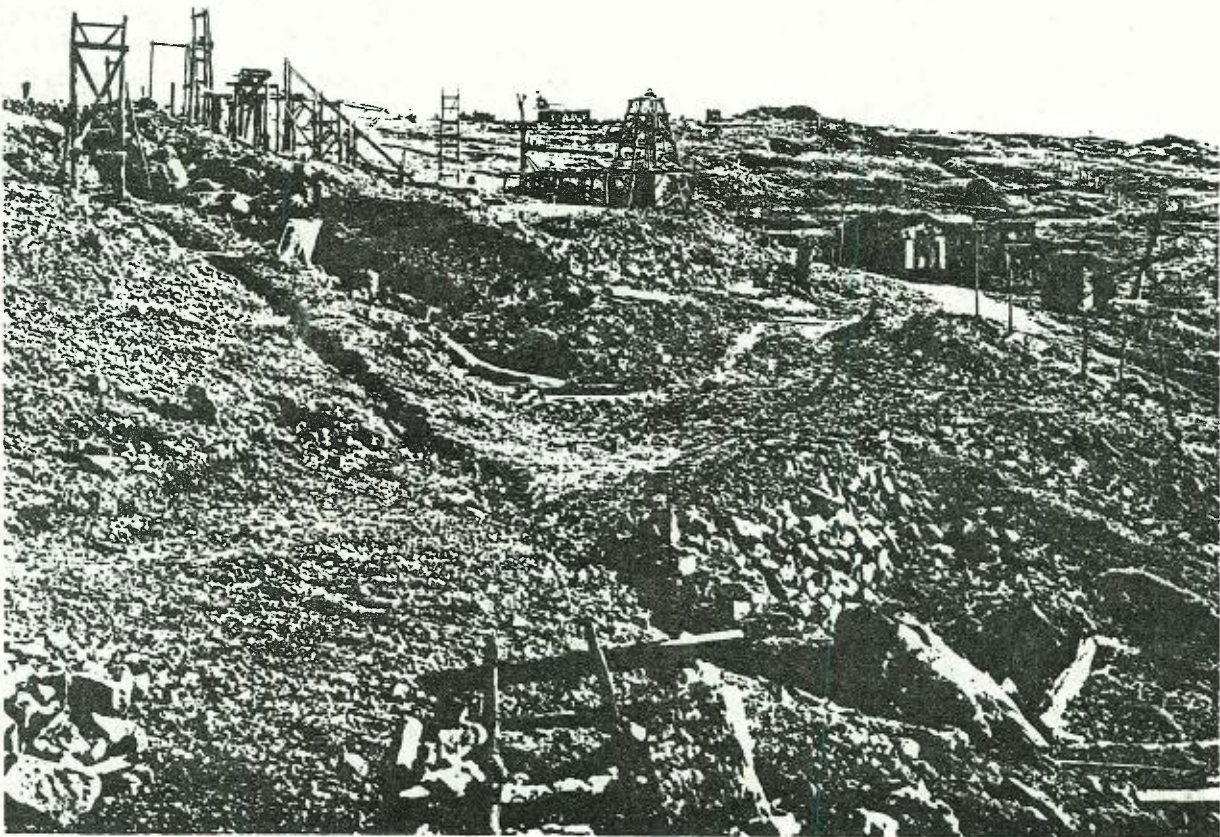
Plate 1. The Ottery tin workings 1906. Photograph reproduced from Carne (1911).

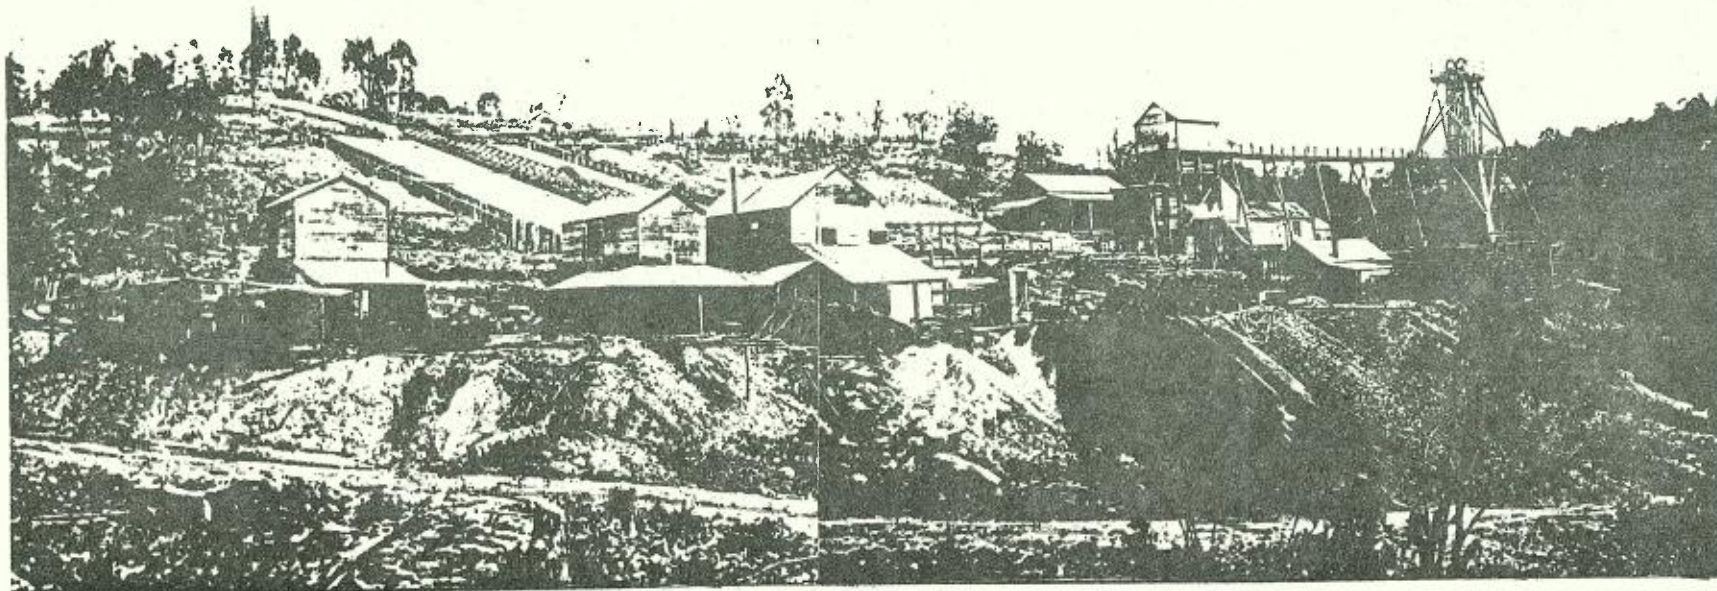
Plates 2 and 3. The Ottery mine and arsenic refining plant in 1922. (Photos courtesy of H. Julius). Below, the remains of the site as they are today.

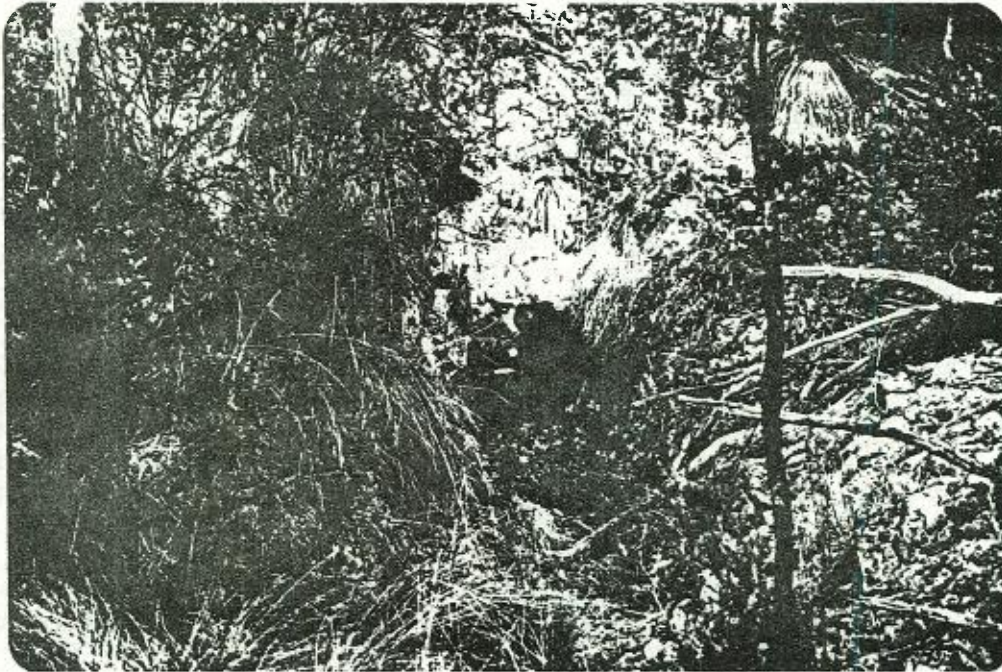
Plate 7. Open portal to No.1 adit.

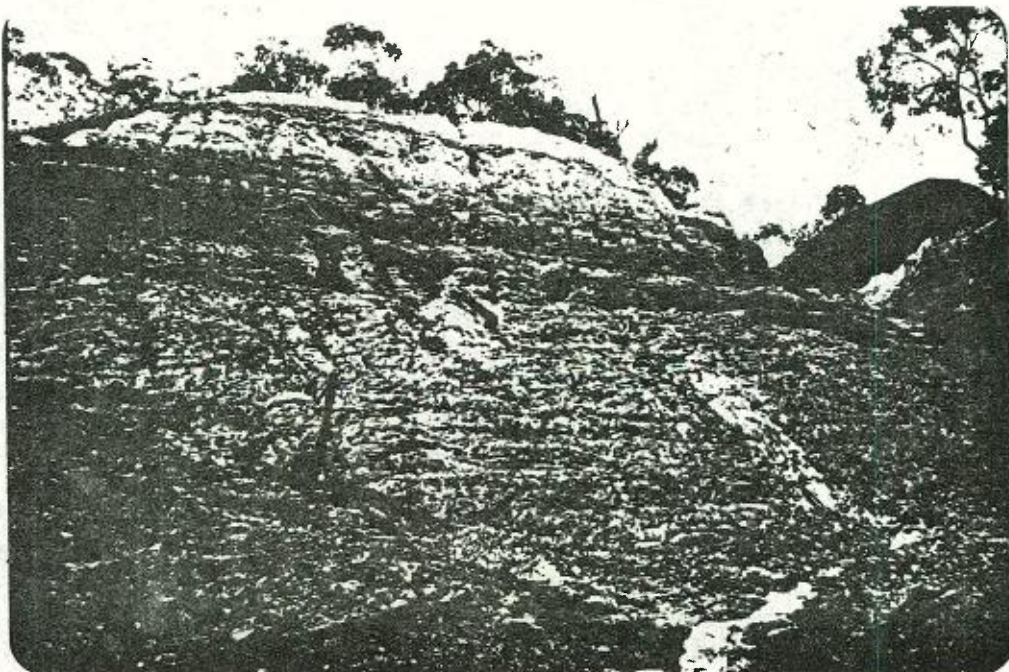
Plate 14. Water seepage through one of the bottom layers  
of the slimes dump.
