Proposed sand & soil extraction : Nepean River & environs,
Menangle NSW : environmental impact statement

PROPOSED SAND & SOIL EXTRACTION NEPEAN RIVER & ENVIRONS MENANGLE NSW

APPENDICES

APPENDIX I	Director's Specifications
APPENDIX II	Cross-sections of Extraction Area
APPENDIX III	Report on Hydrology, Hydraulics, Geomorphology and Sedimentology
APPENDIX IV	Air Emission Assessment
APPENDIX V	Noise Impact Assessment
APPENDIX VI	Traffic Impact Report
APPENDIX VII	Archaeological Survey
APPENDIX VIII	Extraction and Rehabilitation Report

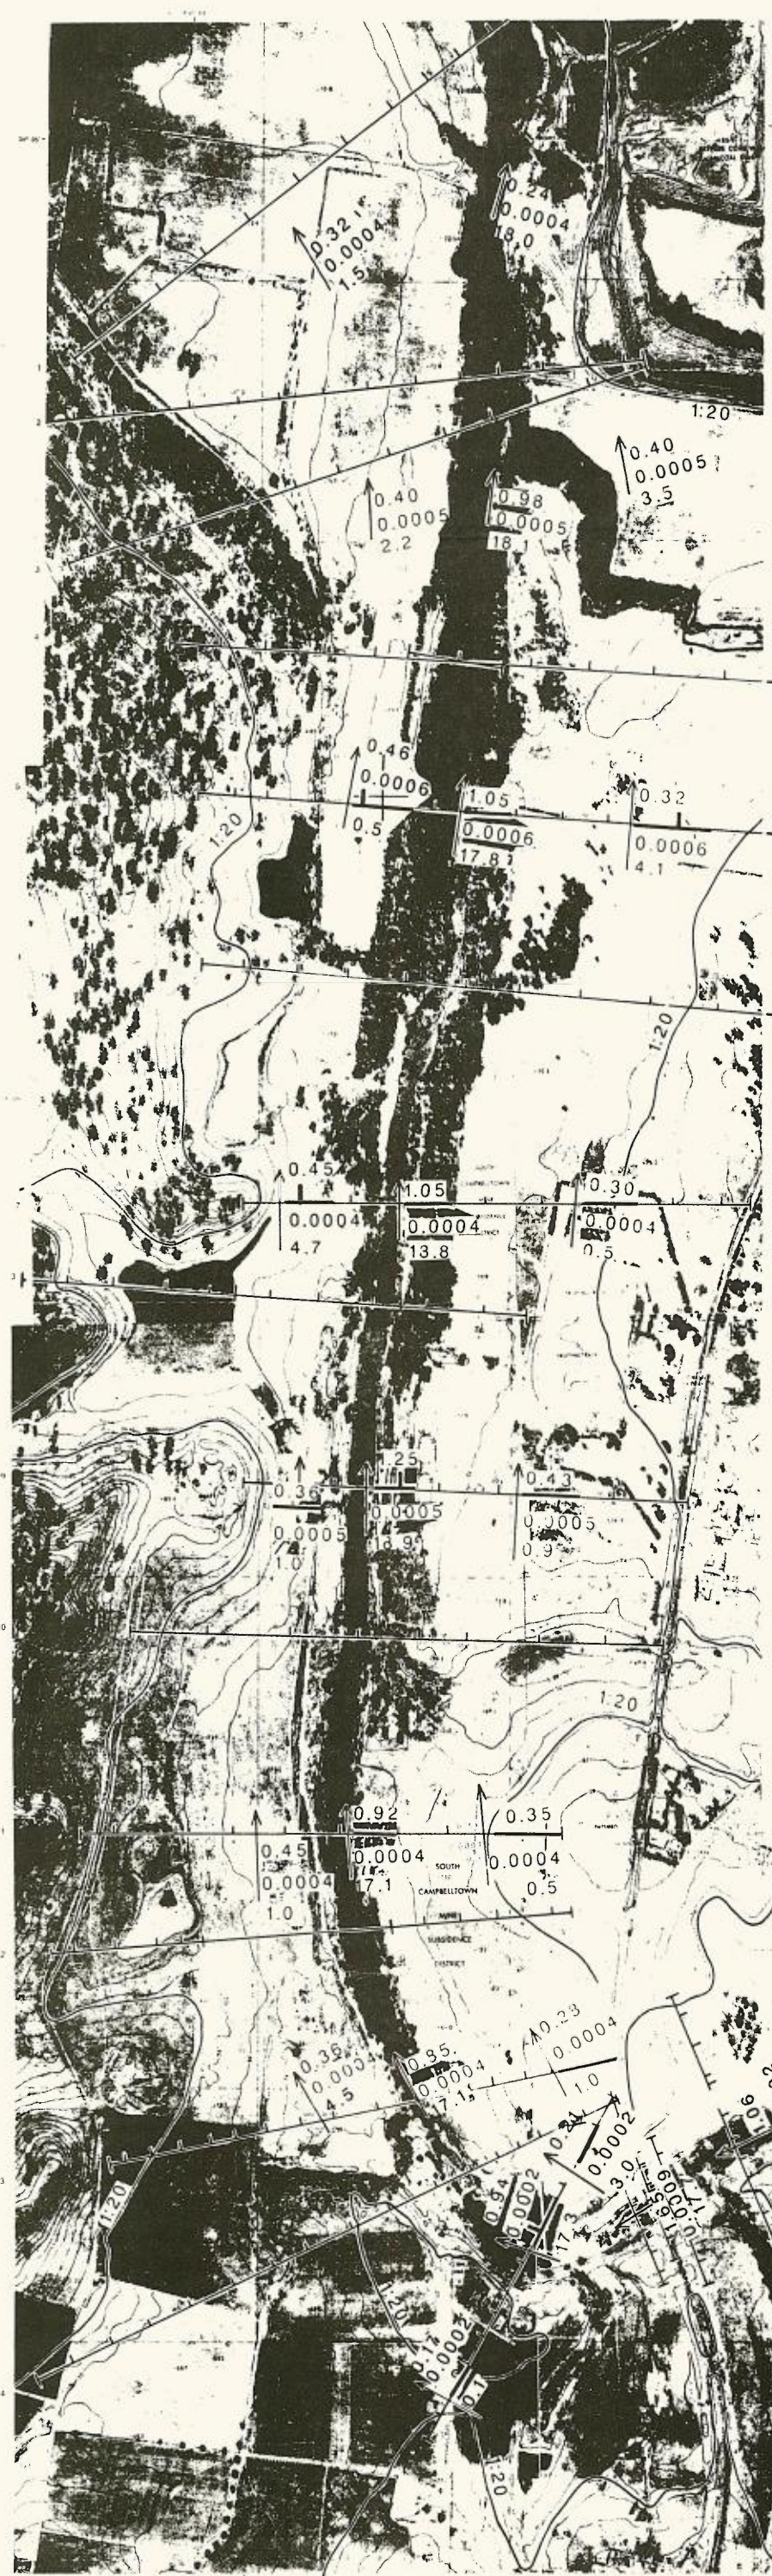
Fig. 3.8

**FLOOD
HYDROLOGY
AND
HYDRAULICS**

determined for that reach of river at cross section 7 in Fig 3.8.

Estimates of sediment load at cross section 7
(see Fig 3.8)

The change has been assessed by applying the HEC-2 backwater model used in Chapter 3.5 to the channel and floodplain of the Nepean River as it would exist at the completion of the operations and comparing the differences between the results of the model applied to the present river system (Fig 3.8) and the future river system. Table 7.1 shows the changes in channel hydraulics at the significant cross sections along the river as computed by the HEC-2 model for the two channel and floodplain configurations.

Velocity, depth and slope changes
along the Nepean River at Menangle
as a result of extraction
-for the 20 year flood
(refer to Fig 3.8 for cross sections)
