Proposed rock crusher and screening plant allied to increased
extraction capacity at approved sand and gravel operation :
portion 22, Parish of Gungoandra, County Beresford, Shire of
Cooma-Monaro : environmental impact statement

**PROPOSED ROCK CRUSHER
AND SCREENING PLANT
ALLIED TO INCREASED
EXTRACTION CAPACITY AT
APPROVED SAND AND
GRAVEL OPERATION**

**PORTION 22 PARISH OF
GUNGOANDRA COUNTY BERESFORD,
SHIRE OF COOMA-MONARO**

**ENVIRONMENTAL IMPACT
STATEMENT**

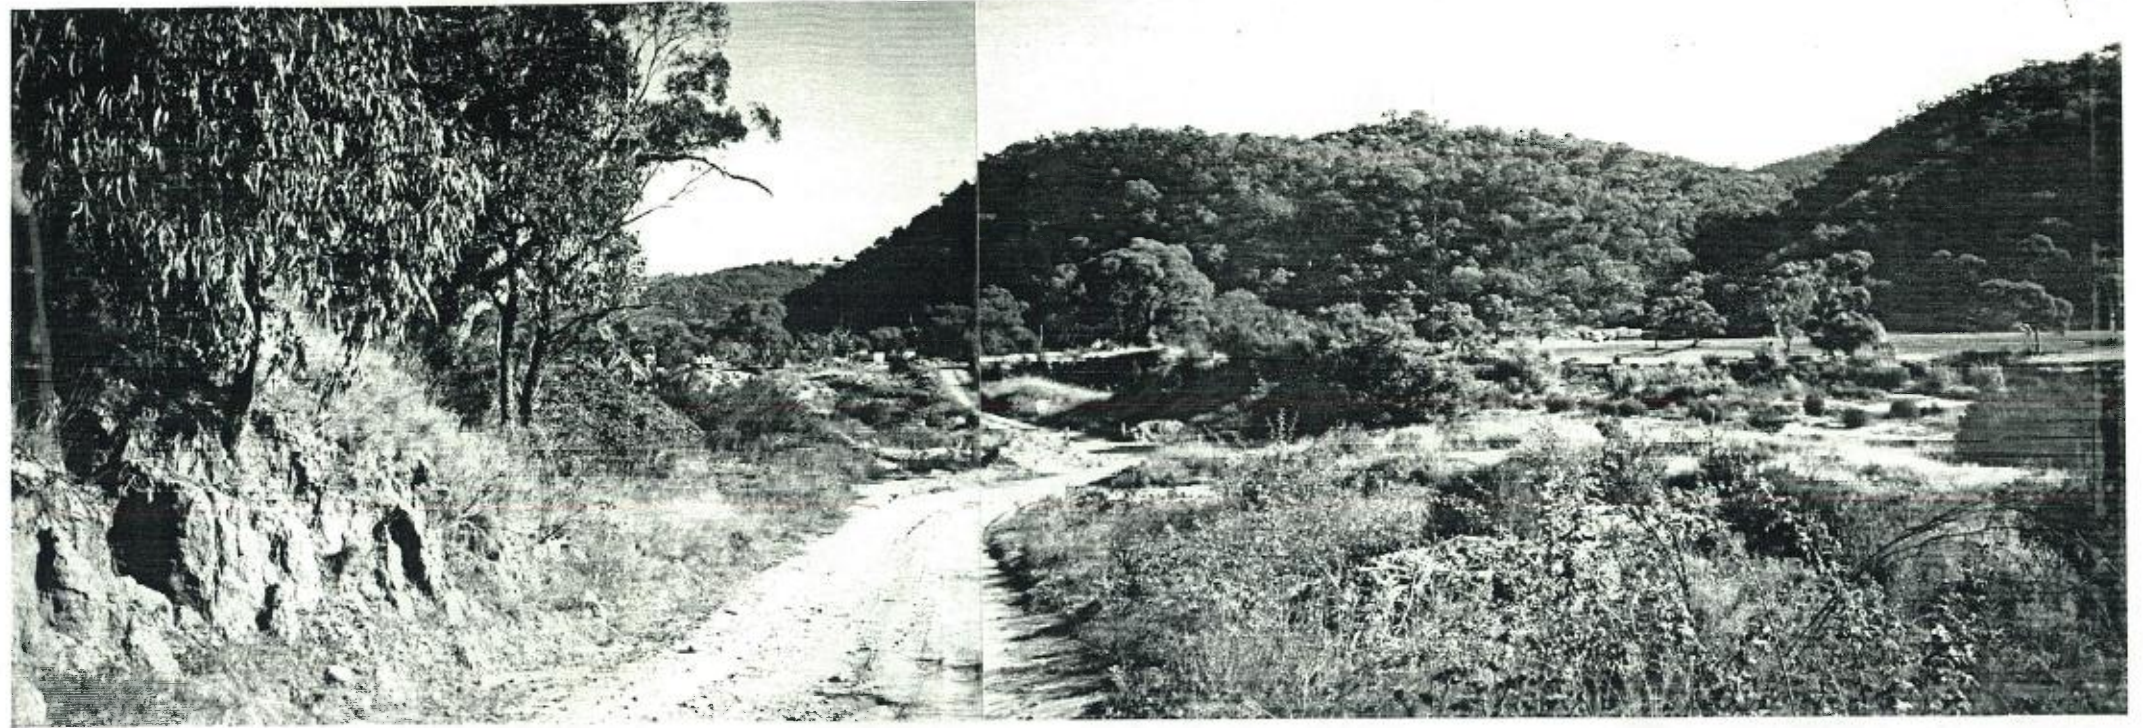
PLATE 1: The access road immediately north of the site. The gateway (middleground low point) is the northern boundary of the site. The main extraction area can be viewed centre left and the vegetation buffer (woodland) to remain is centre right.

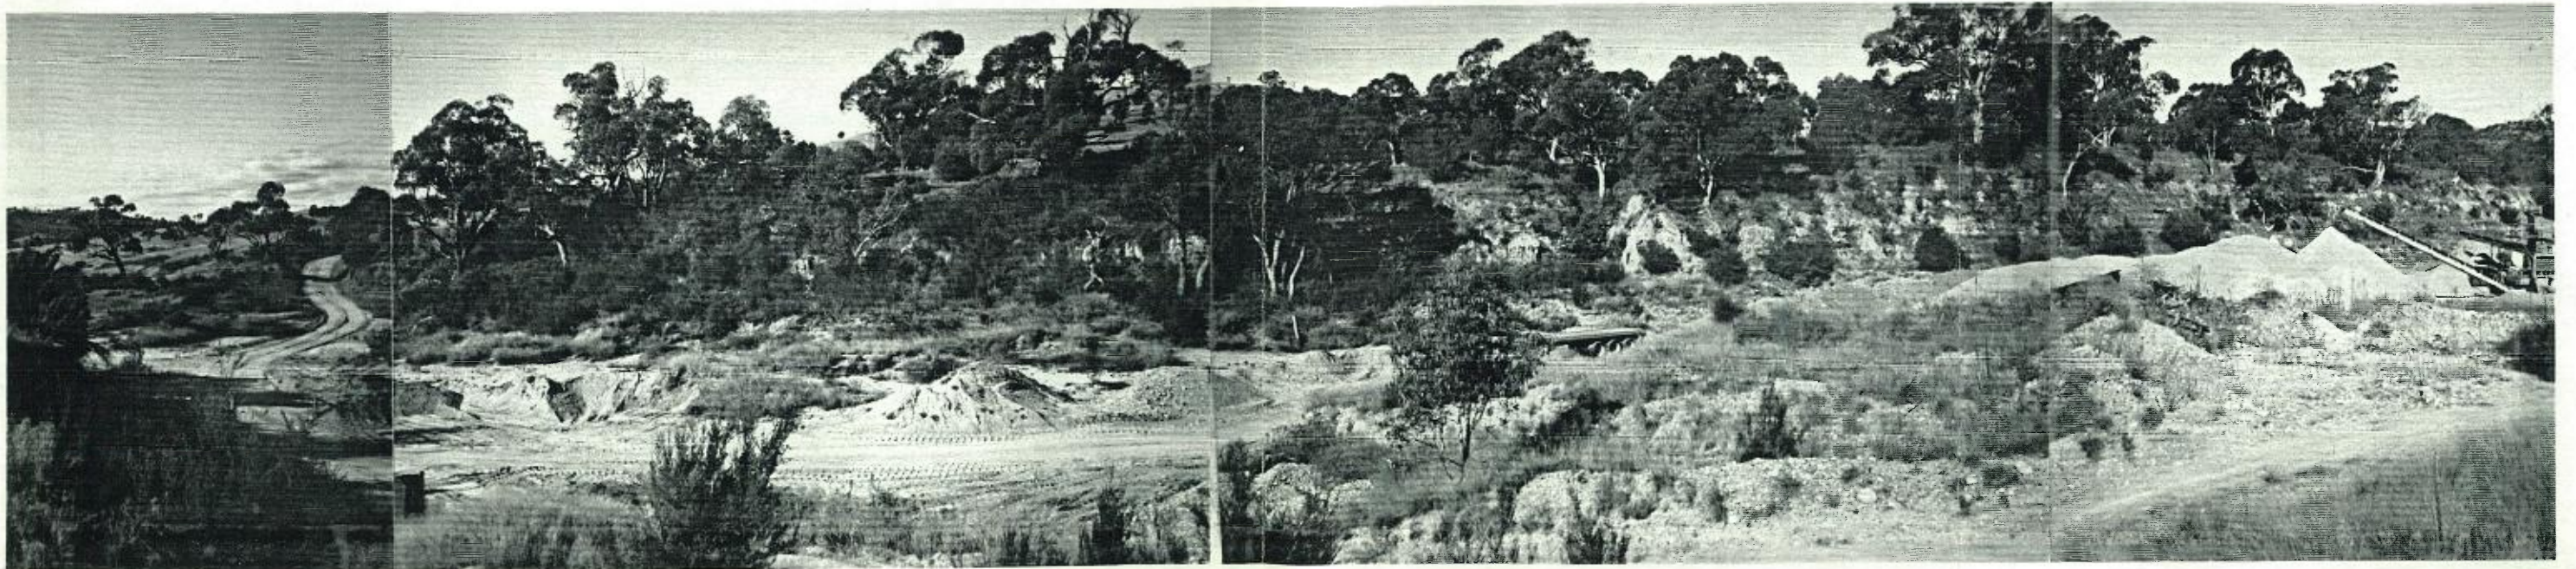
PLATE 1 & 2 Views of the northern entry and main extraction area

PLATE 2: The current main extraction area with the access road left and in the background the wooded eastern hill to remain. The steep slopes will be undisturbed. The main water quality control pond to be formed in the centre low point.

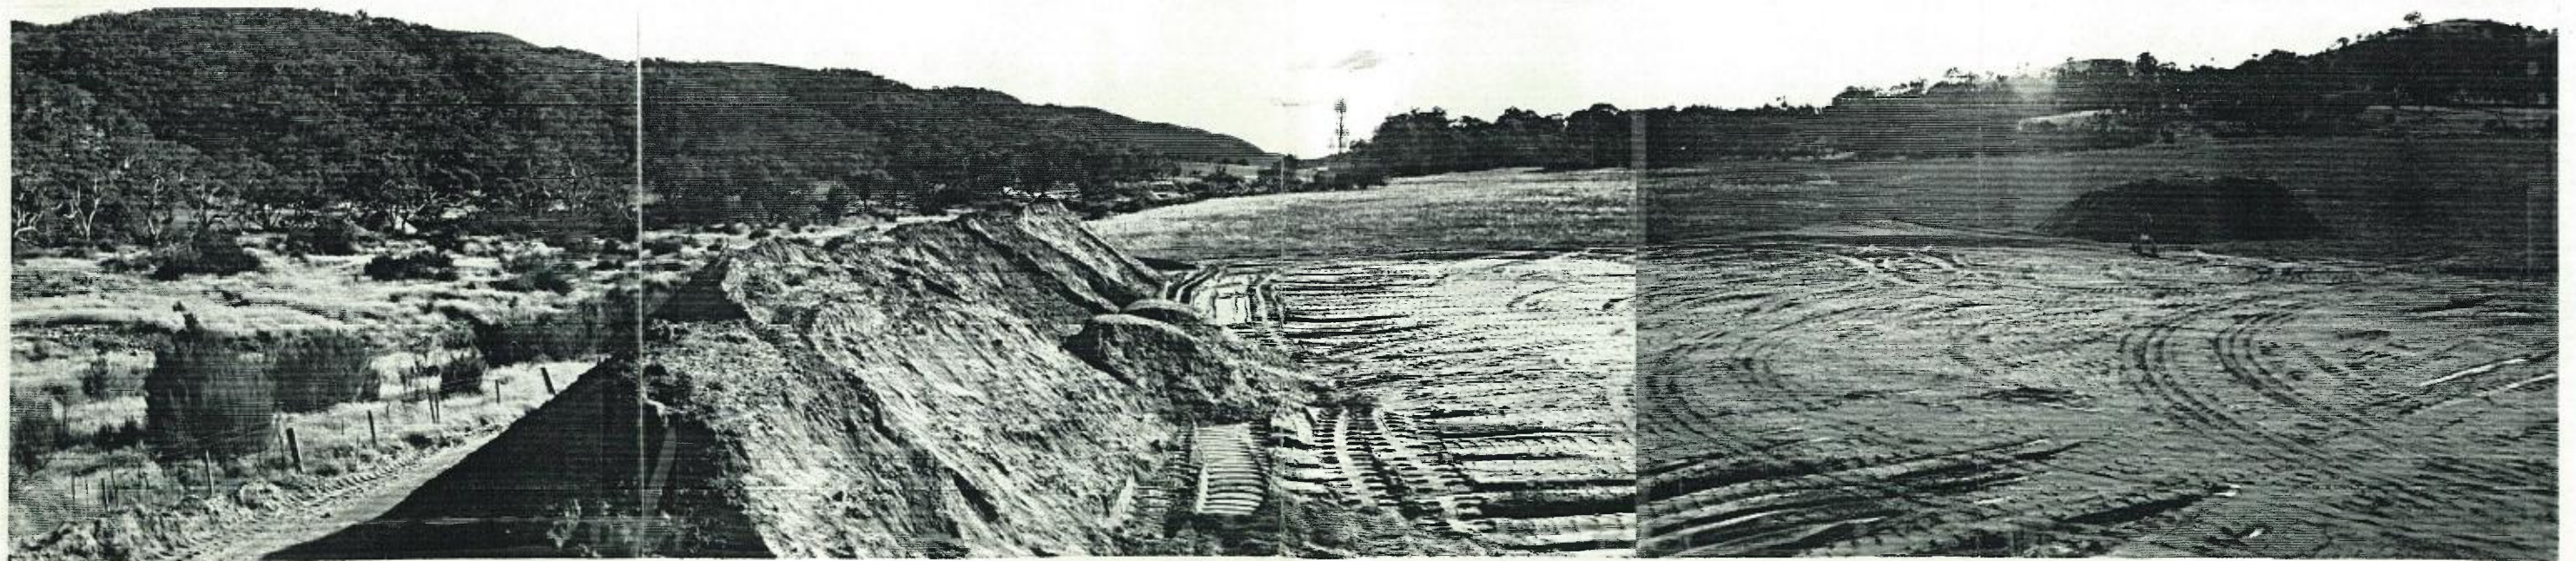
PLATE 3 & 4 Views (200°) from the dark sand extraction area across the alluvial flats

PLATE 4: View to the north west (middleground left) of the wooded riparian buffer zone to remain. The current main extraction area (centre left background) and main expansion area (centre middleground). The wooded hill to remain is right background. The pasture paddock (right foreground) is the proposed dark sand extraction area. Current stripped area and stockpiles in the foreground.

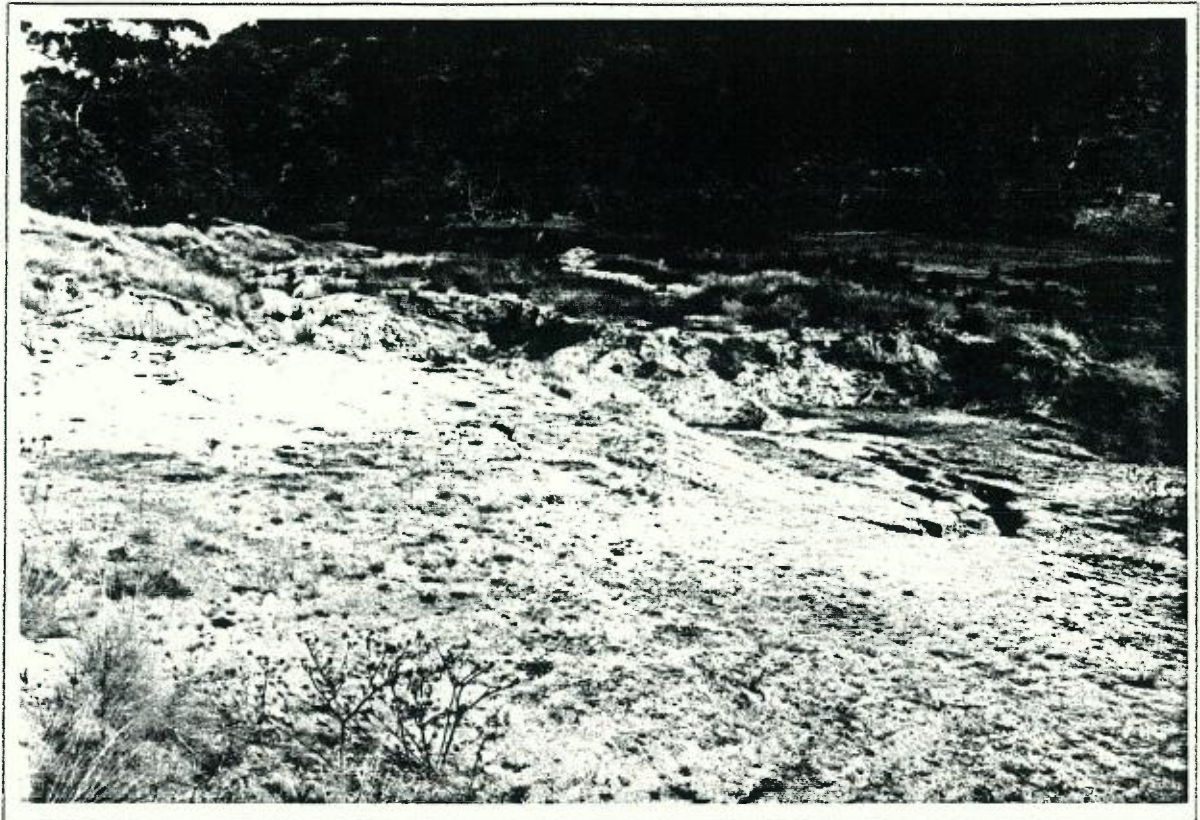
Plate 2: View of quarry area in sand terrace (a) located adjacent to riverbank.

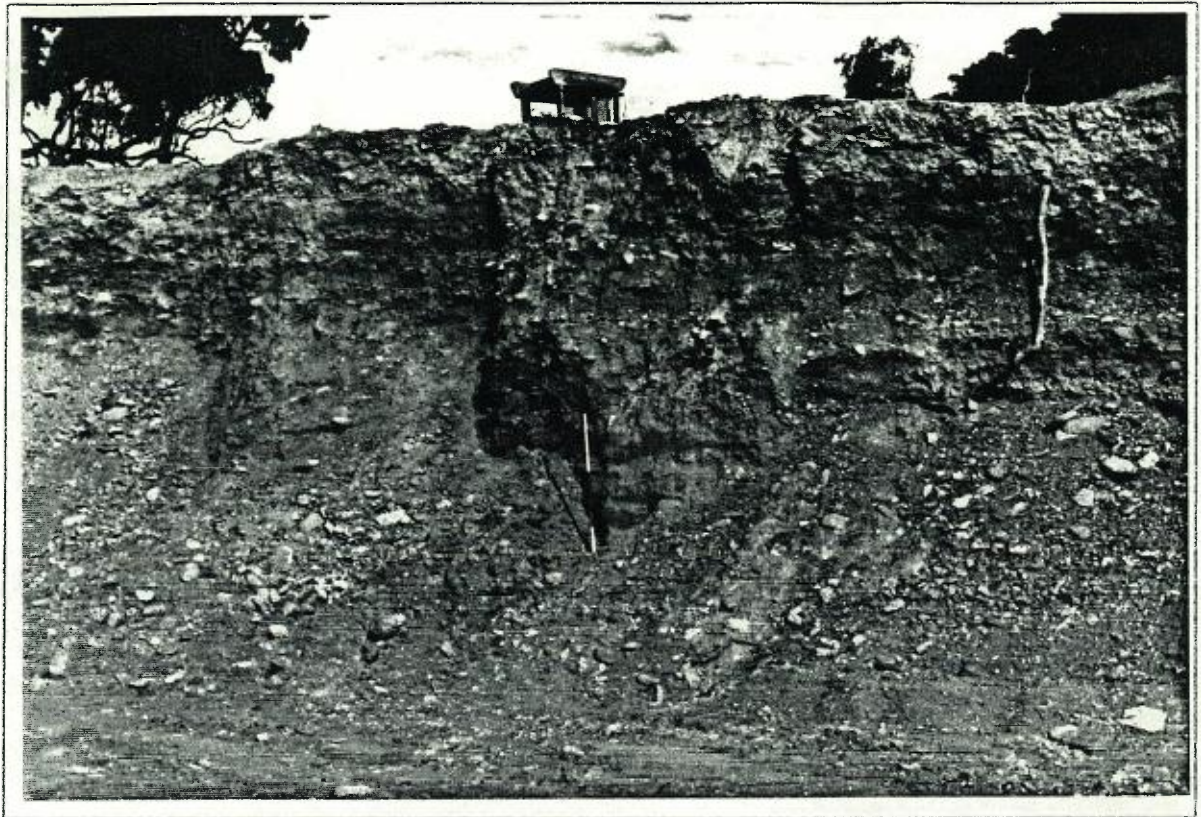
Plate 4: The southern quarry face in the gravel terrace deposit (b). Note poorly sorted silts and gravels, and horizontal bedding characteristic of a high energy depositional environment.

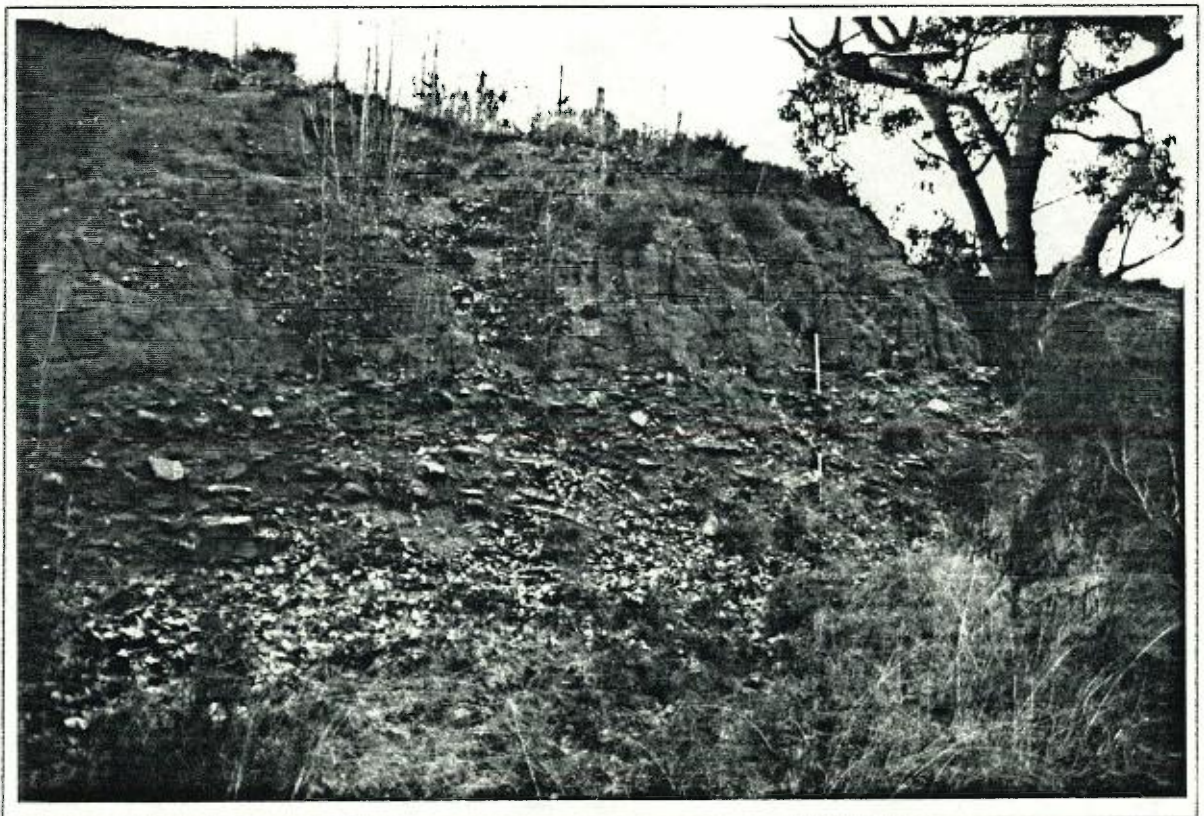
Plate 5: Stratigraphy exposed in the eastern bank of the flood channel. Note lower gravel deposit (terrace b facies) underlying finer sediments in upper portion.

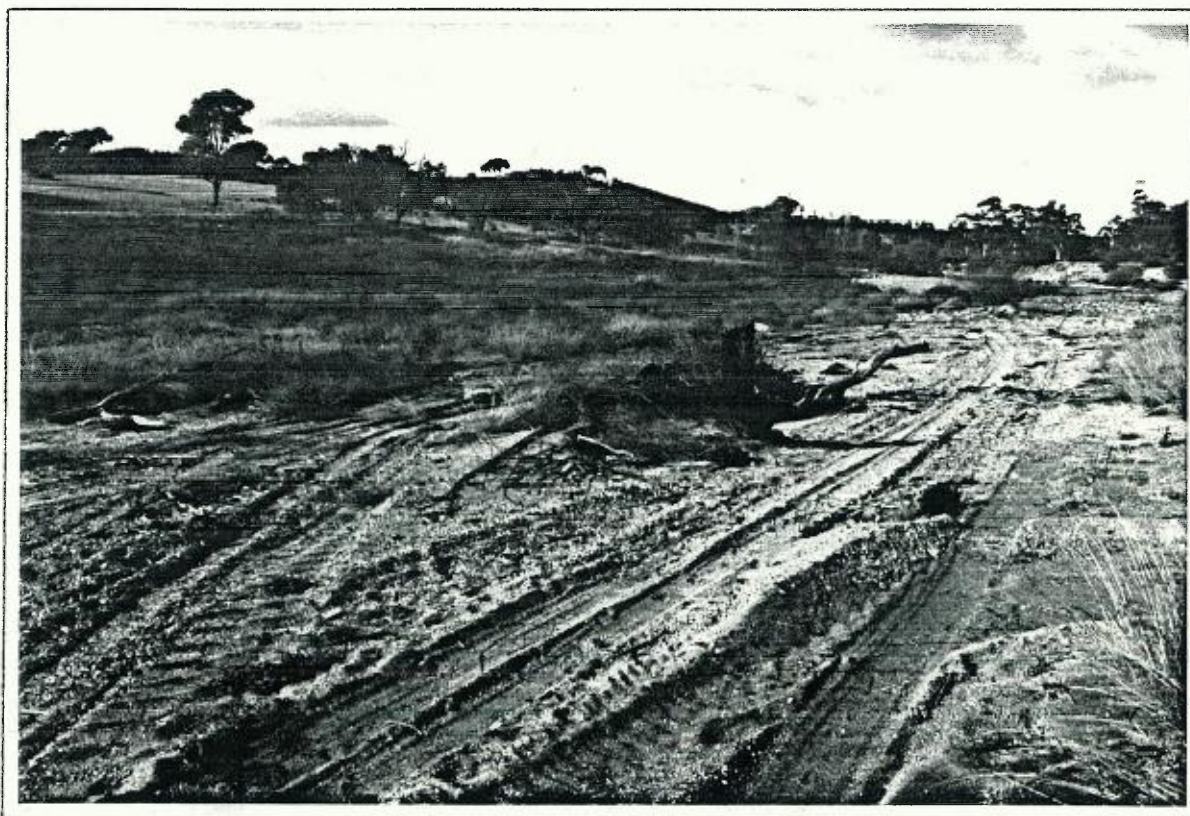
Plate 7: View of southern portion of study area, looking across flood channel toward site C3. Note mounds in middle foreground associated with previous quarrying.

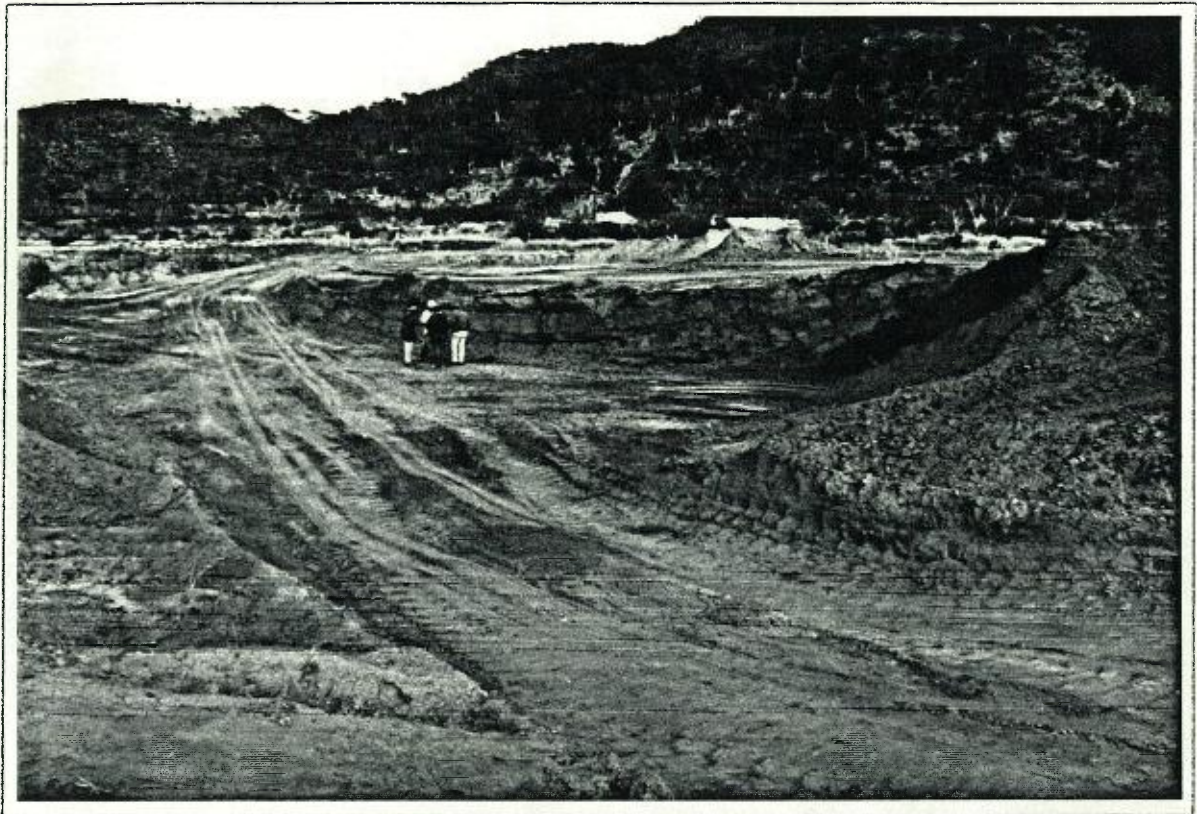
Plate 8: The western quarry face in the sandy silt deposits of terrace (c).

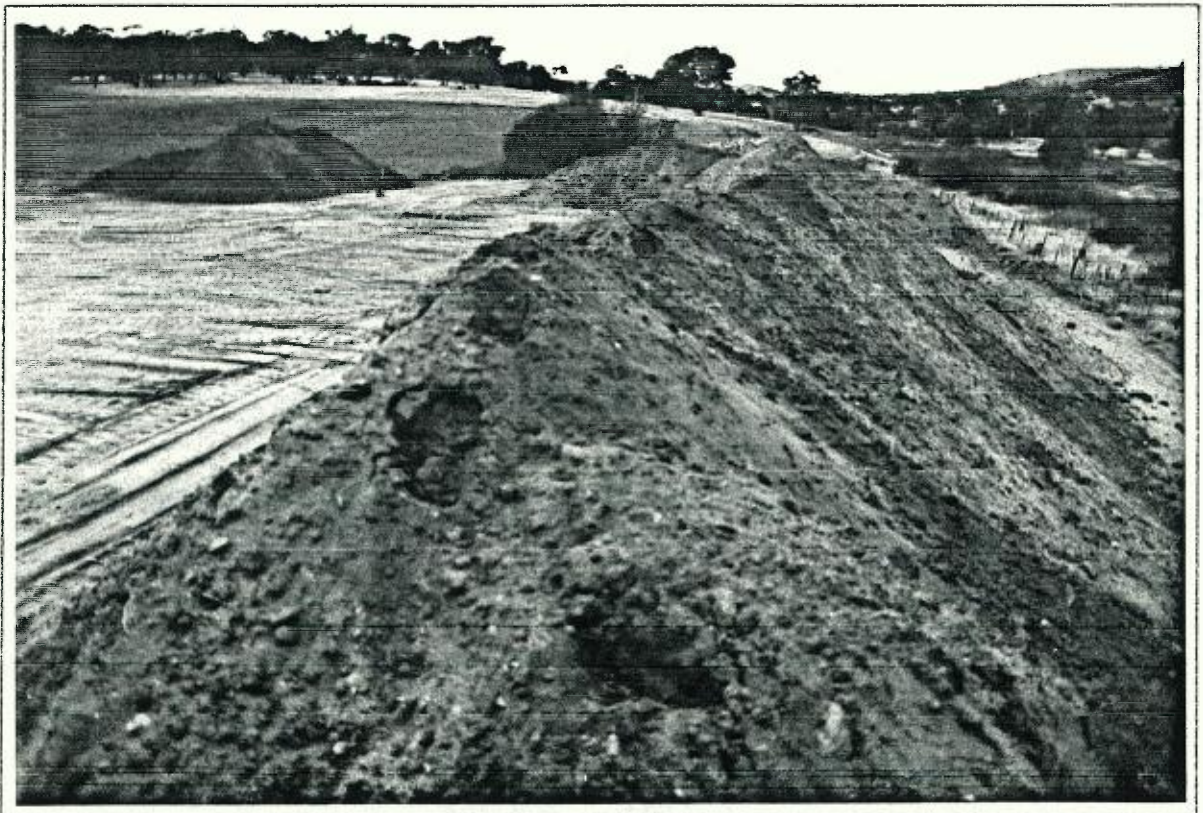
Plate 11: Stockpile area and associated surface stripping on terrace (c). Artefacts (site C4), were located near bag (top middle left) and by the fence line (far left).

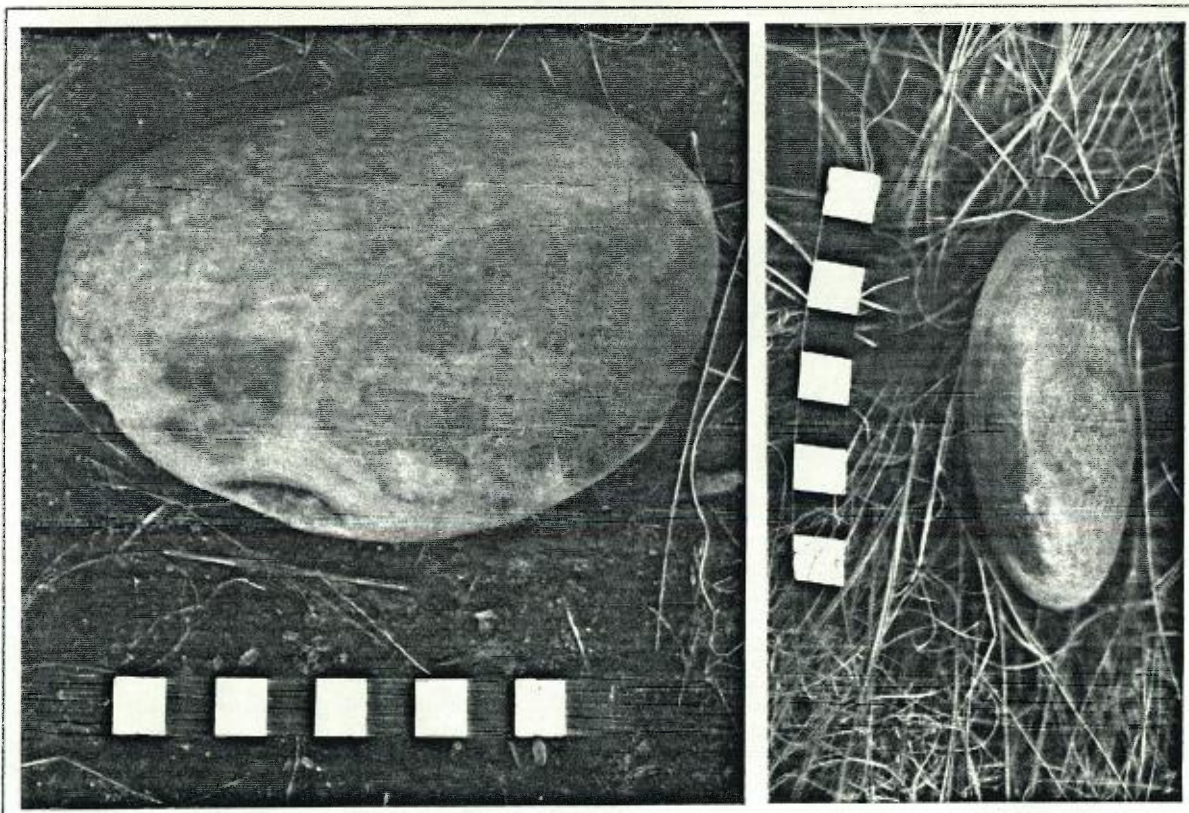
Plates 14, 15 & 16: The ground edge hatchet head located on the surface at site C1.

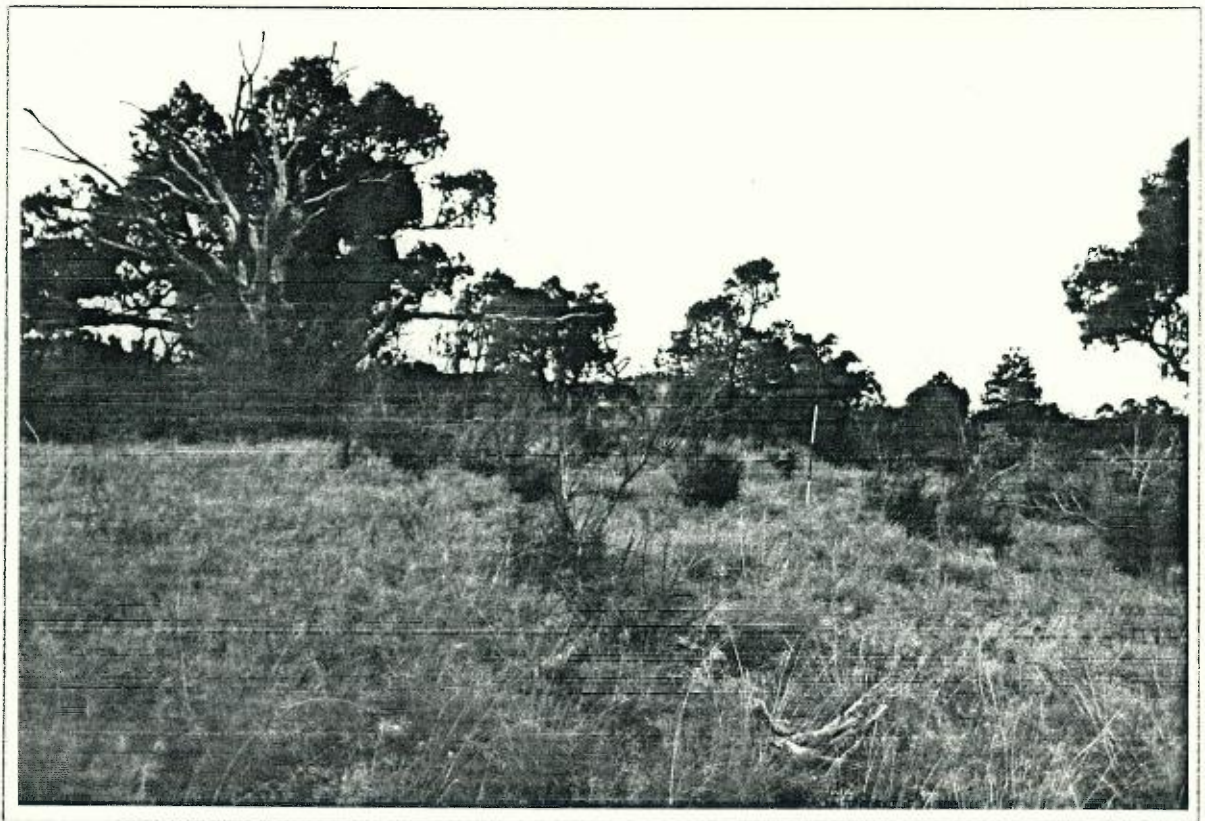
Plate 17: View of site C2 looking south. A backed blade was located at the ranging pole position.

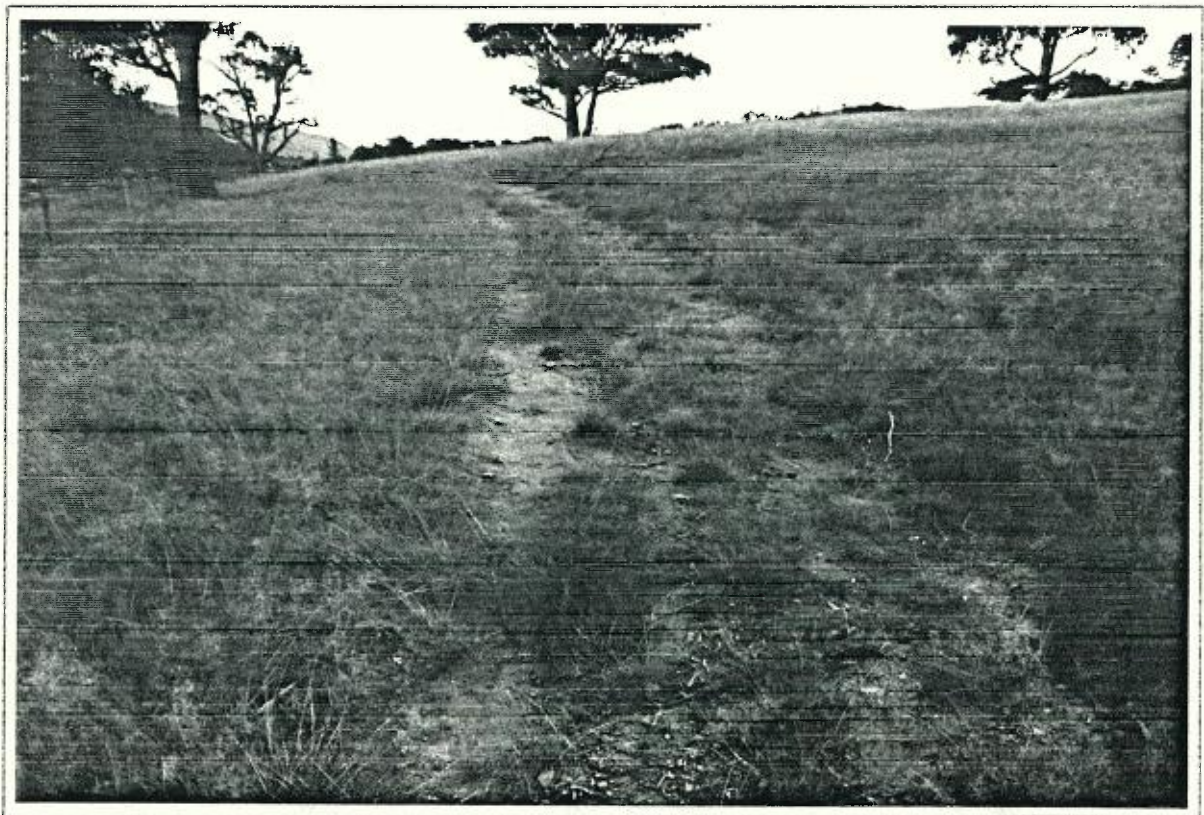
Plate 18: View of exposure 'b' in site C3, looking north. A low density surface artefact scatter occurs within the track exposure. Terrace sediments occur further downslope (see Plate 19).
