## Arboricultural Impact Assessment

Prepared For: Vincent Fairfax Family Foundation

35A and 35B North Road  
Woodridge QLD 4114

IAS12700

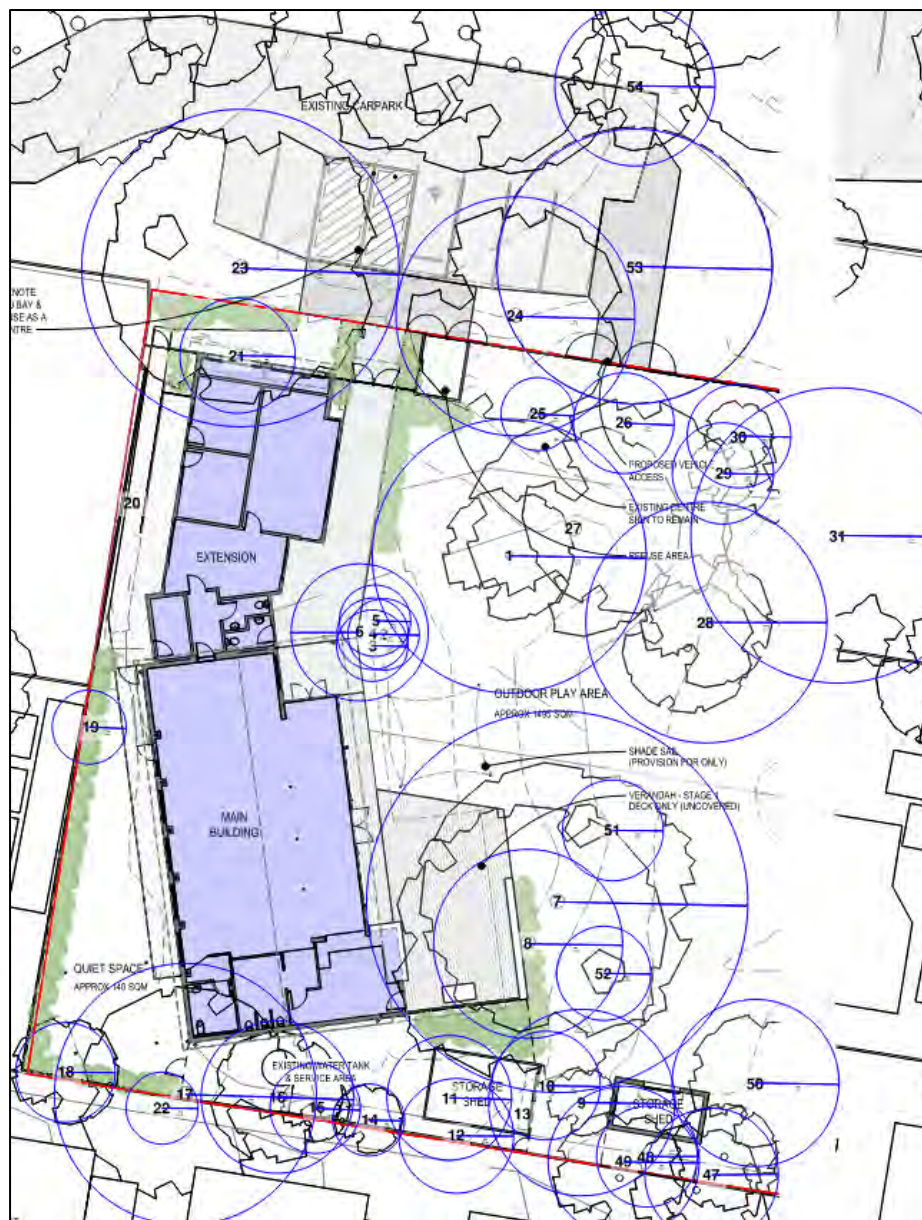
- Covered deck within the TPZ of Tree 7 and 8 to utilise pier and beam construction methodology. Pier holes to be vacuum excavated under the supervision of the Project Arborist. Roots encountered under 50mm diameter to be cut cleanly by the Project Arborist. Roots encountered over 50mm diameter will require the pier to be offset to reduce impacts to identified roots. Pier holes to be lined with builder's black plastic prior to concrete pour to isolate concrete from exposed roots.

- Meeting with construction team is to be held prior to works commencing to determine if pruning of Trees 7, 8, or 9 will be required to allow adequate clearance from the proposed structure during construction. Any required pruning works are to be conducted by a minimum AQF Level 3 Arborist, under the supervision of the Project Arborist.

- Proposed concrete slab for relocated storage shed within the TPZ of Tree 9 is to be constructed above current grade. Maximum 50mm depth excavation is permitted prior to construction to remove existing grass and other organic material.

- Require piers for the proposed shade sail, and/or fence within the TPZ of Trees 17, 18, 23, and 24 are to be hand/vacuum excavated under the supervision of the Project Arborist. Roots encountered under 50mm diameter are to be cut cleanly by the Project Arborist. Roots encountered over 50mm diameter will require pier to be offset to avoid impacts to identified roots. Builder's black plastic to be used to line new concrete prior to pour.

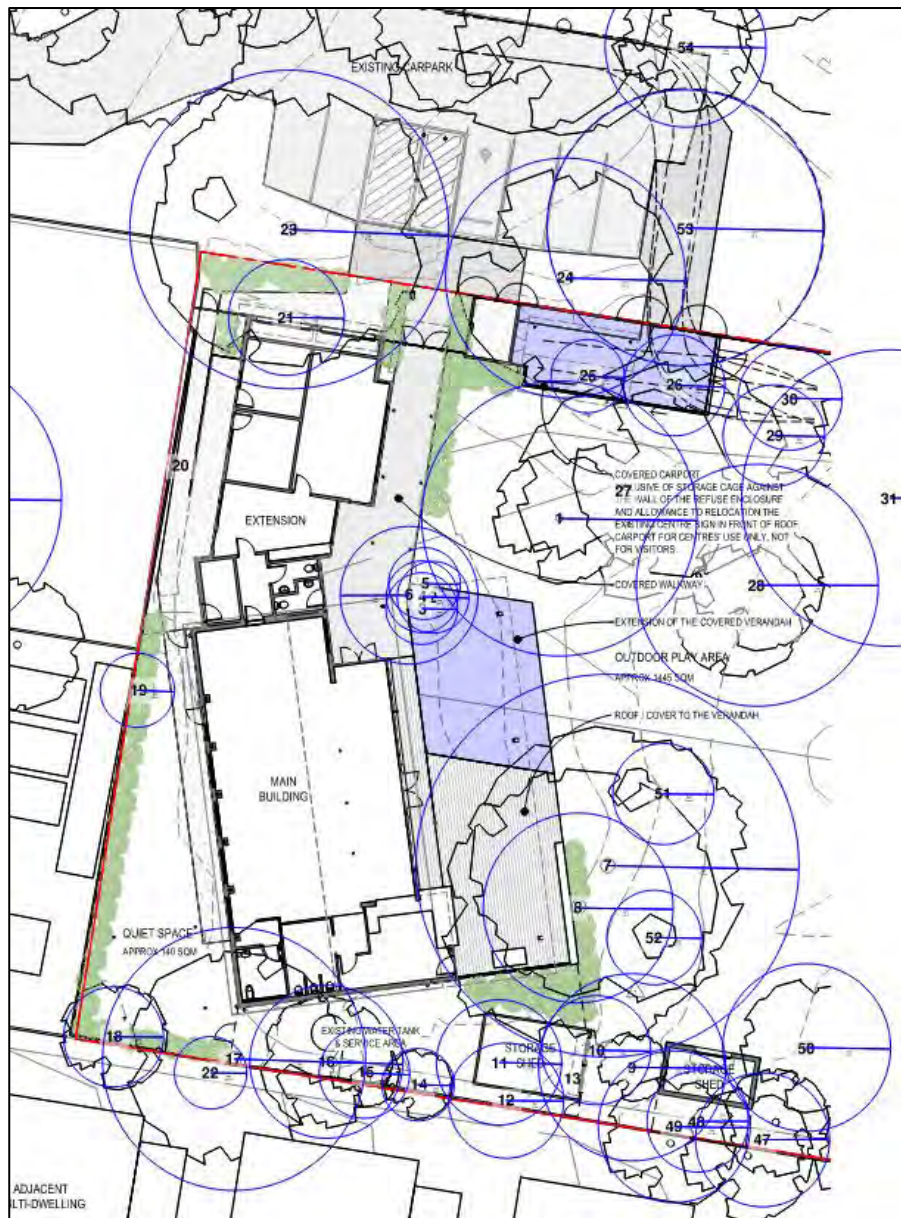
• Proposed concrete footpath/refuse area/carport within the TPZ of Trees 17, 23, and 24 are to be constructed above current grade utilising a bed of level 2 structural soils/pea gravel/coarse river sand wherein the TPZ (50mm depth excavation is permitted to remove existing turf/organic material prior to construction). Builder’s black plastic to be used to line new concrete prior to pour.

• Undertake exploratory vacuum excavation on the alignment of required cut for construction of the proposed building footings within the TPZ of Tree 23. Roots encountered under 50mm diameter to be cut cleanly by the Project Arborist. Roots encountered over 50mm diameter to be inspected and managed accordingly. This may require project redesign to reduce impacts to encountered roots, or review of the viability for retention of the tree.

• Ensure LCC permission is in place prior to root zone interference within the TPZ of Trees 23, 24, and 53.

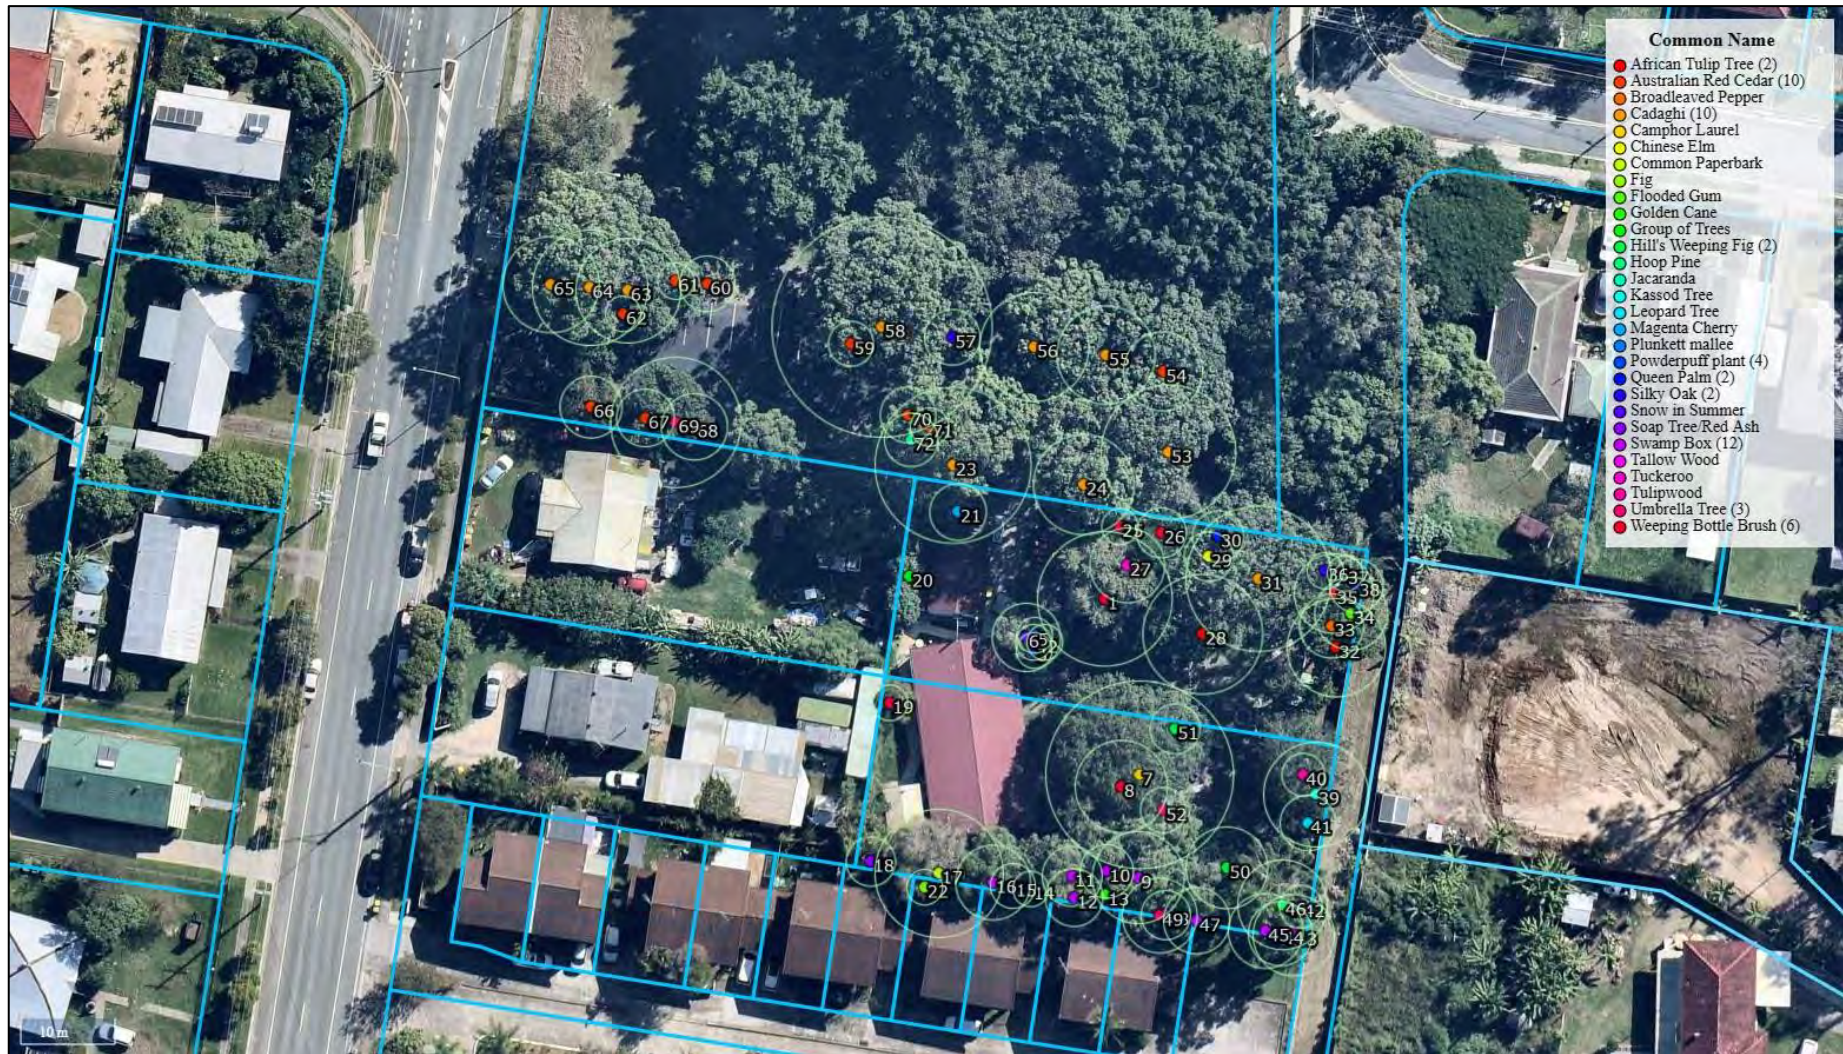
## Tree Species Locations

Please Note: Tree Locations are an approximate only and not survey accurate. Circles indicate Tree Protection Zones as defined under AS4970:2009 – Protection of Trees on development sites.

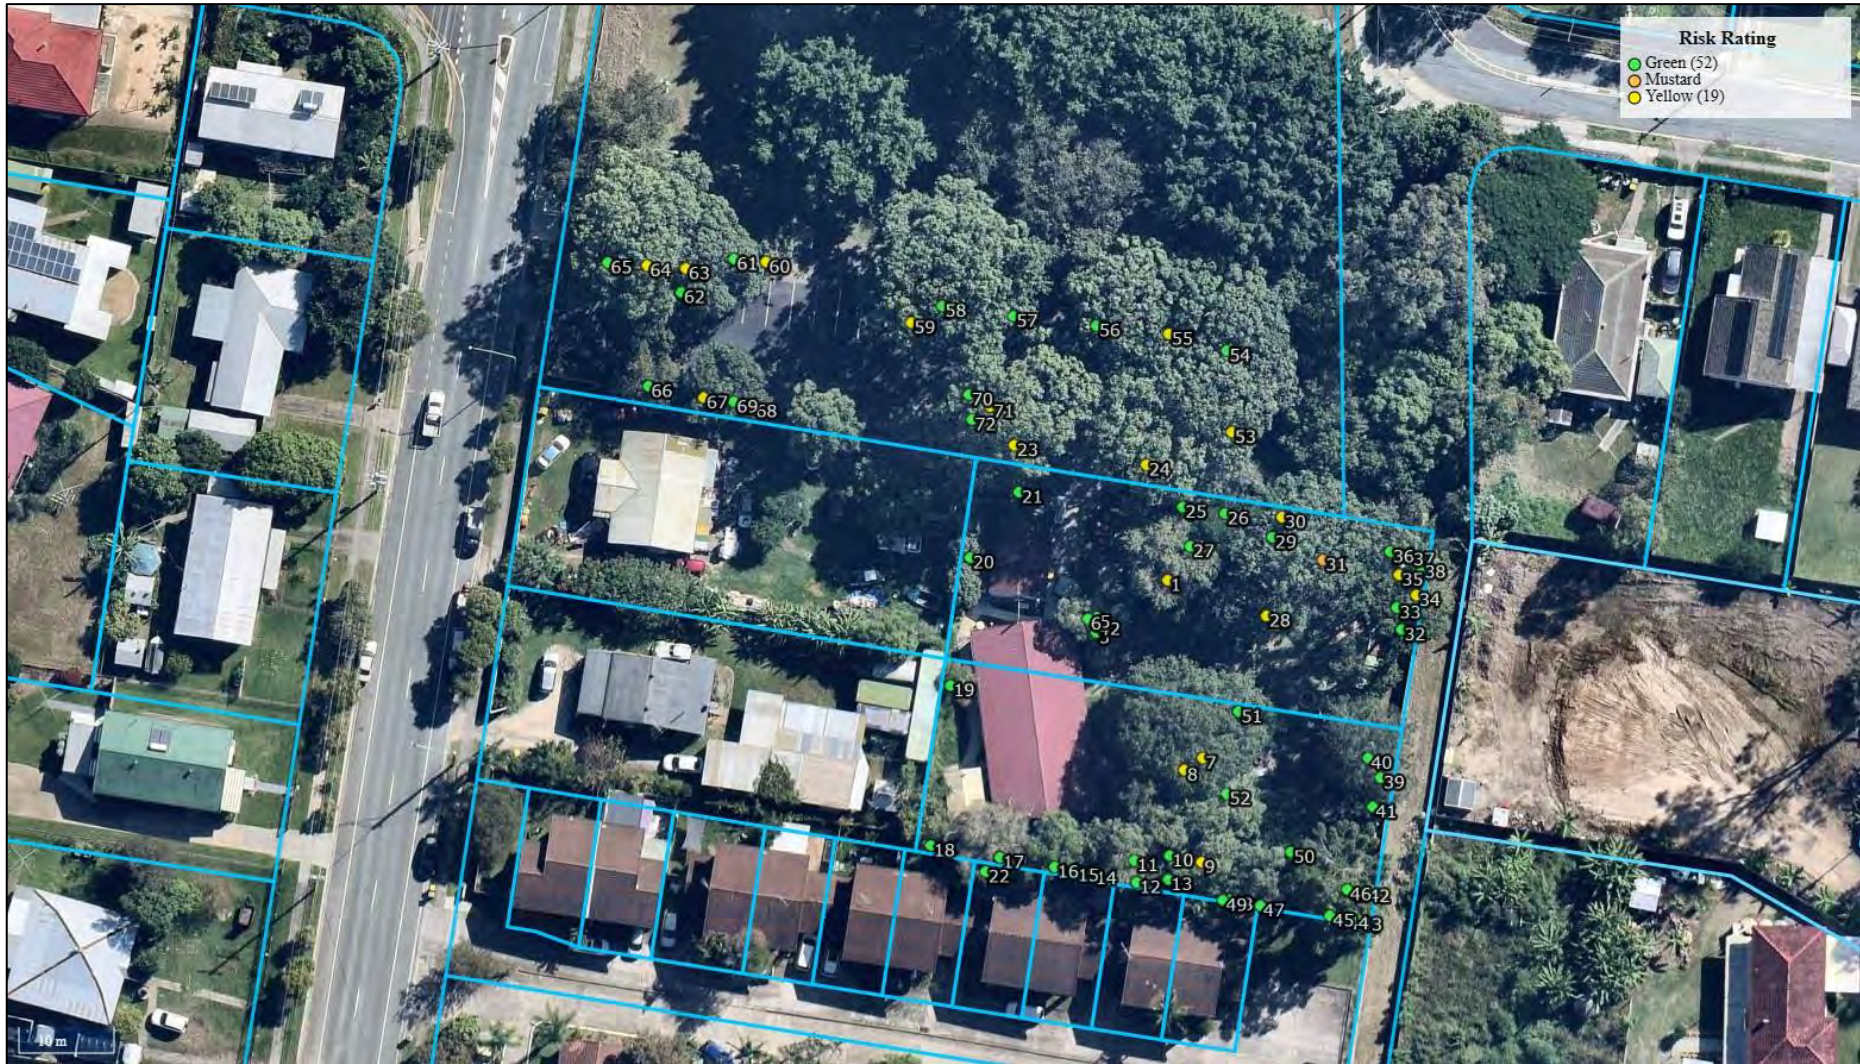
## Tree Locations and Risk Rating

Please Note: Tree Locations are an approximate only and not survey accurate. Colours designated to the trees correspond with the relevant risk ratings.

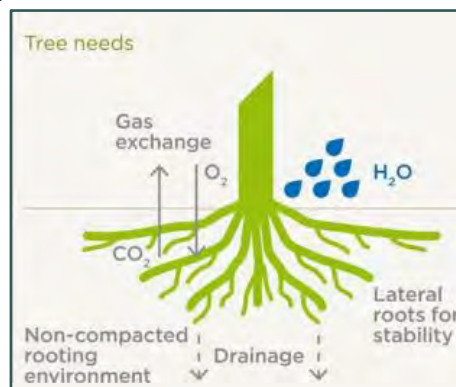
Figure 8: Gas exchange in woody tissues: the diffusion of gases into and out of a particular region (Jaluzot)
