# Pre-Purchase Inspection - Residential Building Report

Complies with Australian Standard AS 4349.1- 2007 Inspection of Buildings Part 1: Pre-Purchase inspections - Residential buildings

339 South Bowan Park Rd Bowan Park

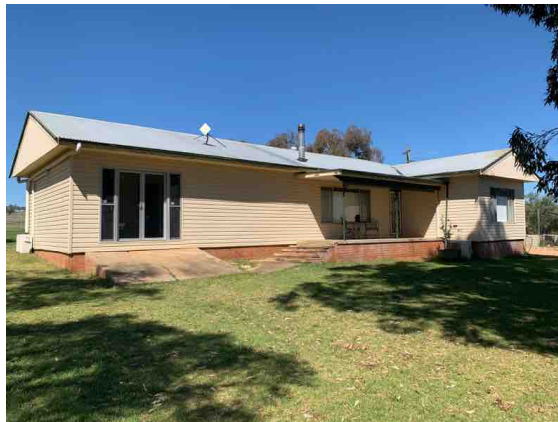
#### Access Issue 1. - Subfloor

Enclosed Foundation Area

There was no access to the subfloor area of the property.

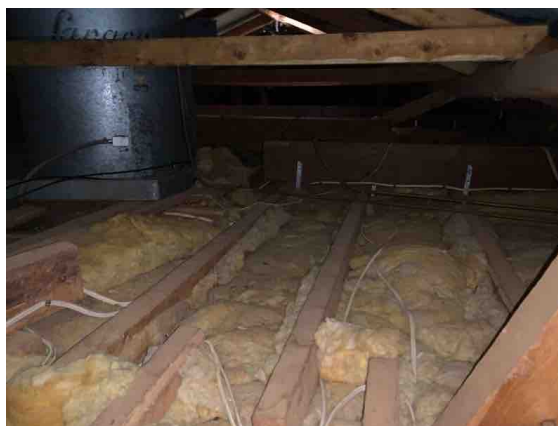
#### Access Issue 2. - Roof Void

Insulation

The ceiling joists could not be inspected as they were covered with insulation.

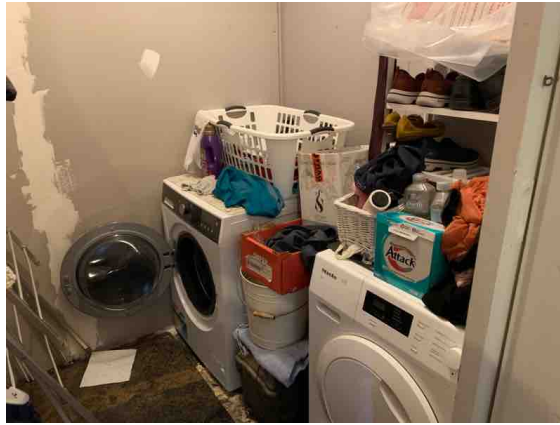
#### Access Issue 3. - Laundry

Dryer, Personal Items, Washing Machine

Areas of the laundry could not be inspected.

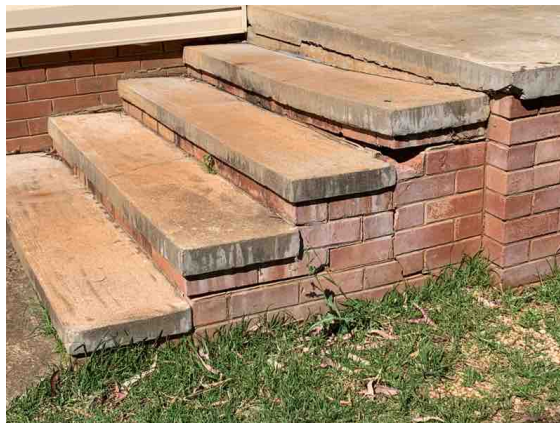
## Defect 1. - Exterior

Defect Location:	West Side
Defect Summary:	Walls - Brick
Type of Defect:	Damage, Structural
Description:	The stairs and brickwork have moved.
Ongoing Consequence:	Damage to surrounding elements
Opinion of Cracking:	Not Applicable
Building Professional:	<b>Note: This defect should be referred to a qualified building professional for the repairs/scope of work required.</b>  Building Professional Required: Builder, Bricklayer

The verandah steps have moved and are damaged.

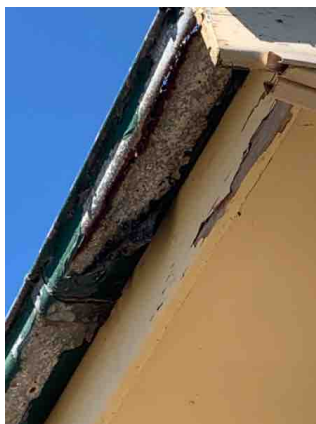
## Defect 2. - Roof Exterior

Defect Location:	Various Areas
Defect Summary:	Guttering
Type of Defect:	Material deterioration
Description:	Guttering is rusted
Ongoing Consequence:	Further deterioration.
Opinion of Cracking:	Not Applicable
Building Professional:	<b>Note: This defect should be referred to a qualified building professional for the repairs/scope of work required.</b>  Building Professional Required: Plumber

The damaged gutter.

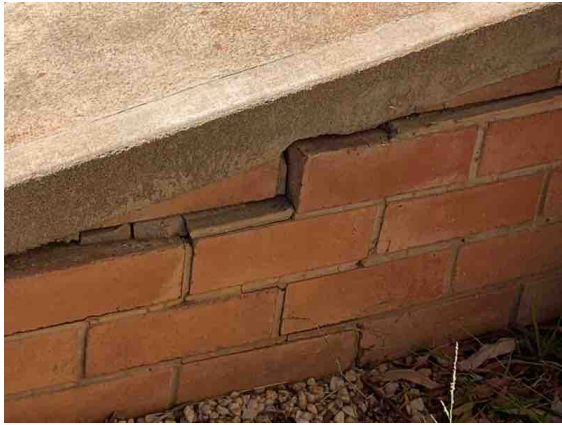
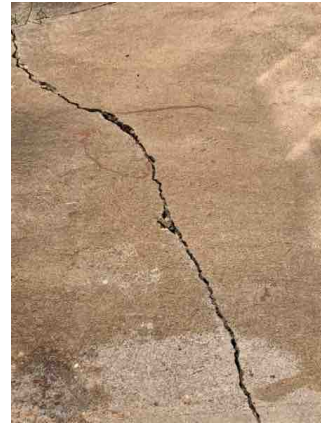
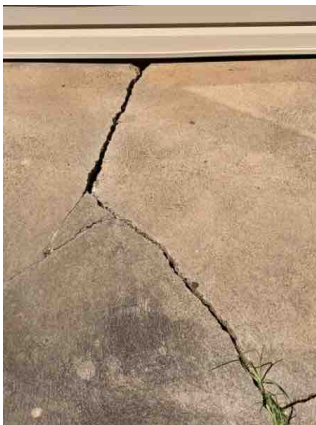
### Defect 3. - Exterior

Defect Location:	West Side
Defect Summary:	Walls - Brick
Type of Defect:	Structural
Description:	The brickwork is damaged and the concrete ramp is cracked.
Ongoing Consequence:	Further deterioration of the brickwork and further cracking in the concrete.
Opinion of Cracking:	Structural cracking
Building Professional:	<b>Note: This defect should be referred to a qualified building professional for the repairs/scope of work required.</b>  Building Professional Required: Builder, Bricklayer, Engineer

The damaged brickwork.

The cracked and failed concrete.

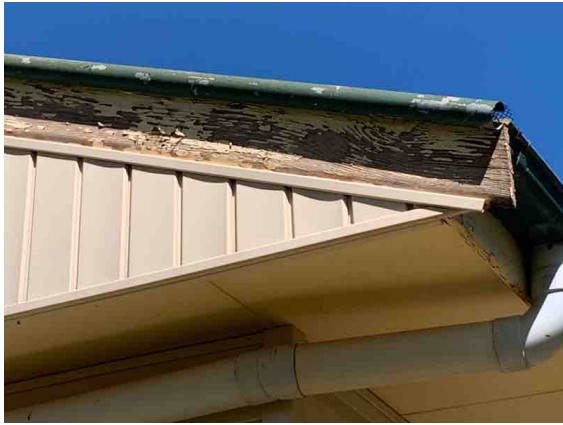
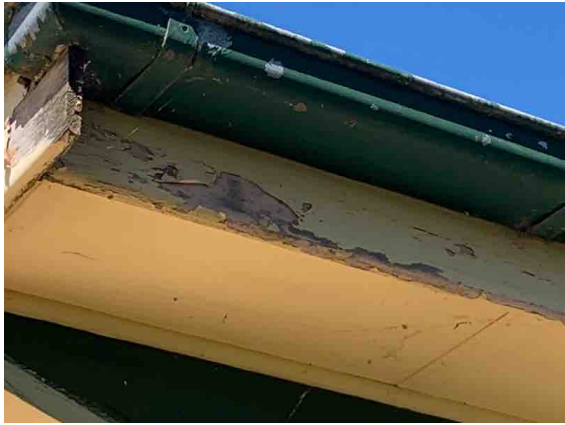
#### Defect 4. - Roof Exterior

Defect Location:	Various Areas
Defect Summary:	Eaves Fascia and Barges
Type of Defect:	Damage
Description:	The paintwork and timber fascia is deteriorating.
Ongoing Consequence:	Further deterioration of the timber and paintwork.
Opinion of Cracking:	Not Applicable
Building Professional:	<b>Note: This defect should be referred to a qualified building professional for the repairs/scope of work required.</b>  Building Professional Required: Carpenter, Painter

The deteriorating paintwork and timber.

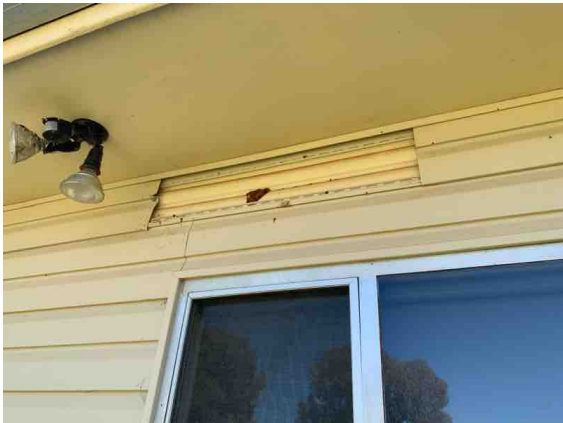
Defect 5. - Exterior

Defect Location:	West Side
Defect Summary:	Walls - Timber Frame
Type of Defect:	Damage
Description:	Cladding has been damaged significantly
Ongoing Consequence:	Damage to surrounding elements
Opinion of Cracking:	Not Applicable
Building Professional:	<b>Note: This defect should be referred to a qualified building professional for the repairs/scope of work required.</b>
	Building Professional Required: Carpenter

The damaged wall cladding.

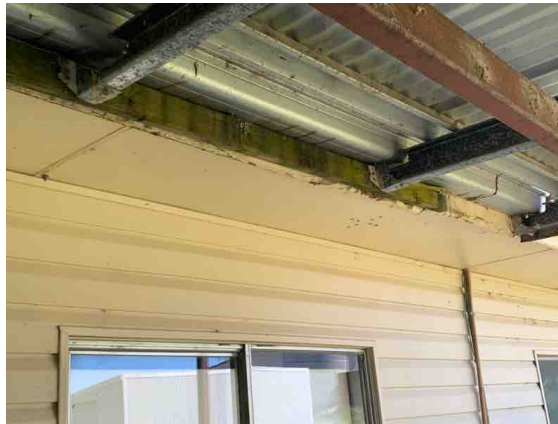
#### Defect 6. - Roof Exterior

Defect Location:	East Side
Defect Summary:	Roof Coverings
Type of Defect:	Water penetration, dampness
Description:	The roof is leaking next to the gutter.
Ongoing Consequence:	Water ingress to Roof Void
Opinion of Cracking:	Not Applicable
Building Professional:	<b>Note: This defect should be referred to a qualified building professional for the repairs/scope of work required.</b>
	Building Professional Required: Roof Plumber

The roof is leaking at the gutter line. Metal flashing is required.

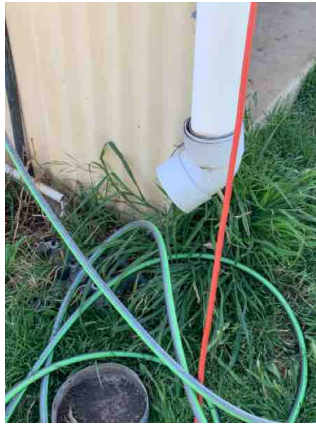
#### Defect 7. - Roof Exterior

Defect Location:	Various Areas
Defect Summary:	Downpipes
Type of Defect:	Installation
Description:	Connection to stormwater drainage is damaged/inadequate
Ongoing Consequence:	Water ingress into building
Opinion of Cracking:	Not Applicable
Building Professional:	<b>Note: This defect should be referred to a qualified building professional for the repairs/scope of work required.</b>
	Building Professional Required: Plumber

The down-pipe is not connected to the stormwater drainage system.

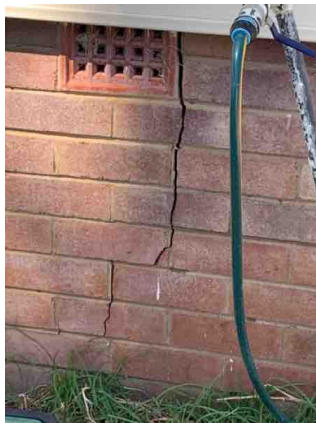
#### Defect 8. - Exterior

Defect Location:	West Side
Defect Summary:	Walls - Brick
Type of Defect:	Structural
Description:	There is vertical cracking
Ongoing Consequence:	Further cracking.
Opinion of Cracking:	Not Applicable
Building Professional:	<b>Note: This defect should be referred to a qualified building professional for the repairs/scope of work required.</b>
	Building Professional Required: Builder, Bricklayer, Engineer

The vertical cracking in various areas.

If cracks have been identified in the table below, a Structural Engineering inspection is recommended.

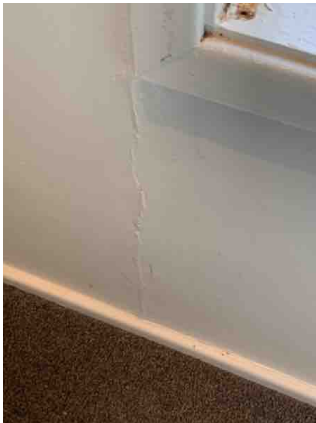
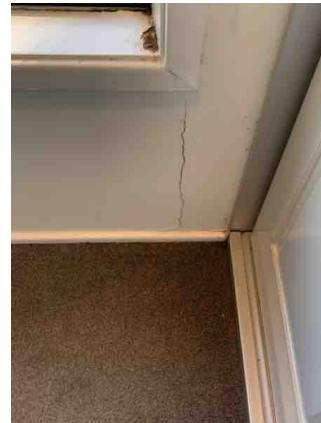
#### Defect 9. - Interior

Defect Location:	Bedroom 1
Defect Summary:	Plaster wall cracking.
Type of Defect:	Damage
Description:	Wall cracking.
Ongoing Consequence:	Further cracking.
Opinion of Cracking:	Not Applicable
Building Professional:	<b>Note: This defect should be referred to a qualified building professional for the repairs/scope of work required.</b>  Building Professional Required: Plasterer, Painter

Wall cracking.

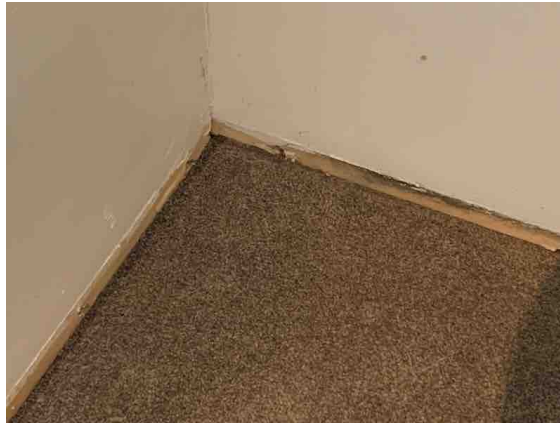
#### Defect 10. - Interior

Defect Location:	Bedroom 1
Defect Summary:	Timber skirting.
Type of Defect:	Installation
Description:	Not installed.
Ongoing Consequence:	Incomplete installation.
Opinion of Cracking:	Not Applicable
Building Professional:	<b>Note: This defect should be referred to a qualified building professional for the repairs/scope of work required.</b>  Building Professional Required: Carpenter

The missing skirting in the bedroom.

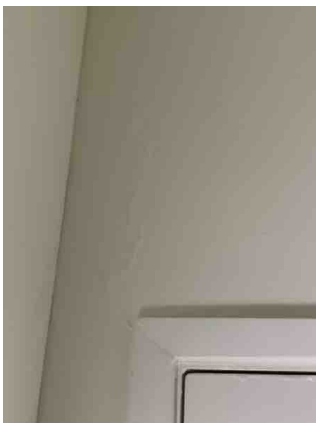
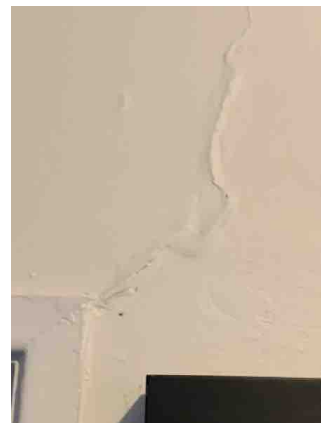
#### Defect 11. - Interior

Defect Location:	Bedroom 2
Defect Summary:	Wall cracking.
Type of Defect:	Damage
Description:	Cracking.
Ongoing Consequence:	Further cracking.
Opinion of Cracking:	Not Applicable
Building Professional:	<b>Note: This defect should be referred to a qualified building professional for the repairs/scope of work required.</b>
	Building Professional Required: Plasterer, Painter

Wall cracking.

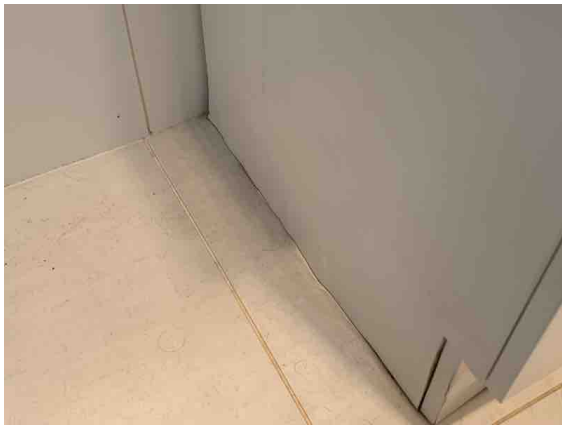
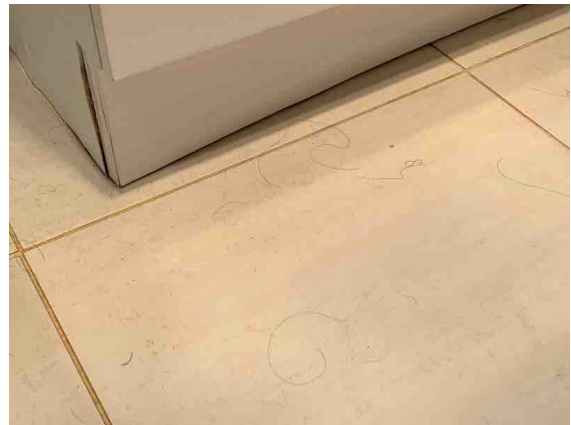
## Defect 12. - Interior

Defect Location:	Bathroom 1
Defect Summary:	Vanity/Basin
Type of Defect:	Water penetration, dampness
Description:	There is evidence of water staining, The vanity is swollen due to water damage
Ongoing Consequence:	Water ingress will affect the serviceability of the vanity
Opinion of Cracking:	Not Applicable
Building Professional:	<b>Note: This defect should be referred to a qualified building professional for the repairs/scope of work required.</b>
	Building Professional Required: Carpenter

The water damaged vanity.

The water damaged vanity kick board.

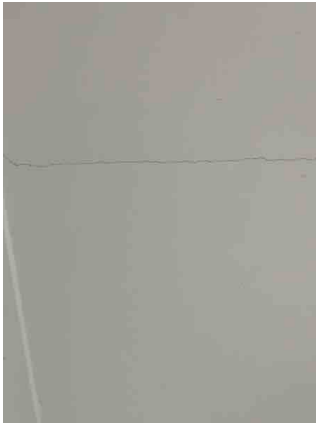
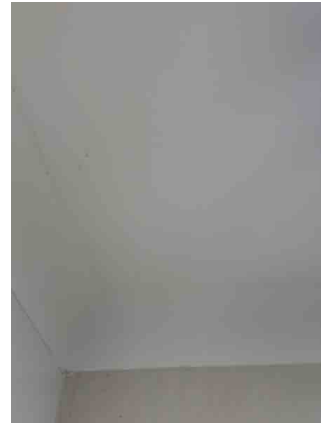
## Defect 13. - Interior

Defect Location:	Bathroom 1
Defect Summary:	Ceiling Dampness and/or Damp Damage
Type of Defect:	Damage
Description:	The sheeting on the ceiling is damaged and cracked.
Ongoing Consequence:	Further deterioration.
Opinion of Cracking:	Not Applicable
Building Professional:	<b>Note: This defect should be referred to a qualified building professional for the repairs/scope of work required.</b>
	Building Professional Required: Plasterer, Painter

The cracked ceiling.

The damaged ceiling.

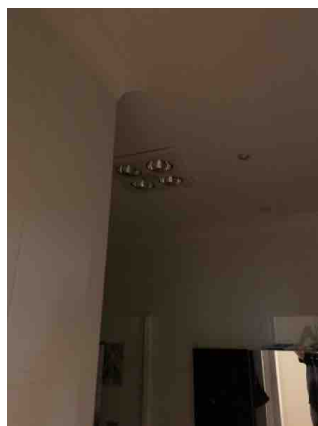
Defect 14. - Interior

The exhaust fan and light.

The light is not operating correctly.

Safety issue.

**Note: This defect should be referred to a qualified building professional for the repairs/scope of work required.**

Building Professional Required: Electrician

The light needs to be checked by a licensed electrician.

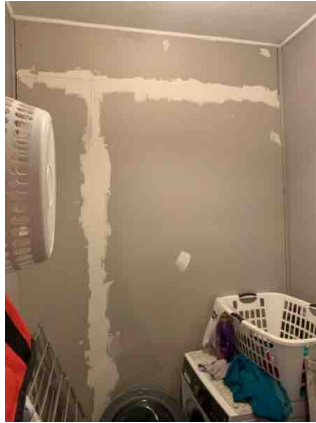
#### Defect 15. - Interior

Defect Location:	Laundry
Defect Summary:	Plaster walls.
Type of Defect:	Installation
Description:	The lining is incomplete.
Ongoing Consequence:	Incomplete installation of the sheeting.
Opinion of Cracking:	Not Applicable
Building Professional:	<b>Note: This defect should be referred to a qualified building professional for the repairs/scope of work required.</b>  Building Professional Required: Plasterer, Painter

The wall sheeting is incomplete.

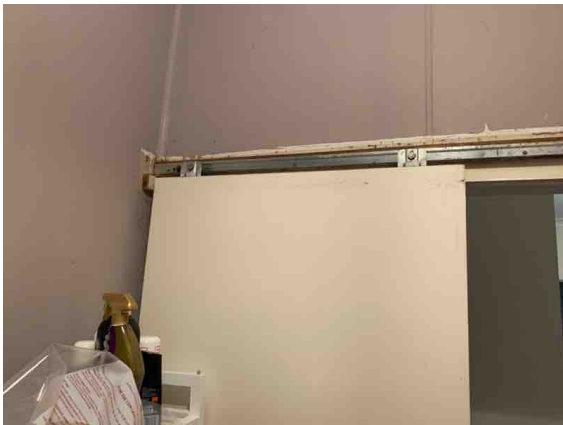
#### Defect 16. - Interior

Defect Location:	Laundry
Defect Summary:	The sliding door.
Type of Defect:	Installation
Description:	The installation of the door is incomplete
Ongoing Consequence:	Incomplete installation of the door.
Opinion of Cracking:	Not Applicable
Building Professional:	<b>Note: This defect should be referred to a qualified building professional for the repairs/scope of work required.</b>  Building Professional Required: Carpenter

The missing door pelment.

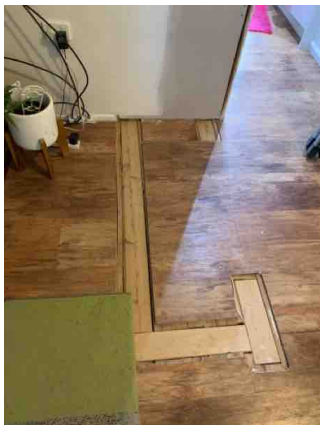
Defect 17. - Interior

Defect Location:	Lounge Room
Defect Summary:	Timber floor damage.
Type of Defect:	Damage
Description:	The flooring is incomplete.
Ongoing Consequence:	Trip hazard.
Opinion of Cracking:	Not Applicable
Building Professional:	<b>Note: This defect should be referred to a qualified building professional for the repairs/scope of work required.</b>
	Building Professional Required: Carpenter

The incomplete flooring.

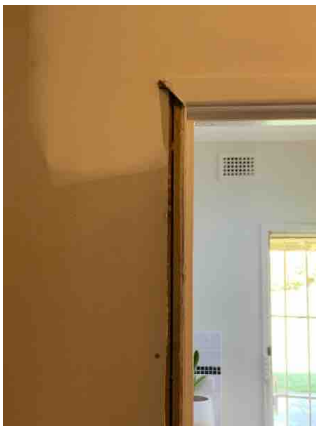
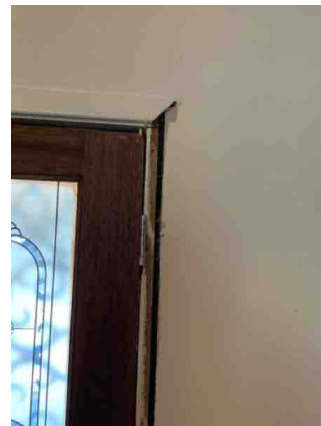
## Defect 18. - Interior

Defect Location:	Lounge Room
Defect Summary:	Timber architrave.
Type of Defect:	Installation
Description:	The architraves are missing.
Ongoing Consequence:	Incomplete installation of the architrave.
Opinion of Cracking:	Not Applicable
Building Professional:	<b>Note: This defect should be referred to a qualified building professional for the repairs/scope of work required.</b>  Building Professional Required: Carpenter

The missing architrave.

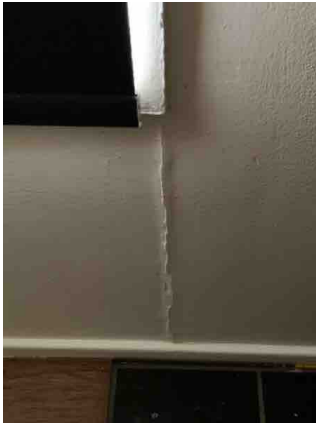
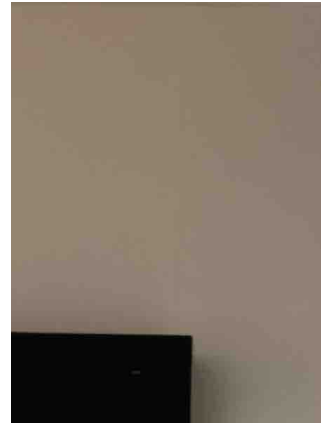
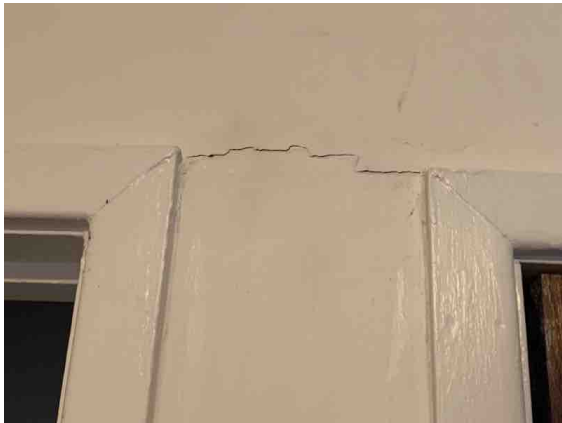
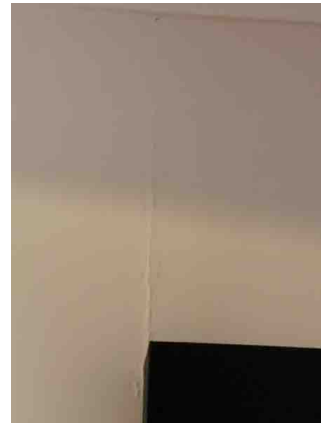
## Defect 19. - Interior

Defect Location:	Lounge Room
Defect Summary:	Wall cracking.
Type of Defect:	Damage
Description:	Wall cracking.
Ongoing Consequence:	Further cracking in the areas.
Opinion of Cracking:	Not Applicable
Building Professional:	<b>Note: This defect should be referred to a qualified building professional for the repairs/scope of work required.</b>  Building Professional Required: Plasterer, Painter

Vertical wall cracking.

Horizontal wall cracking.

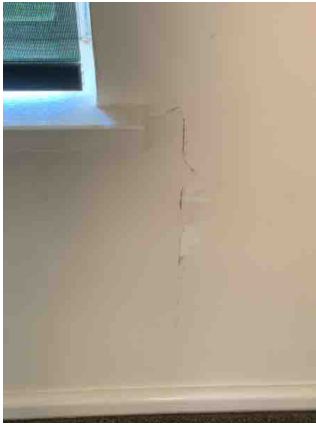
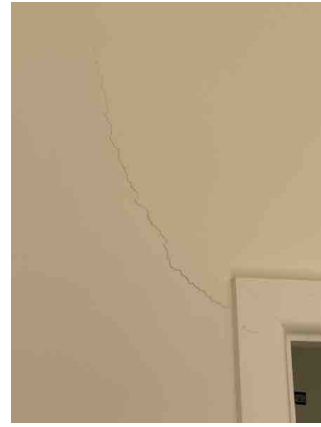
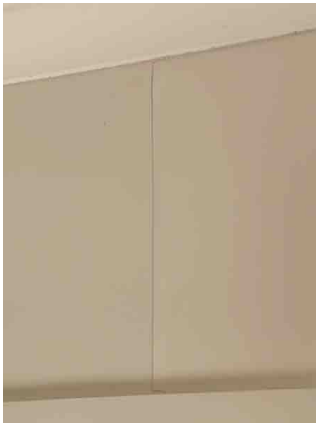
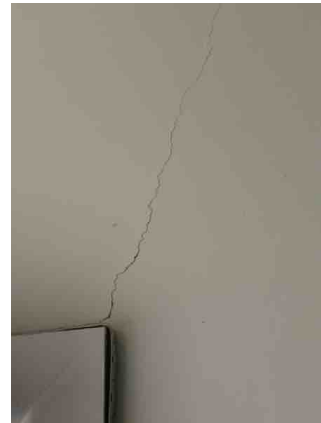
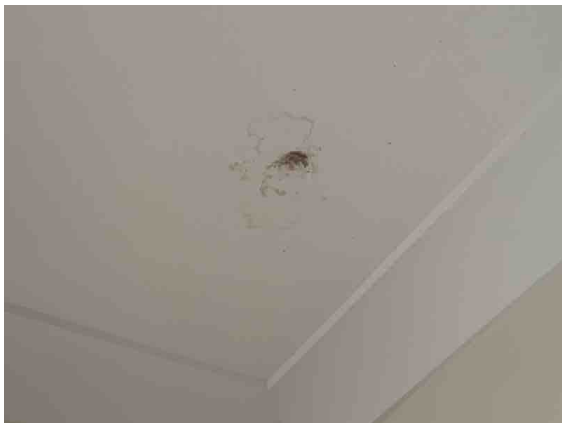
#### Defect 20. - Interior

Wall cracking and ceiling water damage.

Cracking and leaking roof.

Further deterioration of the areas.

Wall cracking.

Water damaged ceiling sheeting.

**Note: This defect should be referred to a qualified building professional for the repairs/scope of work required.**

Building Professional Required: Roof Plumber, Plasterer, Painter

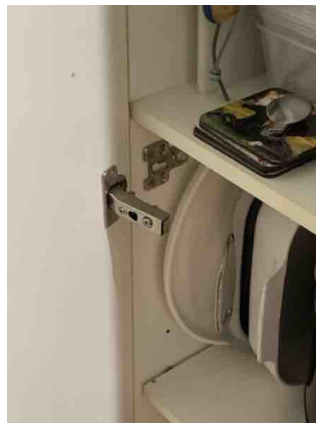
#### Defect 21. - Interior

Defect Location:	Kitchen
Defect Summary:	Cupboards
Type of Defect:	Material deterioration
Description:	The hinges are damaged.
Ongoing Consequence:	Further deterioration.
Opinion of Cracking:	Not Applicable
Building Professional:	<b>Note: This defect should be referred to a qualified building professional for the repairs/scope of work required.</b>  Building Professional Required: Carpenter

The damaged hinge.

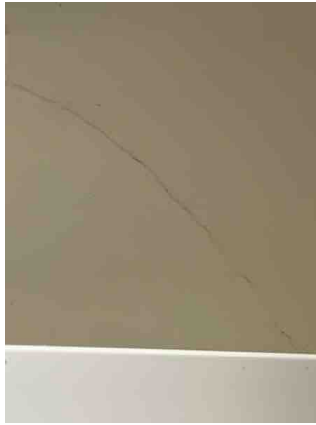
#### Defect 22. - Interior

Defect Location:	Kitchen
Defect Summary:	Wall cracking.
Type of Defect:	Damage
Description:	Cracking.
Ongoing Consequence:	Further cracking.
Opinion of Cracking:	Not Applicable
Building Professional:	<b>Note: This defect should be referred to a qualified building professional for the repairs/scope of work required.</b>  Building Professional Required: Plasterer, Painter

The wall cracking.

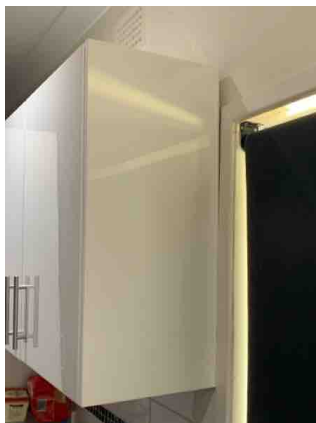
#### Defect 23. - Interior

Defect Location:	Kitchen
Defect Summary:	Cupboards
Type of Defect:	Installation
Description:	The over-head cupboard cupboards are not fixed to the wall correctly.
Ongoing Consequence:	The cupboards could fall off the wall.
Opinion of Cracking:	Not Applicable
Building Professional:	<b>Note: This defect should be referred to a qualified building professional for the repairs/scope of work required.</b>
	Building Professional Required: Carpenter

The loose wall cupboard.

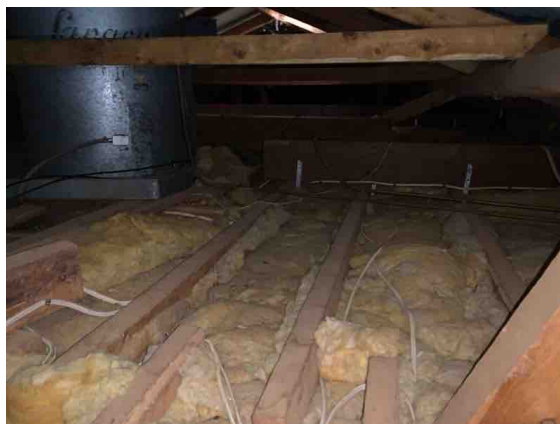
#### Observation 1

Area Location:	Roof void area.
Description:	There was no visual signs of any loose fill insulation in the roof void area.

Insulation in the roof void area.
