Pre-Purchase Inspection - Residential Building Report

Complies with Australian Standard AS 4349.1- 2007 Inspection of Buildings Part 1: Pre-Purchase inspections - Residential buildings

641 Mitchell Hwy Orange

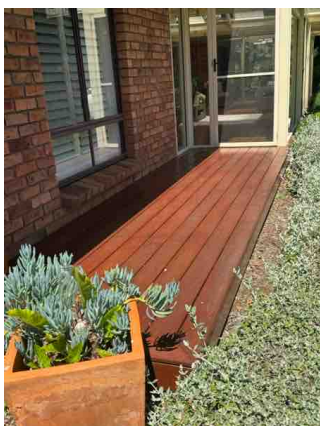
Access Issue 1. - Subfloor

Height

The subfloor areas of the deck could not be inspected.

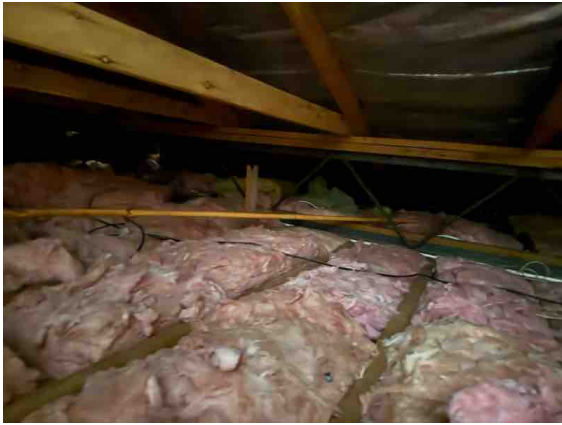
Access Issue 2. - Roof Void

Insulation

The ceiling joists could not be inspected as they were covered with insulation.

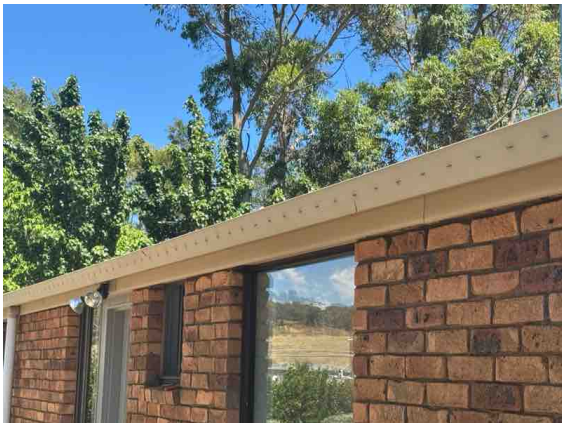
Defect 1. - Roof Exterior

Defect Location:	Various Areas
Defect Summary:	Guttering
Type of Defect:	Installation
Description:	The gutter is sagging
Ongoing Consequence:	Damage to surrounding elements
Opinion of Cracking:	Not Applicable
Building Professional:	Note: This defect should be referred to a qualified building professional for the repairs/scope of work required.
	Building Professional Required: Plumber

The gutter is sagging in areas and needs to be straightened/refixed.

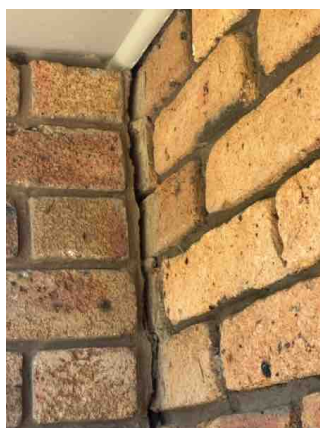
Defect 2. - Exterior

Defect Location:	South Side
Defect Summary:	Walls - Brick
Type of Defect:	Damage
Description:	There is vertical cracking
Ongoing Consequence:	Damage to surrounding elements
Opinion of Cracking:	Serviceability cracking
Building Professional:	Note: This defect should be referred to a qualified building professional for the repairs/scope of work required.
	Building Professional Required: Bricklayer

Wall cracking in the brick pier.

Type	Area	Description	Opinion of Cracking
Exterior	South Side	There is vertical cracking	Serviceability cracking
Interior	Lounge Room	There is stepped cracking	Serviceability cracking

If cracks have been identified in the table below, a Structural Engineering inspection is recommended.

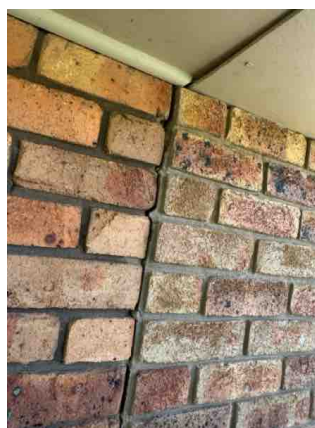
Wall cracking and movement.

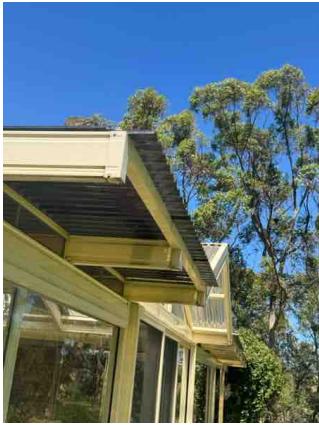
Defect 3. - Roof Exterior

Defect Location:	North Side
Defect Summary:	Roof Flashings
Type of Defect:	Installation
Description:	Flashing not fixed There is no gutter installed and the sheet ends need extra fixings installed
Ongoing Consequence:	Water ingress to Roof Void Excessive ground moisture
Opinion of Cracking:	Not Applicable
Building Professional:	Note: This defect should be referred to a qualified building professional for the repairs/scope of work required.
	Building Professional Required: Plumber, Roof Plumber

The missing gutter. The end of the sheeting needs extra screws installed.

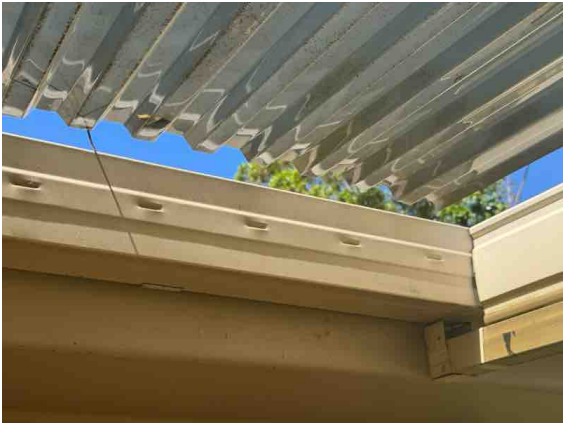
The missing roof flashing and loose sheeting.

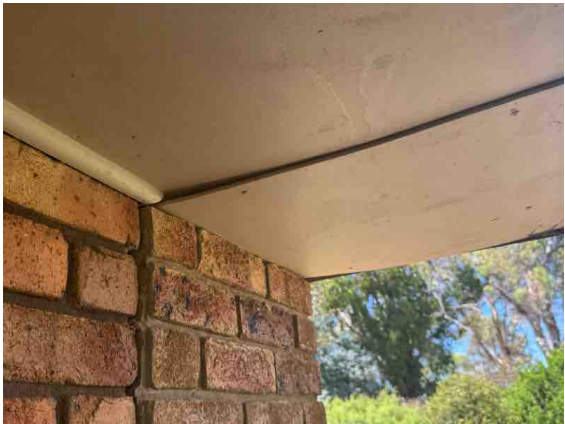
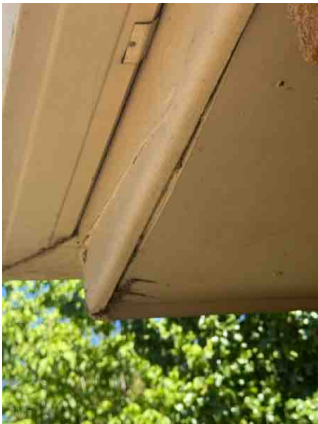
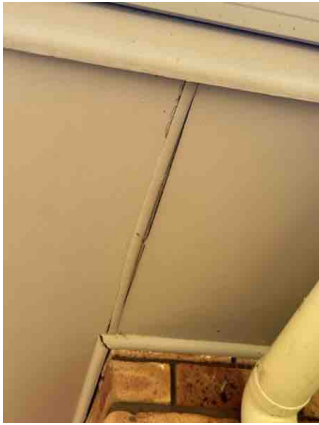
Defect 4. - Roof Exterior

Eaves Fascia and Barges

Material deterioration

Loose eave sheeting

Possible further movement

Building Professional Required: Carpenter

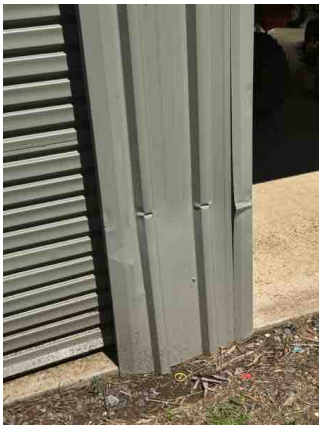
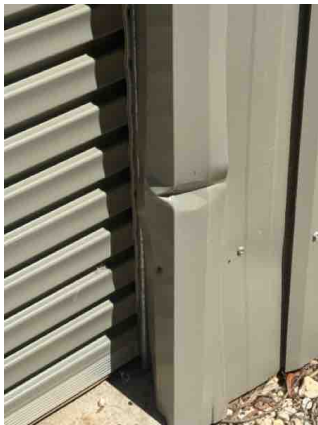
Defect 5. - Exterior

Defect Location:	Shed area.
Defect Summary:	Damaged wall cladding
Type of Defect:	Damage
Description:	Dented
Ongoing Consequence:	Further deterioration of the area.
Opinion of Cracking:	Not Applicable
Building Professional:	Note: This defect should be referred to a qualified building professional for the repairs/scope of work required.
	Building Professional Required: Carpenter

Damaged cladding

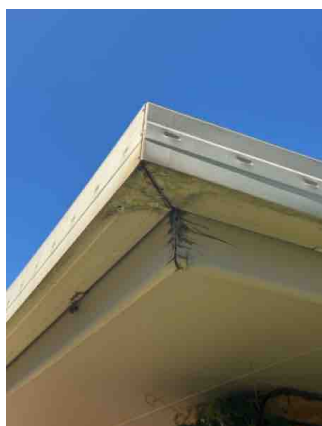
Defect 6. - Roof Exterior

Defect Location:	Various Areas
Defect Summary:	Guttering
Type of Defect:	Water penetration, dampness, Material deterioration
Description:	The gutter is leaking
Ongoing Consequence:	Damage to surrounding elements
Opinion of Cracking:	Not Applicable
Building Professional:	Note: This defect should be referred to a qualified building professional for the repairs/scope of work required. Building Professional Required: Carpenter, Painter

The gutter is leaking on the joins in various areas.

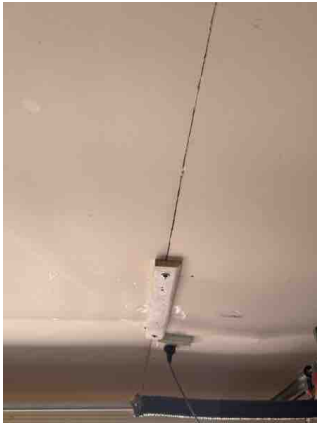
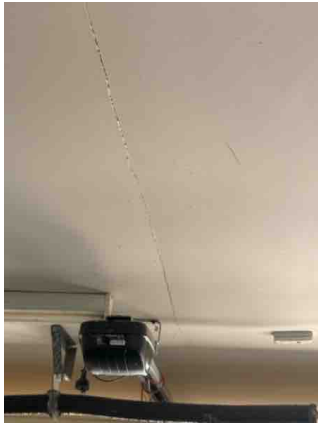
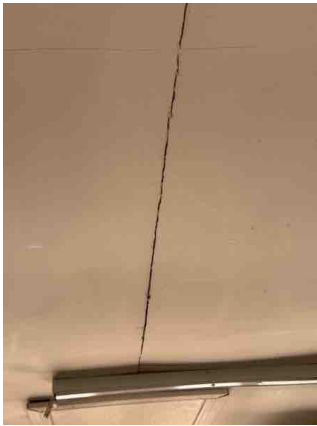
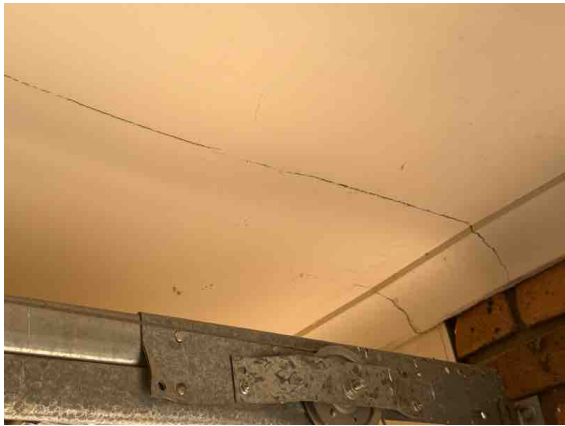
Defect 7. - Interior

Defect Location:	Attached Garage
Defect Summary:	Cracked and sagging ceilings
Type of Defect:	Damage
Description:	Sagging and cracking
Ongoing Consequence:	Safety issue.
Opinion of Cracking:	Not Applicable
Building Professional:	Note: This defect should be referred to a qualified building professional for the repairs/scope of work required. Building Professional Required: Plasterer, Painter

Sagging and cracked ceiling

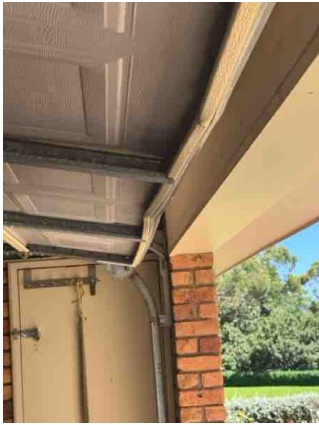
Defect 8. - Interior

Defect Location:	Attached Garage
Defect Summary:	Garage door damage
Type of Defect:	Damage
Description:	The door is dented
Ongoing Consequence:	Further deterioration of the area.
Opinion of Cracking:	Not Applicable
Building Professional:	Note: This defect should be referred to a qualified building professional for the repairs/scope of work required.
	Building Professional Required: Carpenter

The dented door.

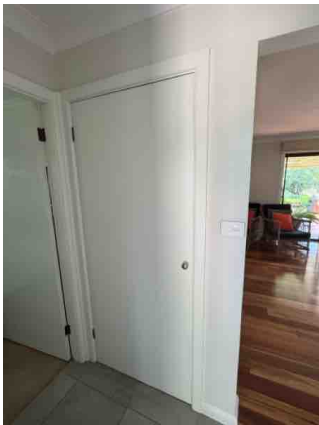
Defect 9. - Interior

Defect Location:	Hallway
Defect Summary:	Timber Doors - Fittings and Hardware
Type of Defect:	Installation
Description:	The door lock/s have broken or are missing
Ongoing Consequence:	The door will not close correctly.
Opinion of Cracking:	Not Applicable
Building Professional:	Note: This defect should be referred to a qualified building professional for the repairs/scope of work required.
	Building Professional Required: Carpenter

The door needs a new closer installed

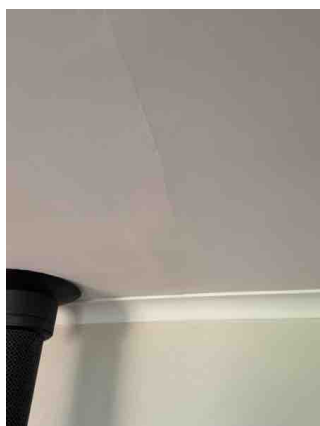
Defect 10. - Interior

Defect Location:	Family Room
Defect Summary:	Ceiling Cracking and/or evidence of damage repaired
Type of Defect:	Damage
Description:	Cracking
Ongoing Consequence:	Further cracking
Opinion of Cracking:	Not Applicable
Building Professional:	Note: This defect should be referred to a qualified building professional for the repairs/scope of work required. Building Professional Required: Plasterer, Painter

Ceiling cracking

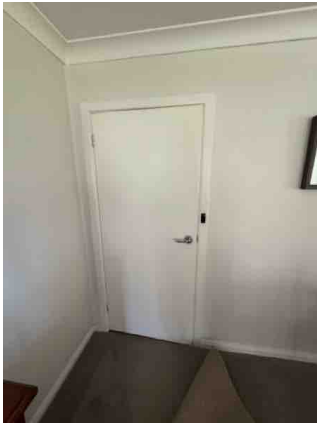
Defect 11. - Interior

Defect Location:	Lounge Room
Defect Summary:	Timber Doors - Operation
Type of Defect:	Operational
Description:	The door is binding.
Ongoing Consequence:	Difficult to operate, Damage to surrounding elements
Opinion of Cracking:	Not Applicable
Building Professional:	Note: This defect should be referred to a qualified building professional for the repairs/scope of work required. Building Professional Required: Carpenter

The door is binding and needs to be eased

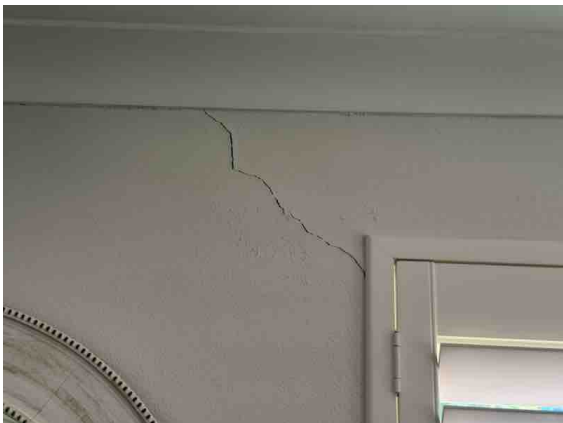
Defect 12. - Interior

Defect Location:	Lounge Room
Defect Summary:	Walls - Brick
Type of Defect:	Damage
Description:	There is stepped cracking
Ongoing Consequence:	Damage to surrounding elements
Opinion of Cracking:	Serviceability cracking
Building Professional:	Note: This defect should be referred to a qualified building professional for the repairs/scope of work required.
	Building Professional Required: Plasterer, Painter

Wall cracking

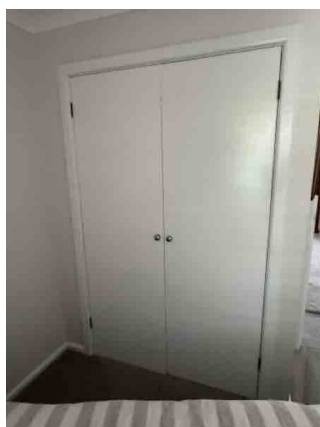
Defect 13. - Interior

Defect Location:	Bedroom 2
Defect Summary:	Timber Doors - Operation
Type of Defect:	Operational
Description:	The doors are binding on the carpet
Ongoing Consequence:	Difficult to operate, Damage to surrounding elements
Opinion of Cracking:	Not Applicable
Building Professional:	Note: This defect should be referred to a qualified building professional for the repairs/scope of work required.
	Building Professional Required: Carpenter

The bottom of the doors needs to be eased on the cupboard.

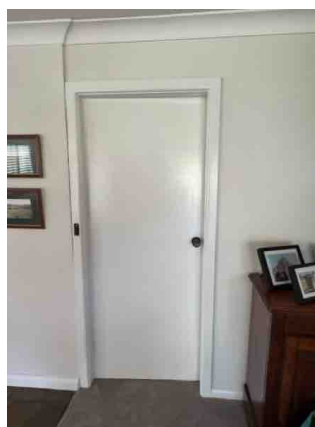
The entry door needs to be eased.

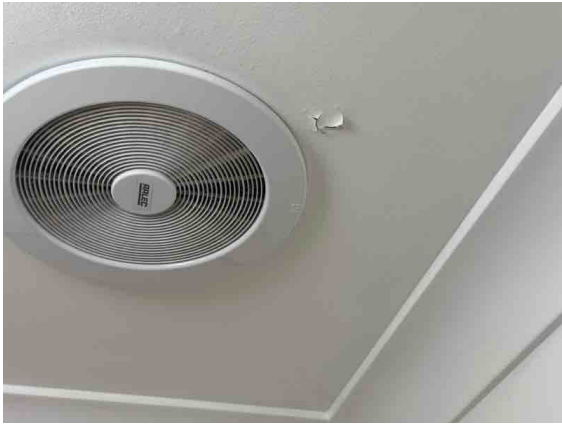
Defect 14. - Interior

Defect Location:	Bathroom 1
Defect Summary:	Deteriorating paintwork.
Type of Defect:	Damage
Description:	Flaking
Ongoing Consequence:	Further deterioration of the area.
Opinion of Cracking:	Not Applicable
Building Professional:	Note: This defect should be referred to a qualified building professional for the repairs/scope of work required.
	Building Professional Required: Painter

Deteriorating paintwork.

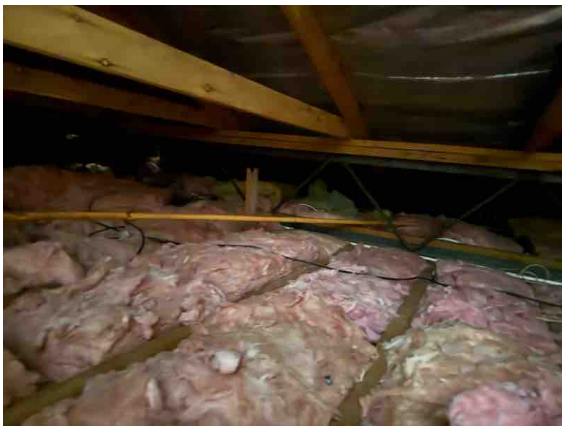
Observation 1

There was no visual signs of any loose fill insulation in the roof void area.

Insulation in the roof void area.

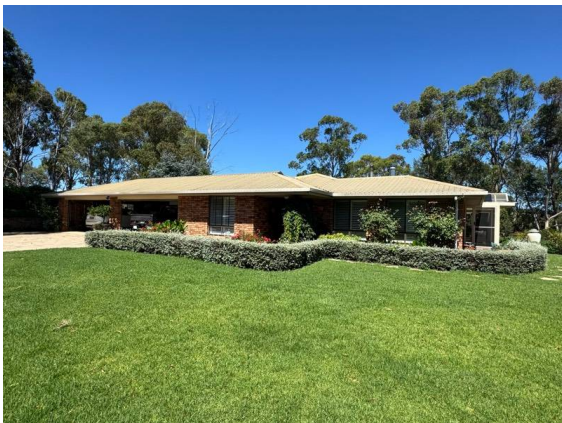
The garage door could not be tested on the day of the inspection.

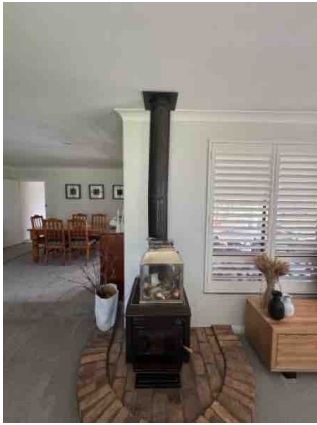
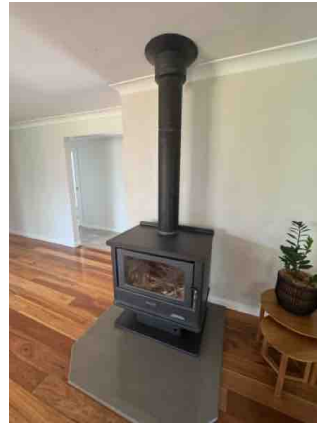
Observation 3

The fire flue needs to be checked that it is installed to the current Australian Standards and is safe before use.

The fire flue needs to be checked before use.
