**Town of Gawler
Council Assessment Panel**

Item		Page No
5.7	Development Application: 490/303/2017 (490/D018/17)	301
	Applicant: C G WYATT	
	Address: 23 Potts Road EVANSTON PARK 5116	
	Nature of Development: Land Division by Torrens Title (1 into 2) and removal of one Regulated Tree (Eucalyptus cladocalyx - Sugar Gum) & one Significant Tree (Eucalyptus camaldensis - River Red Gum)	
	Attachment 1 – Application Plans and Documentation	302
	Attachment 2 – Applicant's Hydrological Report	310
	Attachment 3 – Applicant's Arborist Report	321
	Attachment 4 – Council Commissioned Arborist Report	351
	Attachment 5 – External Referrals	365
	Attachment 6 – Internal Referrals	366
	Attachment 7 – Photographs of Watercourse 16 August 2017	367

Tree Report – 23 Potts Road, Evanston Park

Tree Report – 23 Potts Road, Evanston Park, SA

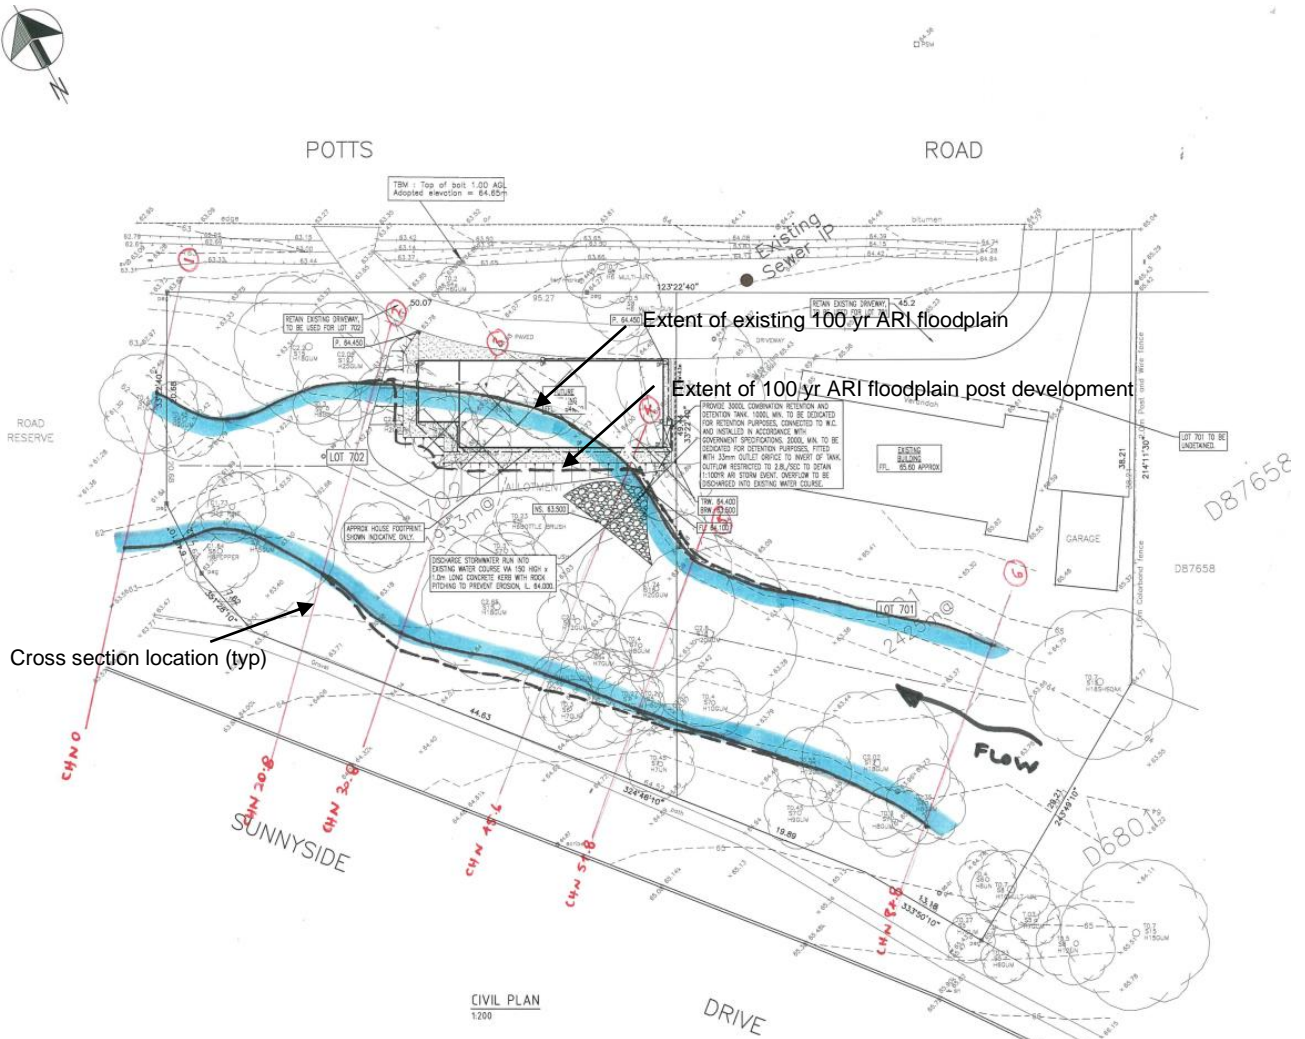
Figure 2: 100 year ARI Floodplain Extents

The HECRAS model extended from the downstream boundary of Lot 702 to a point within 10 m of the upstream boundary of Lot 701. Cross sections used in the modelling were taken from the survey shown on the TMK drawings. The location of the modelled cross sections is shown in Figure 2 below. For the developed scenario, the cross sections were modified to reflect the fill extents shown on the TMK drawings.

Figure 2 shows the flood extents for the existing and proposed conditions. Due to the relatively steep sided nature of the watercourse, the increase in flood extent within Lot 701 is relatively minor.

We note that the proposed filling extends into the existing floodplain, with the toe of the filling being close to the existing channel invert. The fill batters are shown to be 1V:2H. Flow velocities in the watercourse are calculated to be between 1 and 1.5 m/s in a 100 year ARI event. While the flow velocities are relatively low, there is some risk that erosion of the fill batter could occur. To mitigate against this risk, we would recommend that:

- The filling encroaches not closer to the watercourse than is shown on the TMK Drawings;
- The fill batter be stabilised using densely planted ground covers, or failing this is protected from scour by the placement of rockwork of nominal 300 mm minimum diameter;
- Footings for the proposed residence are pierced through the fill and founded on natural material.

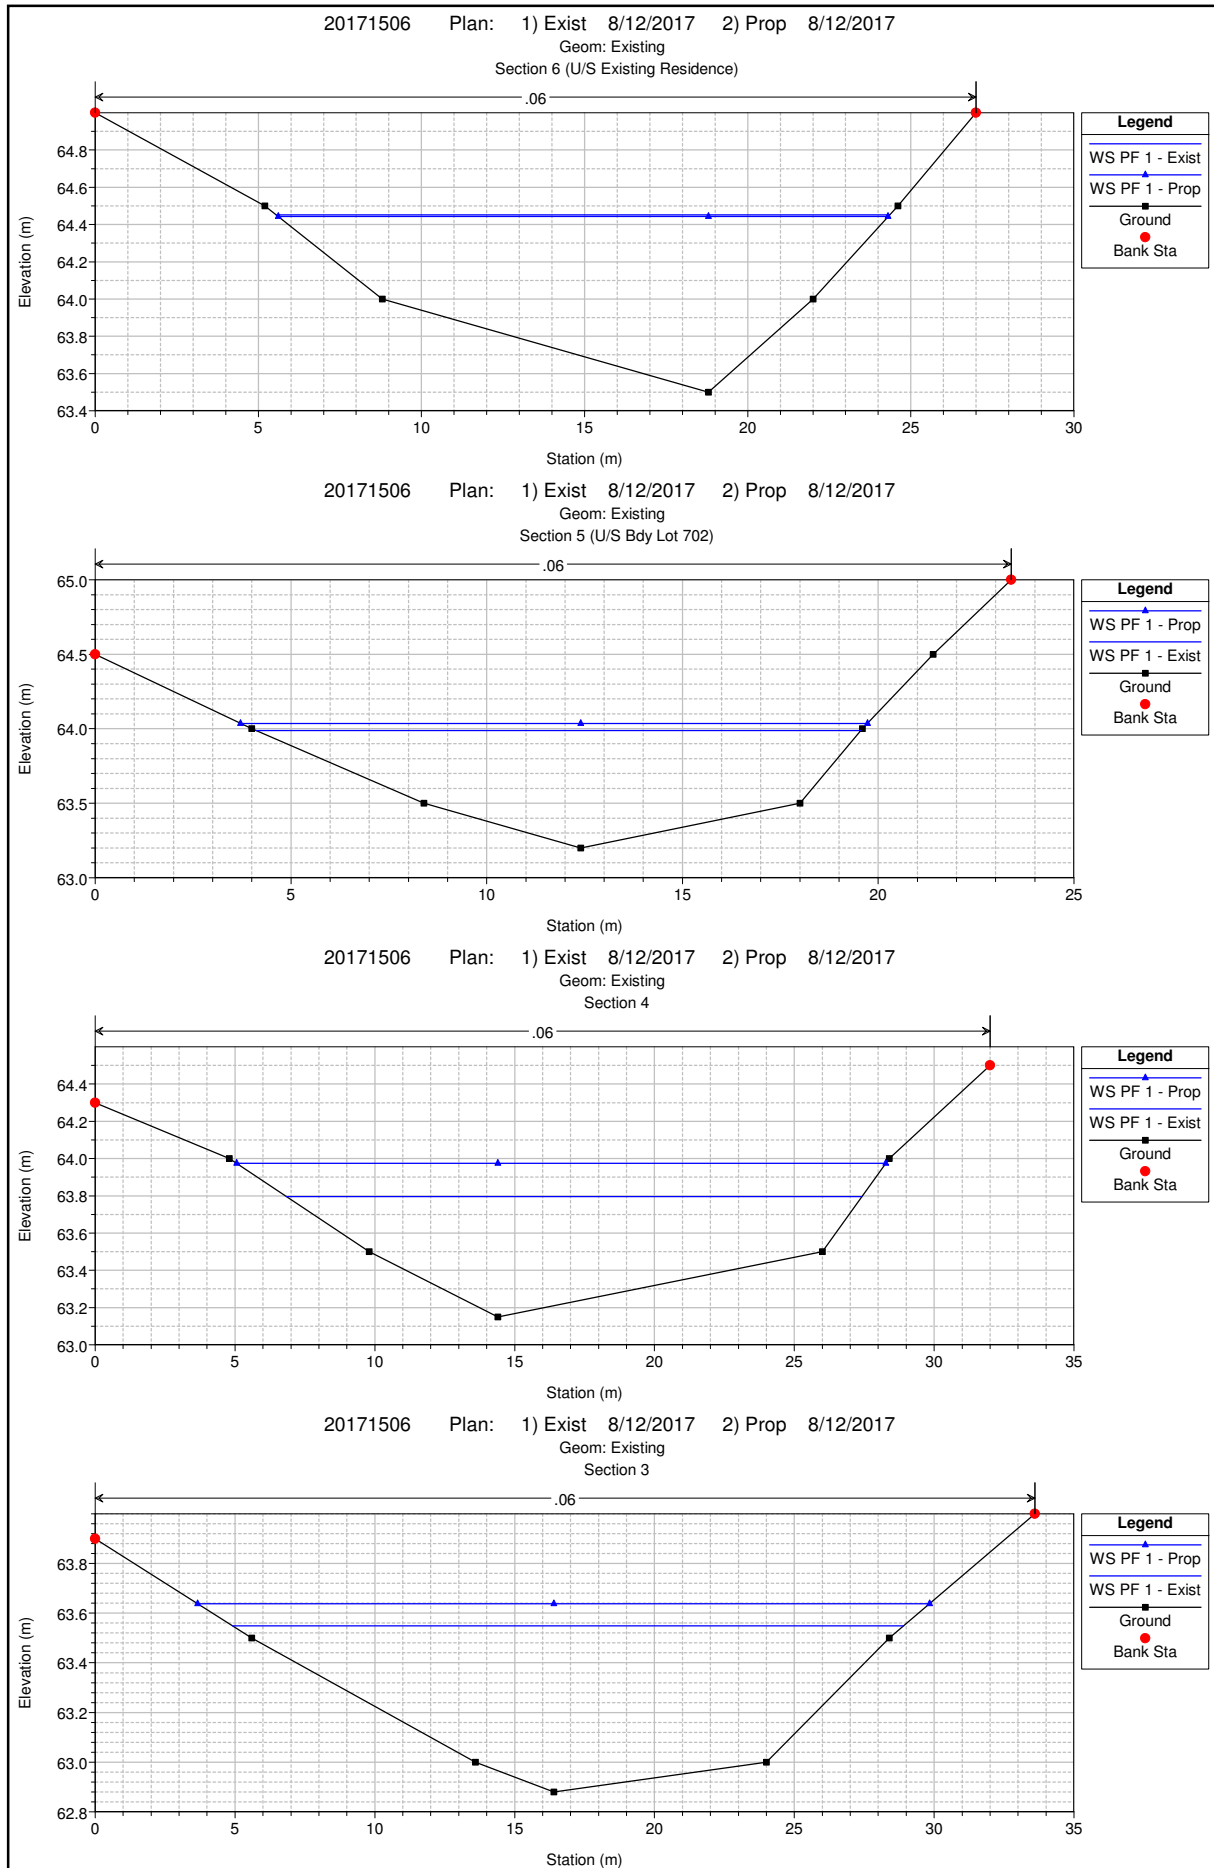
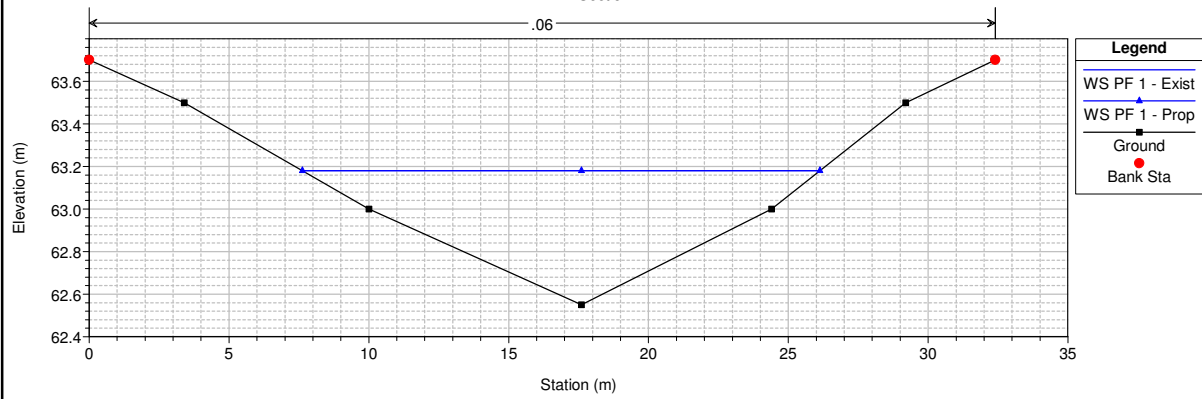
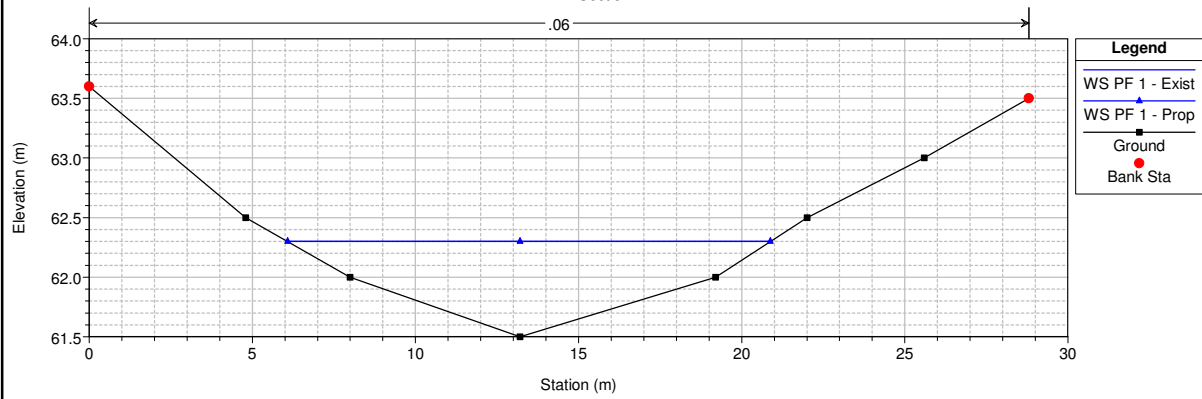
20171506 Plan: 1) Exist 8/12/2017 2) Prop 8/12/2017
 Geom: Existing
 Section 2

Flood levels through the site were calculated using the HECRAS computer model. HECRAS is a hydraulic modelling package which can be used to perform one-dimensional steady flow water surface profile computations.

This scenario corresponds to the existing site conditions and was used to determine the base case against which any change in flood level brought about by the proposed development was assessed.

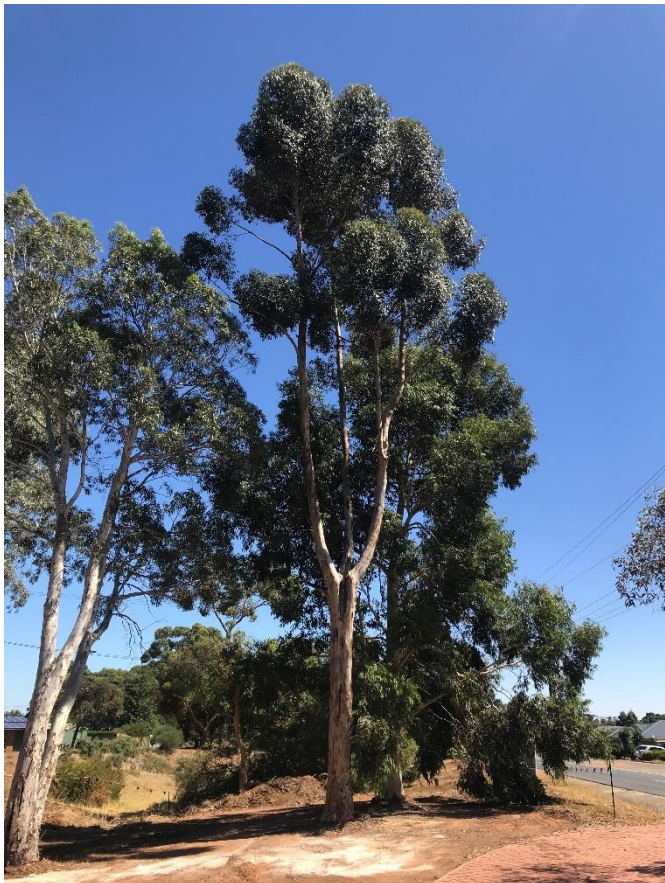
Tree 1		<i>Eucalyptus cladocalyx</i> - Sugar Gum
Assessment Date	27 th February 2018

GPS Location	34°37'25.45"S 138°44'29.50"E	
Height	16 metres	
Spread (Diameter)	9 metres	
Age	Mature	
Useful Life Expectancy	< 10 years	
Basic Health	Fair to Good	
Basic Structure	Fair to Poor	
Right: Tree 1 when viewed from the east and within the subject allotment.		
Circumference	2.05 metres	
Legislative Control	This tree's trunk circumference when measured at one metre above ground level is greater than two metres and less than three metres and it is therefore classified as a Regulated Tree under the current provisions of the <i>Development Act 1993</i> .	
Root Protection Zones		
Diameter @ Breast Height	0.63 metres	
Tree Protection Zone	= 0.63 x 12 = 7.56 metres as a radius from the centre of the trunk at ground level.

Tree health is considered to be fair to good. Foliage density, colour and size throughout the form are typical of the species and there are no significant signs of pests or disease to indicate health decline or environmental stress.

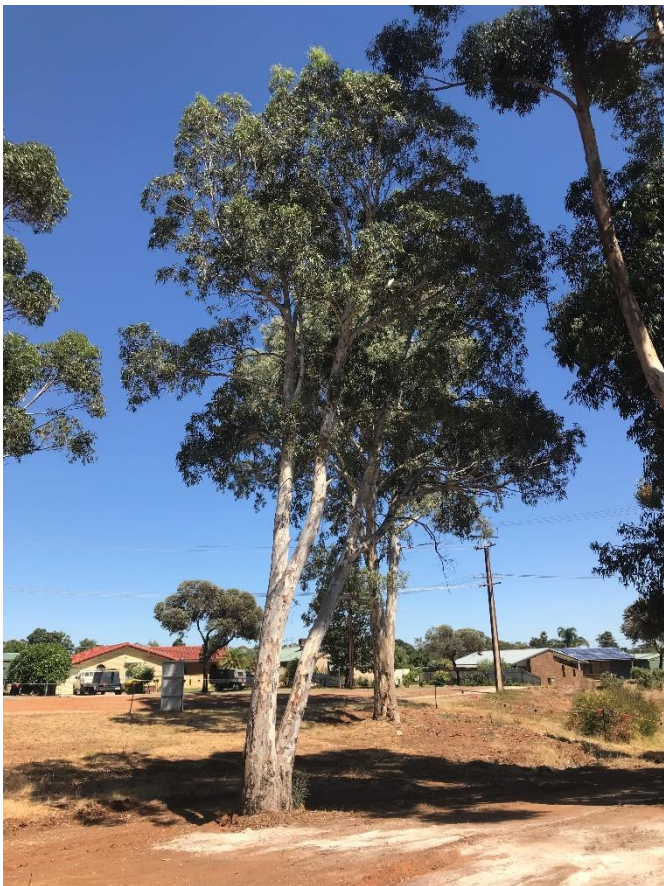
Tree 2		<i>Eucalyptus camaldulensis</i> - River Red Gum
Assessment Date	27 th February 2018

GPS Location	34°37'25.69"S 138°44'29.51"E	
Height	10 metres	
Spread (Diameter)	12 metres	
Age	Mature	
Useful Life Expectancy	> 10 years	
Basic Health	Fair to Good	
Basic Structure	Fair to Good	
Right: Tree 2 when viewed from the north east and within the subject allotment.		
Circumference	$1.34 + 1.91 = 3.25$ metres Average Circumference = 1.62 metres	
Legislative Control	This tree has a combined trunk circumference when measured at one metre above ground level that is greater than three metres. The average circumference of these trunks is greater than 0.625 metres and the tree is therefore classified as a Significant Tree under the current provisions of the <i>Development Act 1993</i> .

Root Protection Zones	
Diameter @ Breast Height	0.41 + 0.58 metres
	$= (0.41)^2 + (0.58)^2$ metres $= 0.71$ metres
Tree Protection Zone	$= 0.71 \times 12$ $= \mathbf{8.52 \text{ metres as a radius from the centre of the trunk at ground level.}}$
Diameter @ Root Buttress	0.78 metres
Structural Root Zone	$= (0.78 \times 50)^{0.42} \times 0.64$ $= \mathbf{2.98 \text{ metres as a radius from the centre of the trunk at ground level.}}$

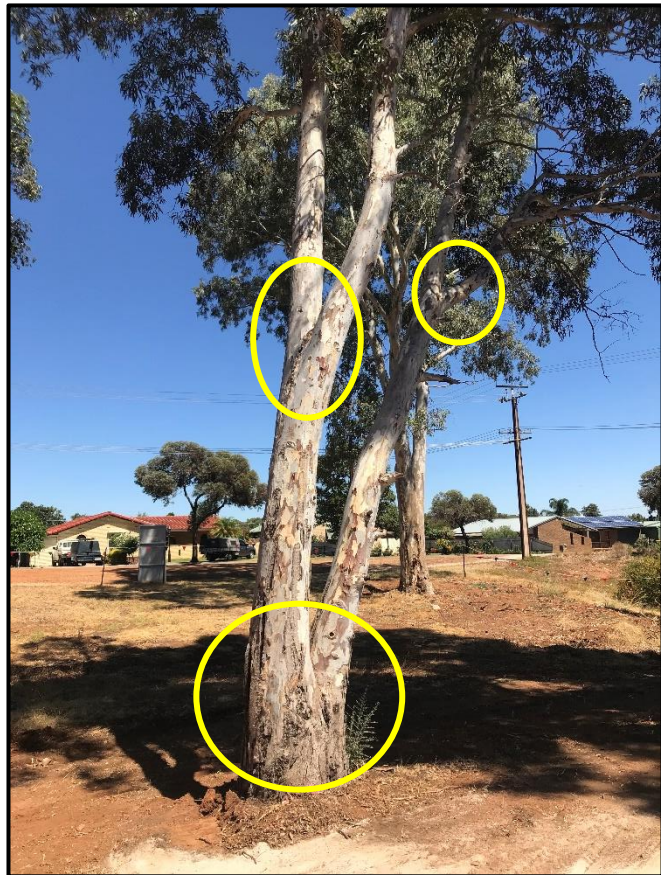
Tree structure is fair. The primary union at 800mm above ground level displays included bark while repeated bifurcations creating stem co-dominance are constant throughout the height of the form (Image 2). While some upper crown branch unions display minor included bark also, most are free of recognisable defects. Lateral branches display typical elongation, taper and distribution for the species and good options are present to maintain the structure of this tree.

- *Image 2 (Right): The repeated occurrence of bifurcation within the primary structure, each with minor included bark. This indicates that this defect is due to the genetic makeup of the tree and can be expected to continue throughout the form and its development.*

The tree displays below average structural form with a series of bifurcations causing codominant stems. The primary union displays included bark indicating that there is an elevated potential for failure at this point. Stem failure will result in the trees Useful Life Expectancy being surpassed.

- Tree 2 has an elevated potential for branch and stem failure as a result of the presence of included bark unions throughout its primary structure.
- Both Trees 1 and 2 are restricting development that is reasonable and expected. The situation of the small water course to the south as well as other Regulated/Significant Trees indicates that the location of the proposed dwelling will have the least possible proportion of tree impact within the allotment while achieving reasonable development.

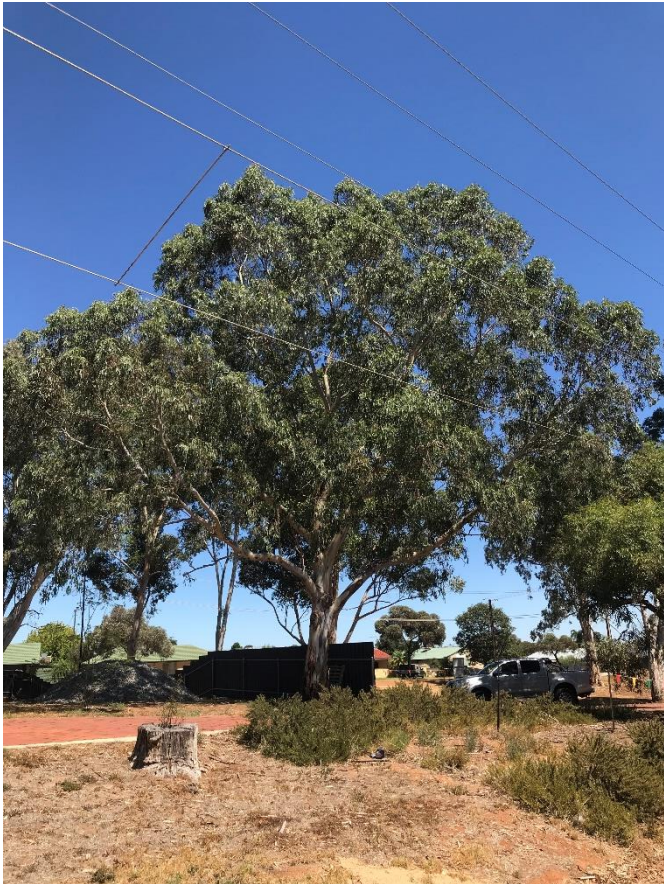
Tree 3		<i>Eucalyptus camaldulensis</i> - River Red Gum
Assessment Date	27 th February 2018

GPS Location	34°37'26.12"S 138°44'30.70"E	
Height	12 metres	
Spread (Diameter)	14 metres	
Age	Mature	
Useful Life Expectancy	> 10 years	
Basic Health	Good	
Basic Structure	Fair to Good	
Right: Tree 3 when viewed from the north east and adjacent to the road surfacing of Potts Road.		
Circumference	2.10 metres	
Legislative Control	This tree's trunk circumference when measured at one metre above ground level is greater than two metres and less than three metres and it is therefore classified as a Regulated Tree under the current provisions of the <i>Development Act 1993</i> .

Root Protection Zones	
Diameter @ Breast Height	0.62 metres
Tree Protection Zone	$= 0.62 \times 12$ = 7.44 metres as a radius from the centre of the trunk at ground level.
Diameter @ Root Buttress	0.68 metres
Structural Root Zone	$= (0.68 \times 50)^{0.42} \times 0.64$ = 2.81 metres as a radius from the centre of the trunk at ground level.

Tree structure is good to fair. Root and trunk buttressing is well formed which leads into good trunk and branch taper. Branch unions throughout the form are free of recognisable defects while distribution of lateral branches is typical for the species and good options are present to maintain the structure of this tree.

The following management recommendations are provided to manage the health, structure and aesthetic condition of Tree 3 during development and construction activities:

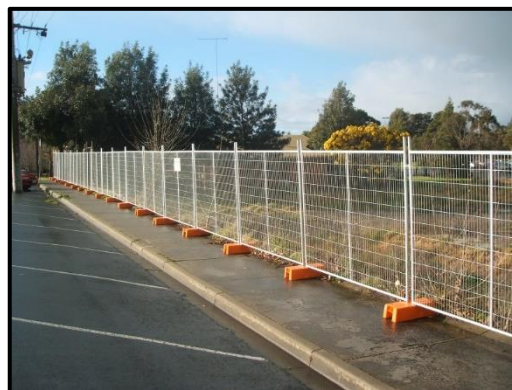
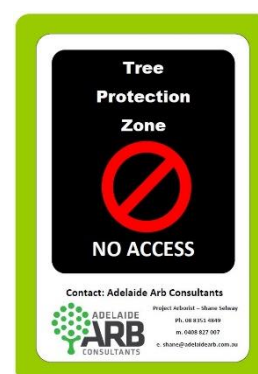
- The following is an extract from Australian Standard AS4970-2009 *Protection of trees on development sites* demonstrating tree protection fencing however, should any part of the tree protection fence construction become problematic, immediate consultation with the project arborist is recommended.

- Fencing materials must comply with the guidelines of Australian Standard AS4687-2007 *Temporary fencing and hoardings*. Fence panels should be fitted with shade cloth to reduce the transport of dusts and particulate matter. This will also reduce the potential for undesirable liquids to be inadvertently projected into the Tree Protection Zone.

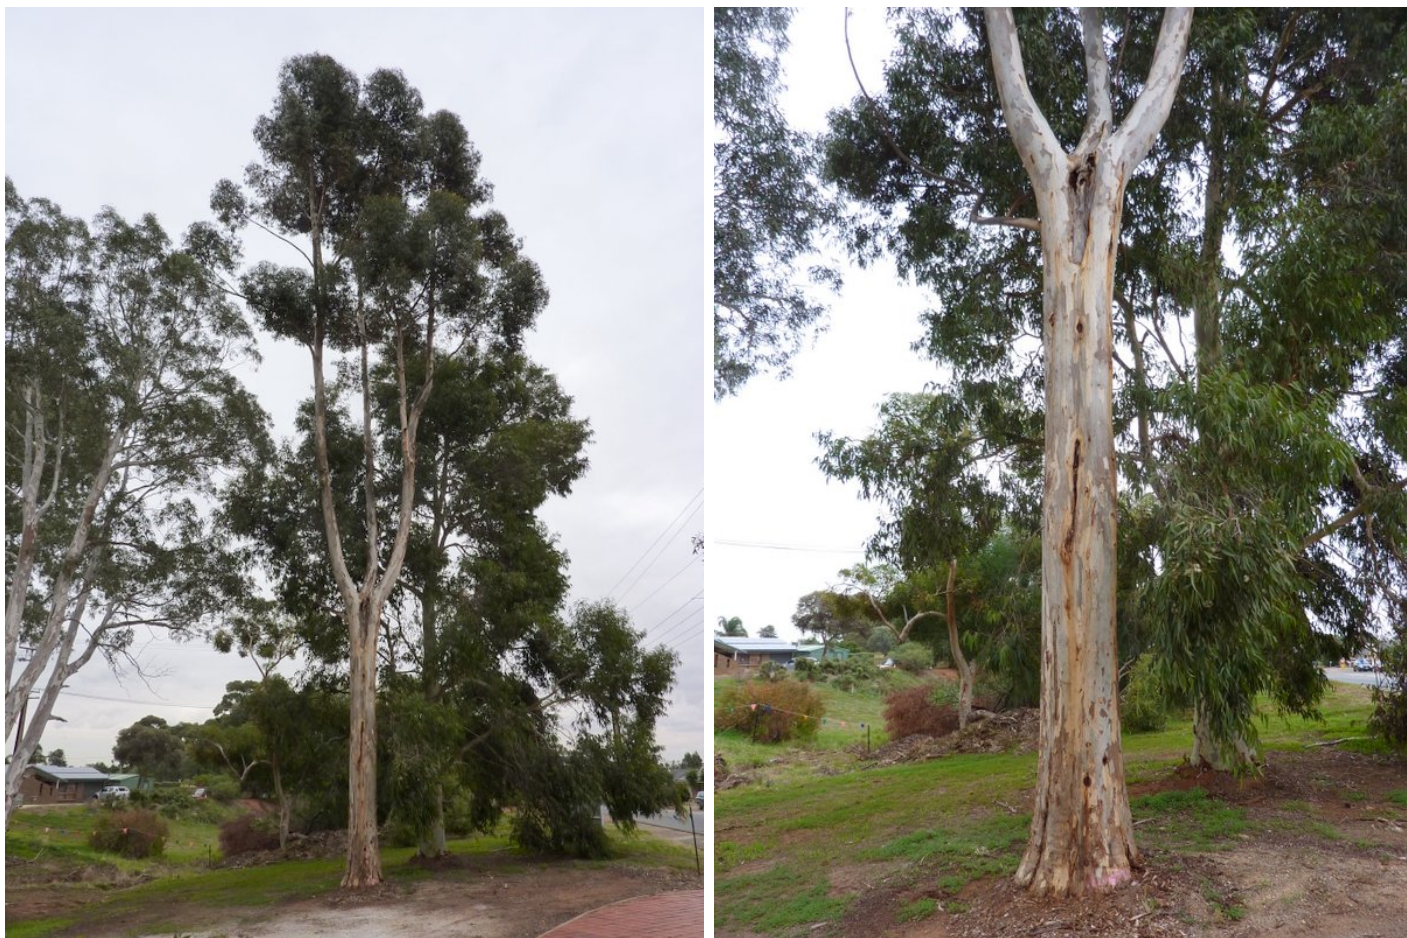
Figure 2. Tree One. Looking approximately west from the subject site.

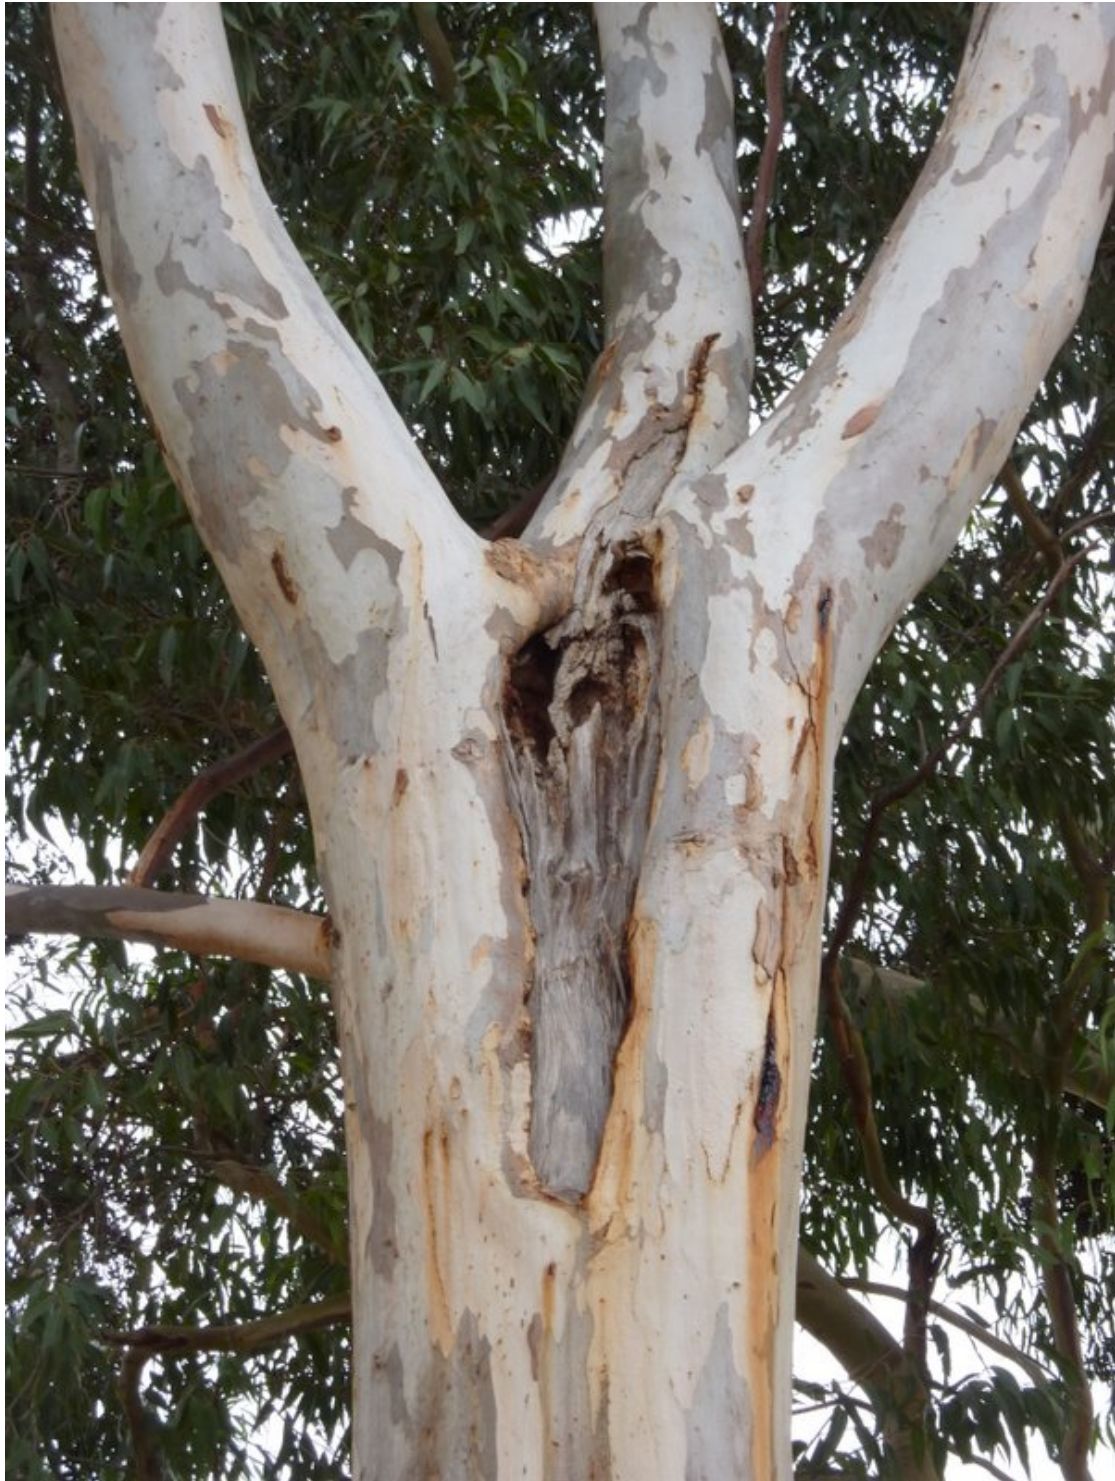
Figure 3. The primary trunk trifurcation in Tree One, which is structurally defective and has a very high likelihood of structural failure.

As the tree is not worthy or retention, a HUS is not provided for this tree.

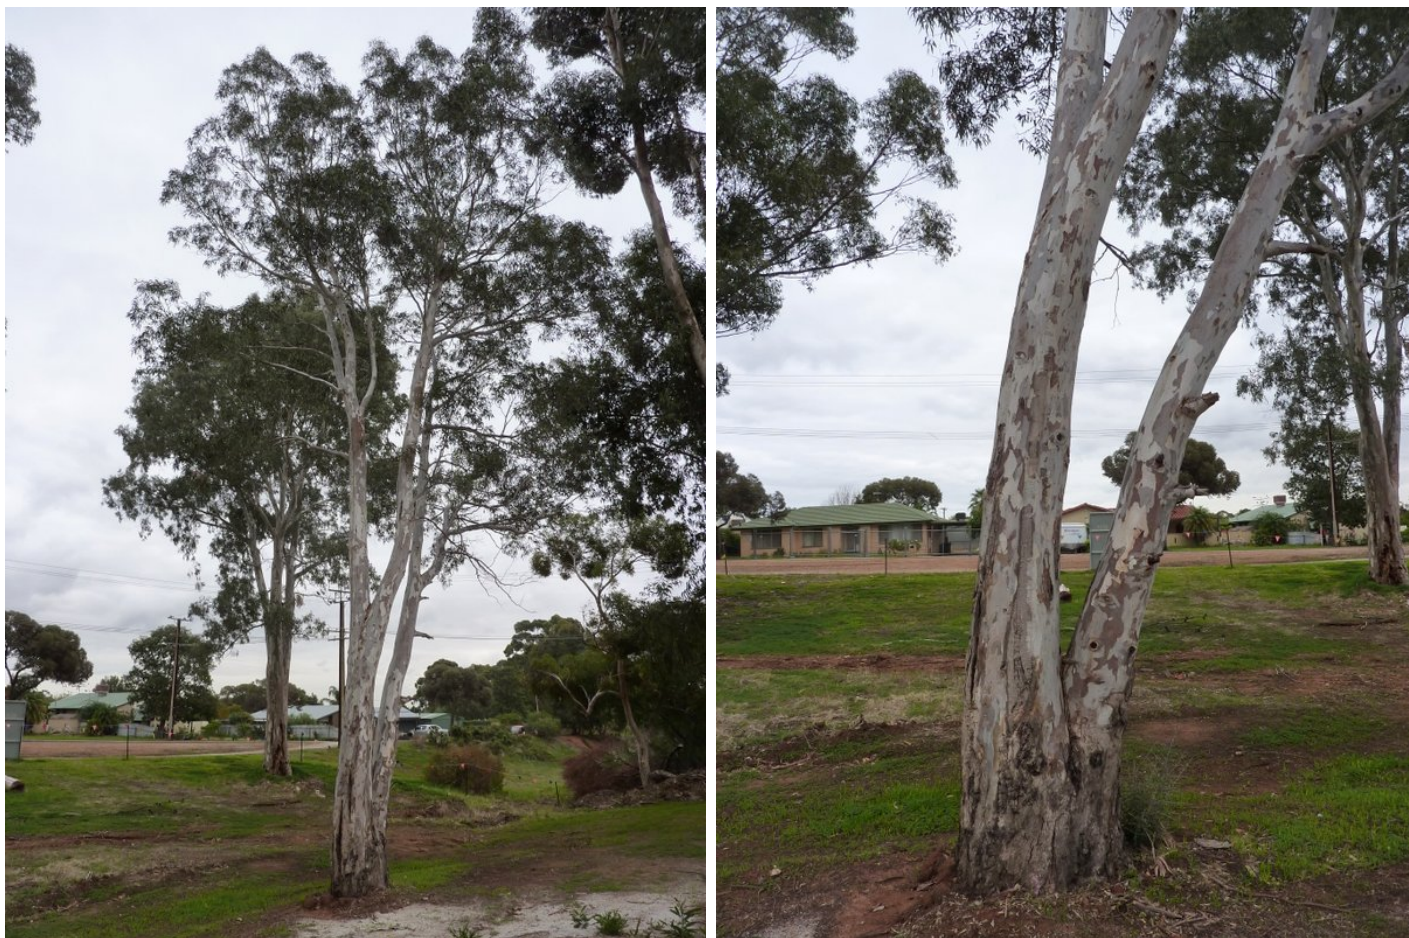
Figure 4. Tree Two. Looking approximately west from the subject site.

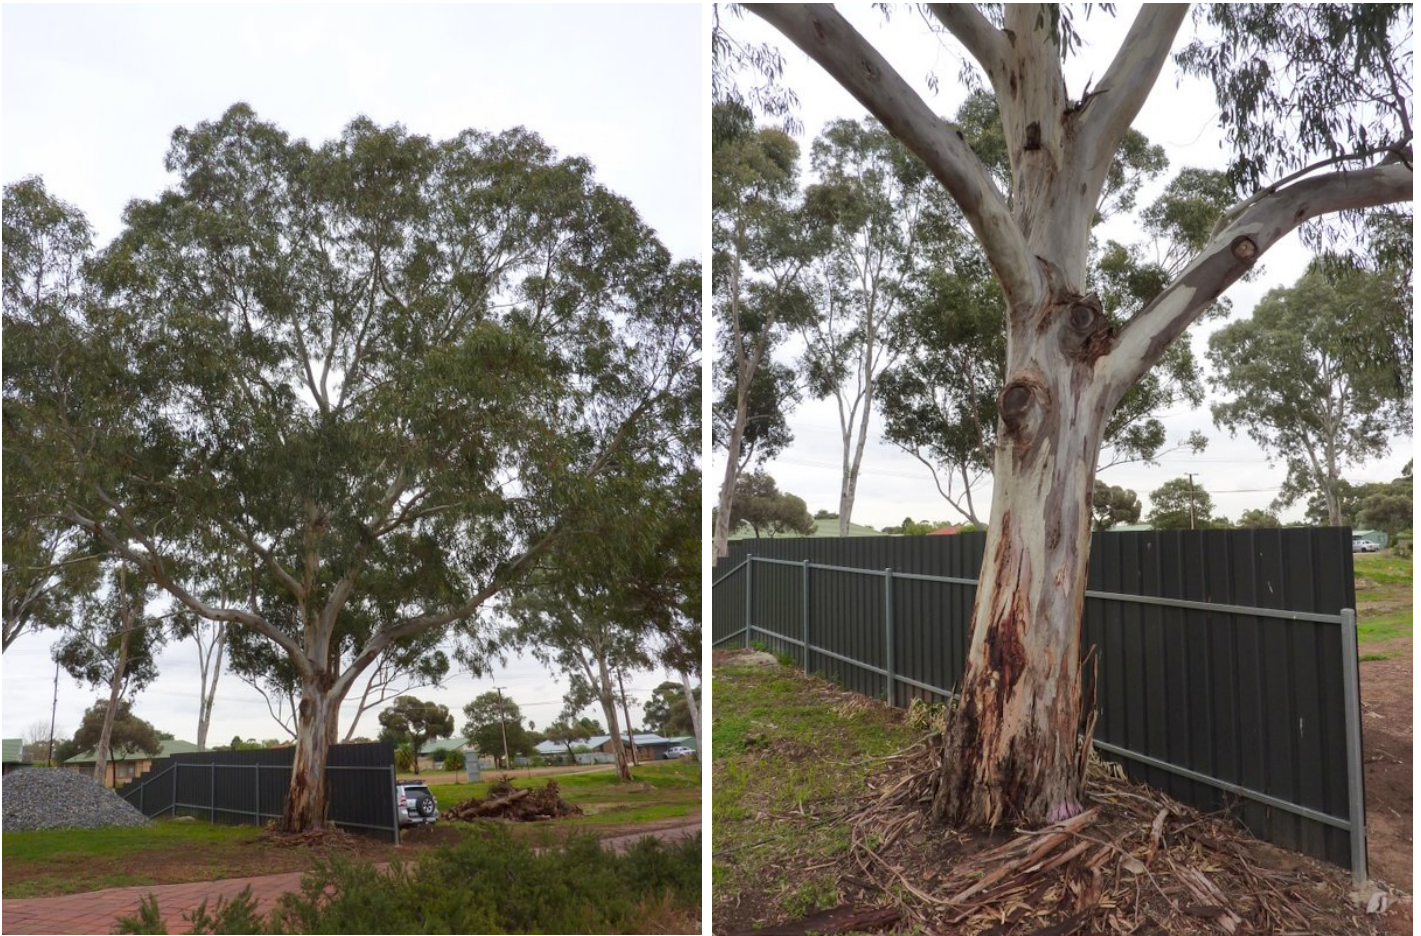
Figure 5. Tree Three. Looking approximately south-west from the subject site.
