# STANDARD RESIDENTIAL BUILDING INSPECTION REPORT

**23 CINNABAR CLOSE, CAVES BEACH**

**Property Address:** 23 CINNABAR CLOSE  
CAVES BEACH NSW 2281

**Inspection Date/Time:** 13/08/2019 8:06 AM

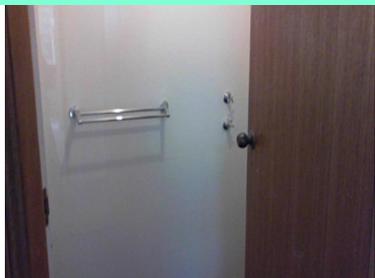
Walls Damaged or incomplete architrave will need repair to restore appearance, cracked or damaged grouting or sealant

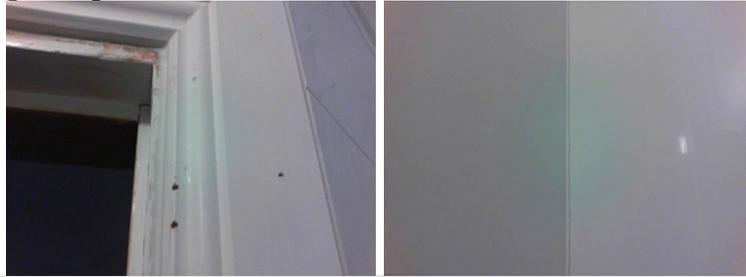
Ceiling Typical cracking and poorly completed works, will need repair and re-finish to improve appearance

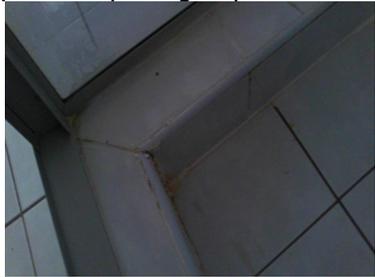
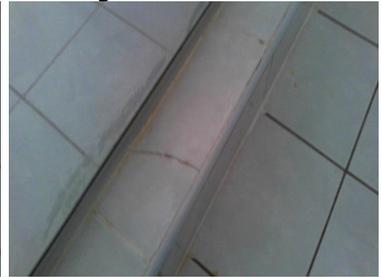
Taps	OK, The item described is performing the function it was designed for and its condition is very typical for it's age
Waste Traps	OK, The item described is performing the function it was designed for and its condition is very typical for it's age
Splashbacks	Tile grouting poorly completed will need repair/re-sealing to ensure water tightness and restore appearance
Bath	OK, The item described is performing the function it was designed for and its condition is very typical for it's age
Shower	Damaged base and will need repair or replacing to prevent water damage

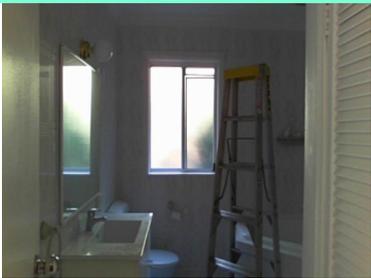
**BATHROOM 3** LOWER LEVEL

Door	Binding, will need adjusting to ensure correct operation.
Walls	OK, The item described is performing the function it was designed for and its condition is very typical for it's age
Ceiling	OK, The item described is performing the function it was designed for and its condition is very typical for it's age

Floors	OK, The item described is performing the function it was designed for and its condition is very typical for it's age
Window/s	Loose Catch/s and/or handle/s need repair to restore function
Painting	OK, The item described is performing the function it was designed for and its condition is very typical for it's age
Other	Loose PC items, toilet roll holder, towel rails or handrails will need repairs to restore integrity
Vanity	OK, The item described is performing the function it was designed for and its condition is very typical for it's age
Basin	OK, The item described is performing the function it was designed for and its condition is very typical for it's age
Taps	OK, The item described is performing the function it was designed for and its condition is very typical for it's age
Waste Traps	OK, The item described is performing the function it was designed for and its condition is very typical for it's age

Splashbacks	OK, The item described is performing the function it was designed for and its condition is very typical for it's age
Bath	OK, The item described is performing the function it was designed for and its condition is very typical for it's age
Shower	Over the bath and adequately performing the function it was designed for
Screen/Curtain	NIL, The item described is not present at the time of the inspection
Mirror/s	OK, The item described is performing the function it was designed for and its condition is very typical for it's age
Ventilation	Noisy fan will need repair to restore correct operation

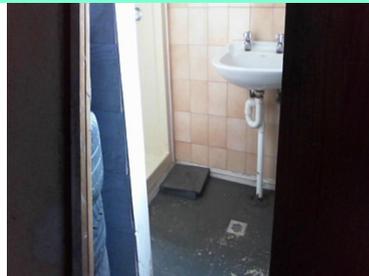
Door	Damaged outside face will need repair to improve appearance
Walls	Typical plaster cracking, may need repair and re-finish to improve appearance

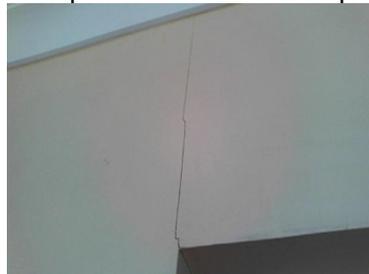
Ceiling	Minor joint cracking needs repair and re-finish to restore appearance
Floors	OK, The item described is performing the function it was designed for and its condition is very typical for it's age
Window/s	Loose Catch/s and/or handle/s need repair to restore function
Painting	Minor touchup repairs only are needed to restore appearance
Other	
Vanity	NIL, The item described is not present at the time of the inspection
Basin	Damaged plug hole will need repair to improve appearance and function
Taps	OK, The item described is performing the function it was designed for and its condition is very typical for it's age
Waste Traps	Leaking waste pipes need repair to prevent water damage
Splashbacks	OK, The item described is performing the function it was designed for and its condition is very typical for it's age
Bath	NIL, The item described is not present at the time of the inspection
Shower	OK, The item described is performing the function it was designed for and its condition is very typical for it's age

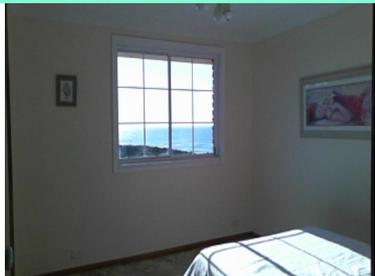
**BEDROOM 1**

Door	Binding, will need adjusting to ensure correct operation.
Walls	OK, The item described is performing the function it was designed for and its condition is very typical for it's age
Ceiling	OK, The item described is performing the function it was designed for and its condition is very typical for it's age
Floors	Out of level and may need repair to restore acceptable levels and appearance
Window/s	Sliding sash wheels are worn or missing and need replacing to ensure correct function.
Painting	OK, The item described is performing the function it was designed for and its condition is very typical for it's age
Other	
Robes	Robe door/s binding and need adjusting to restore correct function

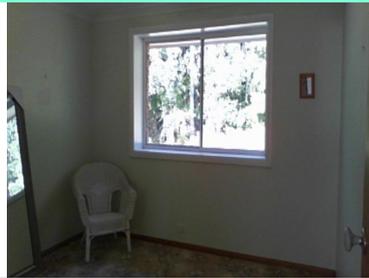
**BEDROOM 3**

Door Binding, will need adjusting to ensure correct operation.  
 Walls Gaps around door architrave will need repair to restore appearance

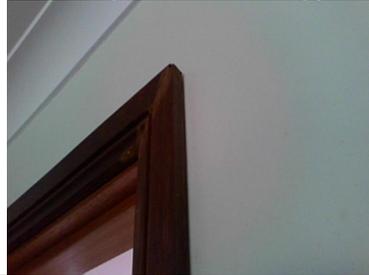
Ceiling OK, The item described is performing the function it was designed for and its condition is very typical for it's age  
 Floors Out of level and may need repair to restore acceptable levels and appearance  
 Window/s Window catch/s are broken or missing and will need repair or replacing to restore function  
 Painting Complete and re-finish repairs and/or incomplete works as above  
 Other  
 Robes OK, The item described is performing the function it was designed for and its condition is very typical for it's age

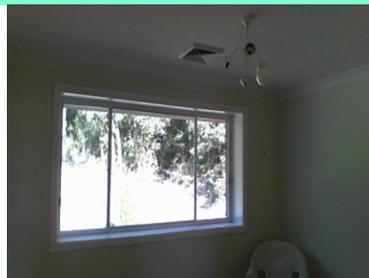
**BEDROOM 4**

Door Binding, will need adjusting to ensure correct operation.  
 Walls Typical plaster cracking and popped nails, may need repair and re-finish to improve appearance  
 Ceiling OK, The item described is performing the function it was designed for and its condition is very typical for it's age  
 Floors OK, The item described is performing the function it was designed for and its condition is very typical for it's age  
 Window/s Loose Catch/s and/or handle/s need repair to restore function  
 Painting OK, The item described is performing the function it was designed for and its condition is very typical for it's age  
 Other  
 Robes NIL, The item described is not present at the time of the inspection

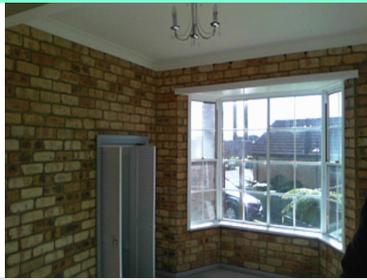
**BEDROOM 5 LOWER LEVEL**

Door	OK, The item described is performing the function it was designed for and its condition is very typical for it's age
Walls	OK, The item described is performing the function it was designed for and its condition is very typical for it's age
Ceiling	Small hole/s need repair to restore appearance
Floors	Out of level and may need repair to restore acceptable levels and appearance
Window/s	Window stay/s broken or missing, will need repair or replacing to reinstate correct operation
Painting	Complete and re-finish repairs and/or incomplete works as above
Other	
Robes	NIL, The item described is not present at the time of the inspection

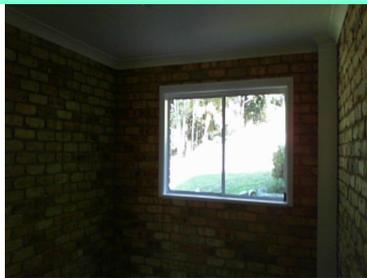
**BEDROOM 6**

Door	Binding and damaged skins will need adjusting to ensure correct operation.
Walls	OK, The item described is performing the function it was designed for and its condition is very typical for it's age
Ceiling	OK, The item described is performing the function it was designed for and its condition is very typical for it's age
Floors	OK, The item described is performing the function it was designed for and its condition is very typical for it's age
Window/s	Loose Catch/s and/or handle/s need repair to restore function
Painting	OK, The item described is performing the function it was designed for and its condition is very typical for it's age
Other	
Robes	NIL, The item described is not present at the time of the inspection

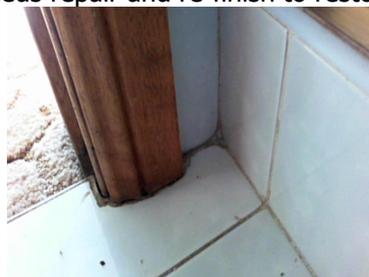
Bath	NIL, The item described is not present at the time of the inspection
Shower	Tile grouting is cracked and or missing and will repair to restore water tightness and appearance

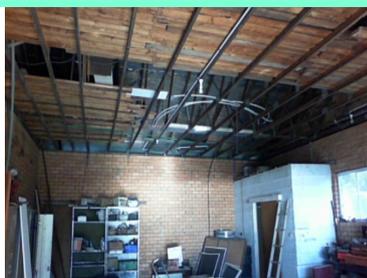
Door	OK, The item described is performing the function it was designed for and its condition is very typical for it's age
Walls	OK, The item described is performing the function it was designed for and its condition is very typical for it's age
Ceiling	Damaged roof framing truss needs repairs

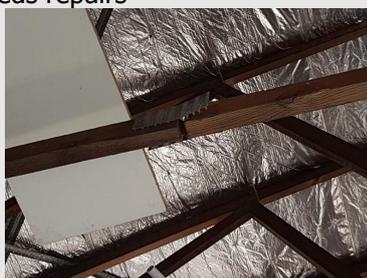
Floors	Minor concrete cracking was noted and should be monitored regularly, a structural engineer should be consulted if further deterioration is noted
Window/s	Window unable to be opened or tested
Painting	NIL, The item described is not present at the time of the inspection
Other	
Vehicle Door/s	OK, The item described is performing its correct function as designed

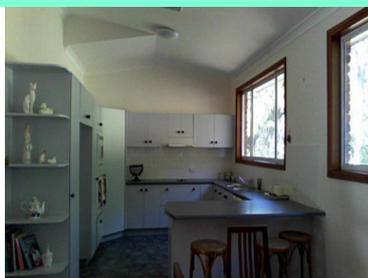
Doors, Drawers & Cabinets	Damaged cabinet and or shelving, will need repair or replacement to restore integrity, loose hinges need repairs
---------------------------	------------------------------------------------------------------------------------------------------------------

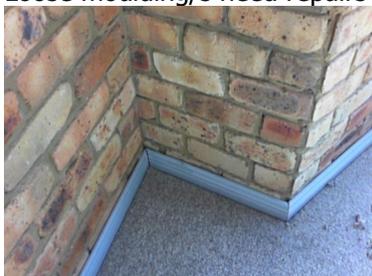
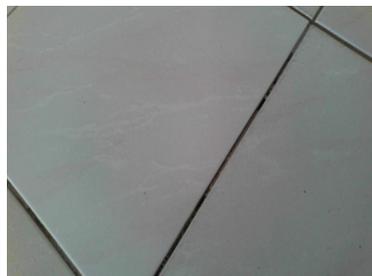
Walls Loose moulding/s need repairs

Ceiling Cornice cracking may need repairs to improve appearance

Floors Out of level and may need repair to restore acceptable levels and appearance, missing grout in tiled area needs repairs to restore condition

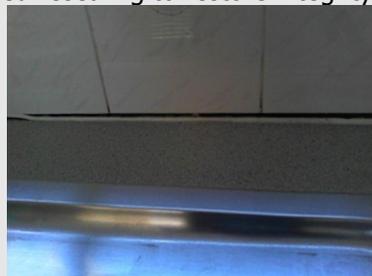
Splashbacks Stained or missing grout will need resealing to restore integrity and appearance

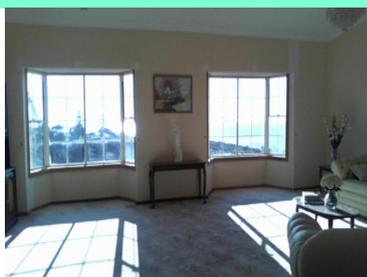
**LOUNGE 2**

Door	NIL, The item described is not present at the time of the inspection
Walls	OK, The item described is performing the function it was designed for and its condition is very typical for it's age
Ceiling	Cornice cracking may need repairs to improve appearance
Floors	Loose and squeaking board/s or sheet/s will need repair to restore integrity
Window/s	Window catch/s are broken or missing and will need repair or replacing to restore function

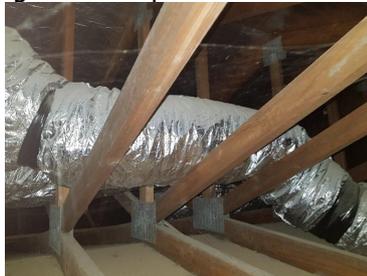
Insulation NIL, No insulation was visible at the time of the inspection  
 Sarking Damaged sisalation was noted, this needs repair to ensure correct function  
 Parti Walls NIL, No parti walls found in this construction  
 Other Spider infestation was noted due to the significant webs throughout, I recommend you consult a pest control expert

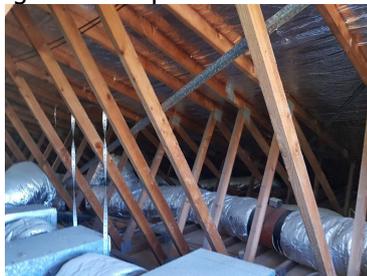
Sarking Damaged sisalation was noted, this needs repair to ensure correct function

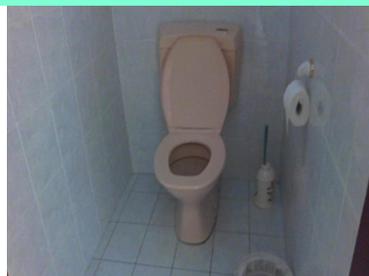
**WC / TOILET 1**

Door	Door needs repair to restore correct and flush closure
Walls	OK, The item described is performing the function it was designed for and its condition is very typical for it's age
Ceiling	OK, The item described is performing the function it was designed for and its condition is very typical for it's age
Floors	OK, The item described is performing the function it was designed for and its condition is very typical for it's age
Window/s	NIL, The item described is not present at the time of the inspection
Painting	OK, The item described is performing the function it was designed for and its condition is very typical for it's age
Other	
Cistern	OK, The item described is performing the function it was designed for and its condition is very typical for it's age
Pan	OK, The item described is performing the function it was designed for and its condition is very typical for it's age

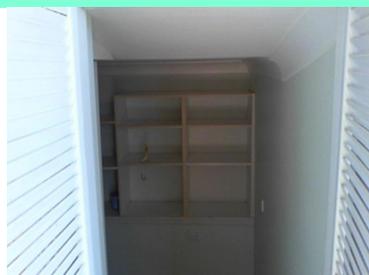
**WIR**

Door	Binding, will need adjusting to ensure correct operation.
Walls	Typical plaster cracking, may need repair and re-finish to improve appearance
Ceiling	OK, The item described is performing the function it was designed for and its condition is very typical for it's age
Floors	OK, The item described is performing the function it was designed for and its condition is very typical for it's age
Window/s	NIL, The item described is not present at the time of the inspection
Painting	OK, The item described is performing the function it was designed for and its condition is very typical for it's age
Other	Cupboards are damaged will need repair to restore appearance

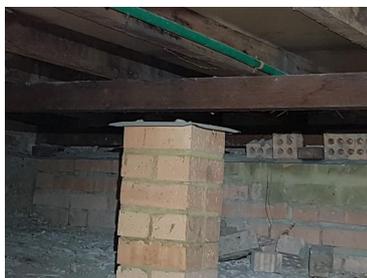
**Bearers/Joists** Some timber framing elements are disengaged from piers and need repairs to ensure integrity and reinstate floor levels

**Piers/Stumps** Some evidence of typical pier subsidence, should be repacked to ensure stability and reinstate levels
