Pre-Purchase Inspection - Residential Building Report

Complies with Australian Standard AS 4349.1- 2007 Inspection of Buildings Part 1: Pre-Purchase inspections - Residential buildings

392 Brunner Road
Adamstown Heights NSW

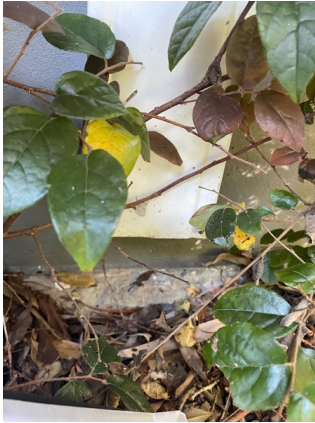
Defect 1. - Roof Exterior

Defect Location:	East Side
Defect Summary:	Downpipes
Type of Defect:	Installation
Description:	Connection to stormwater drainage is damaged/inadequate
Ongoing Consequence:	Damage to surrounding elements
Opinion of Cracking:	Not Applicable
Building Professional:	Note: This defect should be referred to a qualified building professional for the repairs/scope of work required. Building Professional Required: Plumber

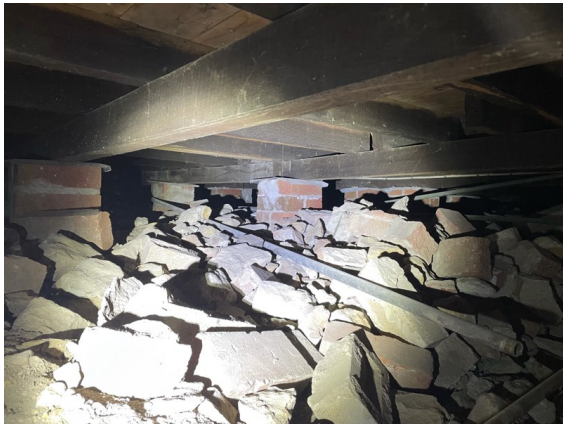
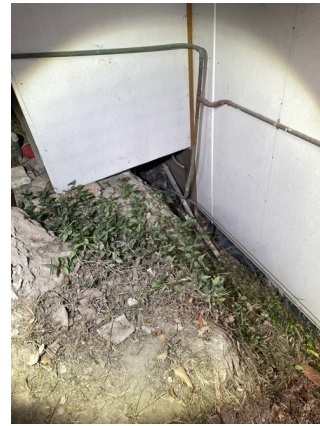
Defect 3. - Subfloor

Defect Location:	Not Applicable
Defect Summary:	Ventilation (Subfloor)
Type of Defect:	Operational
Description:	The drainage appears to be inadequate
Ongoing Consequence:	Damage to surrounding elements
Opinion of Cracking:	Not Applicable
Building Professional:	Note: This defect should be referred to a qualified building professional for the repairs/scope of work required. Building Professional Required: Plumber

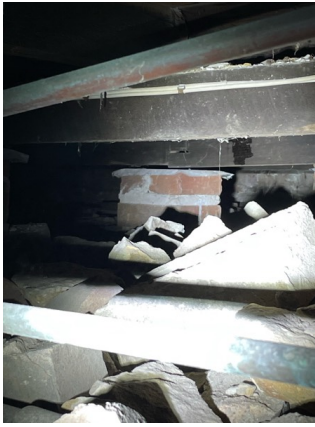
Defect 4. - Subfloor

Defect Location:	Not Applicable
Defect Summary:	Piers and Foundation Walls
Type of Defect:	Distortion, warping, twisting
Description:	Piers appear to have settled
Ongoing Consequence:	Possible further settlement piers (typical for age)
Opinion of Cracking:	Not Applicable
Building Professional:	Note: This defect should be referred to a qualified building professional for the repairs/scope of work required. Building Professional Required: Builder

Eastern area

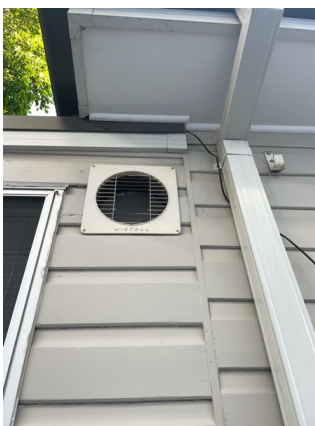
Defect 5. - Exterior

South Side

Vent

Damage

Damaged vent

Possible water ingress

Note: This defect should be referred to a qualified building professional for the repairs/scope of work required.

Building Professional Required: Builder

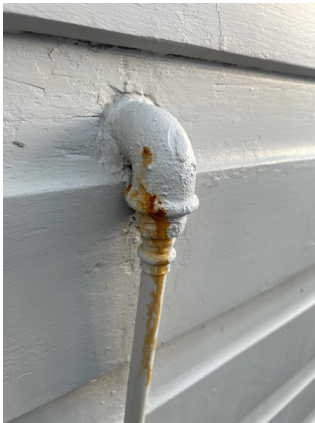
Defect 6. - Exterior

Defect Location:	South Side
Defect Summary:	Water supply
Type of Defect:	Water penetration, dampness, Material deterioration
Description:	Corrosion and minor leaking
Ongoing Consequence:	Further leaking
Opinion of Cracking:	Not Applicable
Building Professional:	Note: This defect should be referred to a qualified building professional for the repairs/scope of work required. Building Professional Required: Plumber

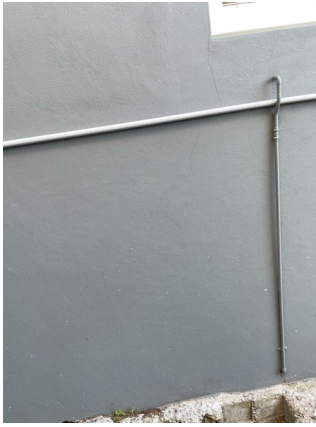
Defect 7. - Exterior

Defect Location:	South Side
Defect Summary:	Walls - Brick
Type of Defect:	Distortion, warping, twisting
Description:	There is drummy render
Ongoing Consequence:	Possible further cracking
Opinion of Cracking:	Appearance cracking
Building Professional:	Note: This defect should be referred to a qualified building professional for the repairs/scope of work required. Building Professional Required: Builder

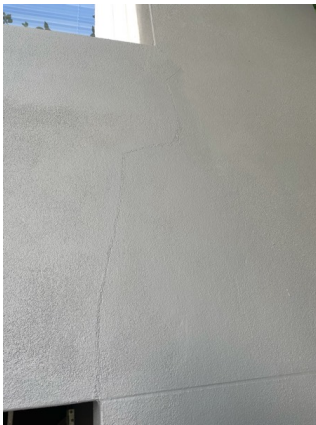
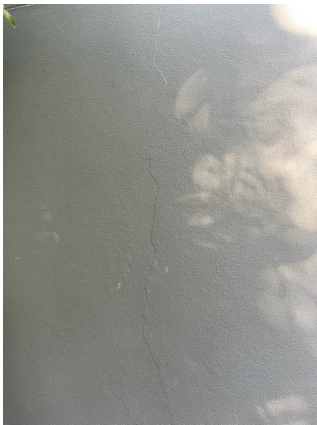
Defect 8. - Exterior

Defect Location:	South Side, East Side
Defect Summary:	Walls - Brick
Type of Defect:	Distortion, warping, twisting
Description:	There is vertical cracking
Ongoing Consequence:	Possible further cracking
Opinion of Cracking:	Appearance cracking
Building Professional:	Note: This defect should be referred to a qualified building professional for the repairs/scope of work required.
	Building Professional Required: Builder

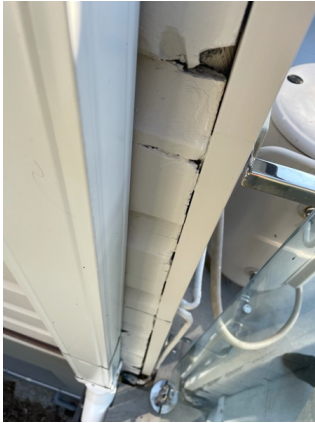
Defect 9. - Exterior

Defect Location:	South Side
Defect Summary:	Walls - Timber Frame
Type of Defect:	Installation
Description:	Inadequate seal cladding
Ongoing Consequence:	Serviceability of surrounding elements negatively affected
Opinion of Cracking:	Not Applicable
Building Professional:	Note: This defect should be referred to a qualified building professional for the repairs/scope of work required.
	Building Professional Required: Builder

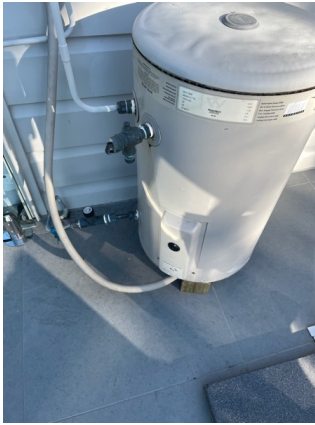
Defect 10. - Exterior

Defect Location:	East Side
Defect Summary:	Hot water system
Type of Defect:	Material deterioration
Description:	10 years life expectancy installed outdoors
Ongoing Consequence:	Anticipate future replacement
Opinion of Cracking:	Not Applicable
Building Professional:	Note: This defect should be referred to a qualified building professional for the repairs/scope of work required.
	Building Professional Required: Plumber

Manufactured 2005

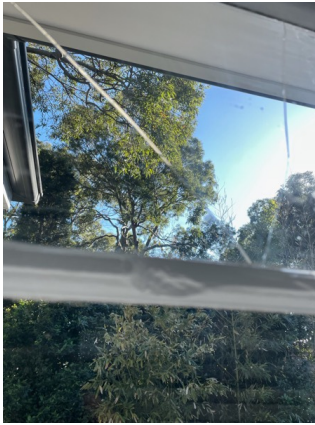
Defect 12. - Interior

Defect Location:	Lounge Room
Defect Summary:	Window
Type of Defect:	Damage, Material deterioration
Description:	Cracked glass and window sash chord damaged
Ongoing Consequence:	Door doesn't function as expected
Opinion of Cracking:	Not Applicable
Building Professional:	Note: This defect should be referred to a qualified building professional for the repairs/scope of work required.
	Building Professional Required: Builder, Glazier

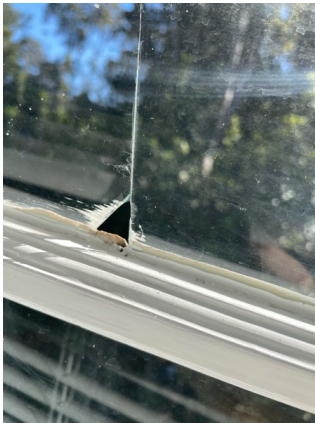
Defect 15. - Interior

Defect Location:	Family Room
Defect Summary:	Window,
Type of Defect:	Damage, Operational
Description:	Cracked glass, missing lock and window needs easing
Ongoing Consequence:	Doesn't function as expected
Opinion of Cracking:	Not Applicable
Building Professional:	Note: This defect should be referred to a qualified building professional for the repairs/scope of work required.
	Building Professional Required: Builder, Glazier

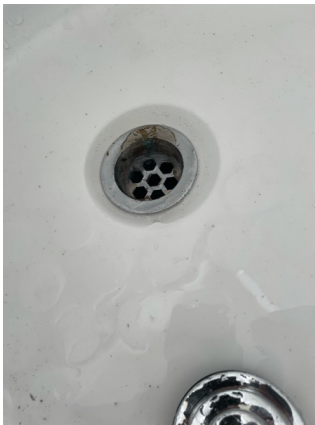
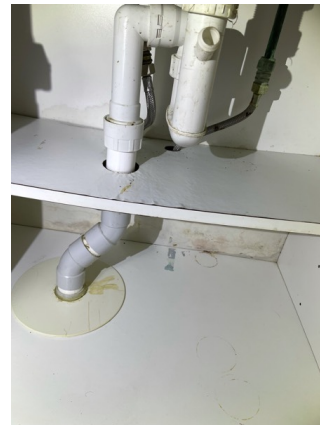
Defect 17. - Interior

Defect Location:	Bathroom 1
Defect Summary:	Bath and vanity
Type of Defect:	Material deterioration, Installation
Description:	Loose waste bath tub and moisture damage vanity
Ongoing Consequence:	Maintenance recommended
Opinion of Cracking:	Not Applicable
Building Professional:	Note: This defect should be referred to a qualified building professional for the repairs/scope of work required. Building Professional Required: Builder, Plumber

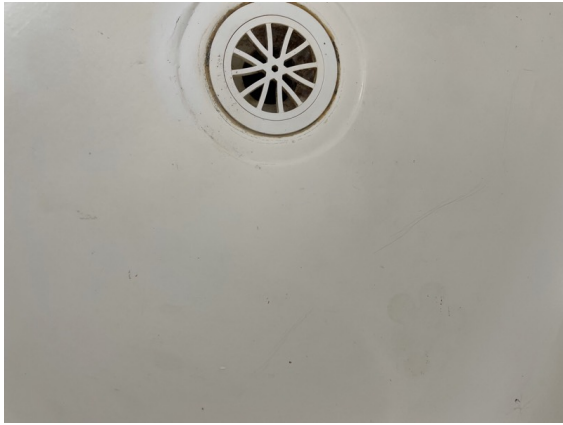
Defect 18. - Interior

Defect Location:	Ensuite 1
Defect Summary:	Shower floor,
Type of Defect:	Distortion, warping, twisting, Installation
Description:	Cracking shower floor tray and inadequate bedding under tray
Ongoing Consequence:	Possible further cracking and damage to surrounding elements
Opinion of Cracking:	Not Applicable
Building Professional:	Note: This defect should be referred to a qualified building professional for the repairs/scope of work required. Building Professional Required: Builder

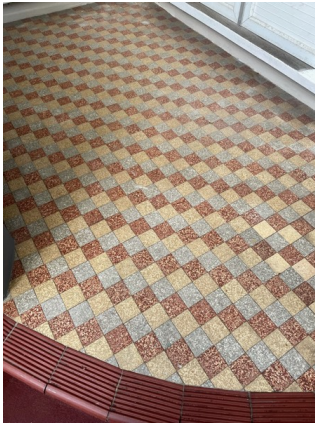
Site Defect 1. - Patio

Type of Defect:	Distortion, warping, twisting
Direction (North being front of Structure):	North
Description:	Drummy tiles
Ongoing Consequence:	Tiles may crack and come loose
Opinion of Cracking:	Not Applicable
Building Professional:	Note: This defect should be referred to a qualified building professional for the repairs/scope of work required.
	Building Professional Required: Builder

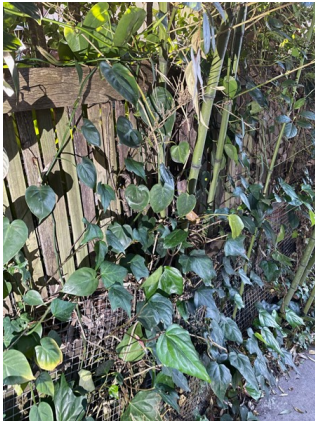
Site Defect 2. - Fencing (general)

Type of Defect:	Material deterioration
Direction (North being front of Structure):	North
Description:	Decay fence
Ongoing Consequence:	Further decay
Opinion of Cracking:	Not Applicable
Building Professional:	Note: This defect should be referred to a qualified building professional for the repairs/scope of work required.
	Building Professional Required: Builder

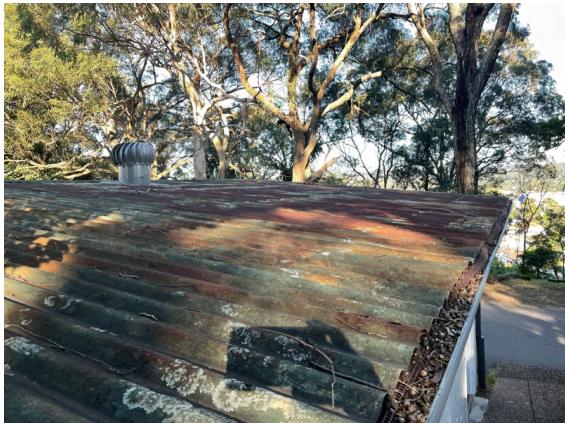
Site Defect 3. - Sheds

Type of Defect:	Material deterioration
Direction (North being front of Structure):	West
Description:	Rusted roof coverings
Ongoing Consequence:	Further corrosion
Opinion of Cracking:	Not Applicable
Building Professional:	Note: This defect should be referred to a qualified building professional for the repairs/scope of work required.
	Building Professional Required: Builder

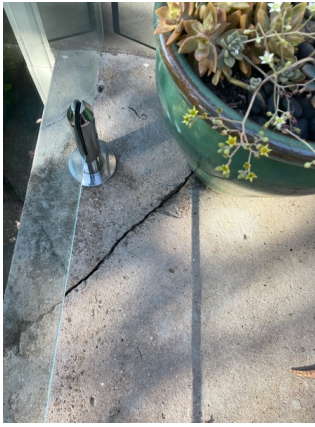
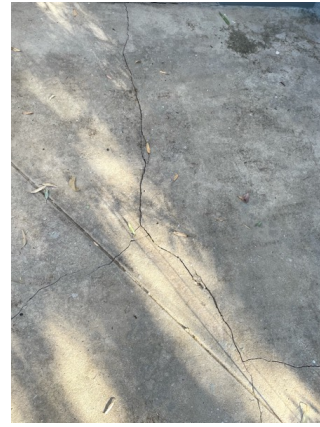
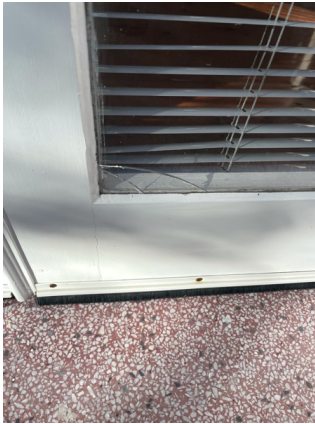
Site Defect 4. - Decks

Type of Defect:	Distortion, warping, twisting
Direction (North being front of Structure):	North, East
Description:	Serviceability cracking slab and cracked glazing door
Ongoing Consequence:	Possible further cracking slab and glazing
Opinion of Cracking:	Serviceability cracking
Building Professional:	Note: This defect should be referred to a qualified building professional for the repairs/scope of work required.
	Building Professional Required: Builder, Glazier

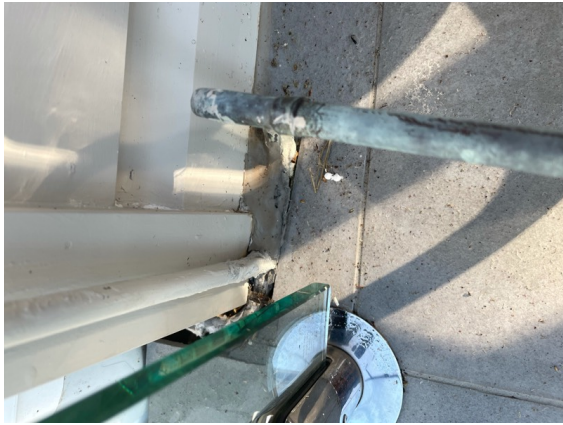
Site Defect 5. - Decks

Type of Defect:	Operational, Installation
Direction (North being front of Structure):	East
Description:	UPPER LEVEL- ensure adequate waterproofing around service
Ongoing Consequence:	Possible water ingress
Opinion of Cracking:	Not Applicable
Building Professional:	Note: This defect should be referred to a qualified building professional for the repairs/scope of work required. Building Professional Required: Builder

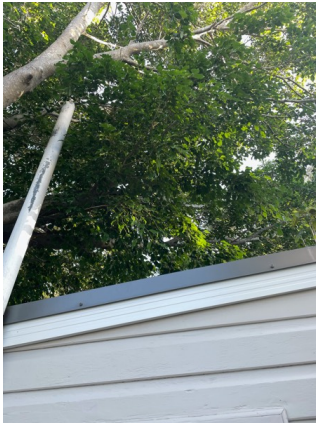
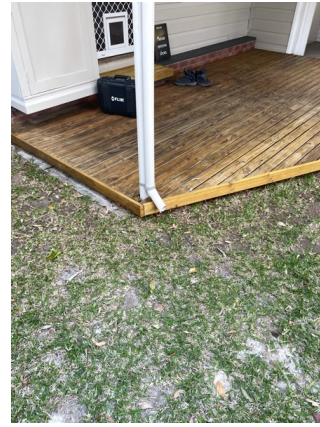
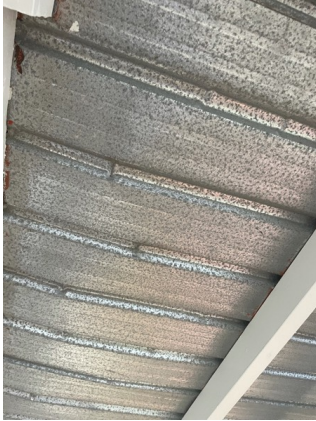
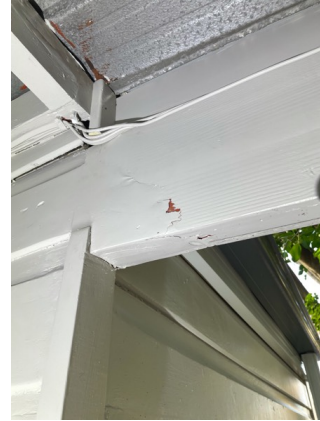
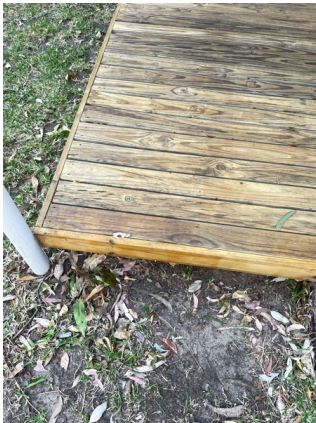
Site Defect 6. - Decks

Type of Defect:	Distortion, warping, twisting, Operational, Installation
Direction (North being front of Structure):	West
Description:	Tree overhang roof line, bogged rafter, deflection end of deck, impact damage roof coverings, downpipe not connected to stormwater
Ongoing Consequence:	Damage to surrounding elements
Opinion of Cracking:	Not Applicable
Building Professional:	Note: This defect should be referred to a qualified building professional for the repairs/scope of work required. Building Professional Required: Builder, Plumber

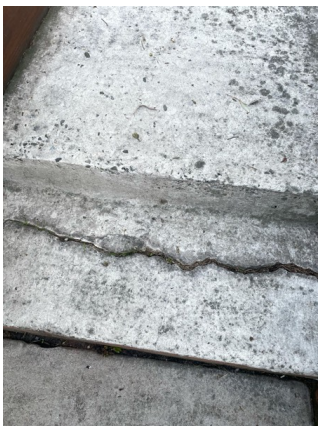
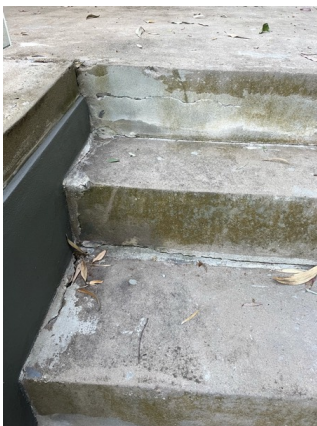
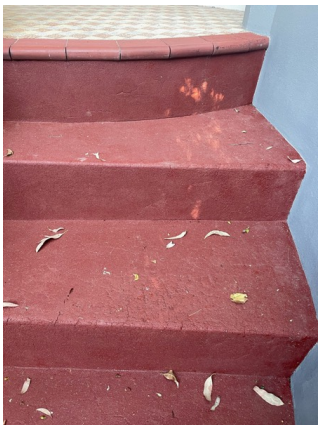
Site Defect 7. - Steps

Type of Defect:	Distortion, warping, twisting, Safety hazard
Direction (North being front of Structure):	North, East
Description:	Risers appear to be uneven Cracking steps, riser height more than 190mm
Ongoing Consequence:	Personal injury Possible further cracking
Opinion of Cracking:	Serviceability cracking
Building Professional:	Note: This defect should be referred to a qualified building professional for the repairs/scope of work required.
	Building Professional Required: Builder

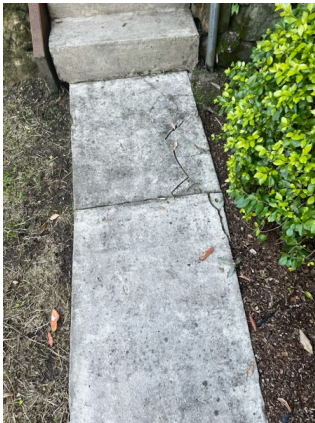
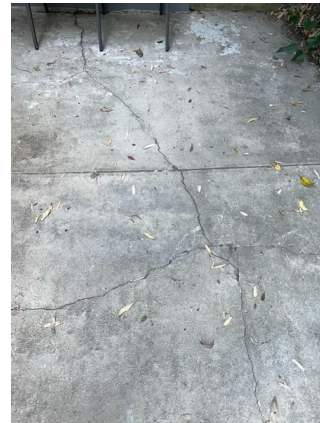
Site Defect 8. - Paths and Driveways

Type of Defect:	The path is beginning to break up
Direction (North being front of Structure):	North, East
Description:	Distortion, warping, twisting
Ongoing Consequence:	The path may become unserviceable
Opinion of Cracking:	Not Applicable
Building Professional:	Note: This defect should be referred to a qualified building professional for the repairs/scope of work required.
	Building Professional Required: Builder

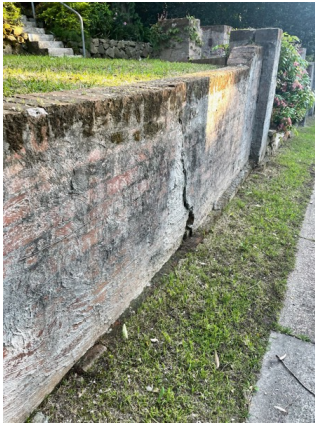
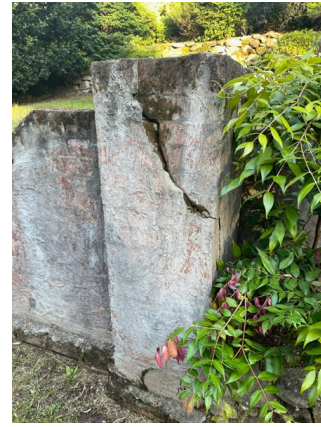
Site Defect 9. - Retaining Walls

Type of Defect:	Distortion, warping, twisting, Structural
Direction (North being front of Structure):	East
Description:	Cracking, Wall appears to be out of align and losing serviceability
Ongoing Consequence:	Possible loss of serviceability, Possible collapse
Opinion of Cracking:	Structural cracking
Building Professional:	Note: This defect should be referred to a qualified building professional for the repairs/scope of work required.
	Building Professional Required: Builder, Engineer
