# STANDARD RESIDENTIAL BUILDING INSPECTION REPORT

**28 NEW YORK AVENUE, WARNERS BAY**

**Property Address:** 28 NEW YORK AVENUE  
WARNERS BAY NSW 2282

BRICK VENEER, CONCRETE FLOOR, ALUMINIUM WINDOWS, TILED ROOFING

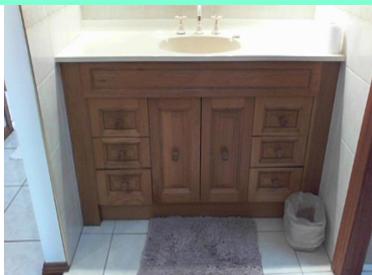
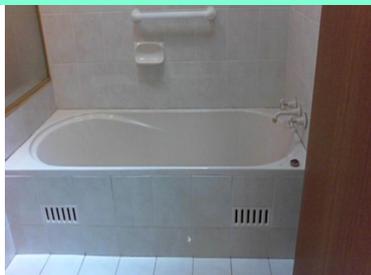
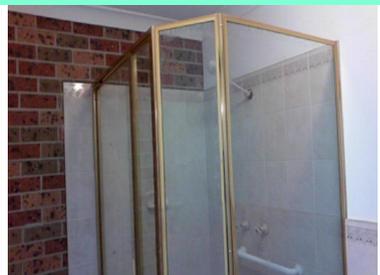
**BATHROOM**

Walls	OK, The item described is performing the function it was designed for and its condition is very typical for it's age
Ceiling	Cornice cracking may need repairs to improve appearance

Floors	As tested there was high moisture readings found in areas of bathroom floor, cracking to floor tiles noted

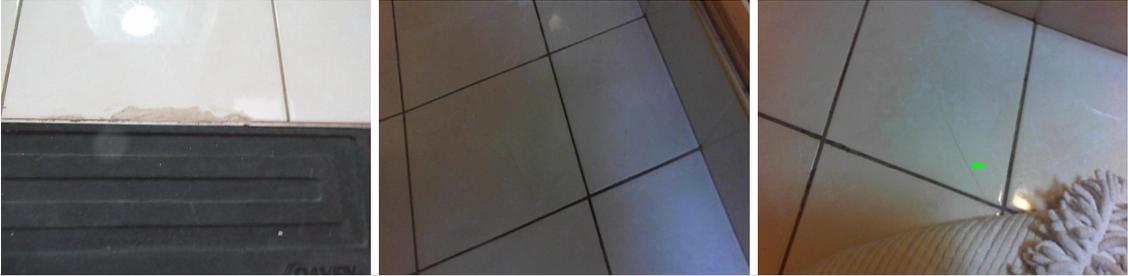
Window/s	NIL, The item described is not present at the time of the inspection
Painting	OK, The item described is performing the function it was designed for and its condition is very typical for it's age
Other	
Vanity	Binding cupboard doors/drawers will need adjusting or repair to restore correct function
Basin	OK, The item described is performing the function it was designed for and its condition is very typical for it's age
Taps	OK, The item described is performing the function it was designed for and its condition is very typical for it's age
Waste Traps	OK, The item described is performing the function it was designed for and its condition is very typical for it's age

Splashbacks	Tile grouting is missing or stained and will need repair/re-sealing to ensure water tightness and restore appearance

Bath	OK, The item described is performing the function it was designed for and its condition is very typical for it's age
Shower	Tiles are cracked will need repair to ensure water tightness and appearance

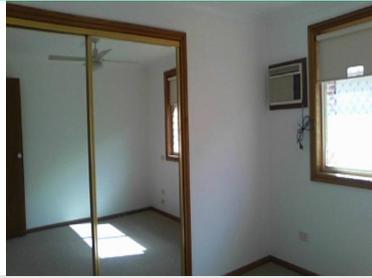
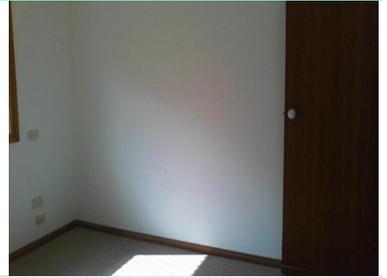
**BEDROOM 1**

Door Damaged outside face will need repair to improve appearance

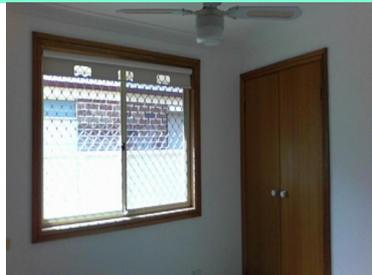
**BEDROOM 2**

Door Binding, will need adjusting to ensure correct operation.

Ceiling Cornice cracking may need repairs to improve appearance

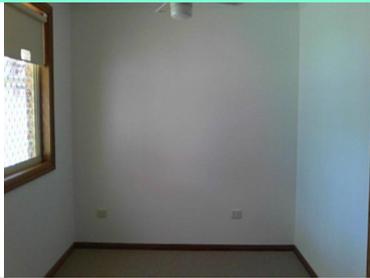
**BEDROOM 3**

Ceiling Cornice cracking may need repairs to improve appearance

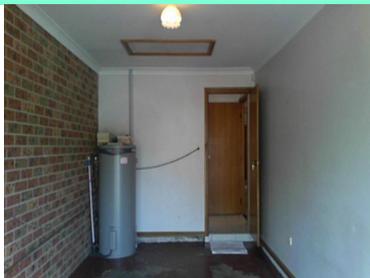
**GARAGE**

Ceiling Popped nails need repair and re-finish to restore appearance

Floors Minor concrete cracking was noted and should be monitored regularly, a structural engineer should be consulted if further deterioration is noted

Painting Minor touchup repairs only are needed to restore appearance

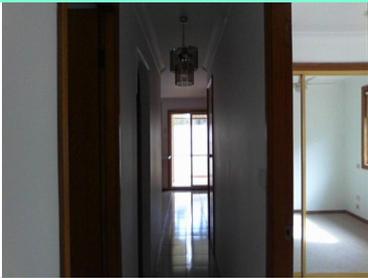
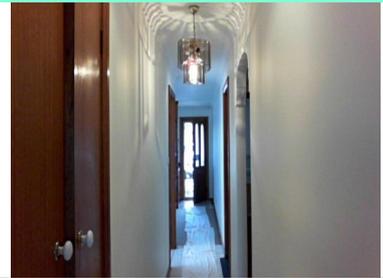
**HALL / PASSAGE**

Ceiling	Minor joint cracking and small holes needs repair and re-finish to restore appearance
---------	---

Floors	Cracked or broken tiles and/or grouting need repairs to reinstate integrity and appearance
--------	--

Other	Cupboard doors are binding and will need repair/adjusting to restore function
-------	---

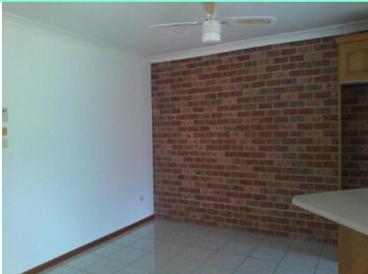
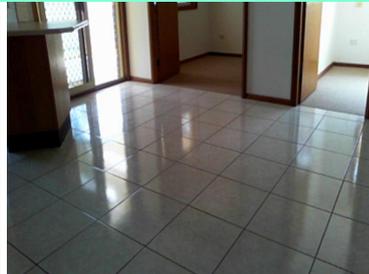
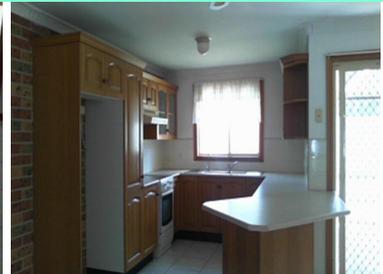
**KITCHEN INCLUDING DINING**

Door	Latch will need adjustment to restore correct function
------	--

Ceiling	Water damage needs repair and re-finish to restore appearance
---------	---

Floors Cracked or chipped tiles and/or grouting need repairs to reinstate appearance

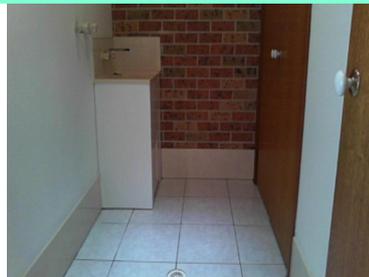
**LAUNDRY**

Door	Binding, will need adjusting to ensure correct operation.
Walls	OK, The item described is performing the function it was designed for and its condition is very typical for it's age

Ceiling	Cornice cracking may need repairs to improve appearance
---------	---

Floors Cracked or broken tiles and/or grouting need repairs to reinstate integrity and appearance, high moisture readings recorded in areas of floor

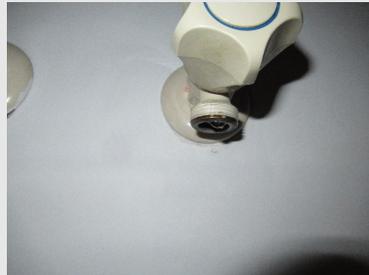
Taps Leaking washing machine tap will need repair to restore correct function and avoid water damage

LAUNDRY/Taps - Leaking washing machine tap will need repair to restore correct function and avoid water damage

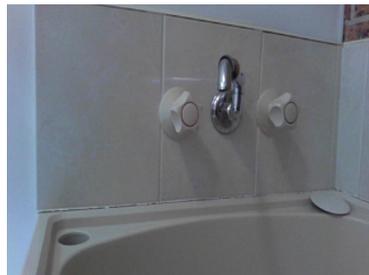
Splashbacks Tile grout is missing or stained and will need repair/re-sealing to ensure water tightness and restore appearance

LAUNDRY/Splashbacks - Tile grout is missing or stained and will need repair/re-sealing to ensure water tightness and restore appearance

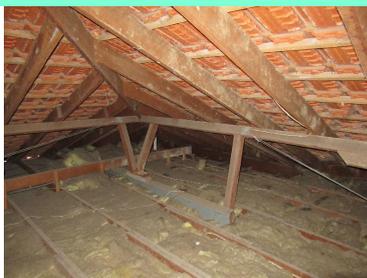
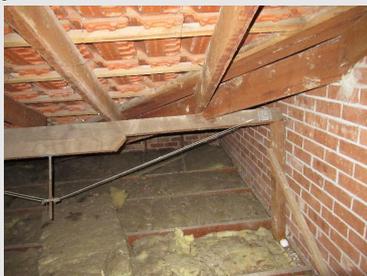
**ROOF SPACE**

Framing	Pitched hardwood framing is OK
---------	--------------------------------

Coverage	OK, Adequate coverage of roofing has been provided
Insulation	Batts, Good coverage
Sarking	NIL, No sarking or sisalation was visible at the time of the inspection
Parti Walls	Parti walls appear to be adequate and in good condition
Other	Minor fretting to roof tiles will need to monitor and replace affected tiles if condition deteriorates

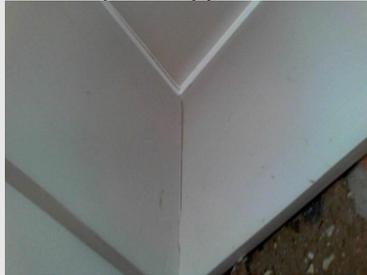
Ceiling Cornice cracking may need repairs to improve appearance

WC / TOILET 1/Ceiling - Cornice cracking may need repairs to improve appearance

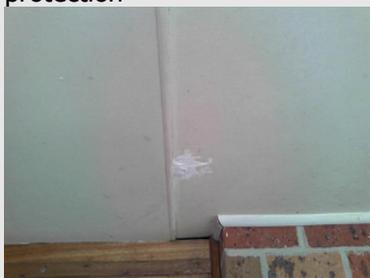
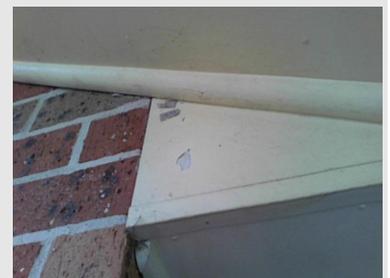
Painting Minor typical touchup repairs needed in some areas to restore appearance and adequate protection

CLADDING/Painting - Minor typical touchup repairs needed in some areas to restore appearance and adequate protection

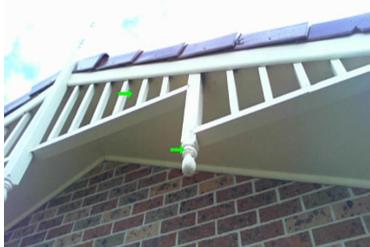
Damp Damage Water/damp damaged area/s will need repair to prevent further damage

CLADDING/Damp Damage - Water/damp damaged area/s will need repair to prevent further damage

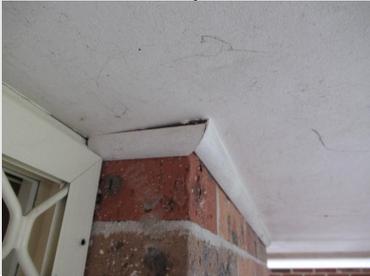
Mouldings	Moulding/s need/s minor typical maintenance repairs to restore appearance

CLADDING/Mouldings - Moulding/s need/s minor typical maintenance repairs to restore appearance

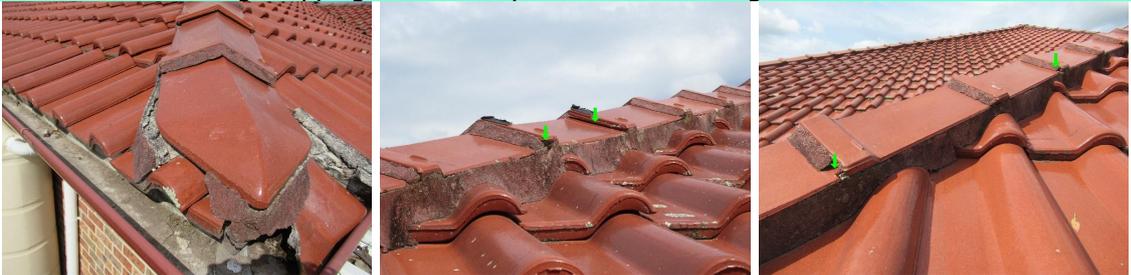
**ROOF EXTERIOR** Cracked or loose ridge capping will need repairs to avoid leaking

ROOF EXTERIOR - Cracked or loose ridge capping will need repairs to avoid leaking

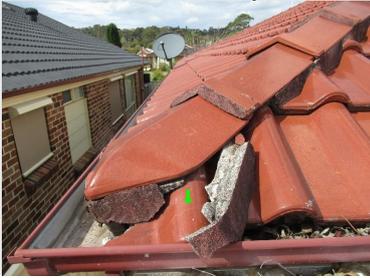
Cladding	Some tiles dislodged will need to be installed correctly to restore integrity and water tightness
----------	---

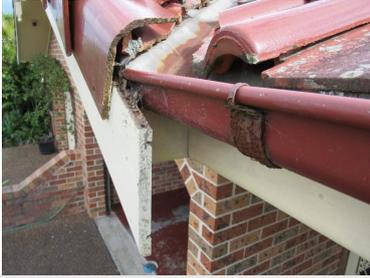
Fascia/Barge boards	Timber fascia/barge boards need repair and paint to prevent further damage
---------------------	--

ROOF EXTERIOR/Fascia/Barge boards - Timber fascia/barge boards need repair and paint to prevent further damage  
 ROOF EXTERIOR/Gutters/Downpipes - Joint leaks will need repair to prevent further leakage, rusting gutter brackets, gutters appear to have poor falls as they are holding water  
 ROOF EXTERIOR/Other - Gutters & Valleys need regular cleaning out around this dwelling as part of general maintenance  
 ROOF EXTERIOR - Cracked or loose ridge capping will need repairs to avoid leaking  
 ROOF EXTERIOR/Soffit/Eaves - Cracked/broken linings will need repair or replacing to improve appearance  
 ROOF EXTERIOR/Valleys - Rusting valley irons will need repair and paint to prevent further corrosion  
 SITE/Boundary Fences / Gates - Some areas of fencing has corroded and needs repairs to restore integrity and correct appearance  
 SITE/Paths / Driveways - Minor typical cracking only, not considered significant

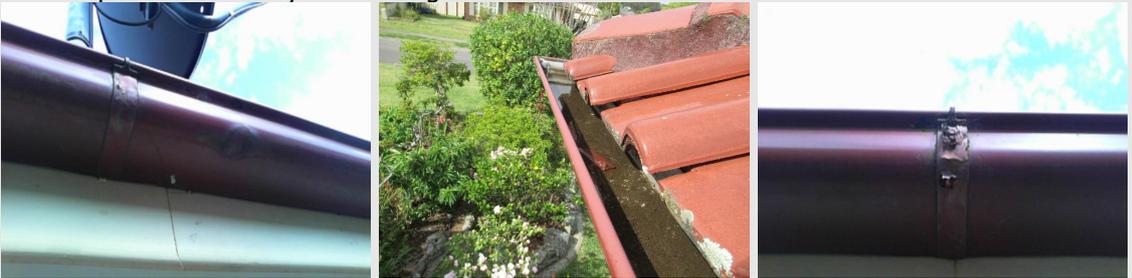
Gutters/Downpipes	Joint leaks will need repair to prevent further leakage, rusting gutter brackets, gutters appear to have poor falls as they are holding water
-------------------	---

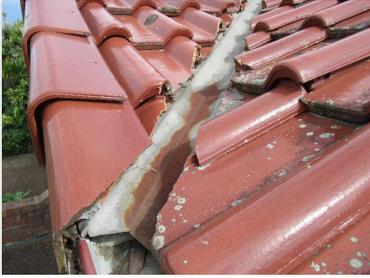
Valleys	Rusting valley irons will need repair and paint to prevent further corrosion
---------	--

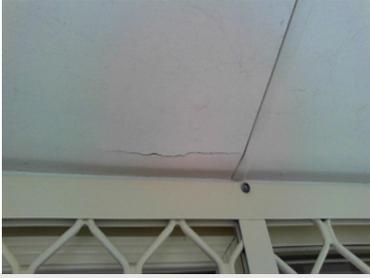
Soffit/Eaves	Cracked/broken linings will need repair or replacing to improve appearance
--------------	--

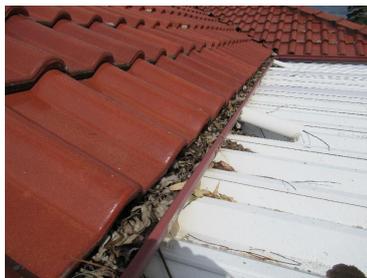
Other Gutters & Valleys need regular cleaning out around this dwelling as part of general maintenance

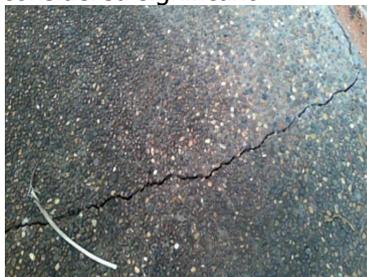
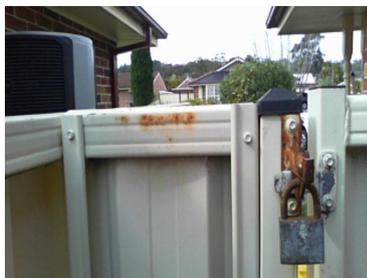
**SITE**

Off street parking Adequate areas for parking have been provided  
 Retaining walls NIL, The item described is not present at the time of the inspection  
 Clothes Line NIL, The item described is not present at the time of the inspection  
 Boundary Fences / Gates Some areas of fencing has corroded and needs repairs to restore integrity and correct appearance
