STANDARD RESIDENTIAL BUILDING INSPECTION REPORT

81 BLANCH STREET, SHORTLAND

East Coast Independent Property Inspections

Inspection Date/Time: 23/03/2018 9:05 AM

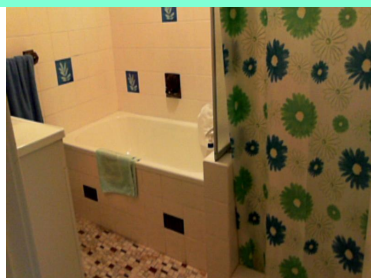
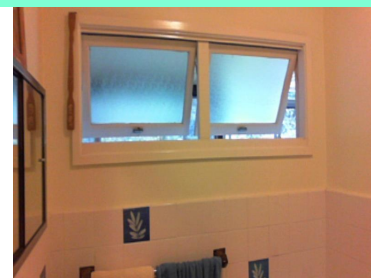
BATHROOM

Walls As tested, there was high moisture readings on sections of the internal walls

BATHROOM/Walls - As tested, there was high moisture readings on sections of the internal walls

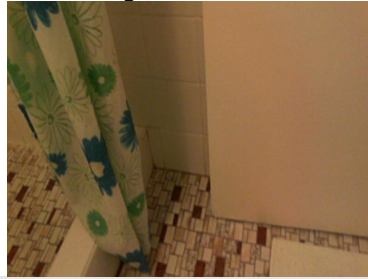
Splashbacks	Splash backs need resealing to ensure water tightness

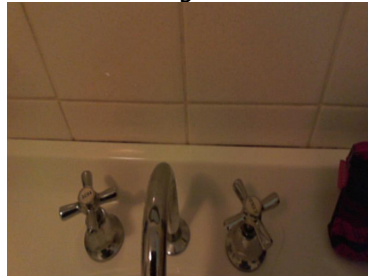
Bath	OK, The item described is performing the function it was designed for and its condition is very typical for it's age
Shower	OK, The item described is performing the function it was designed for and its condition is very typical for it's age
Screen/Curtain	The screen is leaking and will need repair to prevent further water damage

BATHROOM/Screen/Curtain - The screen is leaking and will need repair to prevent further water damage

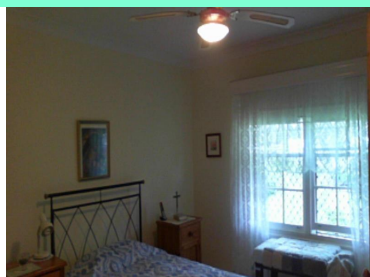
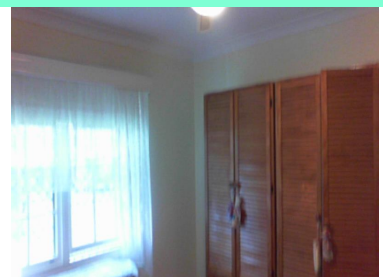
BEDROOM 1

Door	Binding, will need adjusting to ensure correct operation.
Walls	OK, The item described is performing the function it was designed for and its condition is very typical for it's age
Ceiling	OK, The item described is performing the function it was designed for and its condition is very typical for it's age
Floors	Out of level and may need repair to restore acceptable levels and appearance
Window/s	Binding sashes will need easing to restore correct function
Painting	OK, The item described is performing the function it was designed for and its condition is very typical for it's age
Other	Ceiling fan appears ok
Robes	NIL, The item described is not present at the time of the inspection

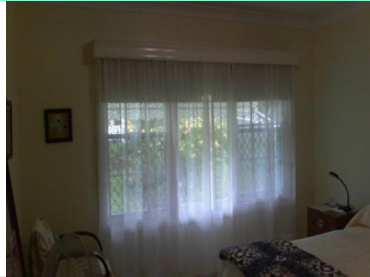
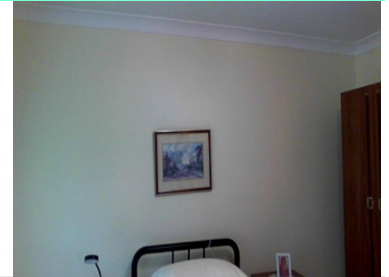
BEDROOM 2

Door	Binding, will need adjusting to ensure correct operation.
Walls	OK, The item described is performing the function it was designed for and its condition is very typical for it's age
Ceiling	OK, The item described is performing the function it was designed for and its condition is very typical for it's age
Floors	Out of level and may need repair to restore acceptable levels and appearance
Window/s	Cracked or broken pane/s will need replacing to reinstate integrity

BEDROOM 2/Window/s - Cracked or broken pane/s will need replacing to reinstate integrity

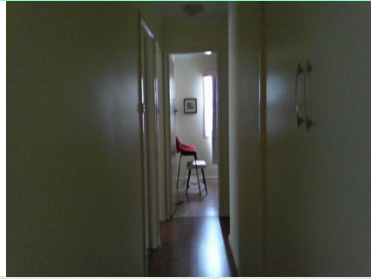
HALL / PASSAGE

Door	Sliding door guides are broken or missing and need repair or replacing to ensure correct operation/function
Walls	OK, The item described is performing the function it was designed for and its condition is very typical for it's age
Ceiling	OK, The item described is performing the function it was designed for and its condition is very typical for it's age
Floors	Out of level and may need repair to restore acceptable levels and appearance
Window/s	NIL, The item described is not present at the time of the inspection
Painting	OK, The item described is performing the function it was designed for and its condition is very typical for it's age
Other	Cupboards are OK

HALL / PASSAGE/Door - Sliding door guides are broken or missing and need repair or replacing to ensure correct operation/function

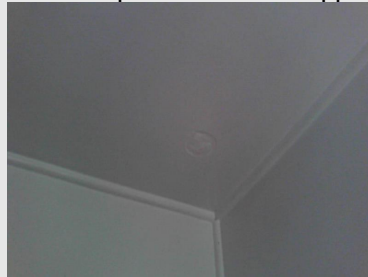
Door	Binding, will need adjusting to ensure correct operation.
Walls	OK, The item described is performing the function it was designed for and its condition is very typical for it's age
Ceiling	Old repaired damage needs repair and repaint to restore appearance

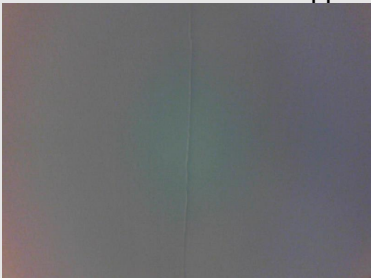
Ceiling	Minor joint cracking needs repair and re-finish to restore appearance

LOUNGE/Ceiling - Minor joint cracking needs repair and re-finish to restore appearance

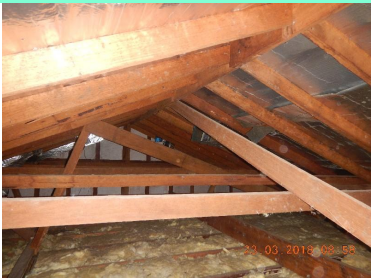
ROOF SPACE

Framing	Hardwood truss framing is OK

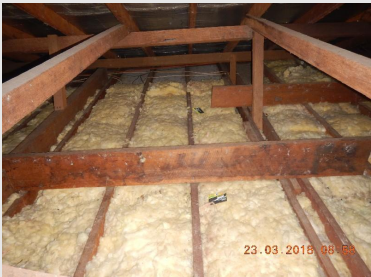
Sarking	Damaged sisalation was noted, this needs repair to ensure correct function

ROOF SPACE/Sarking - Damaged sisalation was noted, this needs repair to ensure correct function

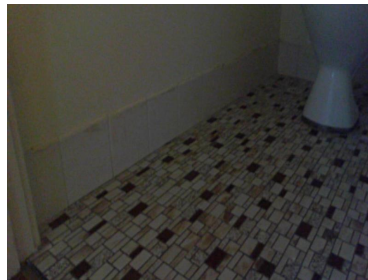
Ceiling	OK, The item described is performing the function it was designed for and its condition is very typical for it's age
Floors	OK, The item described is performing the function it was designed for and its condition is very typical for it's age
Window/s	OK, The item described is performing the function it was designed for and its condition is very typical for it's age
Painting	OK, The item described is performing the function it was designed for and its condition is very typical for it's age
Other	
Cistern	OK, The item described is performing the function it was designed for and its condition is very typical for it's age
Pan	Loose pan needs securing to the floor for stability

WC / TOILET 1/Pan - Loose pan needs securing to the floor for stability

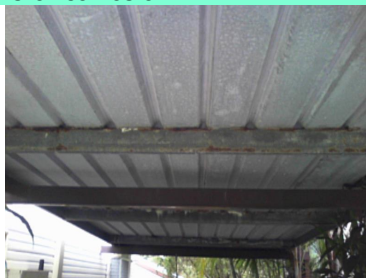
CARPORT Posts and or frame showing signs of corrosion

Ceilings Not lined
Roofing Rusting roof or flashings will need repair and paint to minimise corrosion

CARPORT - Posts and or frame showing signs of corrosion

CARPORT/Roofing - Rusting roof or flashings will need repair and paint to minimise corrosion

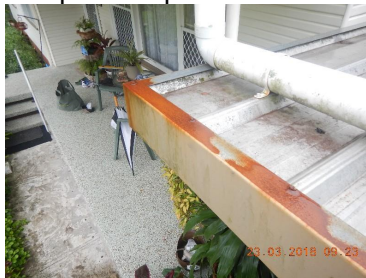
Gutters/Downpipes Downpipes discharge onto ground, will need to connecting to stormwater drain to avoid water damage to areas

CARPORT/Gutters/Downpipes - Downpipes discharge onto ground, will need to connecting to stormwater drain to avoid water damage to areas

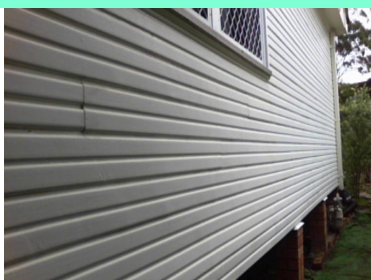
CLADDING

Painting Blistered and/or peeling paint will need repair to restore adequate protection and appearance
Damp Damage Minor water damage in some areas will need repair to restore integrity and appearance
Mouldings Moulding/s need/s minor typical maintenance repairs to restore appearance
Deck/s Balconies, Patios & Ramps OK, The item described is performing the function it was designed for and its condition is very typical for it's age
Verandah/s, Pergola/s OK, The item described is performing the function it was designed for and its condition is very typical for it's age

CLADDING/Damp Damage - Minor water damage in some areas will need repair to restore integrity and appearance

CLADDING/Painting - Blistered and/or peeling paint will need repair to restore adequate protection and appearance

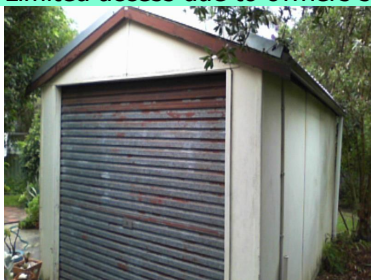
GARAGE Limited access due to owners storage

Walls	Water damage needs repair and re-finish to restore appearance
-------	---

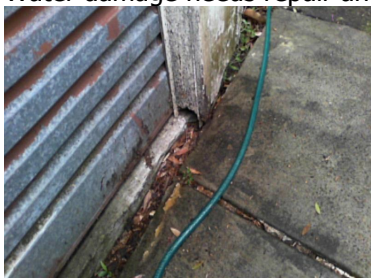
Ceiling	Linings not present at the time of the inspection
Floors	Minor concrete cracking was noted and should be monitored regularly, a structural engineer should be consulted if further deterioration is noted

GARAGE/Floors - Minor concrete cracking was noted and should be monitored regularly, a structural engineer should be consulted if further deterioration is noted

GARAGE/Walls - Water damage needs repair and re-finish to restore appearance

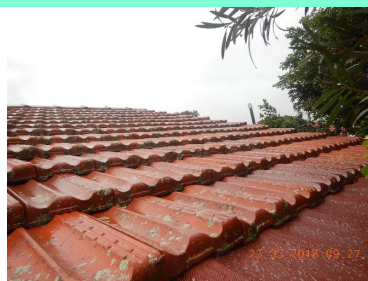
ROOF EXTERIOR

Timber fascia/barge boards need repair and paint to prevent further damage
Downpipes discharge onto ground and will need connecting to stormwater drain to avoid water damage areas, leaking gutter joints noted

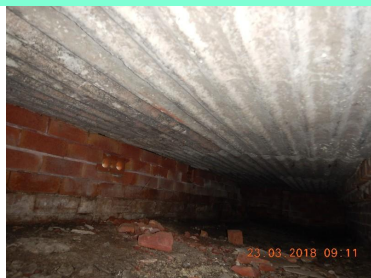
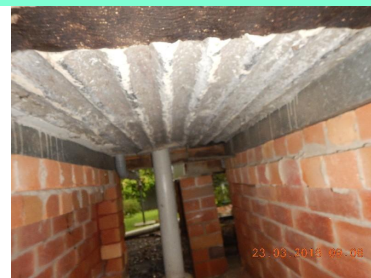
SUSPENDED CONCRETE FLOORS

Condition of concrete	Minor cracking was noted, not considered significant, however this should be monitored annually and a structural engineer consulted if deterioration is noted
Dampness	Minor typical ground seepage was noted, not considered significant however I recommend this is monitored during and after wet periods
Drainage	OK, The item described is performing the function it was designed for and its condition is very typical for it's age
Ventilation	This sub floor area has limited cross flow ventilation
Cracked or leaking pipes	NIL, No cracked or leaking pipes were noted at the time of the inspection, however this should be monitored periodically
Debris	NIL, No significant debris in this area
Other

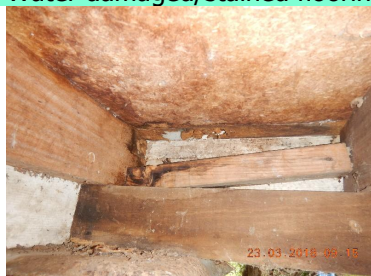
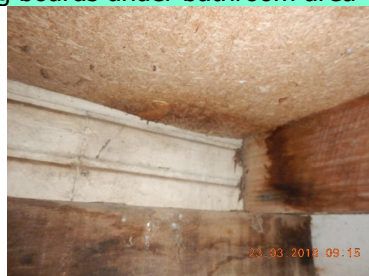
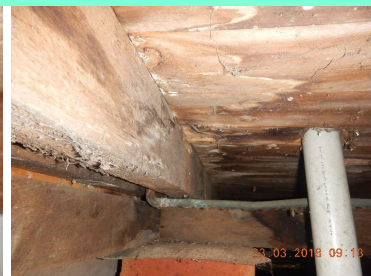
UNDERFLOOR SPACE Water damaged/stained flooring boards under bathroom area

Bearers/Joists	Wood decay damage to Bearer/s not considered significant
Piers/Stumps	Minor fretting and mortar erosion to some bricks piers not significant

this should be monitored annually and a structural engineer consulted if deterioration is noted
 SUSPENDED CONCRETE FLOORS/Ventilation - This sub floor area has limited cross flow ventilation
 UNDERFLOOR SPACE/Bearers/Joists - Wood decay damage to Bearer/s not considered significant
 UNDERFLOOR SPACE/Dampness - Minor typical ground seepage was noted, not considered significant however I recommend this is monitored during and after wet periods
 UNDERFLOOR SPACE/Piers/Stumps - Minor fretting and mortar erosion to some bricks piers not significant
 UNDERFLOOR SPACE - Water damaged/stained flooring boards under bathroom area

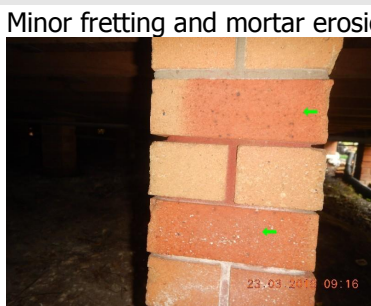
Dampness	Minor typical ground seepage was noted, not considered significant however I recommend this is monitored during and after wet periods

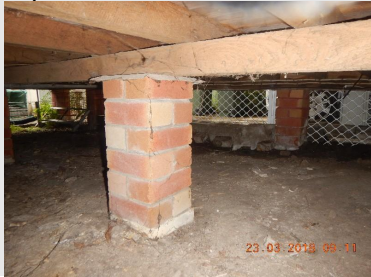
Drainage	OK, The item described is performing the function it was designed for and its condition is very typical for it's age	
Ventilation	Adequate, The item described is performing the function it was designed for and its condition is very typical for it's age	
Cracked or leaking pipes	Cracked/Leaking pipes were noted in this area, I recommend you consult a licensed plumber for repair

UNDERFLOOR SPACE/Cracked or leaking pipes - Cracked/Leaking pipes were noted in this area, I recommend you consult a licensed plumber for repair
