STANDARD RESIDENTIAL BUILDING INSPECTION REPORT

1 GRANADA AVENUE , MACQUARIE HILLS

Complies with Australian Standard AS4349.1 Property Inspections - Part 1 Residential Buildings

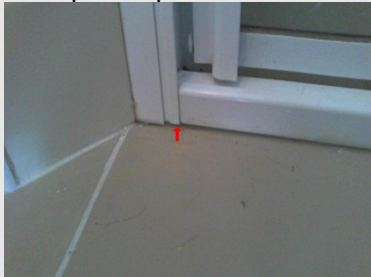
Floors	As tested there was high moisture readings found in areas of bathroom floor

Splashbacks	OK, The item described is performing the function it was designed for and its condition is very typical for it's age
Bath	NIL, The item described is not present at the time of the inspection
Shower	OK, The item described is performing the function it was designed for and its condition is very typical for it's age
Screen/Curtain	The screen is leaking and will need repair to prevent further water damage

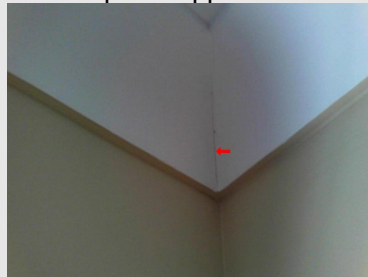
Ceiling Cornice cracking may need repairs to improve appearance

BEDROOM 1/Ceiling - Cornice cracking may need repairs to improve appearance

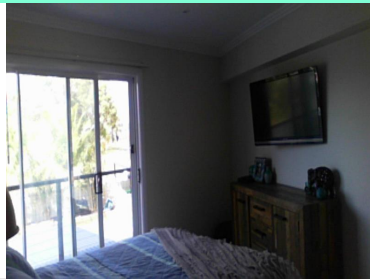
BEDROOM 3**UPPER LEVEL**

Door handle/s or latch/s are missing and need repair to restore correct function

Out of level and may need repair to restore acceptable levels and appearance

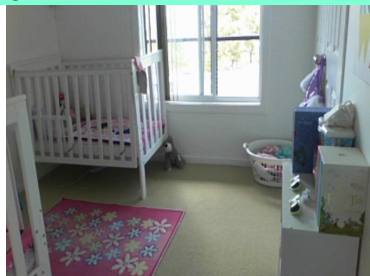
BEDROOM 4**UPPER LEVEL**

Out of level and squeaks in various areas, may need repair to restore acceptable levels and appearance

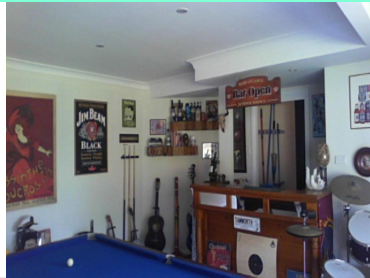
FAMILY ROOM LOWER LEVEL

Door	OK, The item described is performing the function it was designed for and its condition is very typical for it's age
Walls	Patches are incomplete and will need finishing to a good standard to restore appearance

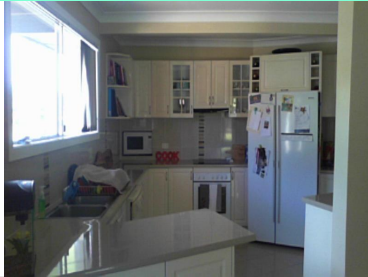
KITCHEN LOWER LEVEL

Door	NIL, The item described is not present at the time of the inspection
Walls	Minor joint cracking needs repair and re-finish to restore appearance

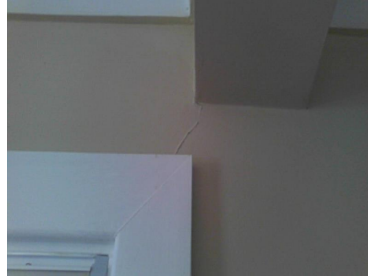
Ceiling	Small hole/s need repair to restore appearance
---------	--

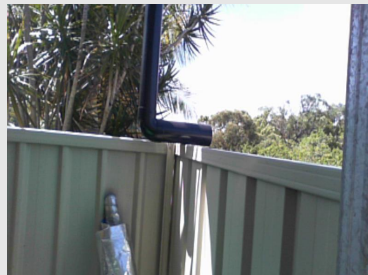
Ceilings	Not lined
Roofing	OK, The item described is performing the function it was designed for and its condition is very typical for it's age
Gutters/Downpipes	Downpipes discharge onto ground, will need to connecting to stormwater drain to avoid water damage to areas

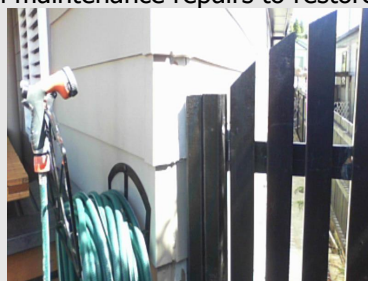
Mouldings Moulding/s need/s minor typical maintenance repairs to restore appearance

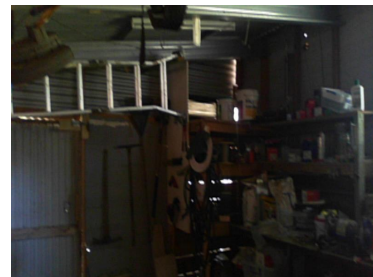
Walls

Water damage needs repair and re-finish to restore appearance

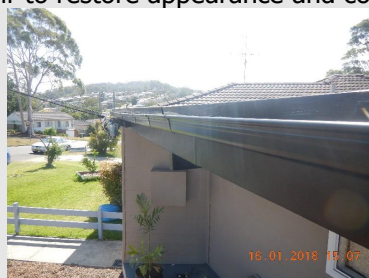
Sagging gutters may need repair to restore appearance and correct flows

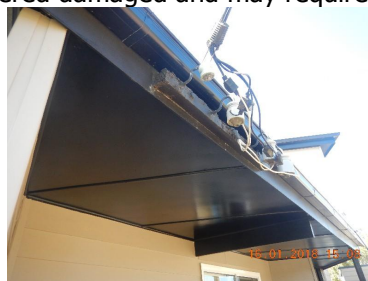
Electrical service head is weathered damaged and may require replacing to avoid damage

ROOF EXTERIOR/Other - Electrical service head is weathered damaged and may require replacing to avoid damage

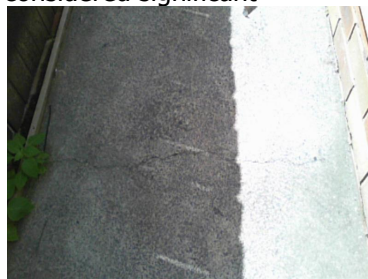
Paths / Driveways

Minor typical cracking only, not considered significant

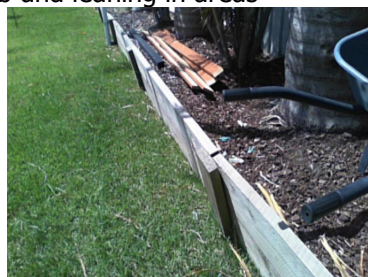
Retaining walls are out of plumb and leaning in areas
