STANDARD RESIDENTIAL BUILDING INSPECTION REPORT

89 MARSDEN STREET, SHORTLAND

Property Address: 89 MARSDEN STREET
SHORTLAND NSW 2307

Inspection Date/Time: 30/05/2018 10:11 AM

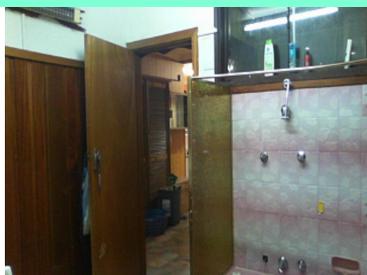
Door

OK, The item described is performing the function it was designed for and its condition is very typical for it's age

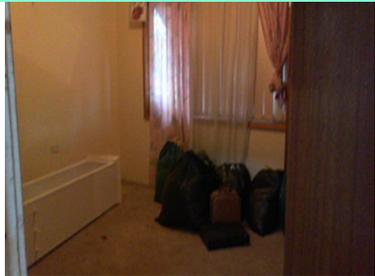
BEDROOM 1

Door	Loose or faulty handle or latch needs repair to restore correct function/operation
Walls	Small hole/s need repair to restore appearance
Ceiling	Minor joint cracking needs repair and re-finish to restore appearance
Floors	Out of level and may need repair to restore acceptable levels and appearance
Window/s	OK, The item described is performing the function it was designed for and its condition is very typical for it's age
Painting	Generally in poor condition and will need repairs to improve appearance.
Other	
Robes	Robe door is damaged and will need repair to restore appearance

BEDROOM 1/Ceiling - Minor joint cracking needs repair and re-finish to restore appearance

BEDROOM 1/Door - Loose or faulty handle or latch needs repair to restore correct function/operation

BEDROOM 1/Floors - Out of level and may need repair to restore acceptable levels and appearance

BEDROOM 1/Painting - Generally in poor condition and will need repairs to improve appearance.

BEDROOM 1/Robes - Robe door is damaged and will need repair to restore appearance

BEDROOM 1/Walls - Small hole/s need repair to restore appearance

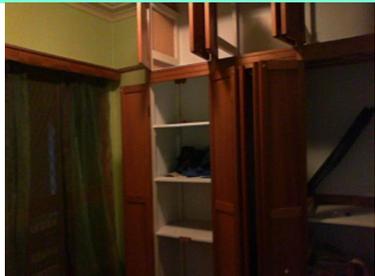
BEDROOM 2

Door	Loose or faulty handle or latch needs repair to restore correct function/operation
Walls	Popped nails need repair and re-finish to restore appearance
Ceiling	Cornice cracking may need repairs to improve appearance
Floors	Out of level and may need repair to restore acceptable levels and appearance
Window/s	Window unable to be opened or tested
Painting	Generally in poor condition and will need repairs to improve appearance.
Other

BEDROOM 2/Ceiling - Cornice cracking may need repairs to improve appearance

BEDROOM 2/Door - Loose or faulty handle or latch needs repair to restore correct function/operation

BEDROOM 2/Floors - Out of level and may need repair to restore acceptable levels and appearance

BEDROOM 2/Painting - Generally in poor condition and will need repairs to improve appearance.

BEDROOM 2/Walls - Popped nails need repair and re-finish to restore appearance

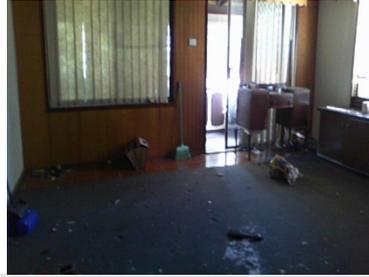
FAMILY ROOM

Door	Damaged outside face will need repair to improve appearance
Walls	OK, The item described is performing the function it was designed for and its condition is very typical for it's age
Ceiling	Water damage needs repair and re-finish to restore appearance
Floors	Out of level and may need repair to restore acceptable levels and appearance
Window/s	Window catch/s are broken or missing and will need repair or replacing to restore function
Painting	Generally in poor condition and will need repairs to improve appearance.
Other	Air-conditioning unit not tested

FAMILY ROOM/Ceiling - Water damage needs repair and re-finish to restore appearance

FAMILY ROOM/Door - Damaged outside face will need repair to improve appearance

FAMILY ROOM/Floors - Out of level and may need repair to restore acceptable levels and appearance

FAMILY ROOM/Painting - Generally in poor condition and will need repairs to improve appearance.

FAMILY ROOM/Window/s - Window catch/s are broken or missing and will need repair or replacing to restore function

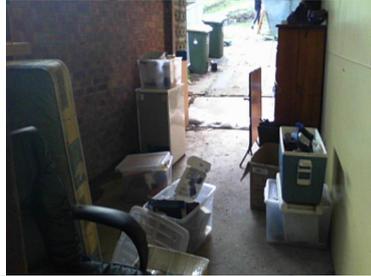
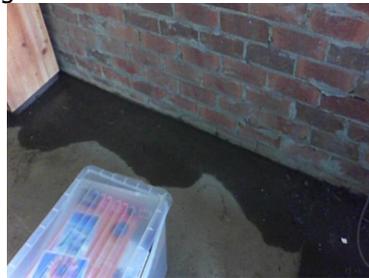
GARAGE

Water ingress into garage area will need investigate drainage system

Door	OK, The item described is performing the function it was designed for and its condition is very typical for it's age
Walls	OK, The item described is performing the function it was designed for and its condition is very typical for it's age
Ceiling	OK, The item described is performing the function it was designed for and its condition is very typical for it's age
Floors	Water observed pooling in garage floor area

GARAGE/Floors - Water observed pooling in garage floor area

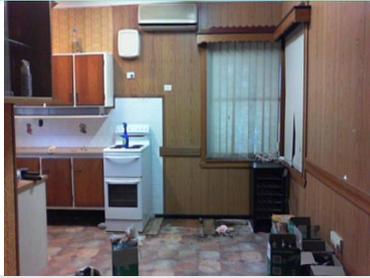
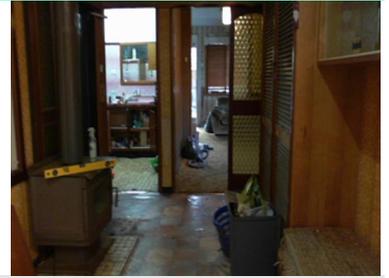
KITCHEN INCLUDING DINING

Door	Binding, will need adjusting to ensure correct operation.
Walls	OK, The item described is performing the function it was designed for and its condition is very typical for it's age
Ceiling	Typical cracking, will need repair and re-finish to improve appearance
Floors	Out of level and may need repair to restore acceptable levels and appearance
Window/s	Window stay/s broken or missing, will need repair or replacing to reinstate correct operation
Painting	Generally in poor condition and will need repairs to improve appearance.
Other	
Bench Tops	Minor damage to the tops was noted, not considered significant but fair wear and tear
Doors, Drawers & Cabinets	Damaged doors and or drawers will need repair to restore correct operation
Sink	OK, The item described is performing the function it was designed for and its condition is very typical for it's age
Waste Traps	OK, The item described is performing the function it was designed for and its condition is very typical for it's age

Taps	OK, The item described is performing the function it was designed for and its condition is very typical for it's age
Splashbacks	Cracked or broken tiles need repair to ensure water tightness

KITCHEN/Bench Tops - Minor damage to the tops was noted, not considered significant but fair wear and tear

KITCHEN/Ceiling - Typical cracking, will need repair and re-finish to improve appearance

KITCHEN/Doors, Drawers & Cabinets - Damaged doors and or drawers will need repair to restore correct operation

KITCHEN/Floors - Out of level and may need repair to restore acceptable levels and appearance

KITCHEN/Painting - Generally in poor condition and will need repairs to improve appearance.

KITCHEN/Splashbacks - Cracked or broken tiles need repair to ensure water tightness

KITCHEN/Window/s - Window stay/s broken or missing, will need repair or replacing to reinstate correct operation

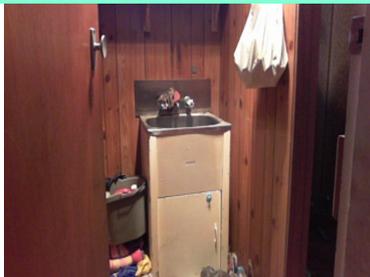
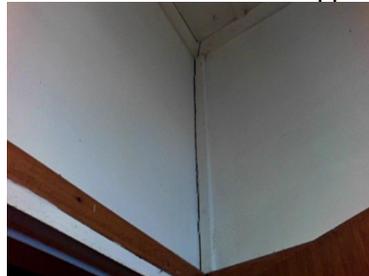
LAUNDRY

Door	Damaged inside face will need repair to improve appearance
Walls	Minor joint cracking needs repair and re-finish to restore appearance

Ceiling	Typical cracking, will need repair and re-finish to improve appearance
Floors	Cracked or broken tiles and/or grouting need repairs to reinstate integrity and appearance
Window/s	OK, The item described is performing the function it was designed for and its condition is very typical for it's age
Painting	Mould stained and will need cleaning, sealing and repainting to restore appearance
Other	
Trough	OK, The item described is performing the function it was designed for and its condition is very typical for it's age
Cabinet	Rusty cabinet will need repair and paint the restore appearance.
Waste Traps	OK, The item described is performing the function it was designed for and its condition is very typical for it's age
Taps	Tap handle/s leaking and will need repair to restore correct function
Splashbacks	OK, The item described is performing the function it was designed for and its condition is very typical for it's age

LAUNDRY/Cabinet - Rusty cabinet will need repair and paint the restore appearance.

LAUNDRY/Ceiling - Typical cracking, will need repair and re-finish to improve appearance

LAUNDRY/Door - Damaged inside face will need repair to improve appearance

LAUNDRY/Floors - Cracked or broken tiles and/or grouting need repairs to reinstate integrity and appearance

LAUNDRY/Painting - Mould stained and will need cleaning, sealing and repainting to restore appearance

LAUNDRY/Taps - Tap handle/s leaking and will need repair to restore correct function

LAUNDRY/Walls - Minor joint cracking needs repair and re-finish to restore appearance

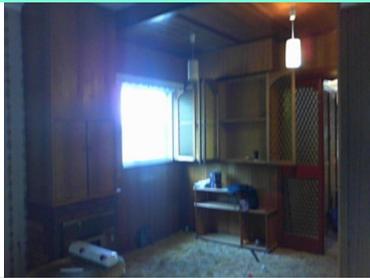
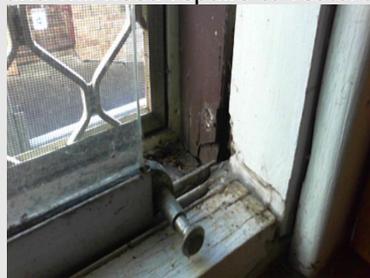
LOUNGE

Door	OK, The item described is performing the function it was designed for and its condition is very typical for it's age
Walls	Hole/s need repair to restore integrity and appearance
Ceiling	Cornice cracking may need repairs to improve appearance
Floors	Out of level and may need repair to restore acceptable levels and appearance
Window/s	Water damaged sashes/frames and will need repairs to restore correct function

LOUNGE/Ceiling - Cornice cracking may need repairs to improve appearance

LOUNGE/Floors - Out of level and may need repair to restore acceptable levels and appearance

LOUNGE/Walls - Hole/s need repair to restore integrity and appearance

LOUNGE/Window/s - Water damaged sashes/frames and will need repairs to restore correct function

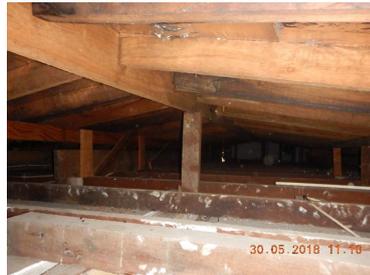
Framing	Pitched hardwood framing is OK
---------	--------------------------------

Coverage	OK, Adequate coverage of roofing has been provided
Insulation	NIL, No insulation was visible at the time of the inspection
Sarking	NIL, No sarking or sisalation was visible at the time of the inspection
Parti Walls	NIL, No parti walls found in this construction
Other

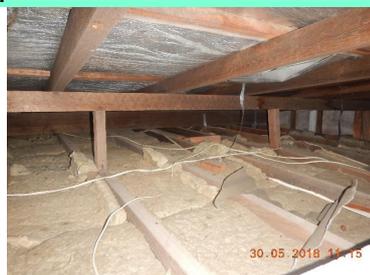
Framing	Pitched hardwood framing is OK

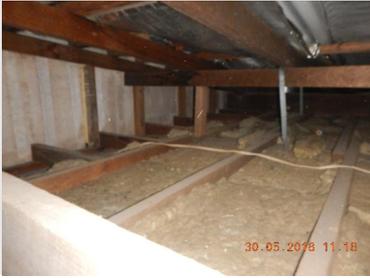
Coverage	OK, Adequate coverage of roofing has been provided	
Insulation	Batts, Good coverage

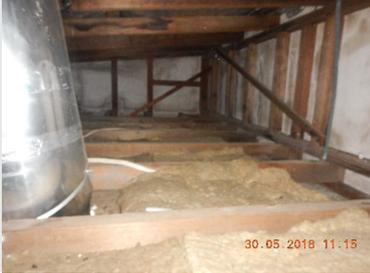
Sarking	Partial coverage only	
Parti Walls	NIL, No parti walls found in this construction	
Other

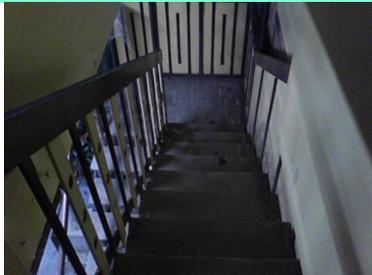
STAIR WELL

Newel Posts	OK, The item described is performing the function it was designed for and its condition is very typical for it's age
Treads & Risers	Damaged tread/s will need repair to restore integrity and or appearance
Other

STAIR WELL/Treads & Risers - Damaged tread/s will need repair to restore integrity and or appearance

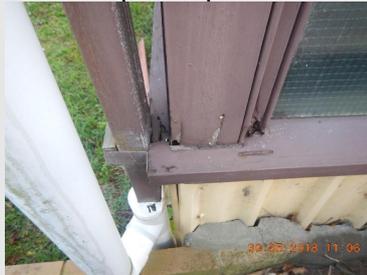
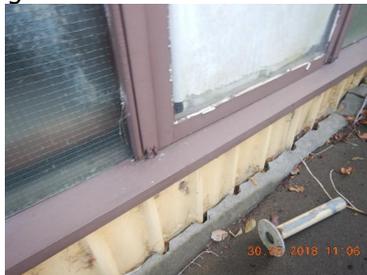
CLADDING

Painting	Blistered and/or peeling paint will need repair to restore adequate protection and appearance
Damp Damage	Water/damp damaged area/s will need repair to prevent further damage

Mouldings	Water damaged areas will need repair or replacing to ensure water tightness and the integrity and performance of the mouldings
-----------	--

Deck/s Balconies, Patios & Ramps	Substandard framing/flooring will need improving to adequately cope with increased traffic or weight
Verandah/s, Pergola/s	OK, The item described is performing the function it was designed for and its condition is very typical for it's age
Handrails	NIL, The item described is not present at the time of the inspection
Steps & Stairs	Substandard steps will need repair to ensure safety
Other

CLADDING/Damp Damage - Water/damp damaged area/s will need repair to prevent further damage

CLADDING/Painting - Blistered and/or peeling paint will need repair to restore adequate protection and appearance

CLADDING/Steps & Stairs - Substandard steps will need repair to ensure safety

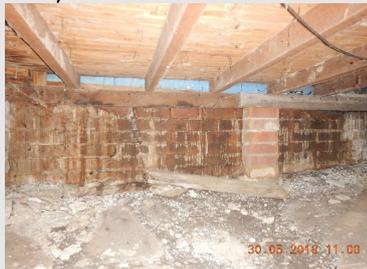
MASONRY WALLS FOUNDATIONS

Bricks fretting	NIL, All bricks/blocks appear to be in acceptable condition for their age
Mortar eroding	Minor erosion was noted in parts, if further deterioration is noted repairs will be needed
Cracking	Brick/block cracking is minor, not considered significant, however this should be monitored annually, We recommend you consult a structural engineer if deterioration is noted
Damp Damage	Significant damp damage was noted, and further advice from a drainage expert should be sort

Differential Movement	Minor Differential movement was noted, not considered significant, however this should be monitored annually, We recommend you consult a structural engineer if deterioration is noted
Visible Flashings	Damaged or rusting flashings will need repairs or replacing to prevent further damage
Weepholes	NIL, No weepholes where noted at the time of the inspection

MASONRY WALLS/Cracking - Brick/block cracking is minor, not considered significant, however this should be monitored annually, We recommend you consult a structural engineer if deterioration is noted

MASONRY WALLS/Differential Movement - Minor Differential movement was noted, not considered significant, however this should be monitored annually, We recommend you consult a structural engineer if deterioration is noted

MASONRY WALLS/Mortar eroding - Minor erosion was noted in parts, if further deterioration is noted repairs will be needed

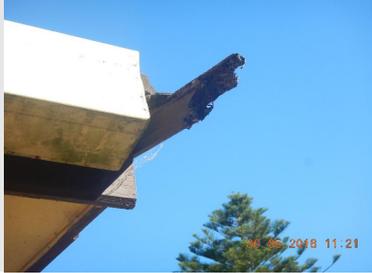
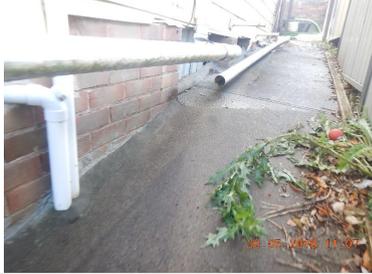
ROOF EXTERIOR Limited access due to excess heights only accessible areas reported on

Cladding	Cracked or loose ridge capping and or mortar bedding will need repairs to avoid leaking
Fascia/Barge boards	Timber fascia/barge boards need repair and paint to prevent further damage

Gutters/Downpipes	Downpipes discharge onto ground and will need connecting to stormwater drain to avoid water damage areas
-------------------	--

Flashings	Loose flashing/s will need repair to restore integrity and water tightness and appearance
Valleys	NIL, The item described is not present at the time of the inspection
Soffit/Eaves	Water damaged linings/mouldings need repair or replacing to restore appearance
Skylights	OK, The item described is performing the function it was designed for and its condition is very typical for it's age
Vents	OK, The item described is performing the function it was designed for and its condition is very typical for it's age
Flues	Not inspected, I recommend you consult an authorized wood heater installer for further detail
Other

ROOF EXTERIOR/Cladding - Cracked or loose ridge capping and or mortar bedding will need repairs to avoid leaking

ROOF EXTERIOR/Fascia/Barge boards - Timber fascia/barge boards need repair and paint to prevent further damage

ROOF EXTERIOR/Flashings - Loose flashing/s will need repair to restore integrity and water tightness and appearance

ROOF EXTERIOR/Gutters/Downpipes - Downpipes discharge onto ground and will need connecting to stormwater drain to avoid water damage areas

ROOF EXTERIOR/Soffit/Eaves - Water damaged linings/mouldings need repair or replacing to restore appearance

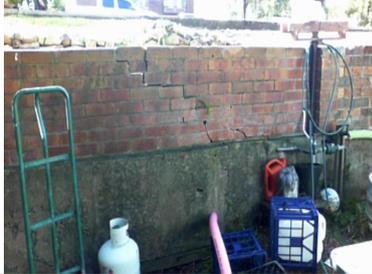
SITE Drainage improvement should be investigated by drainage expert to help minimise subfloor moisture areas

Garden shed/s	NIL, The item described is not present at the time of the inspection
Paths / Driveways	Minor typical cracking only, not considered significant
Off street parking	Adequate areas for parking have been provided
Retaining walls	Significant cracking and differential movement was noted, I strongly recommend you consult a structural engineer to determine its significance

Clothes Line	NIL, The item described is not present at the time of the inspection
Boundary Fences / Gates	Timber railings on fence are wood decayed

SITE/Boundary Fences / Gates - Timber railings on fence are wood decayed

SITE/Paths / Driveways - Minor typical cracking only, not considered significant

SITE - Drainage improvement should be investigated by drainage expert to help minimise subfloor moisture areas

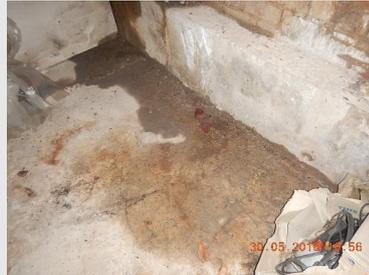
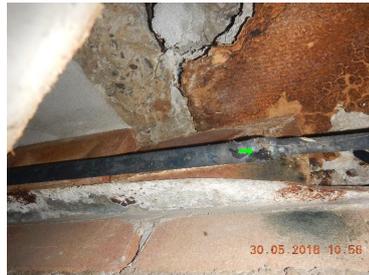
SUSPENDED CONCRETE FLOORS

Condition of concrete Minor cracking was noted, not considered significant, however this should be monitored annually and a structural engineer consulted if deterioration is noted

Dampness Significant dampness was noted, I recommend the site drainage be improved to help minimise dampness in this area

Drainage Inadequate, I recommend the subfloor drainage is improved, improving the site drainage may also help limit the dampness in this area

Ventilation This sub floor area has limited cross flow ventilation

Cracked or leaking pipes Cracked/Leaking pipes were noted in this area, I recommend you consult a licensed plumber for repair

Debris Debris was noted in this area and should be removed
Other

SUSPENDED CONCRETE FLOORS/Condition of concrete - Minor cracking was noted, not considered significant, however this should be monitored annually and a structural engineer consulted if deterioration is noted

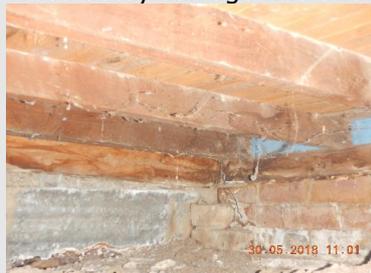
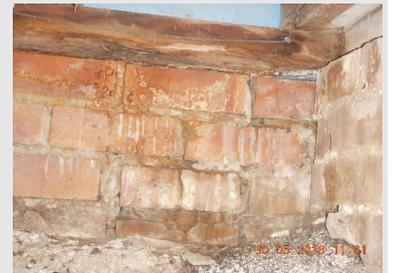
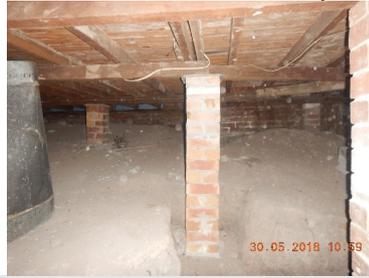
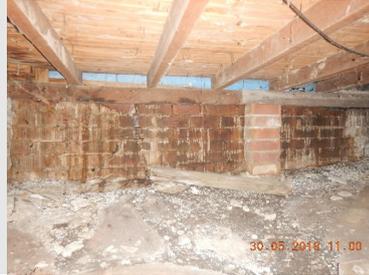
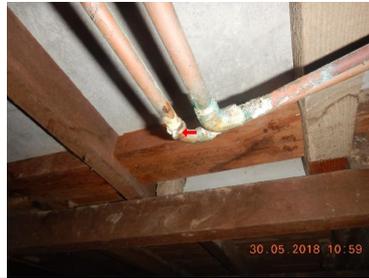
UNDERFLOOR SPACE

Bearers/Joists Wood decay damage was evident to bearers

Piers/Stumps Some evidence of typical pier subsidence and should be repacked to ensure stability

Dampness Significant dampness was noted, I recommend the site drainage be improved to help minimise dampness in this area

Drainage Inadequate, I recommend the subfloor drainage is improved, improving the site drainage may also help limit the dampness in this area

Ventilation Inadequate, I recommend the subfloor ventilation is improved
 Cracked or leaking pipes Cracked/Leaking pipes were noted in this area, I recommend you consult a licensed plumber for repair

Debris Rubbish will need removal from this area
 Other
