# STANDARD RESIDENTIAL BUILDING INSPECTION REPORT

**18 THE GRANGE, CARDIFF SOUTH**

Complies with Australian Standard AS4349.1 Property Inspections - Part 1 Residential Buildings

**Property Address:** 18 THE GRANGE  
CARDIFF SOUTH NSW 2285

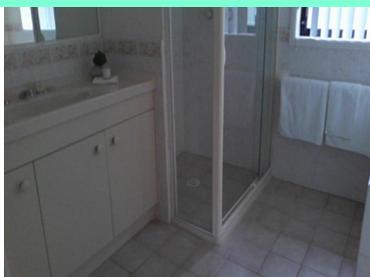
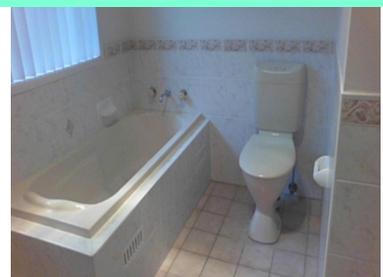
Walls As tested, there was high moisture readings on sections of the internal walls

BATHROOM/Walls - As tested, there was high moisture readings on sections of the internal walls

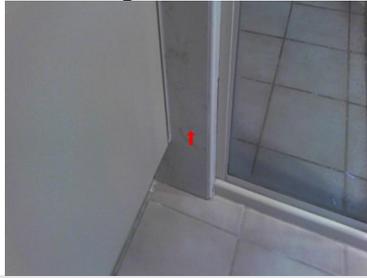
Ceiling Cornice cracking may need repairs to improve appearance

Floors As tested there was high moisture readings found in areas of bathroom floor

BATHROOM/Floors - As tested there was high moisture readings found in areas of bathroom floor

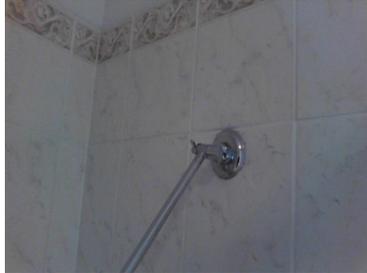
Shower Tile grouting is cracked and or missing and will repair to restore water tightness and appearance

BATHROOM/Shower - Tile grouting is cracked and or missing and will repair to restore water tightness and appearance

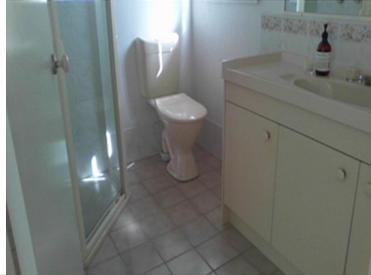
As tested, there was elevated moisture readings on sections of the internal walls

Cornice cracking may need repairs to improve appearance

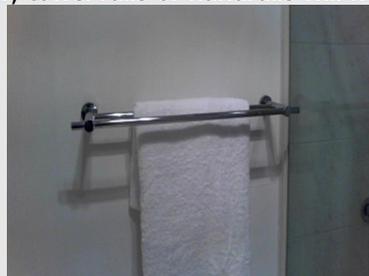
Shower rose is leaking and will need repair to restore function

Tile grouting is missing or stained and will need repair/re-sealing to ensure water tightness and restore appearance

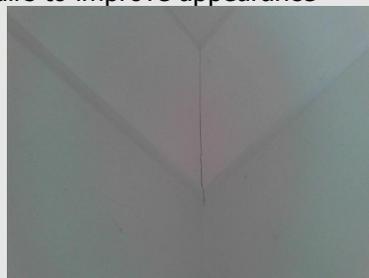
Floors	Cracked or broken tiles and/or grouting need repairs to reinstate integrity and appearance
--------	--

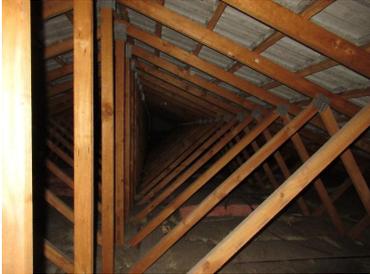
Framing	Pine Truss framing is OK

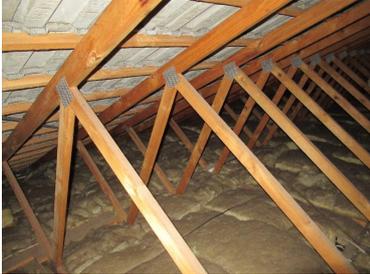
Insulation	Some insulation observed covering light fittings and or exhaust fan/light

ROOF SPACE/Insulation - Some insulation observed covering light fittings and or exhaust fan/light

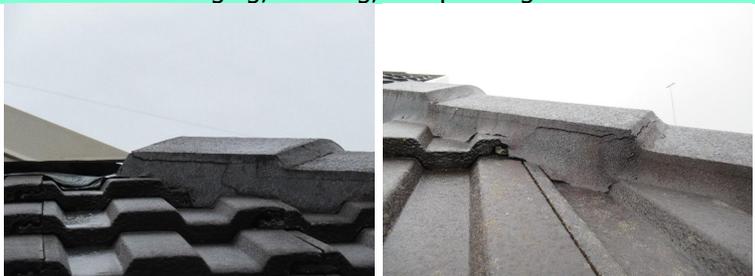
**ROOF EXTERIOR** Settlement cracking was visible to the roof tile ridging, bedding, and pointing areas

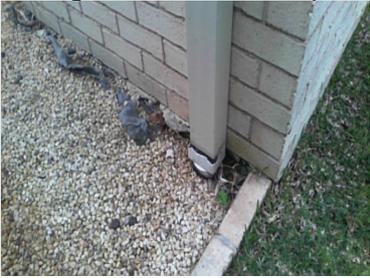
Gutters/Downpipes	Damaged and will need repair or replacing

Flashings	OK, The item described is performing the function it was designed for and its condition is very typical for it's age	
Valleys	Debris in valleys will need removal to avoid water damages
