STANDARD RESIDENTIAL BUILDING INSPECTION REPORT

21 ELIZABETH STREET, FLORAVILLE

East Coast Independent Property Inspections

Complies with Australian Standard AS4349.1 Property Inspections - Part 1 Residential Buildings

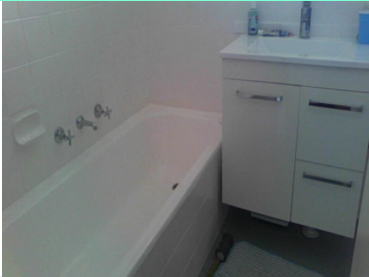
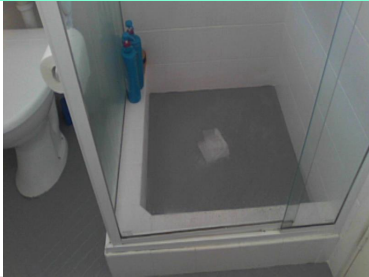
BATHROOM

Binding, will need adjusting to ensure correct operation.

Walls	OK, The item described is performing the function it was designed for and its condition is very typical for it's age
Ceiling	OK, The item described is performing the function it was designed for and its condition is very typical for it's age
Floors	As tested there was elevated moisture readings found in areas of bathroom floor

BATHROOM/Floors - As tested there was elevated moisture readings found in areas of bathroom floor

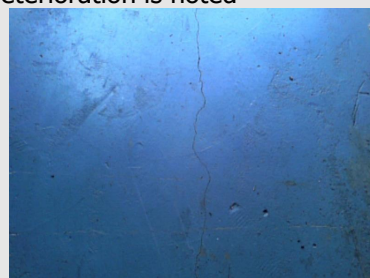
GARAGE

Door	External door is weather damaged and will need repair and paint to minimise further deterioration
Walls	OK, The item described is performing the function it was designed for and its condition is very typical for it's age
Ceiling	OK, The item described is performing the function it was designed for and its condition is very typical for it's age
Floors	Minor concrete cracking was noted and should be monitored regularly, a structural engineer should be consulted if further deterioration is noted

GARAGE/Door - External door is weather damaged and will need repair and paint to minimise further deterioration

GARAGE/Floors - Minor concrete cracking was noted and should be monitored regularly, a structural engineer should be consulted if further deterioration is noted

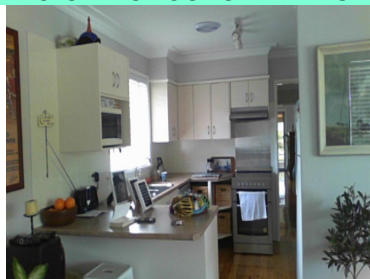
KITCHEN**INCLUDING LOUNGE DINING**

Door	OK, The item described is performing the function it was designed for and its condition is very typical for it's age
Walls	OK, The item described is performing the function it was designed for and its condition is very typical for it's age
Ceiling	OK, The item described is performing the function it was designed for and its condition is very typical for it's age
Floors	Out of level and may need repair to restore acceptable levels and appearance
Window/s	Loose Catch/s and/or handle/s need repair to restore function
Painting	OK, The item described is performing the function it was designed for and its condition is very typical for it's age
Other	
Bench Tops	OK, The item described is performing the function it was designed for and its condition is very typical for it's age
Doors, Drawers & Cabinets	OK, The item described is performing the function it was designed for and its condition is very typical for it's age

Sink	OK, The item described is performing the function it was designed for and its condition is very typical for it's age
Waste Traps	OK, The item described is performing the function it was designed for and its condition is very typical for it's age
Taps	OK, The item described is performing the function it was designed for and its condition is very typical for it's age
Splashbacks	OK, The item described is performing the function it was designed for and its condition is very typical for it's age
Fans	Range hood is ok and functioning as intended

KITCHEN/Floors - Out of level and may need repair to restore acceptable levels and appearance

KITCHEN/Window/s - Loose Catch/s and/or handle/s need repair to restore function

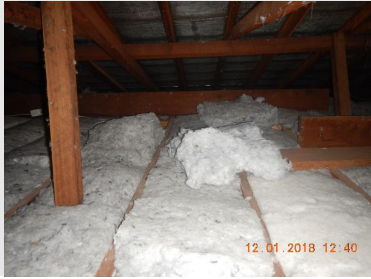
Sarking	Damaged sisalation was noted, this needs repair to ensure correct function

ROOF SPACE/Sarking - Damaged sisalation was noted, this needs repair to ensure correct function

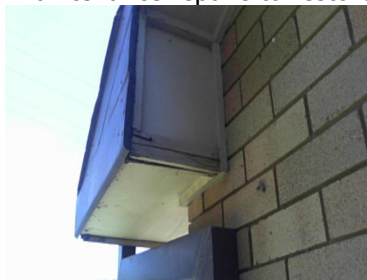
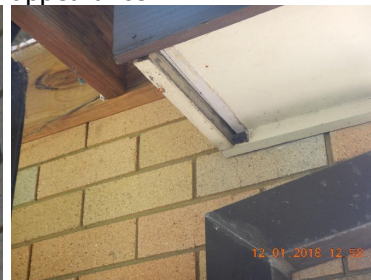
CLADDING

Painting	Repairs needed to reinstate adequate protection and appearance
Damp Damage	Water/damp damaged area/s will need repair to prevent further damage
Mouldings	Moulding/s need/s minor typical maintenance repairs to restore appearance

CLADDING/Damp Damage - Water/damp damaged area/s will need repair to prevent further damage

CLADDING/Mouldings - Moulding/s need/s minor typical maintenance repairs to restore appearance

CLADDING/Painting - Repairs needed to reinstate adequate protection and appearance

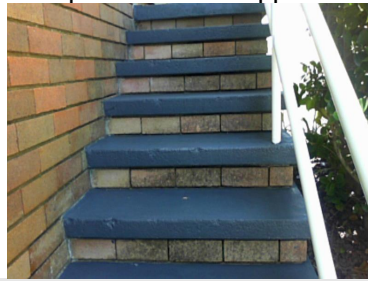
Steps & Stairs

Chipped concrete edges may need repair to restore appearance

CLADDING/Steps & Stairs - Chipped concrete edges may need repair to restore appearance

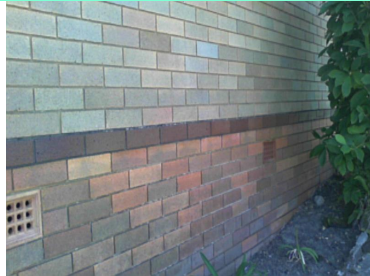
Bricks fretting

Minor fretting was noted in some areas, if further deterioration is noted replacement of effected bricks/blocks may be needed

MASONRY WALLS/Bricks fretting - Minor fretting was noted in some areas, if further deterioration is noted replacement of effected bricks/blocks may be needed

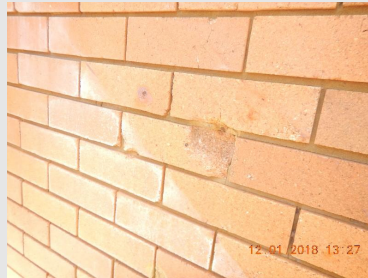
Mortar eroding
Cracking

Minor erosion was noted in parts, if further deterioration is noted repairs will be needed
Minor typical settlement cracking only, not considered significant, however this should be monitored annually

MASONRY WALLS/Cracking - Minor typical settlement cracking only, not considered significant, however this should be monitored annually

MASONRY WALLS/Mortar eroding - Minor erosion was noted in parts, if further deterioration is noted repairs will be needed

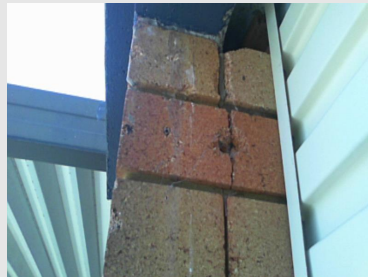
Damp Damage

Minor damp staining was noted at ground level, however this should be monitored during wet periods

MASONRY WALLS/Damp Damage - Minor damp staining was noted at ground level, however this should be monitored during wet periods

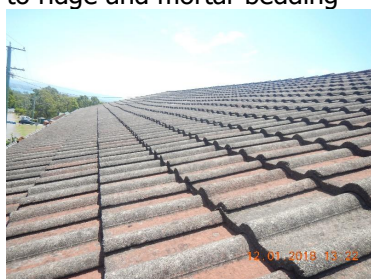
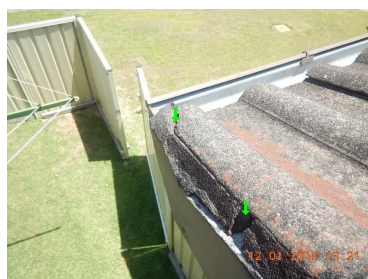
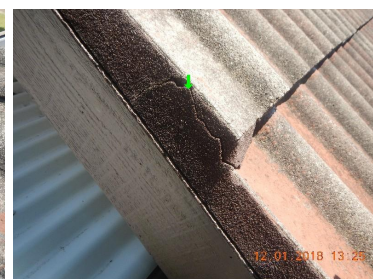
Cladding Roof undulation was visibly evident in areas due to its construction type, settlement cracking to ridge and mortar bedding

ROOF EXTERIOR/Cladding - Roof undulation was visibly evident in areas due to its construction type, settlement cracking to ridge and mortar bedding

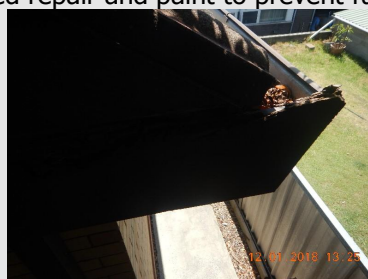
Fascia/Barge boards Timber fascia/barge boards need repair and paint to prevent further damage

ROOF EXTERIOR/Fascia/Barge boards - Timber fascia/barge boards need repair and paint to prevent further damage

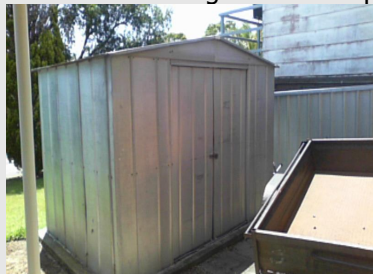
Garden shed/s

Corroded cladding will need repair to restore appearance

SITE/Garden shed/s - Corroded cladding will need repair to restore appearance

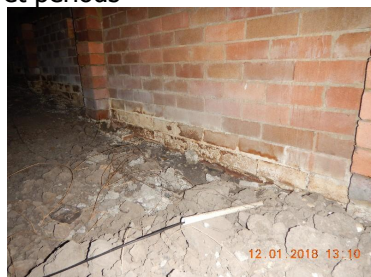
Dampness

Minor typical ground seepage was noted, not considered significant however I recommend this is monitored during and after wet periods

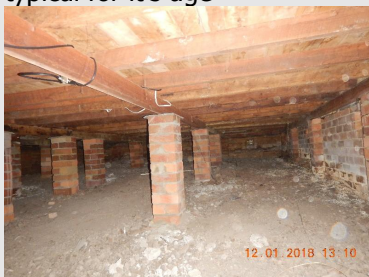
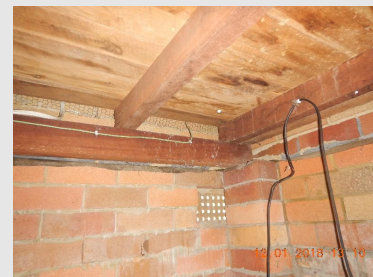
Piers/Stumps	Minor fretting to some bricks piers not significant
--------------	---
