Woodsreef Asbestos Mine, Barraba : synopsis for risk
assessment

Woodsreef Asbestos Mine, Barraba.

Synopsis for Risk Assessment

September, 1996

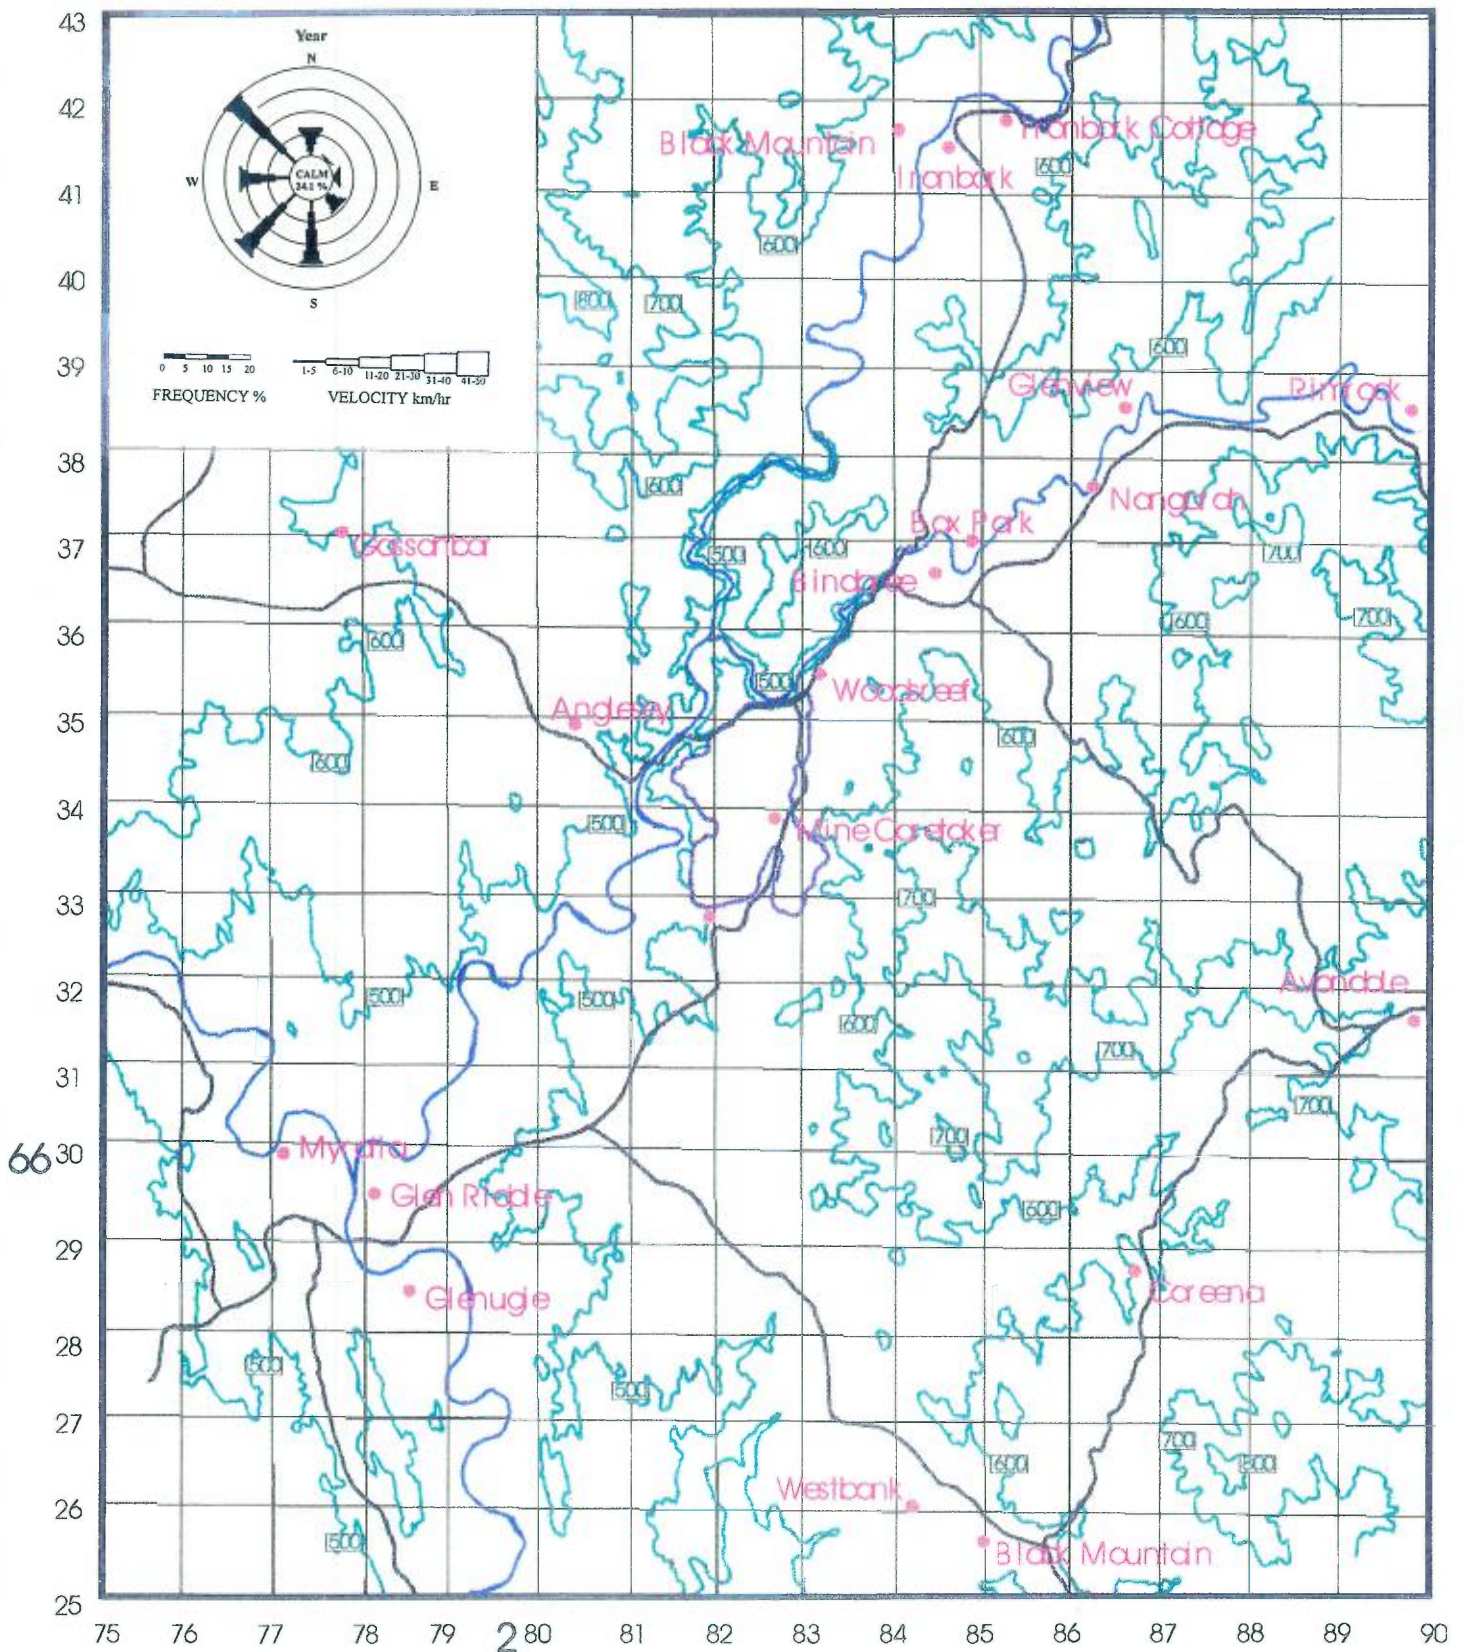
Figure 5.5: Occupied dwellings surrounding Woodsreef Asbestos Mine, with annual wind rose.

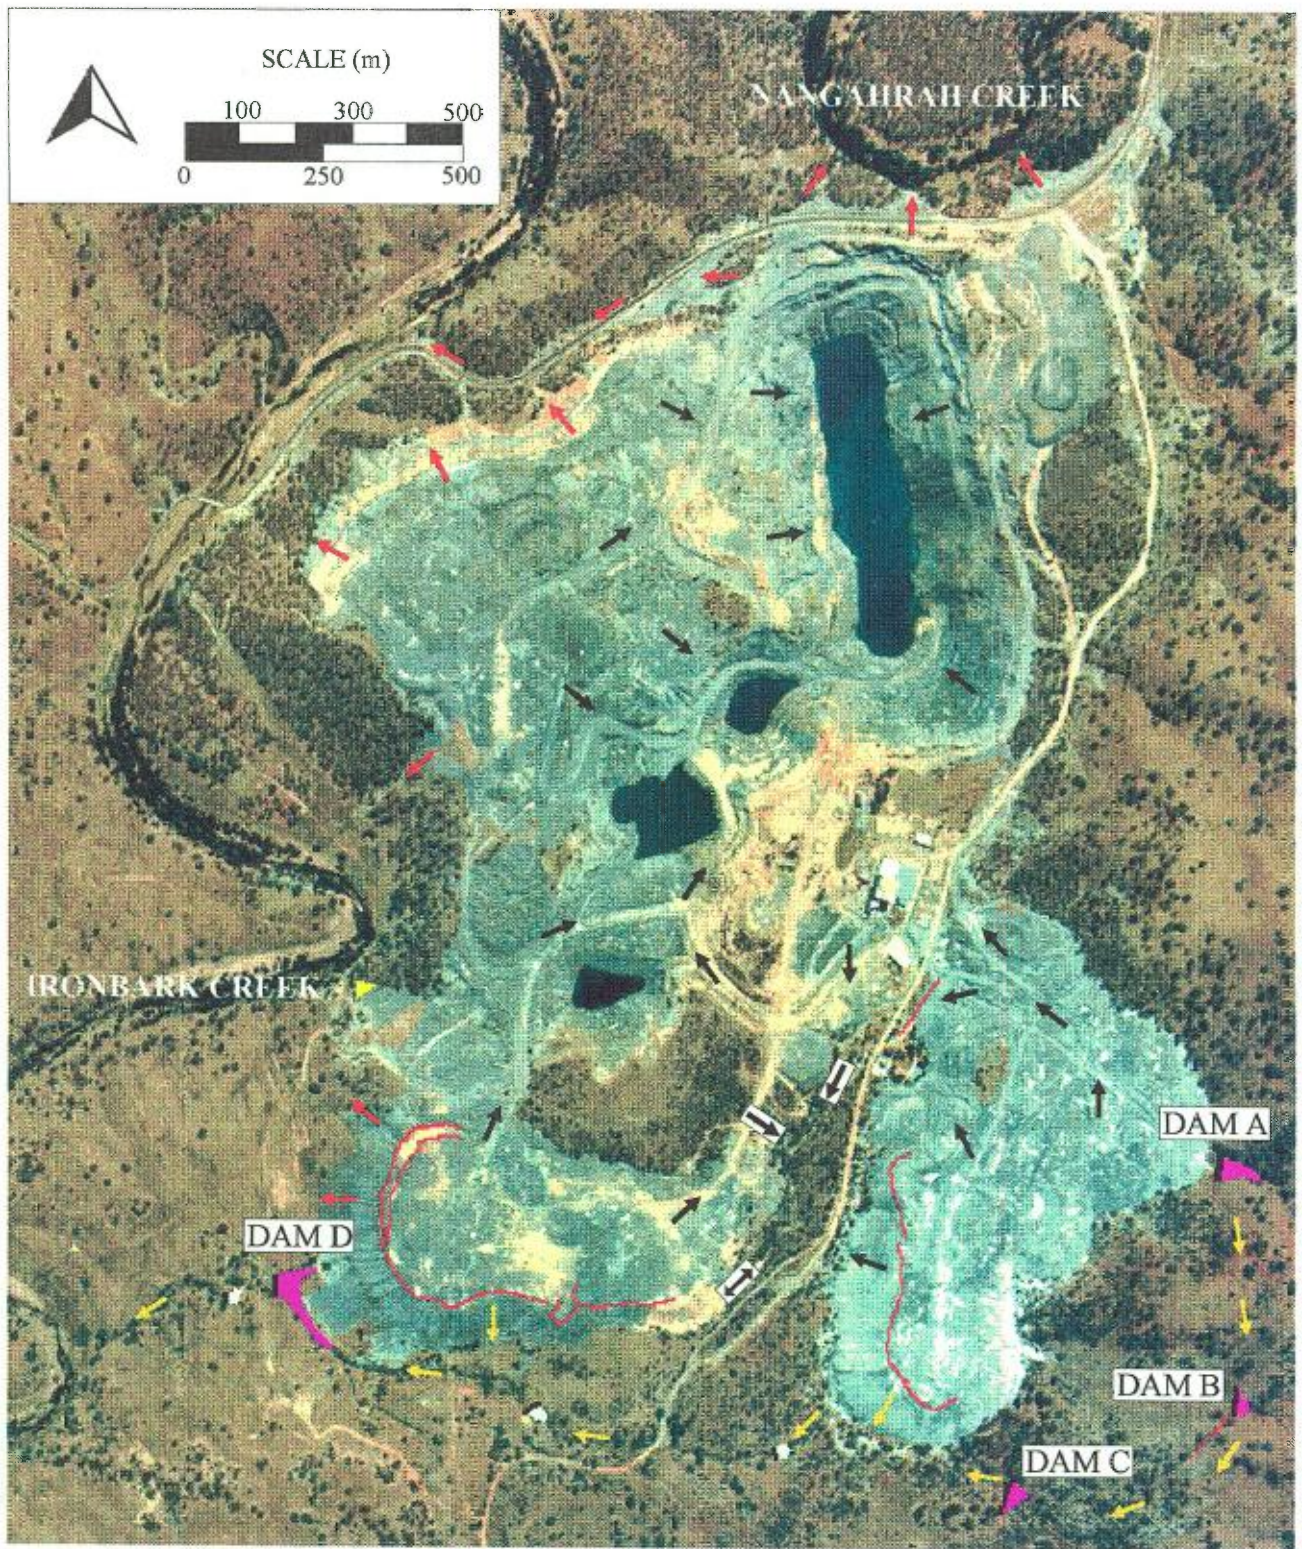
Prior to mine closure the Corporation constructed settling ponds, shown in Figure 8.4, in accordance with recommendations made by Toyer and Main (1978). These ponds, however, are only considered to be short term solutions, as the company was looking to re-mill the tailings using wet processing around 1977.

Figure 8.4: Sedimentation and erosion control structures, site location map.

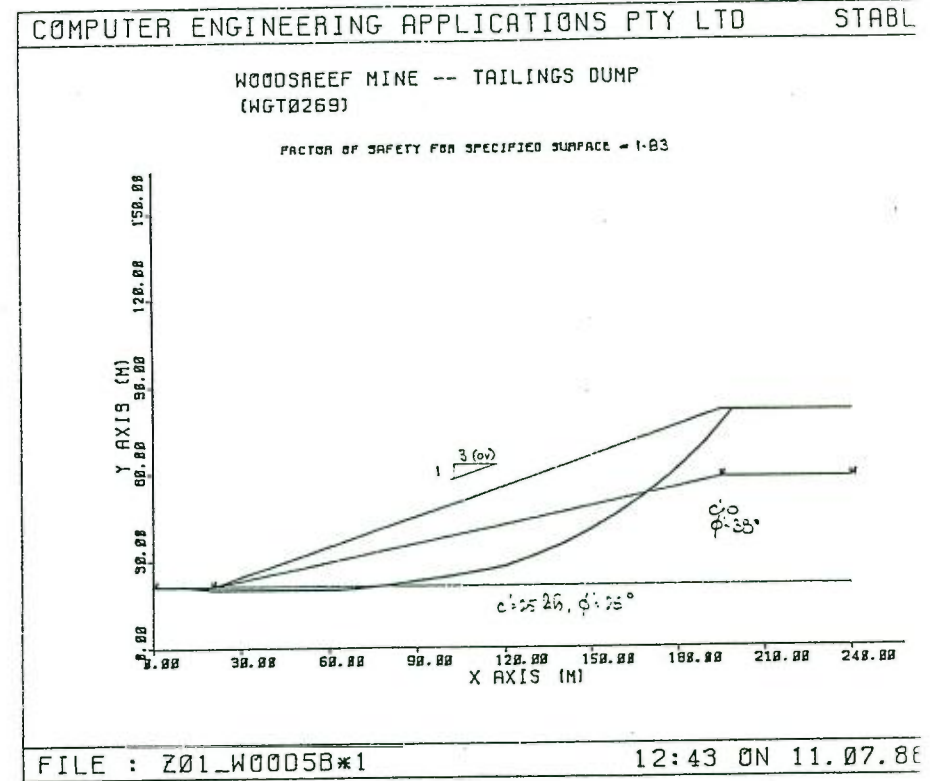
WOODSREEF MINE -- TAILINGS DUMP
(NGT0269)

Model	Calculated Factor of Safety	Improvement in Factor of Safety over Base Model
BASE MODEL	0.95	-
30° LEADING EDGE	1.20	26%
1.5:1 LEADING EDGE (Approx 34°)	1.11	17%
3:1 LEADING EDGE (Approx 18°)	1.83	93%

FACTOR OF SAFETY FOR SPECIFIED SURFACE = 1.11
