Elura Mine subsidence, 16 & 17 March 1996 : report

**ELURA MINE SUBSIDENCE
16 & 17 MARCH 1996**

REPORT

**Graham TERREY
Chief Inspector of Mines
Department of Mineral Resources, NSW**

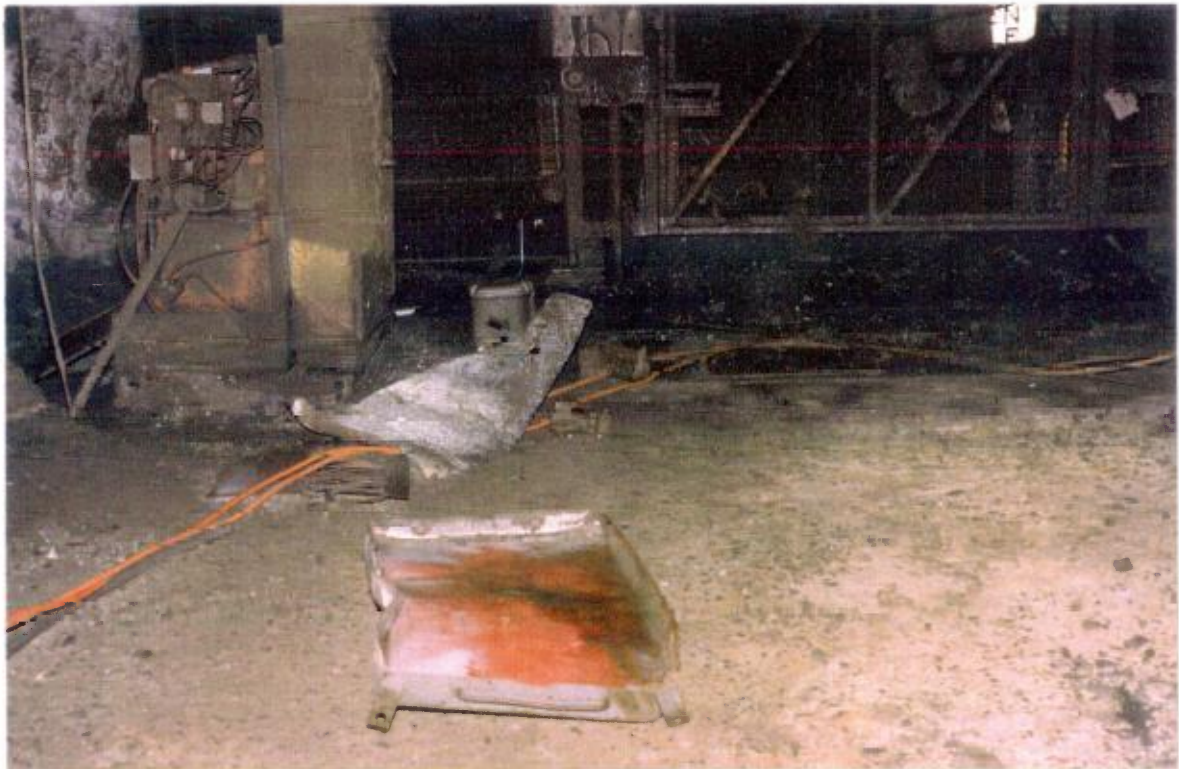
2 Drill

Fallen ground showing debris from supergene workings

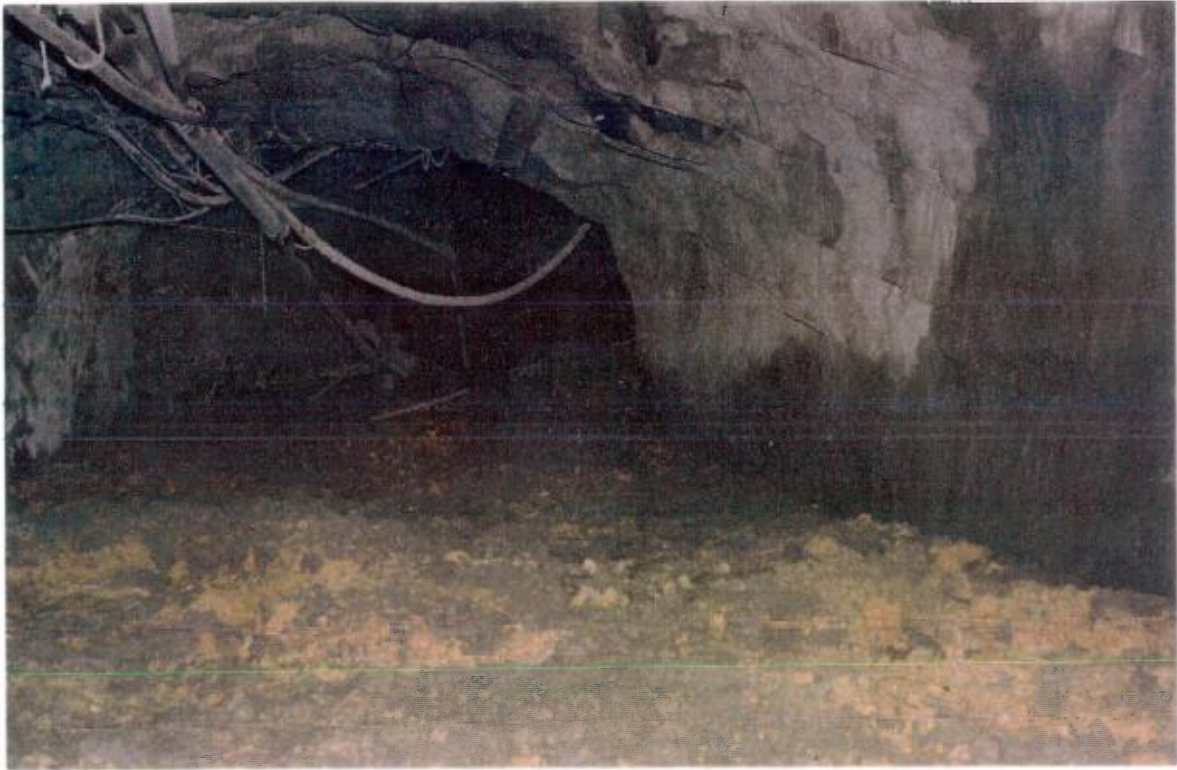
4 Drill Access just West of Substation

18 March 1996 4 Drill Access just West of substation showing fill flow
Consistency of fill "sloppy"

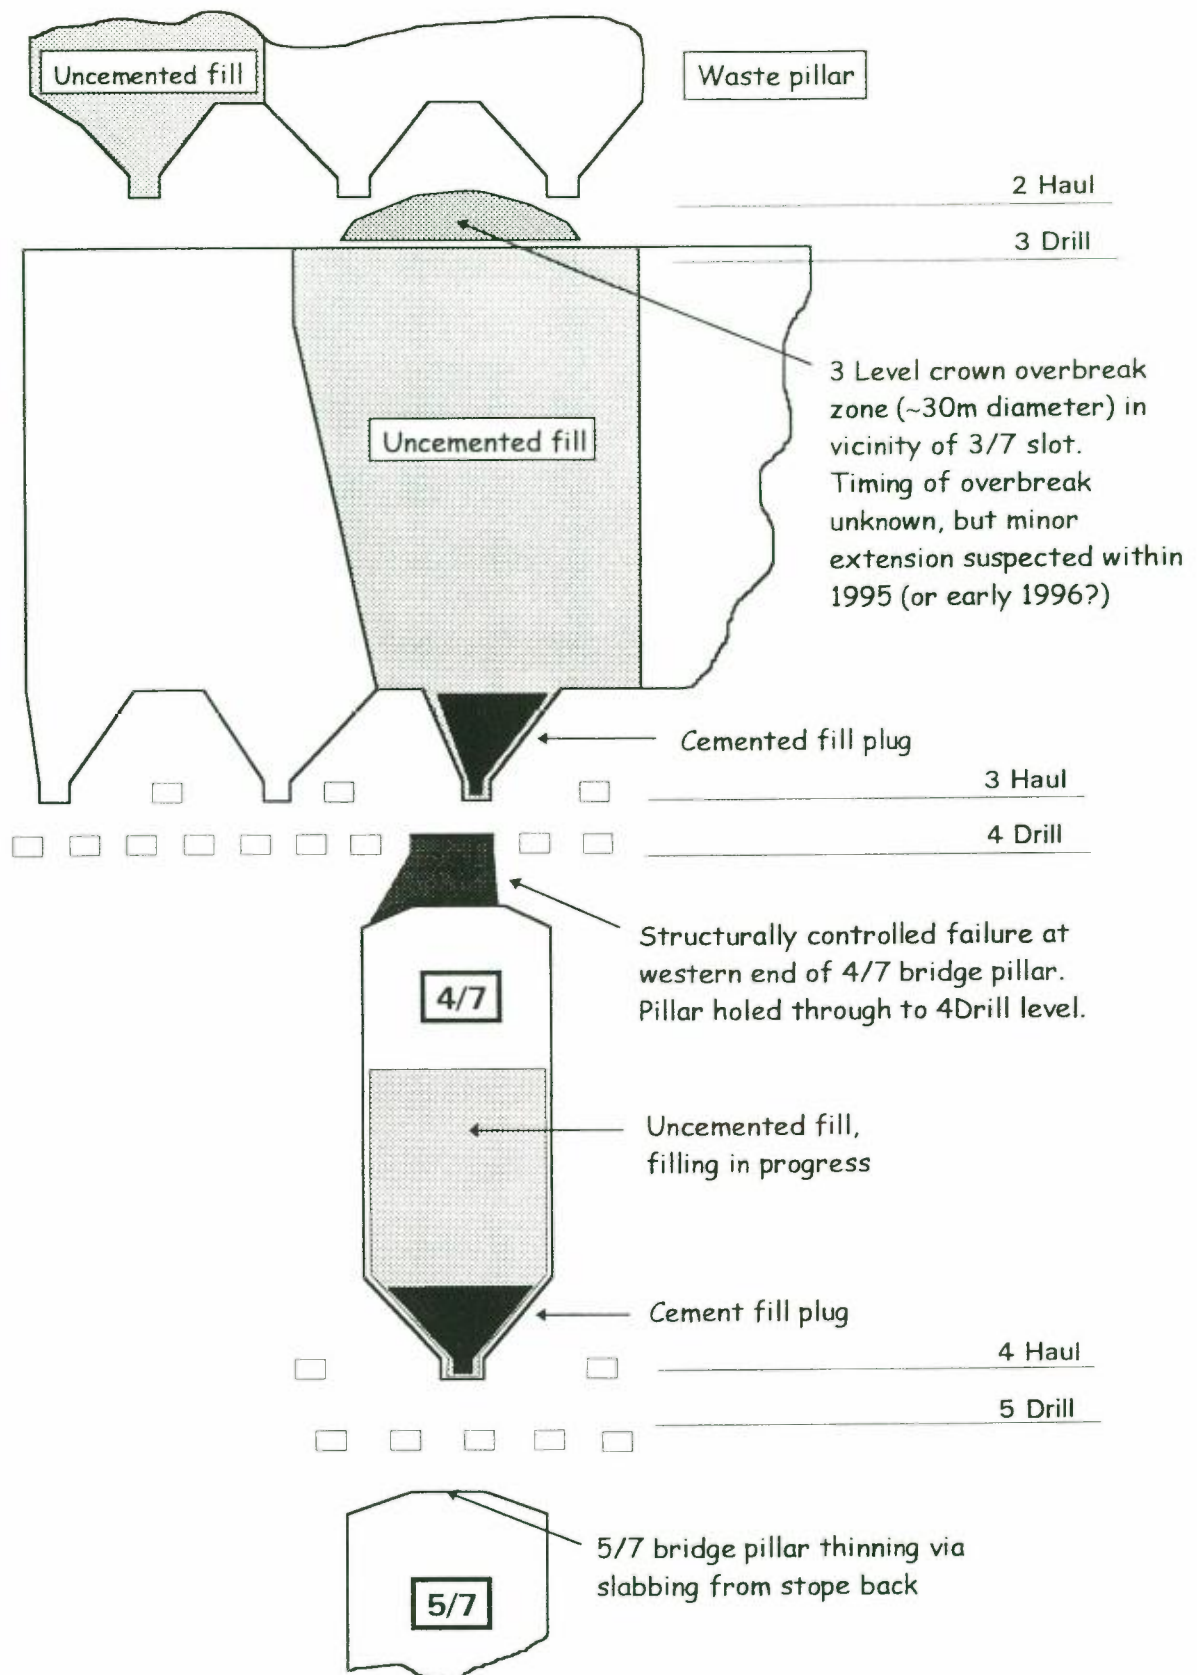
FIGURE 2A ELURA STATUS - PRE 1994

The 3/6, 3/7 and 3/9 stopes immediately above the 4/7 crown were filled with uncemented material, Figure 2A, which would fail/run as soon as exposed. Given the size of the void (~220,000m³) within the 4/7 - 4/9 stope at the time, there was no chance of choking-off the initial run of fill. The fill would have fallen into 4/7, and fallen and/or flowed into 4/9.
