The Newcastle earthquake '89 : background, causes, effects,
implications

A publication of the Munich Re
Service Division

The Newcastle earthquake, December 28, 1989 – causes, effects, implications

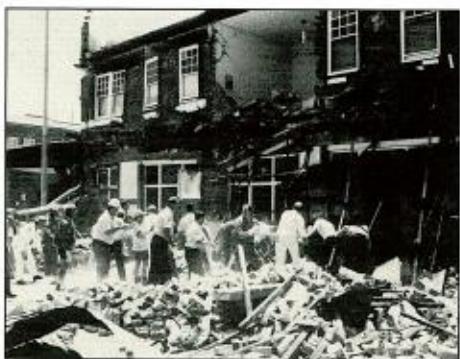
Workers clearing rubble in Beaumont Street, Hamilton, a suburb of Newcastle. (Photograph by courtesy of the Newcastle Morning Herald)

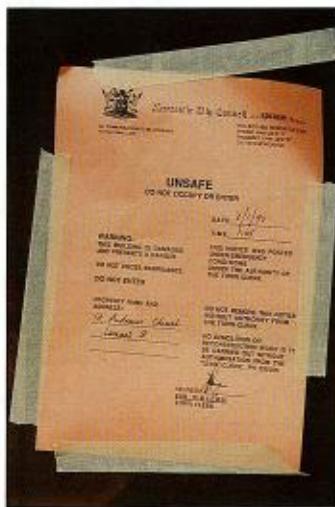
16. An "unsafe" notice, indicating that the structure has been inspected and found to be dangerous. In suburbs such as Cooks Hill, many buildings had notices similar to this one. (Photograph by courtesy of C. Featherstone)

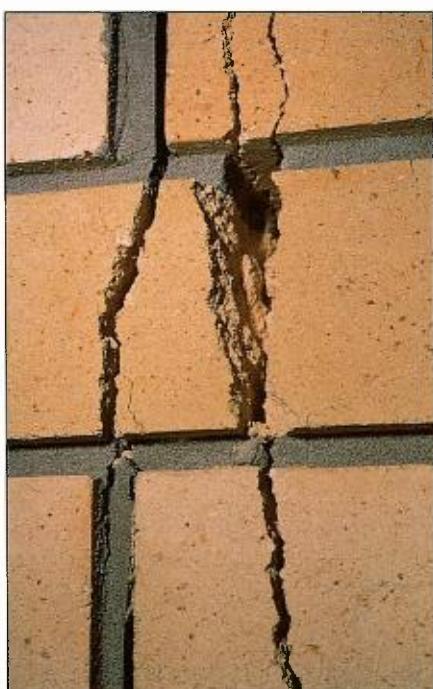
20. Close-up of damage to light-coloured modern bricks at Kotara High School constructed in 1968. These bricks are generally underfired to produce the light colour. (Photograph by courtesy of GIO (NSW))

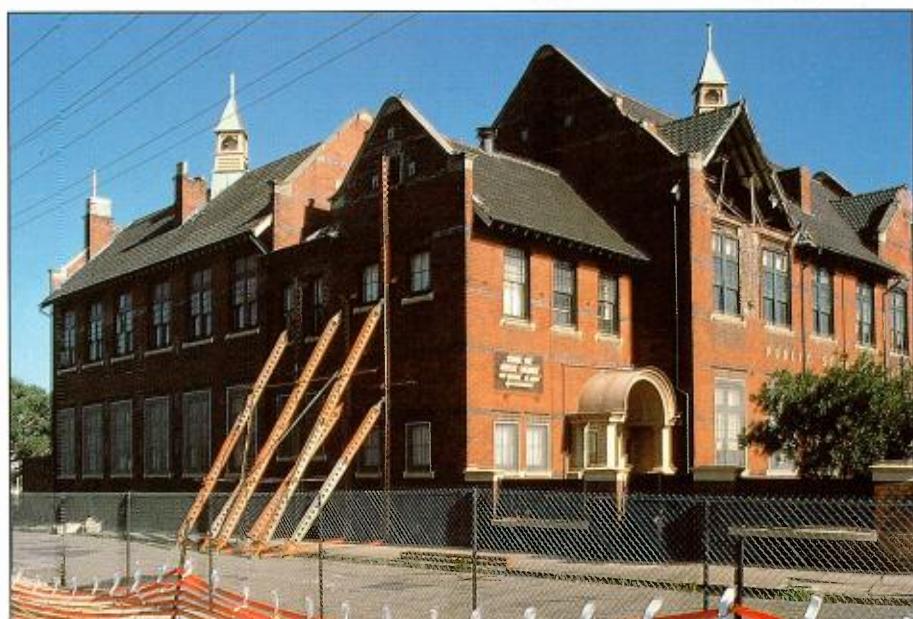
22, 23. The top of this wall at Wickham Public School leans outwards by 7-10 cm. The gable on the front of the building has also been damaged producing large amounts of debris in the school playground. If the earthquake had occurred on a normal school day many children may have been injured. (Photographs by courtesy of the GIO (NSW))

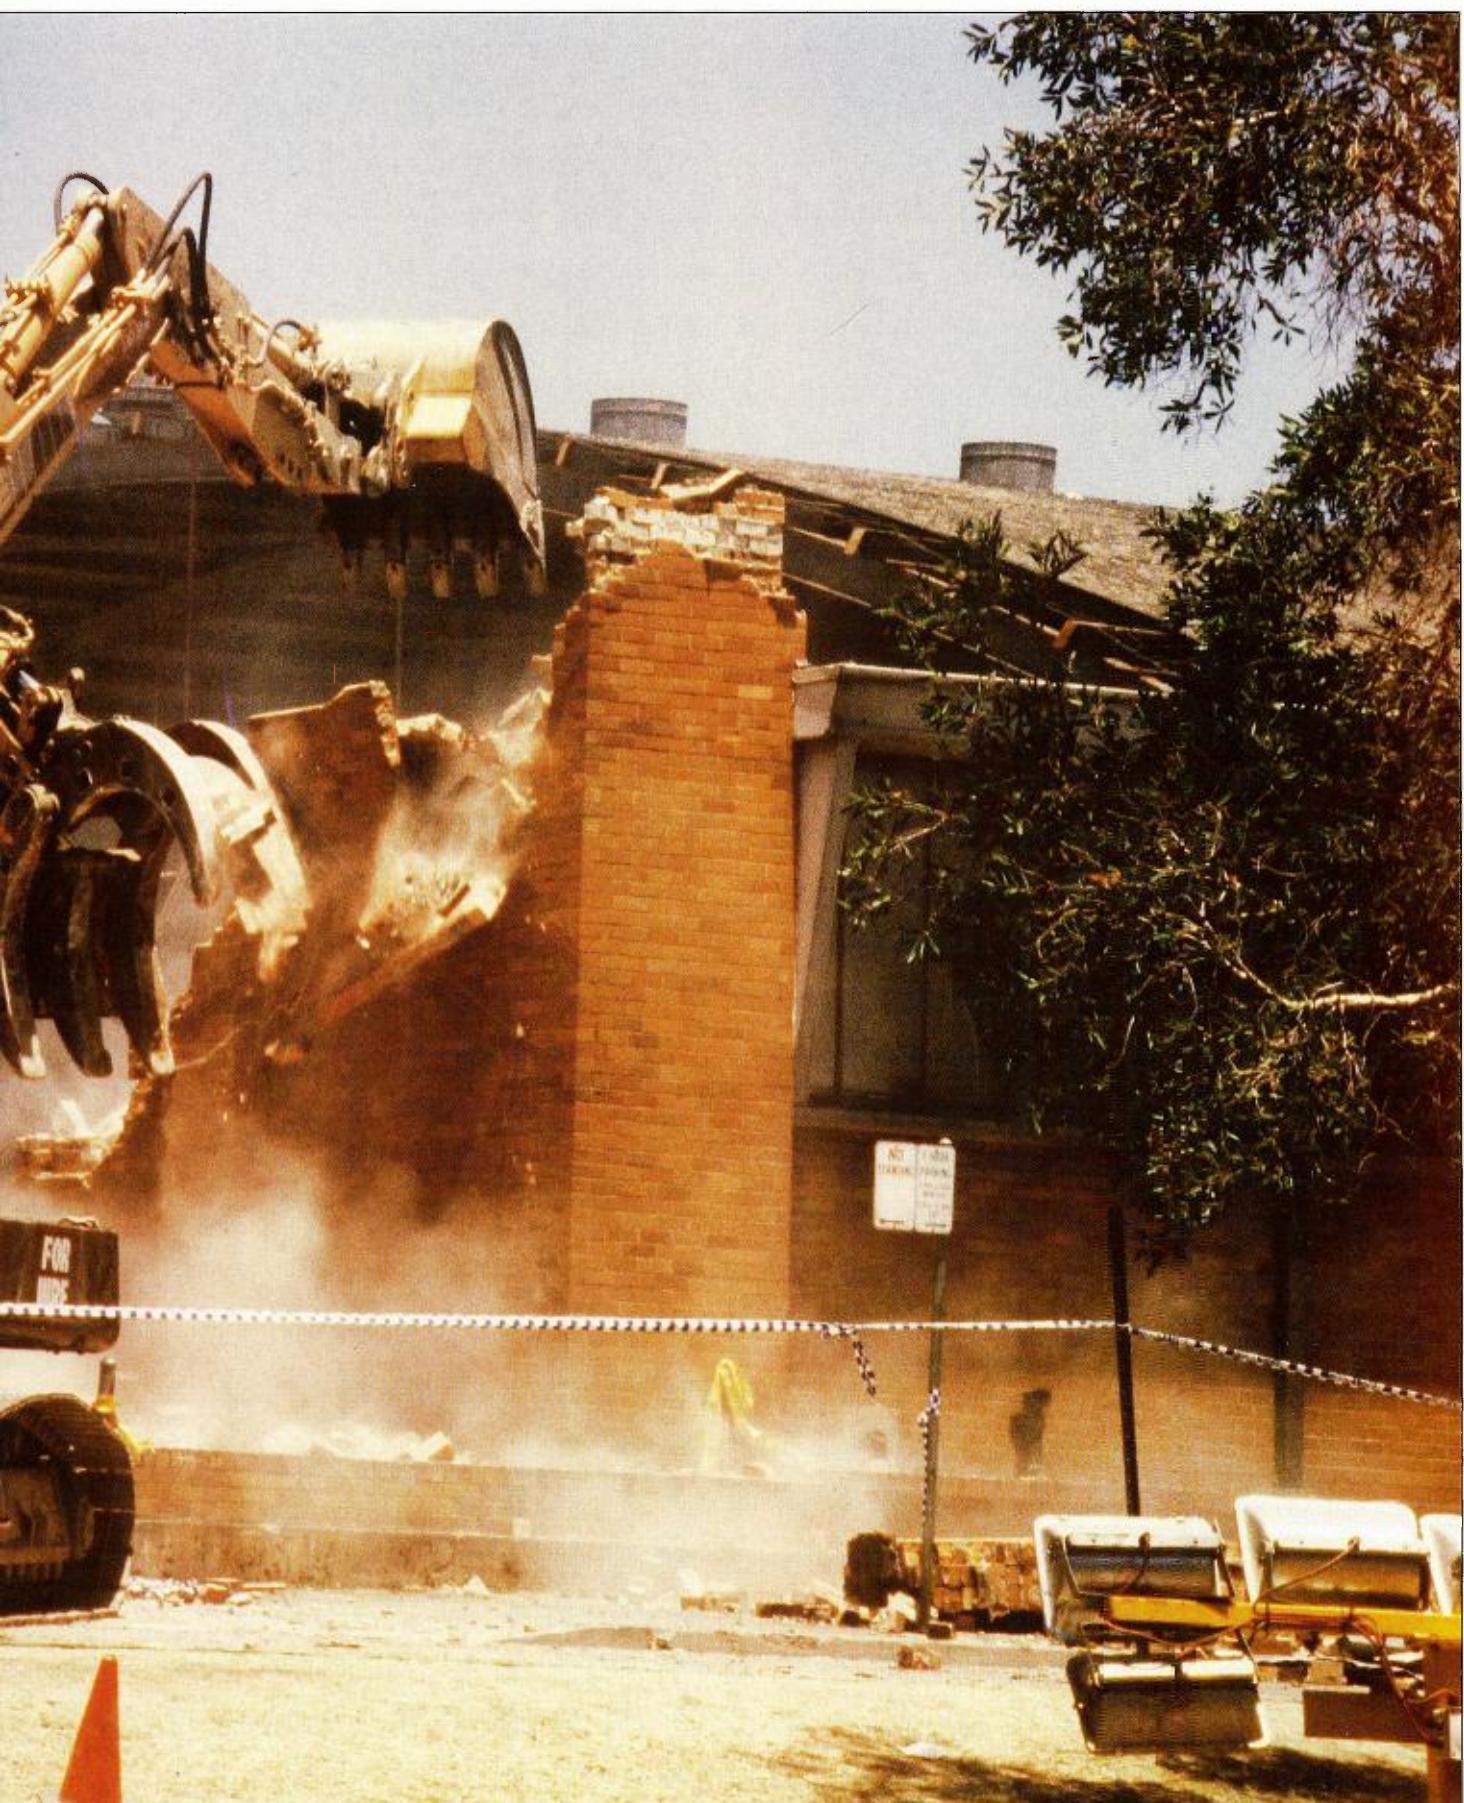
25. A large section of the Newcastle Workers Club collapsed leading to the deaths of nine people. In the photograph workers tear down a damaged wall that was hampering efforts to get heavy machinery into the Workers Club. (Photograph by courtesy of the Newcastle Morning Herald)

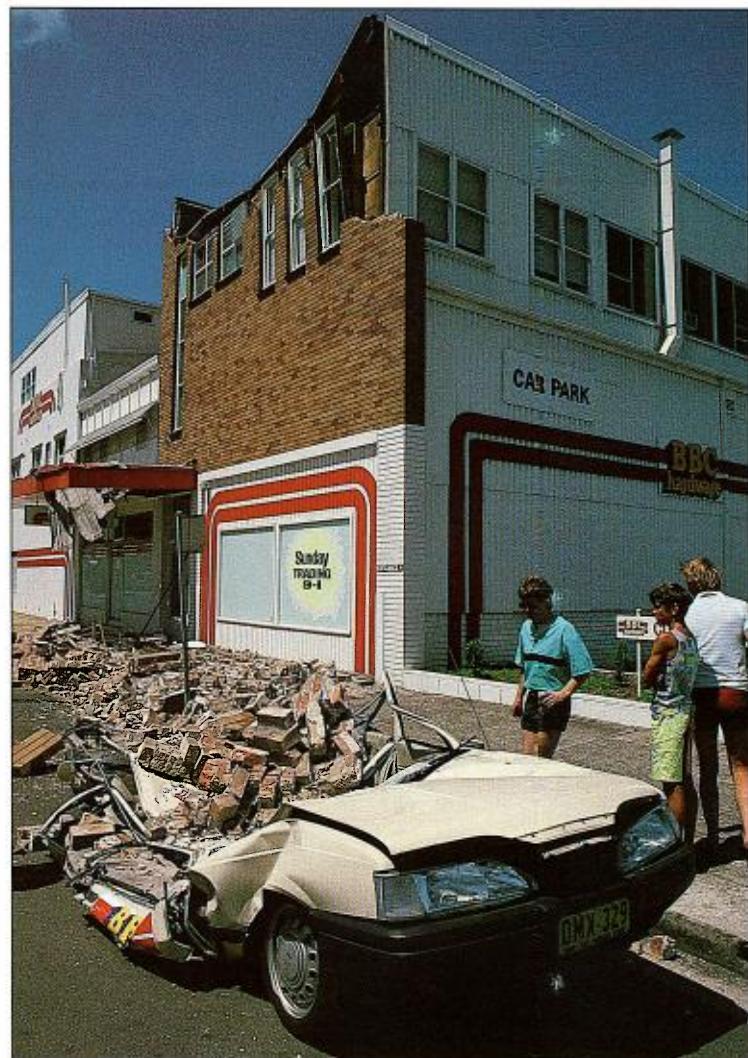
32. Ground motions are greatest at the tops of buildings. Parapets commonly fail because they are poorly supported, producing large amounts of debris in the streets. (Photograph by courtesy of K. Schreiber)

Failures of unreinforced brick parapets are common because the tops of buildings experience greater motion in an earthquake than the lower portions of the structure and there is little weight on top of them. As a parapet is weakest in the direction at right angles to its length, parapet failures probably most frequently occurred where the strongest ground motion was also in this direction. Buildings with high parapets, with lime rather than cement mortars, and built on alluvium or other soft sediments were most prone to parapet failure. One report suggests that between 200 and 300 buildings experienced parapet failure. In some of these, cracked parapets remained balanced above streets and pavements forming a continuing danger. In other cases, parapets fell, sometimes causing damage to adjacent lower buildings.

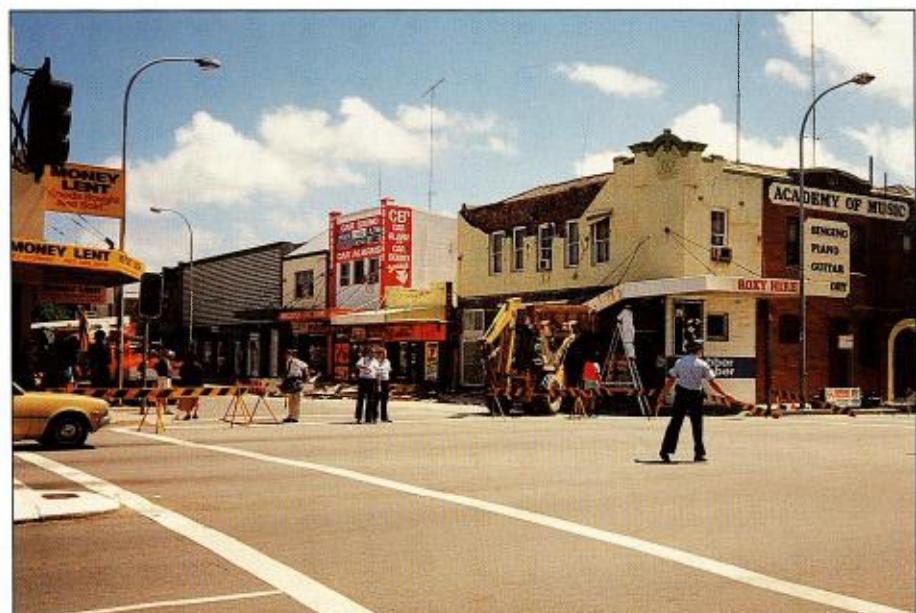
Corner failures occur where ground motion produces alternate compressive and tensile forces in walls, particularly those walls oriented at right angles to the dominant direction of ground motion. Once these forces generate cracks in the walls, widening of the cracks occurs as ground motion continues. As movement is greatest near the top of a structure, failure tends to be initiated near the tops of the walls.

Two storey buildings in the city centre and the Beaumont Street, Hamilton areas were particularly affected by corner failures. Some buildings in these areas suffered from complete wall failures initiated at the corners, while others suffered from severe cracking of brickwork at the upper corners.

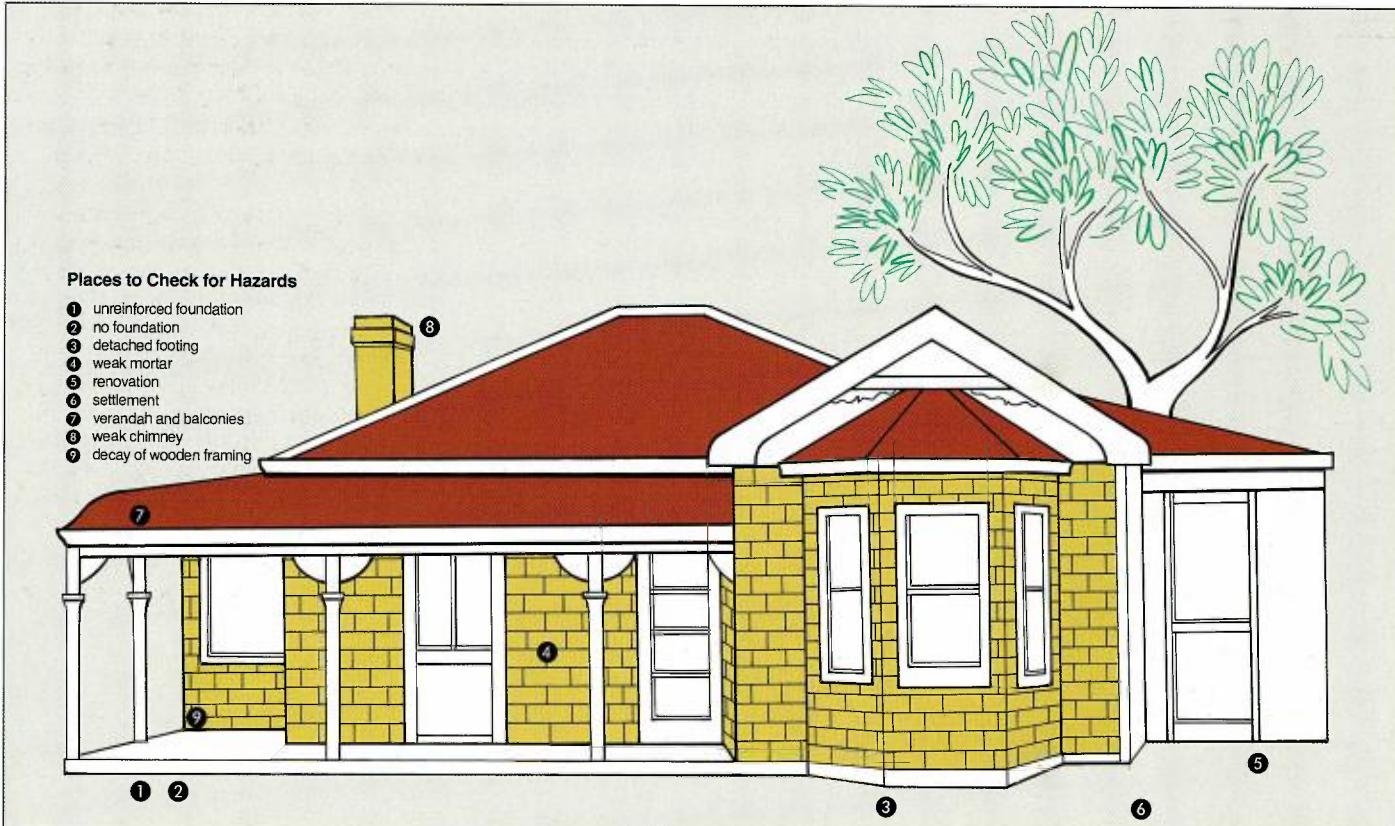
45. Older unreinforced masonry homes may have low seismic resistance. Some of the points that should be checked are shown (modified after Home Buyer's Guide to Earthquake Hazards).
