Inspection Report

111 Newport Rd, Dora Creek, NSW, 2264

Inspection Date: 13 Jan 2025

Pest And Building Inspection

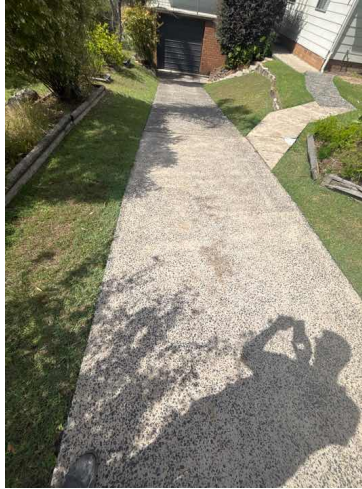
Driveway Condition

On visual inspection, the general condition of the driveway is serviceable.

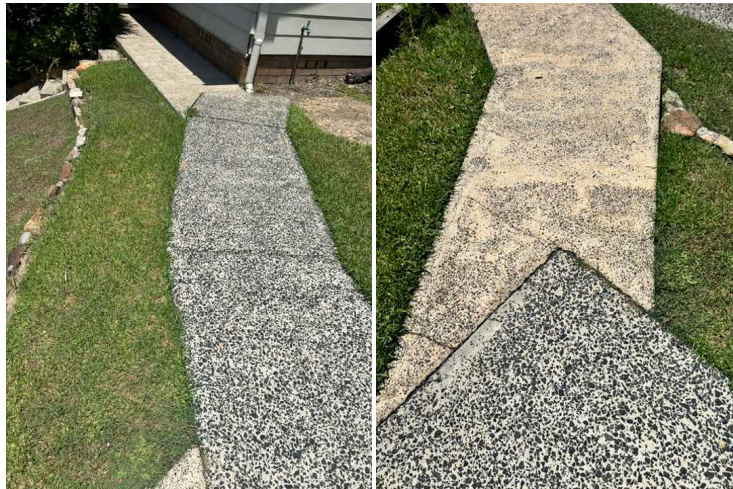
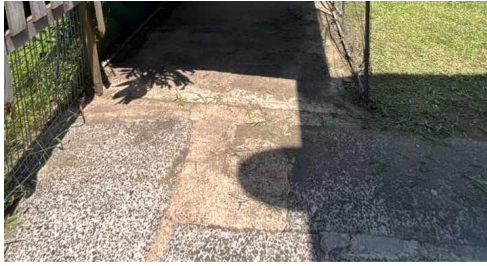
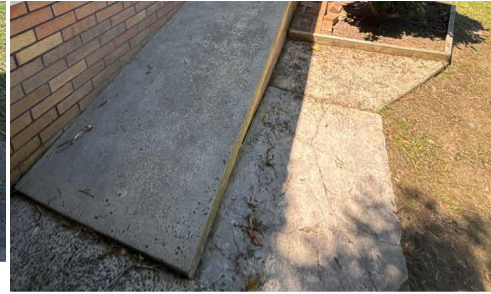
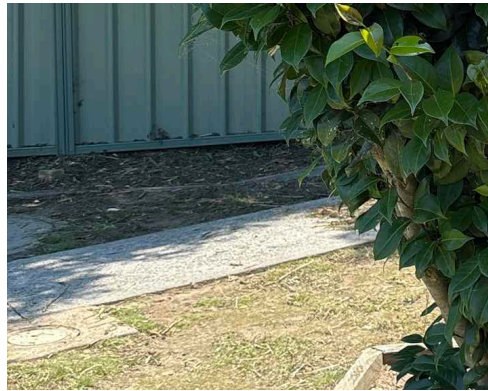
Pathways Condition

There was cracking and settlement within the pathways. Recommend repair as necessary by a suitably qualified tradesperson.

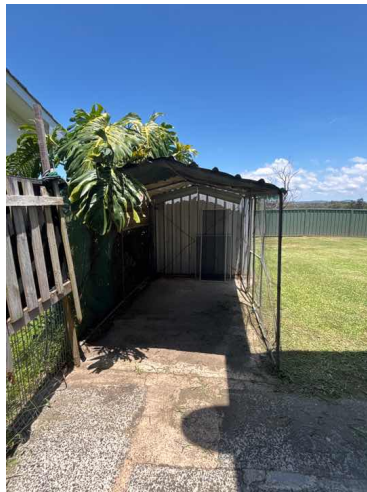
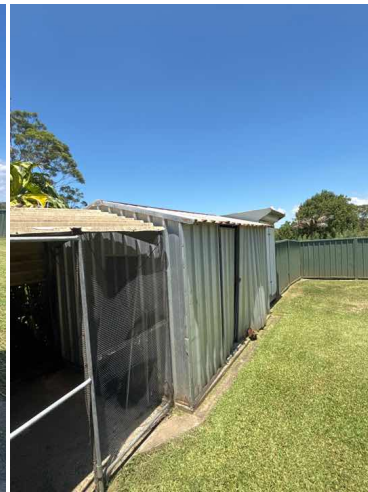
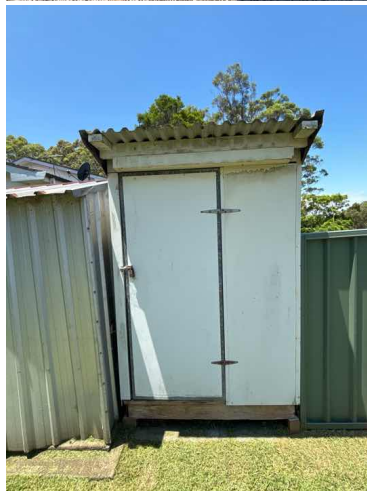
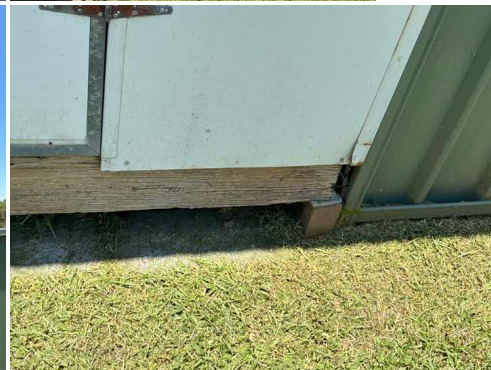
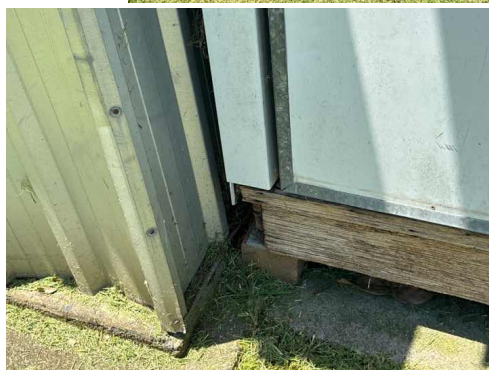
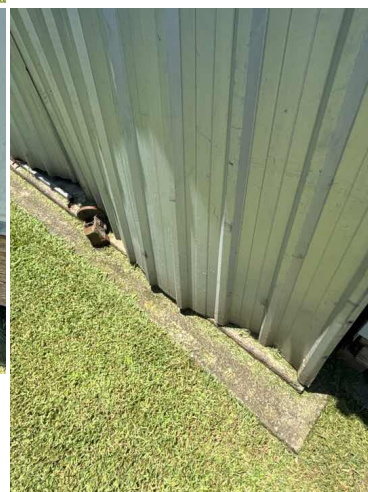
Shed Condition

Interior of sheds were locked or obstructed. Not inspected

The sheds had some deterioration and damage and require repair. These include but are not limited to: deterioration in floors / supporting substructure, wall damage, doors and frames; deterioration to the roof frame and cladding.

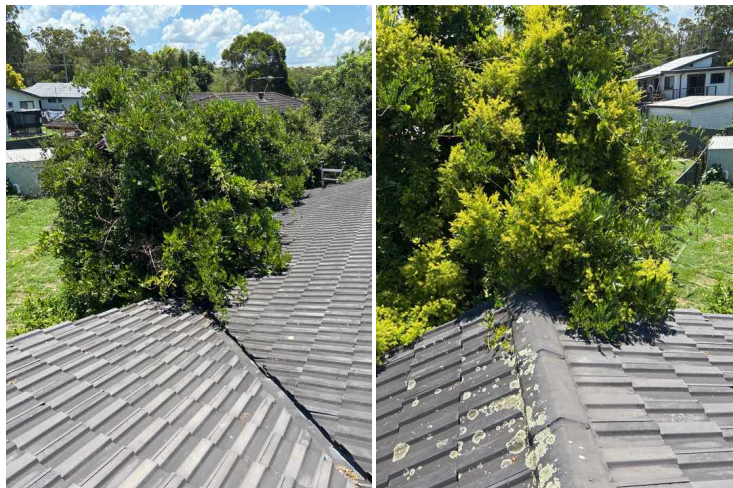
Tree Findings

Trees are overhanging roof areas. These should be cut back away from the roof line and gutters.

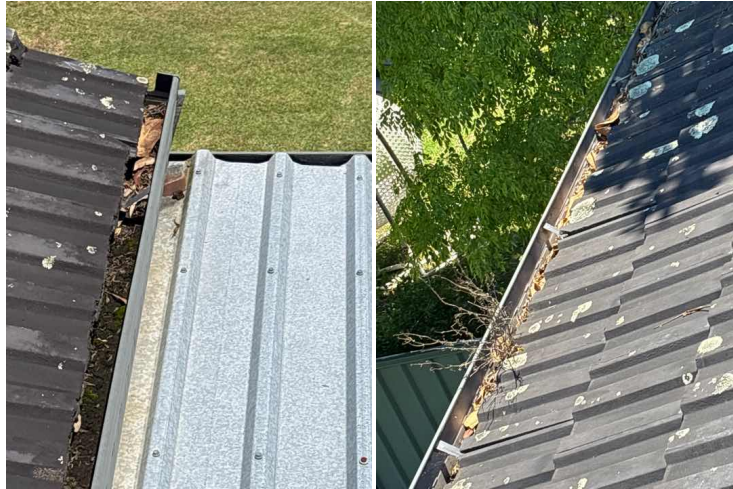
Gutter Findings

Debris in guttering areas- this requires cleaning out to prevent blocking of downpipes and leaking into eaves and fascia. Have gutters cleaned and assessed by a plumber for adequate fall. Regularly clean to prevent ponding. Ponding water will contribute to rust.

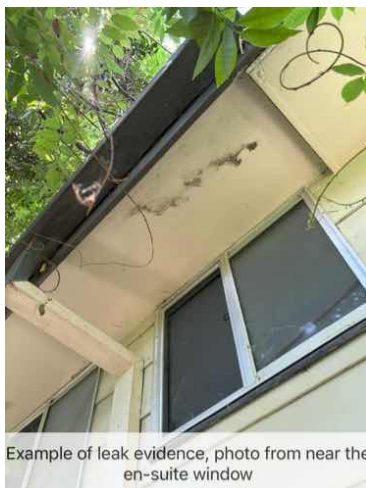
Eave Condition

There was evidence of leaking from the roof and/or flashings (e.g. staining, paint deterioration, bubbles paint). Recommend the roof and flashings (e.g.) are repaired as necessary by a licensed roofer.

Example of leak evidence, photo from near the en-suite window

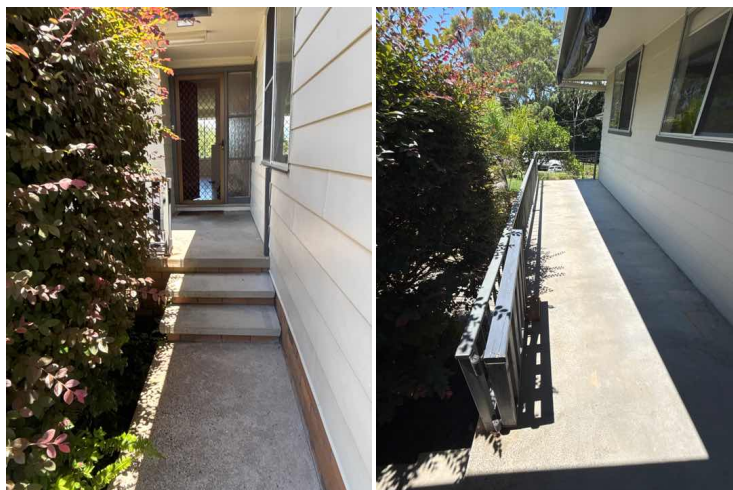
The entry porch / portico area had a generally fair appearance, however there were some observations. Please refer to the following statements.

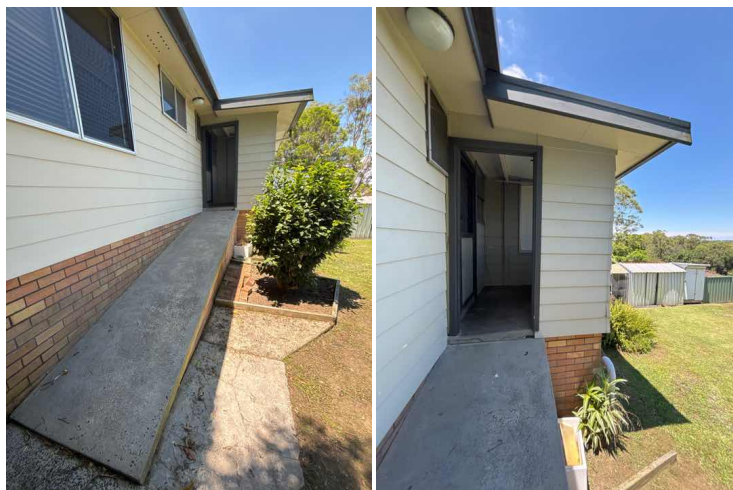
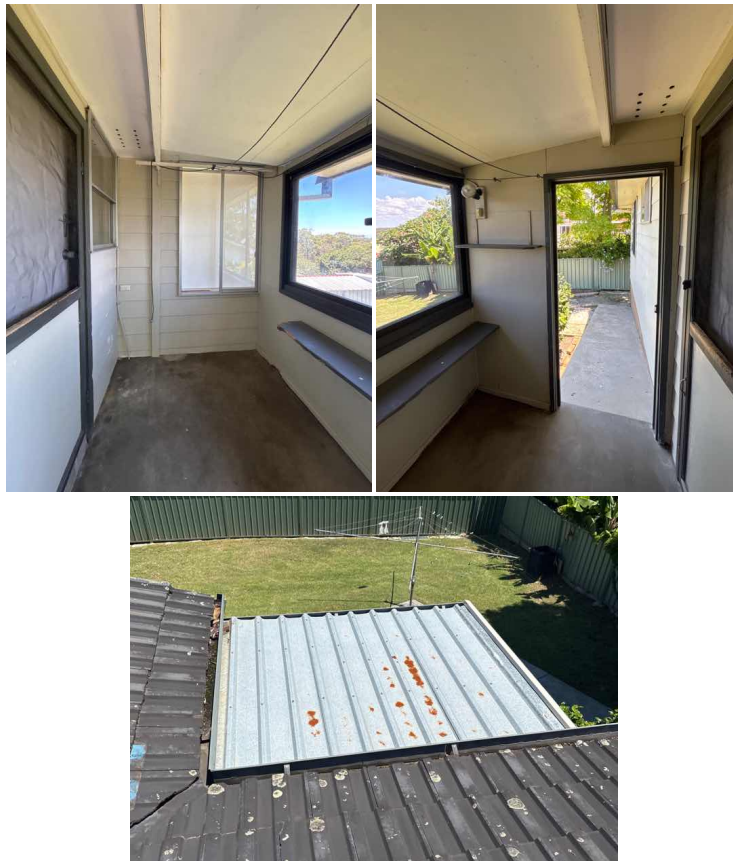
Roof & Ceiling Lining Condition

The entry porch / portico area had a generally fair appearance, however there were some observations. Please refer to the following statements.

There was rust deterioration in the rear portico roof cladding. Recommend repair as necessary by a licensed roofer.

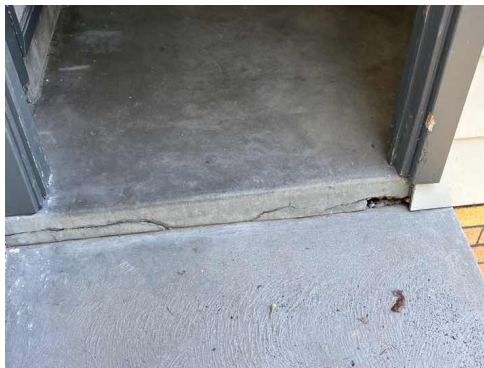
Concrete cracking and spalling was observed to the slab (e.g. slab edge).

Please note: Whilst these cracks appeared to be minor and typical at the time of inspection, we recommend you monitor these cracks and if worsening occurs contact a qualified concreter for repairs.

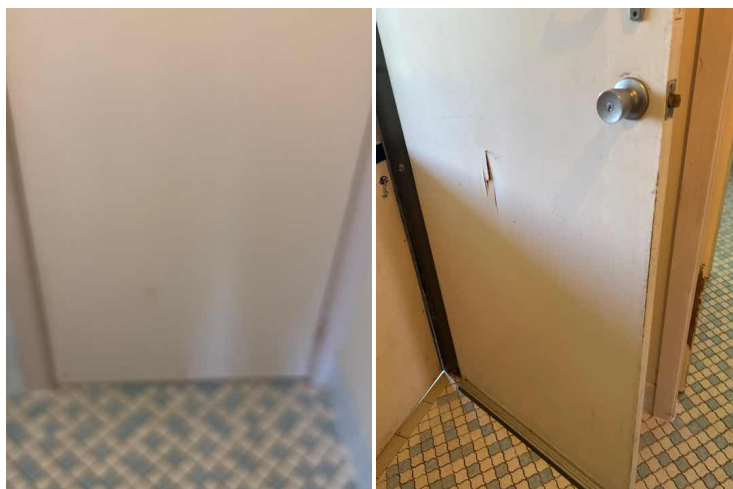
Door Findings - Laundry

The laundry door is damaged and deteriorated. Recommend repair or replacement as necessary by a suitably qualified tradesperson.

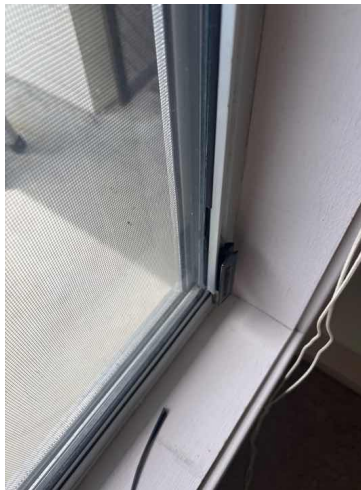
Overall Condition

The windows opened and functioned but require general maintenance and repair as necessary by a suitably qualified tradesperson (e.g. rollers, locks / latches, glazing seals).

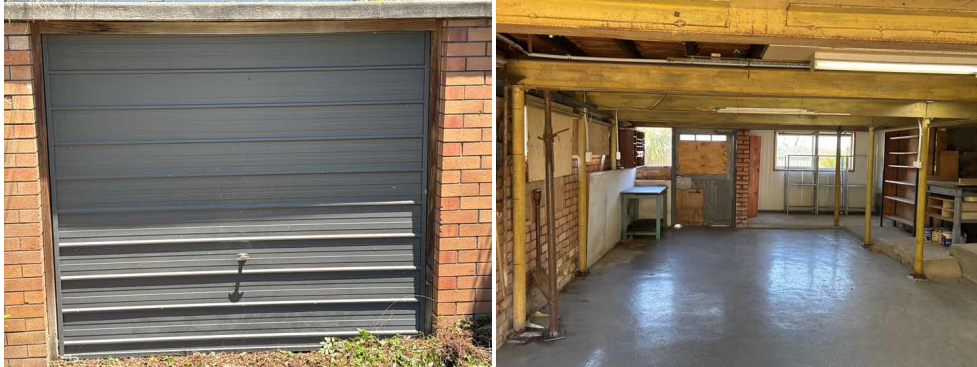
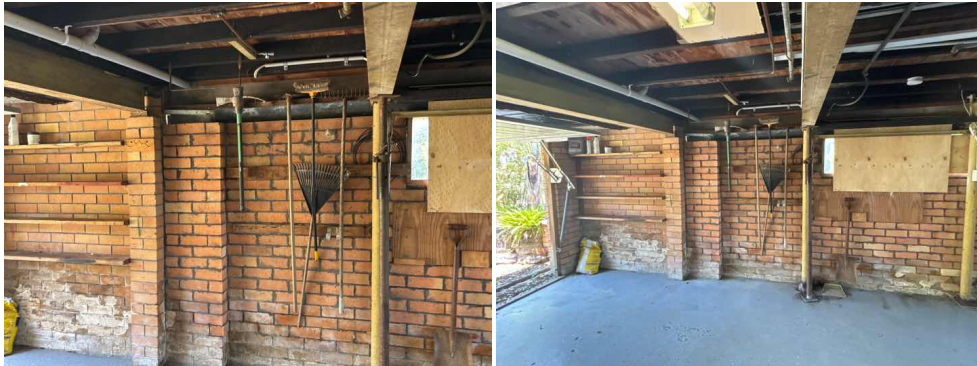
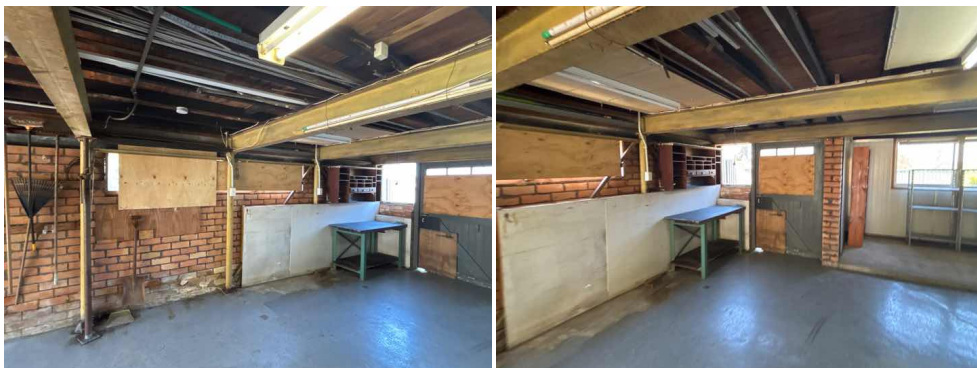
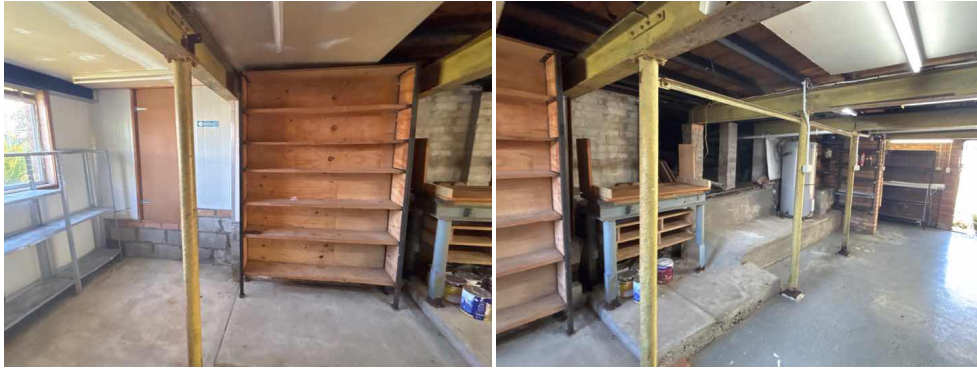
Overall Condition

On inspection, defects were present that will require further assessing and recommendations by qualified trades persons, please read below for details.

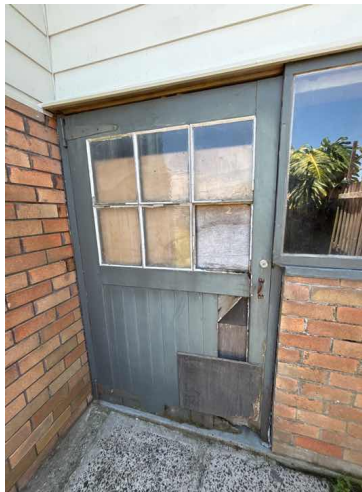
Door Findings

The personnel / rear access door requires repair or replacement (e.g. notable deterioration). Recommend repair or replacement as necessary by a suitably qualified tradesperson.

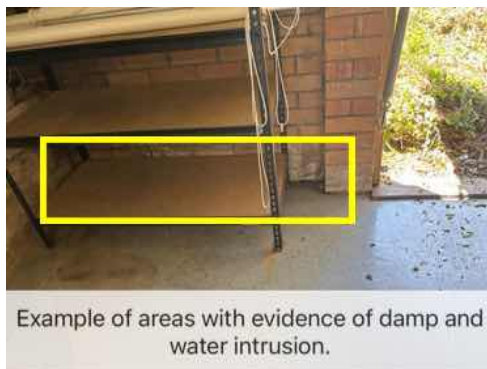
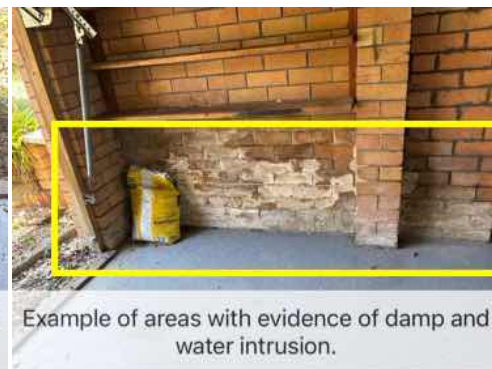
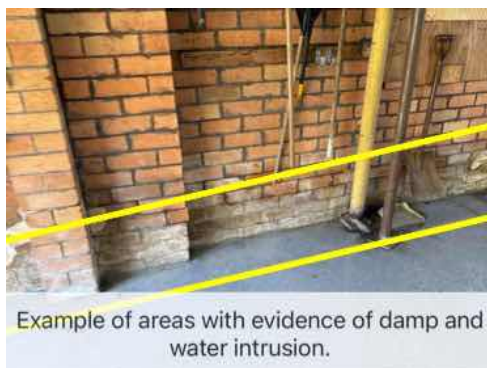
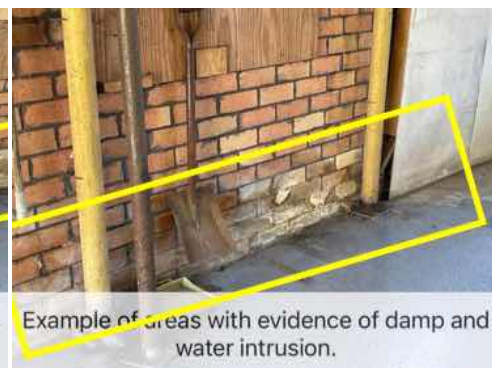
Internal Wall Findings

Moisture/damp detected and evidence of water intrusion, particularly to areas abutted by soil. This is not uncommon for the presumed age, construction type, and location. It is recommended that specialist advice be sought to obtain accurate diagnosis of the cause and extent of the damp problem, and repaired as necessary by a suitably qualified tradesperson.

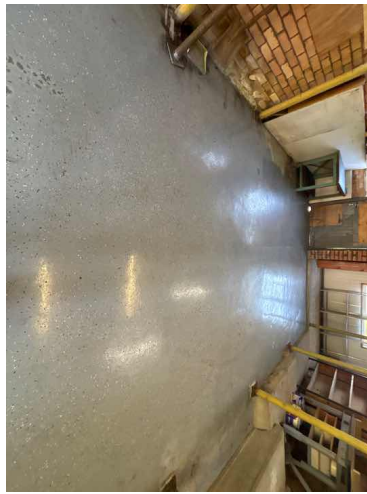
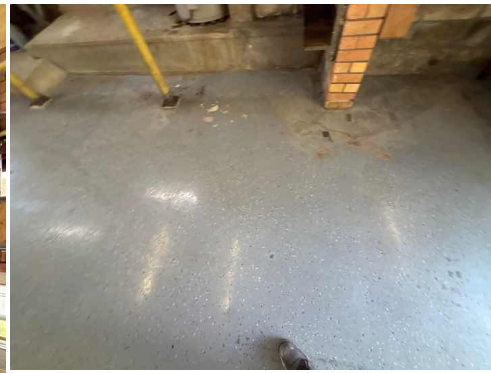
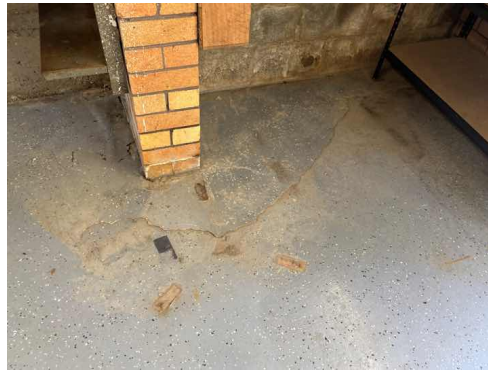
Floor Findings

Minor slab cracks - Note. Whilst these cracks appeared to be minor at the time of inspection, we strongly recommend you monitor these cracks and if worsening occurs contact a qualified concreter for further advice.

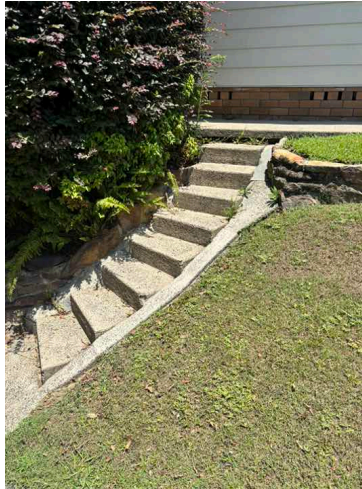
The front stairs appeared generally sound, however there was no handrail. Recommend a handrail is installed and stairs maintained or repaired as necessary by a suitably qualified tradesperson.

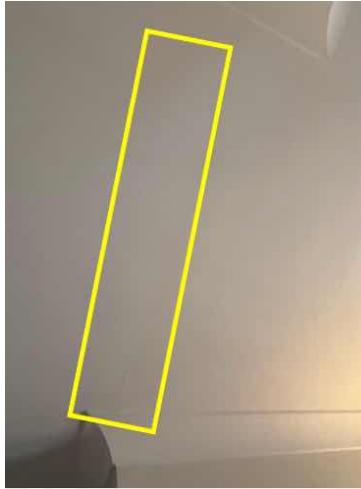
Ceiling

Settlement / movement cracks observed. These are typical and generally patch and paint will suffice, however monitoring these cracks is advised for 12 months and if they become worse, further investigation by a suitably qualified professional is advised.

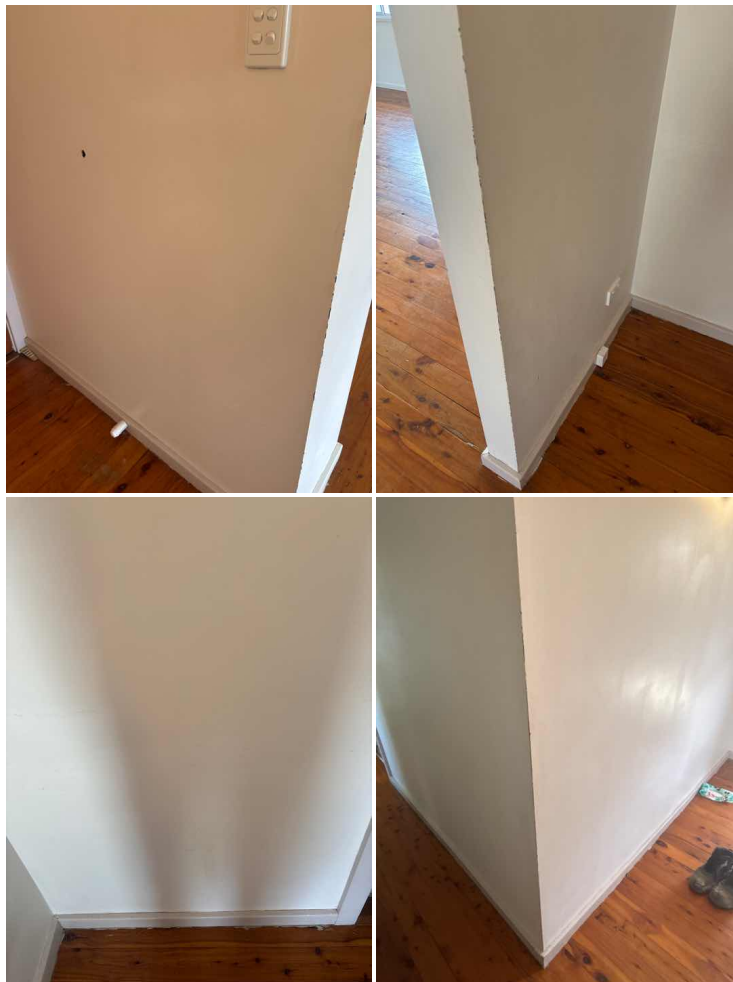
Walls

General age and wear deterioration, dings, or the like in wall linings and trims. Recommend a suitably qualified tradesperson be engaged for general maintenance and repair as necessary (e.g. patch and paint)

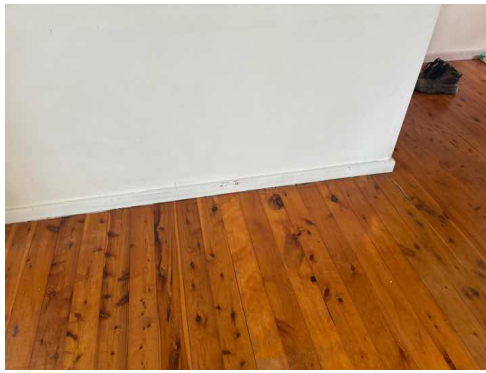
The stairs had some general wear deterioration (e.g. scratches and the like). Recommend general maintenance and repair as necessary by a suitably qualified tradesperson.

There were marks, scratches, paint, or the like on flooring / floorboards. Recommend repair as necessary by a suitably qualified tradesperson.

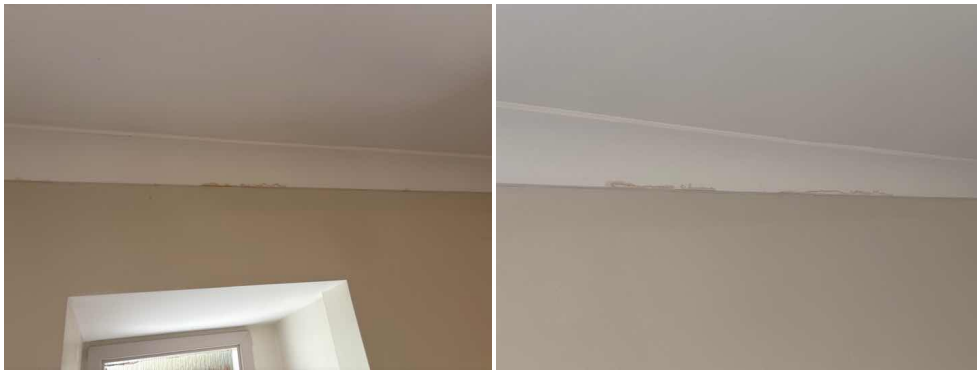
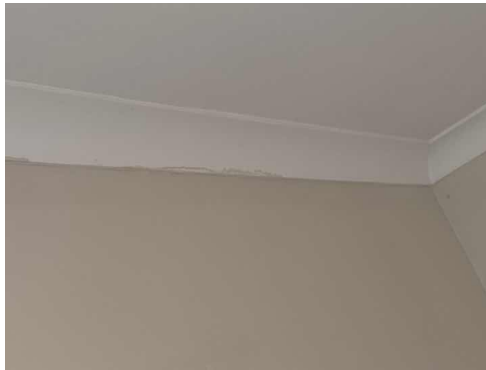
Ceiling

There was evidence of leaking from the roof. The areas were tested with electronic impedance moisture testing equipment and / or thermal imaging and found to be dry (consistent with other areas / linings) at the time of inspection. Recommend repair as necessary to deteriorated damaged materials by a suitably qualified tradesperson and monitoring for further issues.

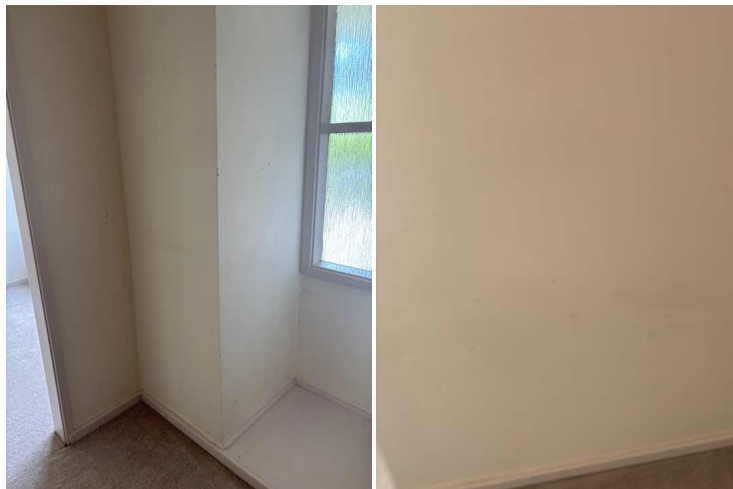
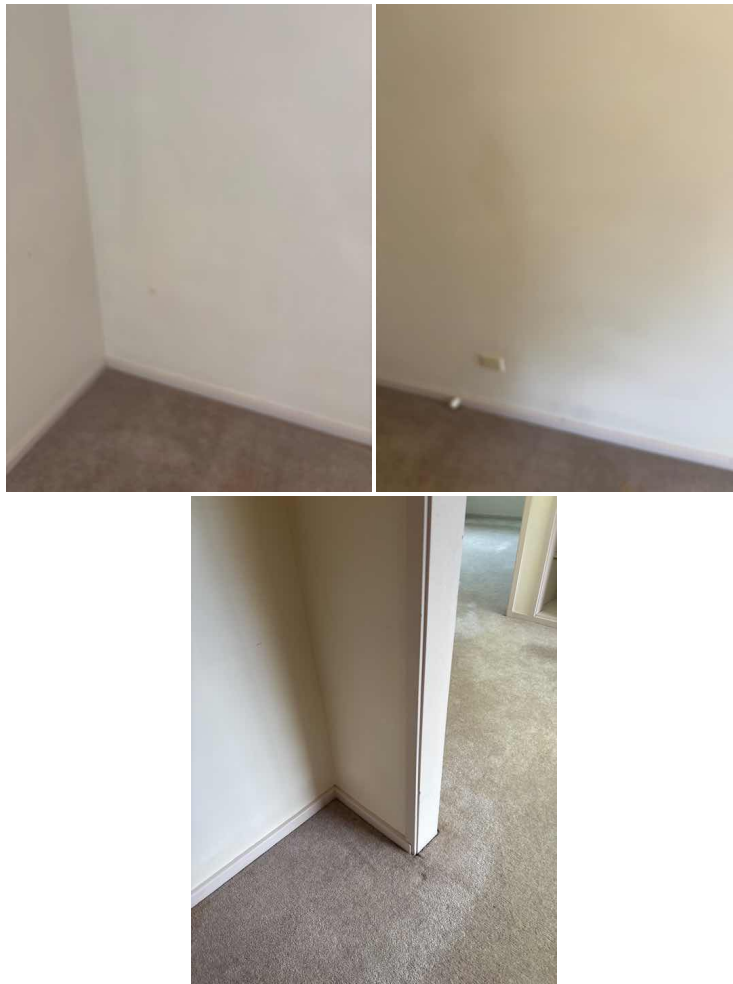
Walls

General age and wear deterioration, dings, or the like in wall linings and trims. Recommend a suitably qualified tradesperson be engaged for general maintenance and repair as necessary (e.g. patch and paint)

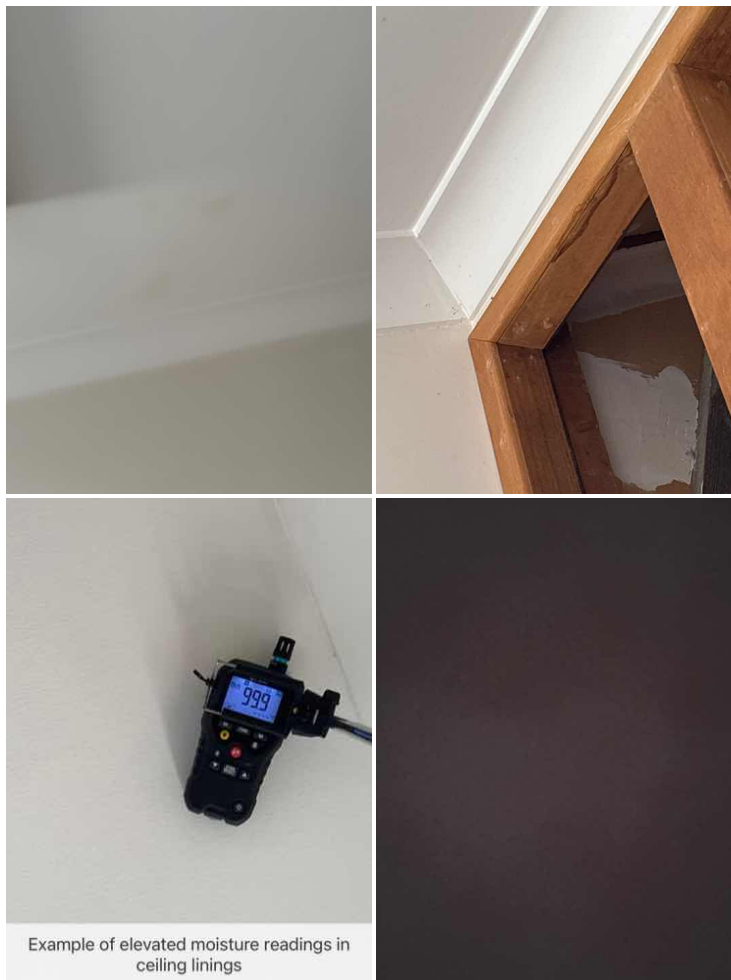
General age and wear deterioration (e.g. dings, marks, scuffs, and the like) in ceiling linings and cornices. Recommend a suitably qualified tradesperson be engaged for general maintenance and repair as necessary (e.g. patch and paint).

Ceiling stains observed, with elevated moisture readings obtained. In the absence of rain It's difficult to ascertain with certainty the location of the leak. A qualified roofer should be engaged to further evaluate the roof and all water damaged materials repaired or replaced as necessary by a suitably qualified tradesperson.

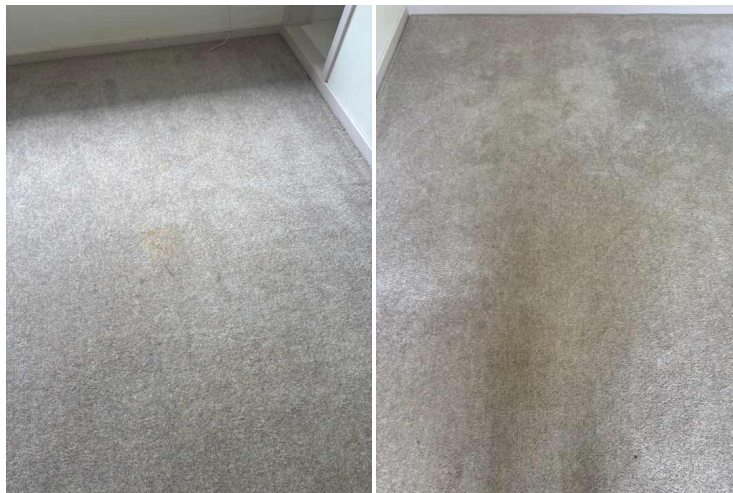
Skirting boards had general wear and damage to areas. Recommend repair as necessary by a suitably qualified tradesperson.

There was deterioration in the carpet (e.g. wear, stains, discolouration). Recommend repair or replacement as necessary by a suitably qualified tradesperson.

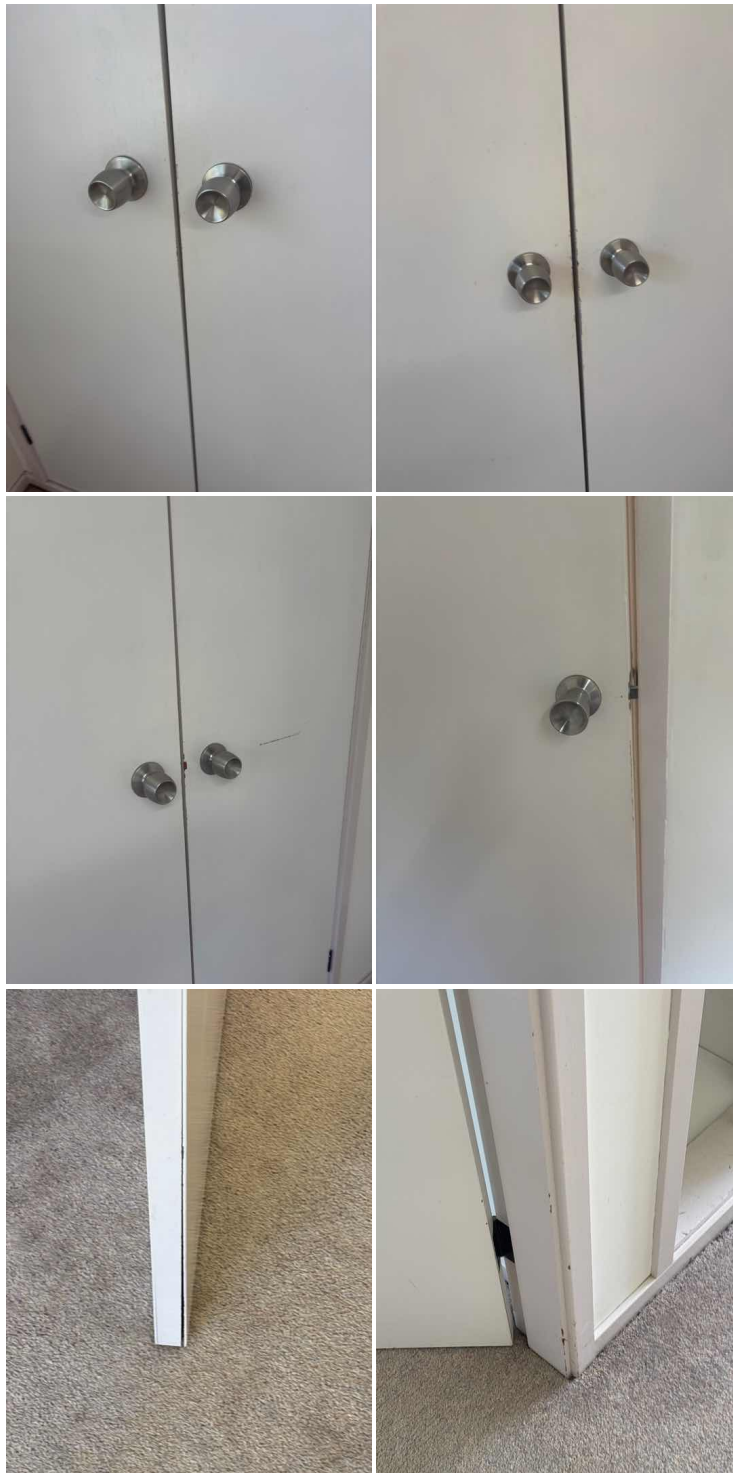
The door/s, frame, trims, and finishes had some general wear (e.g. marks, scuffs, dings, and the like) but had a fair to good appearance. Recommend general maintenance and repair as necessary by a suitably qualified tradesperson (e.g. patch and paint).

The entry door had some deterioration (e.g. delamination). Recommend repair or replacement as necessary by a suitably qualified tradesperson.

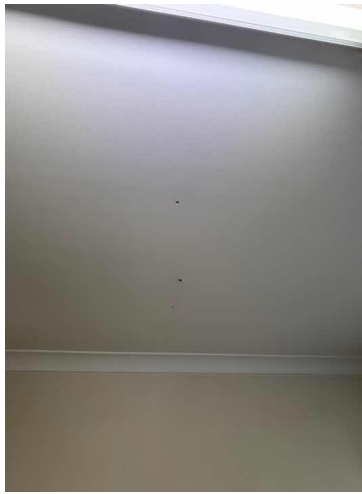
Ceiling

General age and wear deterioration (e.g. dings, marks, scuffs, holes, and the like) in ceiling linings and cornices. Recommend a suitably qualified tradesperson be engaged for general maintenance and repair as necessary (e.g. patch and paint).

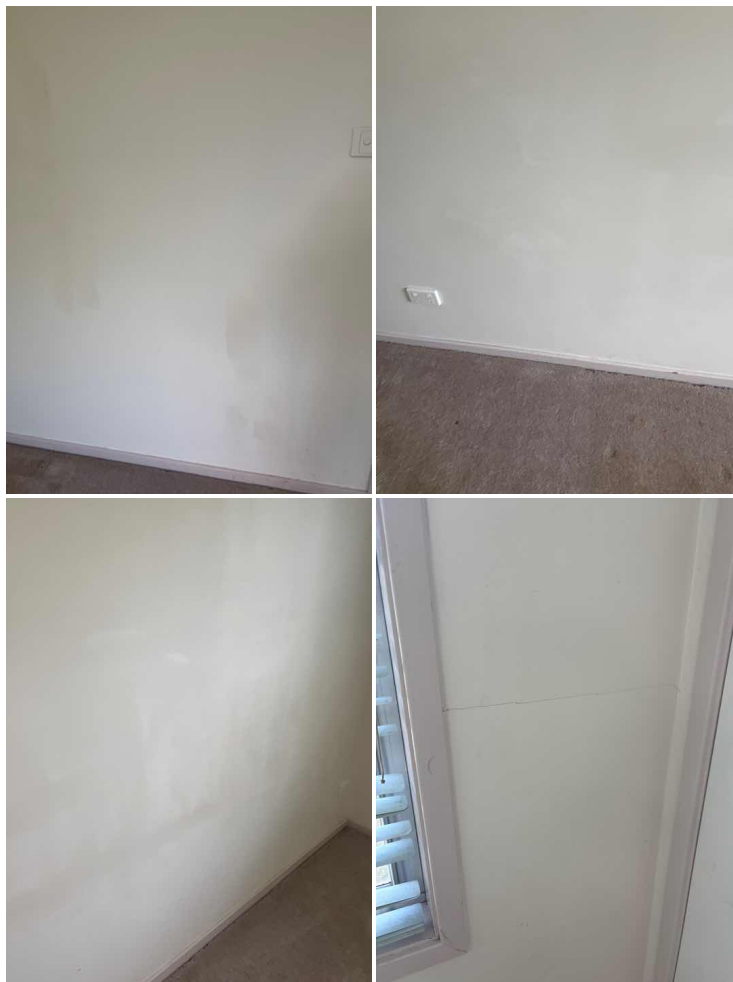
Walls

General age and wear deterioration, dings, or the like in wall linings and trims. Recommend a suitably qualified tradesperson be engaged for general maintenance and repair as necessary (e.g. patch and paint)

Settlement / movement cracks were observed. These are typical and generally patch and paint will suffice, however we recommend you monitor these cracks and if they become wider or longer further evaluation is recommended.

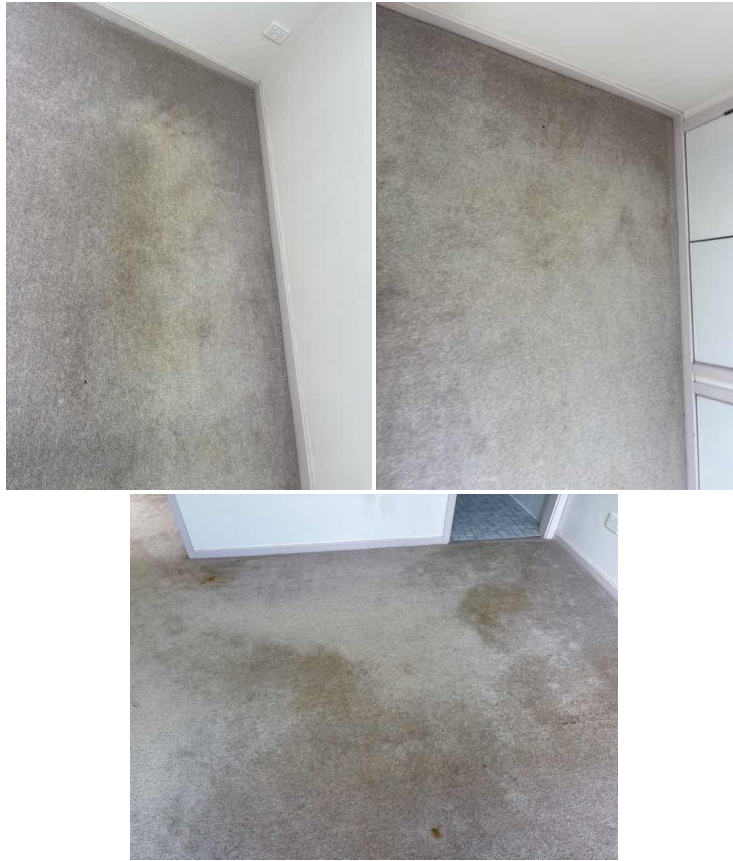
Flooring

Floorboards had general age and wear deterioration (e.g. scratches and stains). Recommend general maintenance and repair (e.g. sanding and refinishing) by a suitably qualified tradesperson.

There was deterioration in the carpet (e.g. wear, stains, pulls, discolouration). Recommend repair or replacement as necessary by a suitably qualified tradesperson.

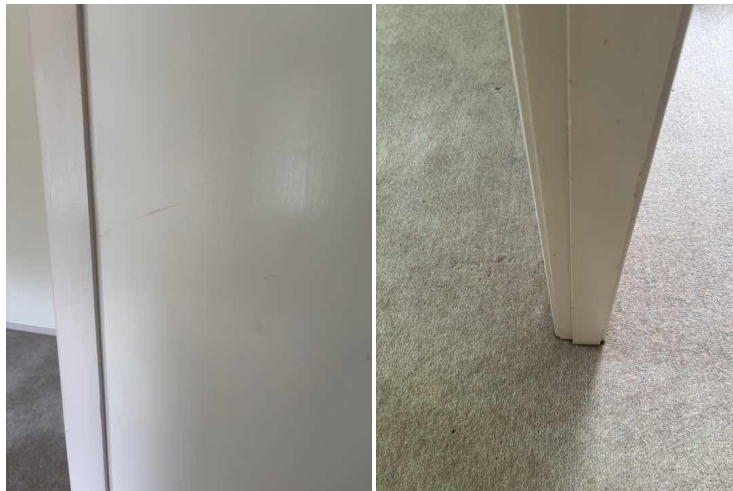
Door/s

The door/s, frame, trims, and finishes had some general wear (e.g. marks, scuffs, dings, and the like) but had a fair to good appearance. Recommend general maintenance and repair as necessary by a suitably qualified tradesperson (e.g. patch and paint).

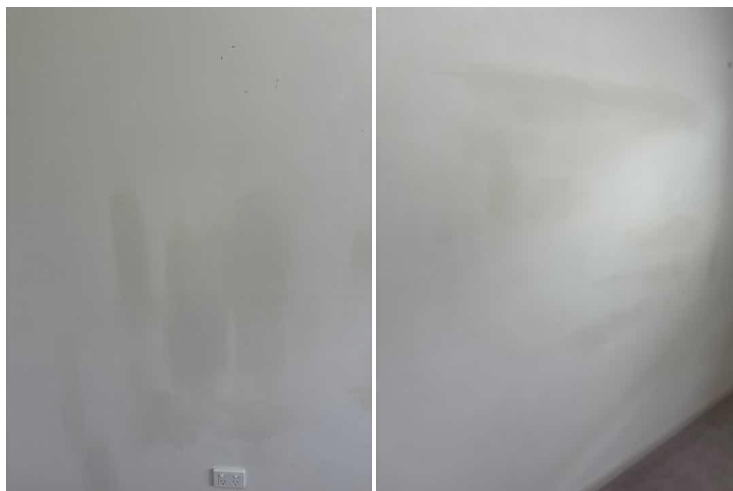
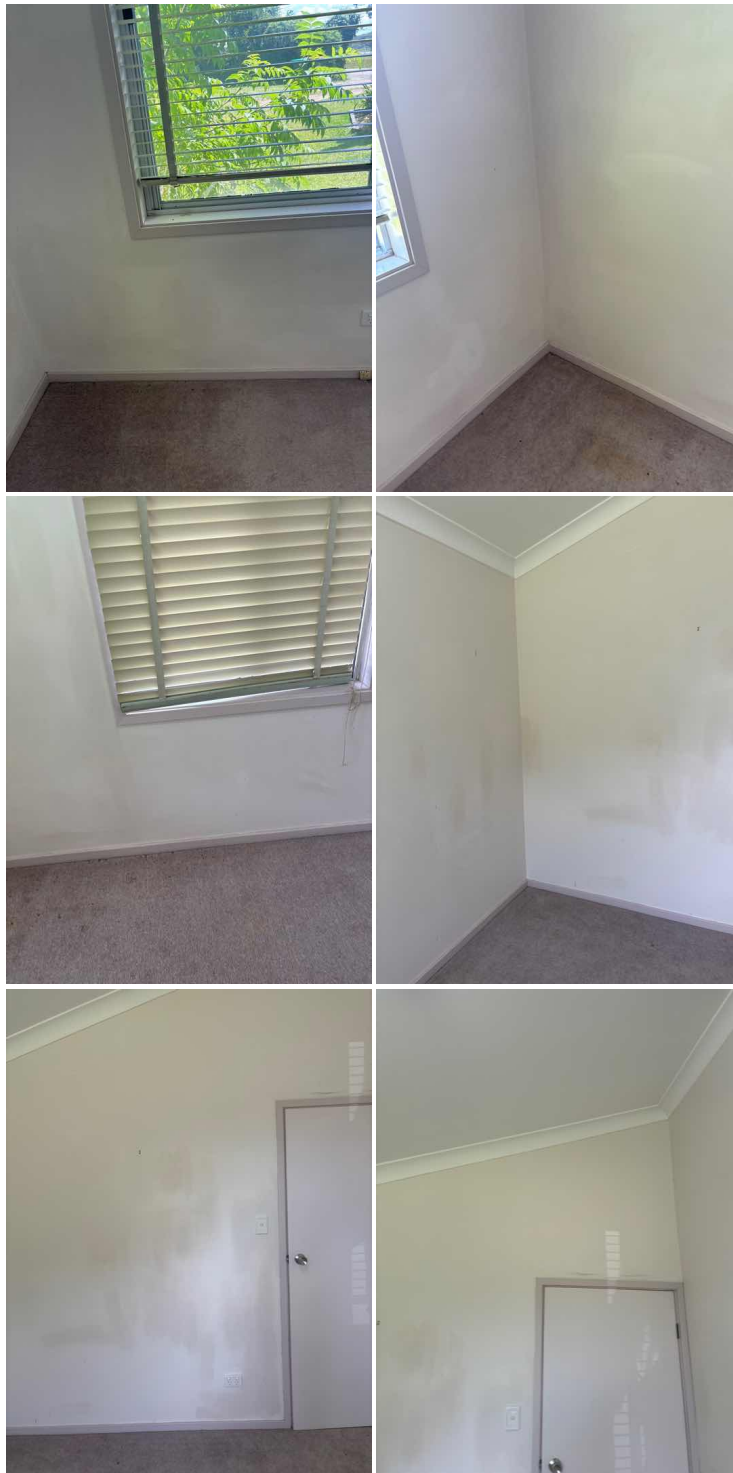
Walls

General age and wear deterioration, dings, or the like in wall linings and trims. Recommend a suitably qualified tradesperson be engaged for general maintenance and repair as necessary (e.g. patch and paint)

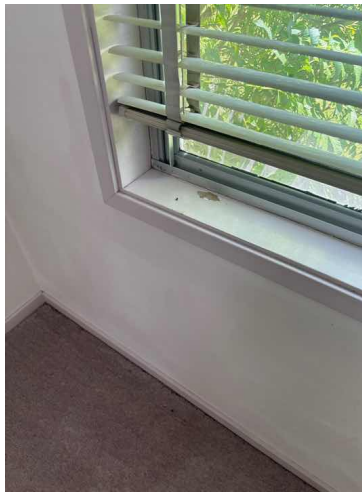
Windows

There was general wear deterioration and separation within the window architraves and separation in junctions. Recommend general maintenance repair as necessary by a suitably qualified tradesperson.

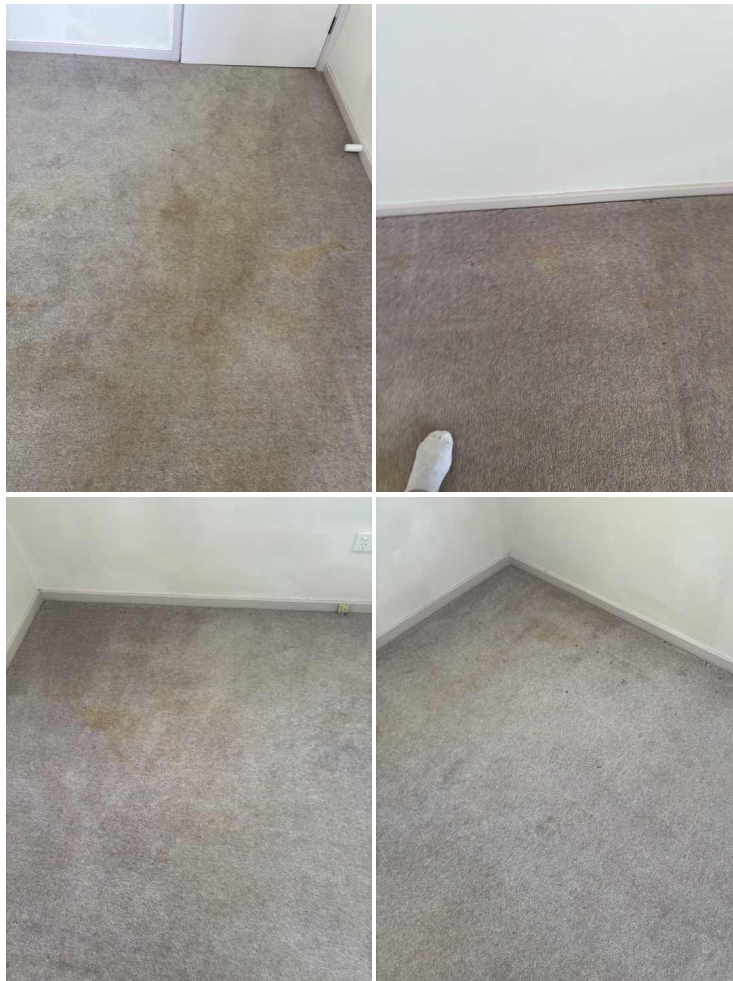
Flooring

There was deterioration in the carpet (e.g. wear, stains, pulls, discolouration). Recommend repair or replacement as necessary by a suitably qualified tradesperson.

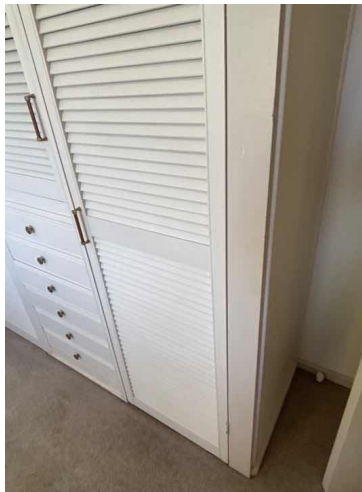
**Door/s**

The door/s, frame, trims, and finishes had some general wear (e.g. marks, scuffs, dings, and the like) but had a fair to good appearance. Recommend general maintenance and repair as necessary by a suitably qualified tradesperson (e.g. patch and paint).

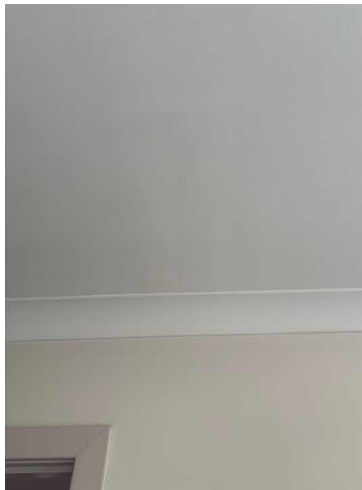
Ceiling

There was cracking in the ceiling linings, particularly along material joints. Recommend general maintenance and repair as necessary,

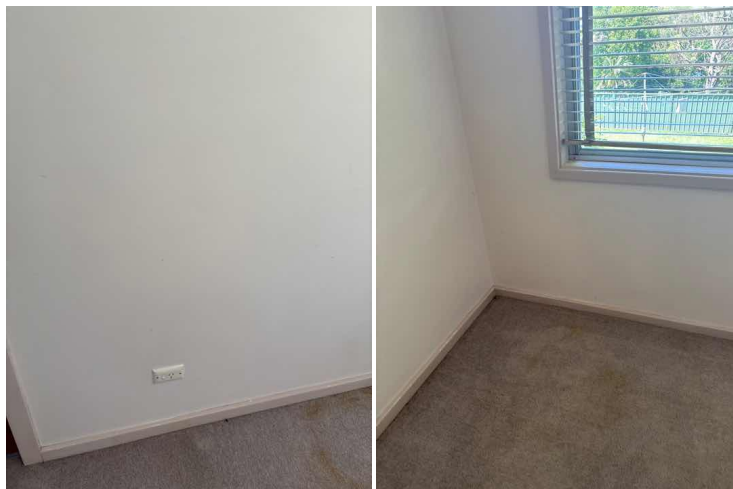
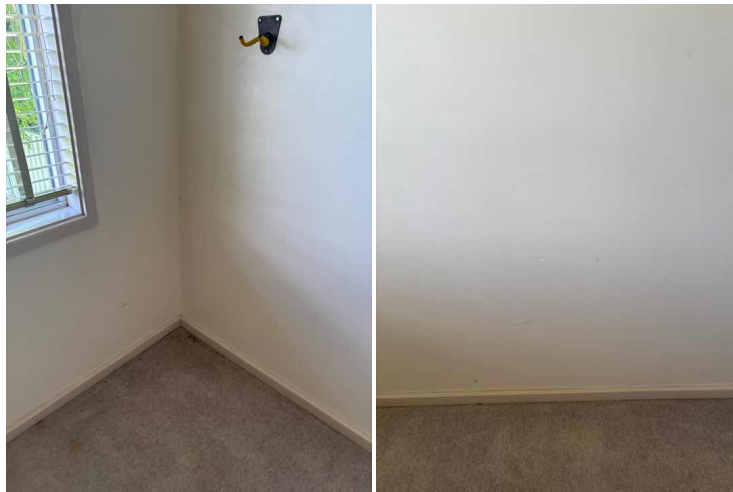
Walls

General age and wear deterioration, dings, or the like in wall linings and trims. Recommend a suitably qualified tradesperson be engaged for general maintenance and repair as necessary (e.g. patch and paint)

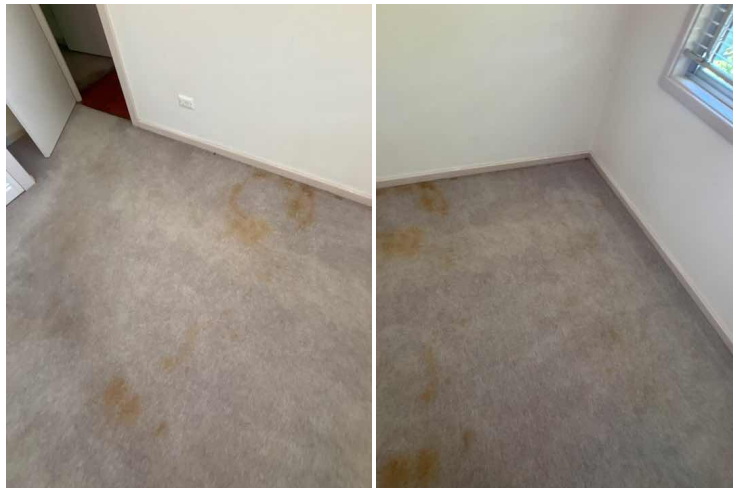
Flooring

There was deterioration in the carpet (e.g. wear, stains, pulls, discolouration). Recommend repair or replacement as necessary by a suitably qualified tradesperson.

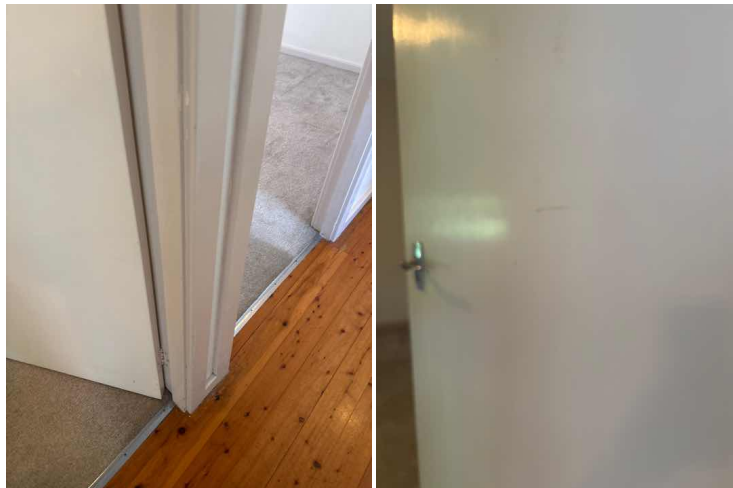
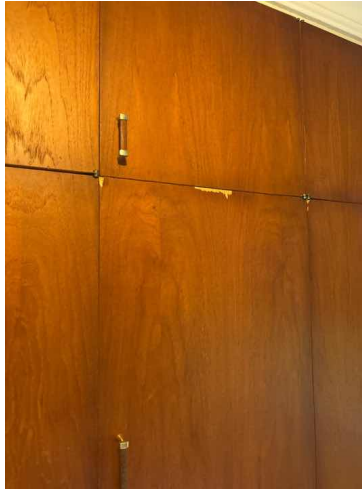
Door/s

The door/s, frame, trims, and finishes had some general wear (e.g. marks, scuffs, dings, and the like) but had a fair to good appearance. Recommend general maintenance and repair as necessary by a suitably qualified tradesperson (e.g. patch and paint).

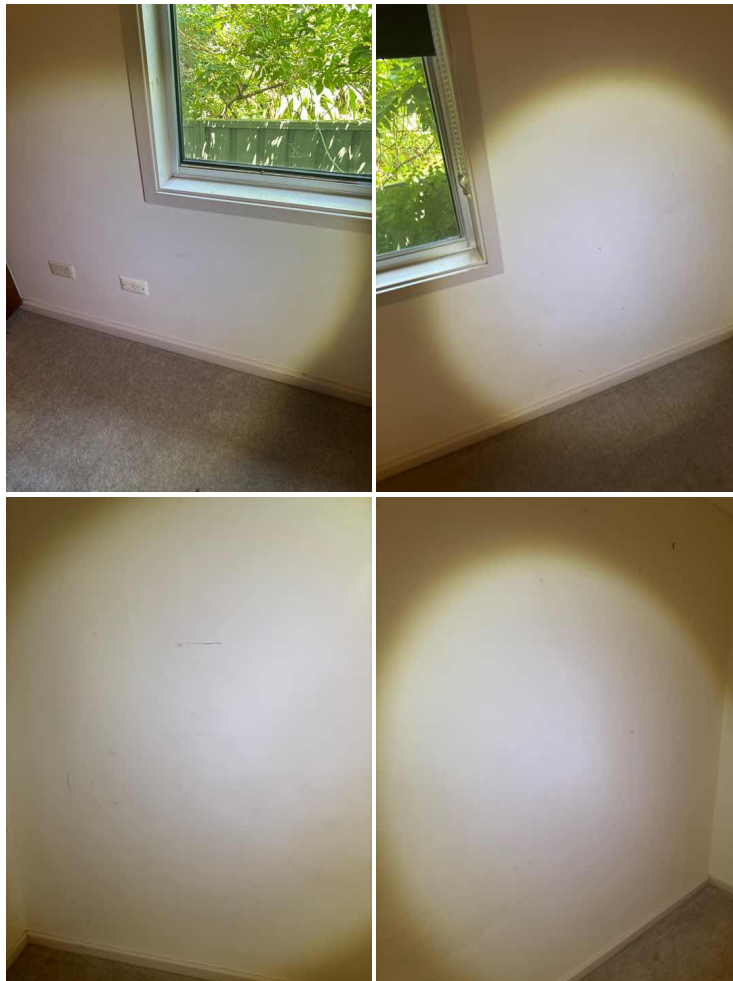
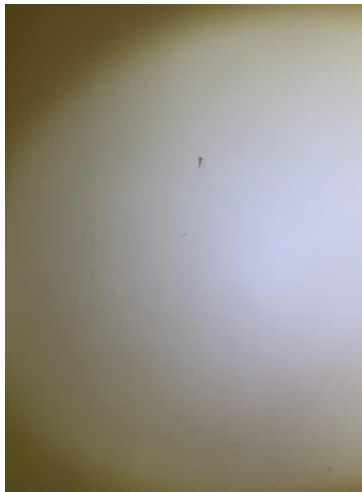
Walls

General age and wear deterioration, dings, or the like in wall linings and trims. Recommend a suitably qualified tradesperson be engaged for general maintenance and repair as necessary (e.g. patch and paint)
