Inspection Report

111 Newport Rd, Dora Creek, NSW, 2264

Inspection Date: 13 Jan 2025

Pest And Building Inspection

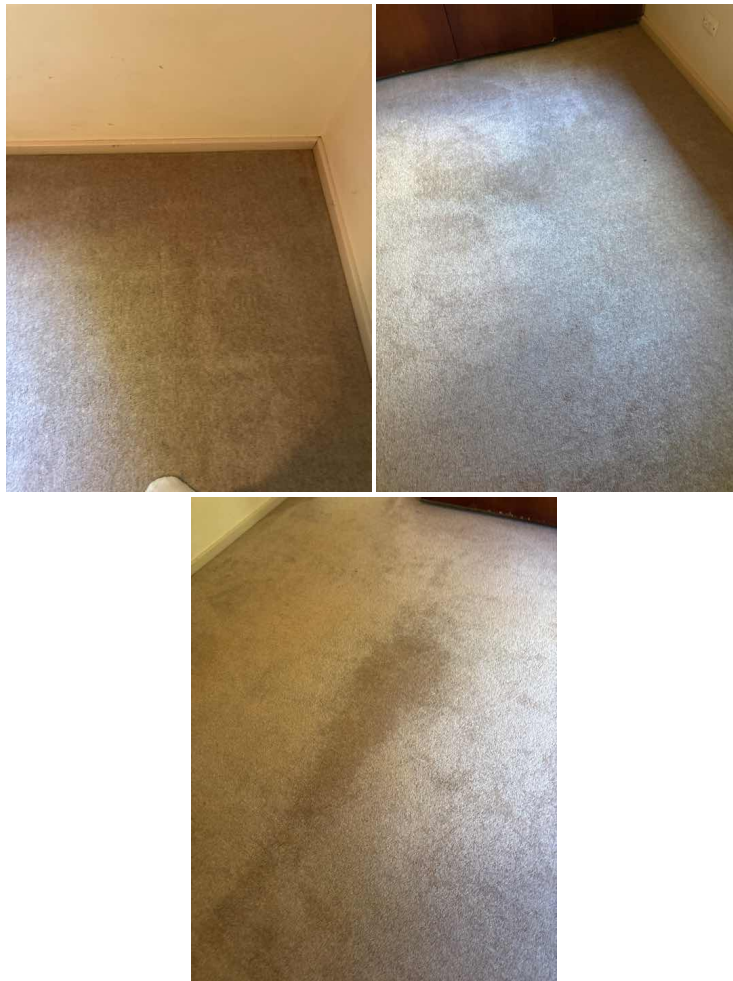
Flooring

There was deterioration in the carpet (e.g. wear, stains, pulls, discolouration). Recommend repair or replacement as necessary by a suitably qualified tradesperson.

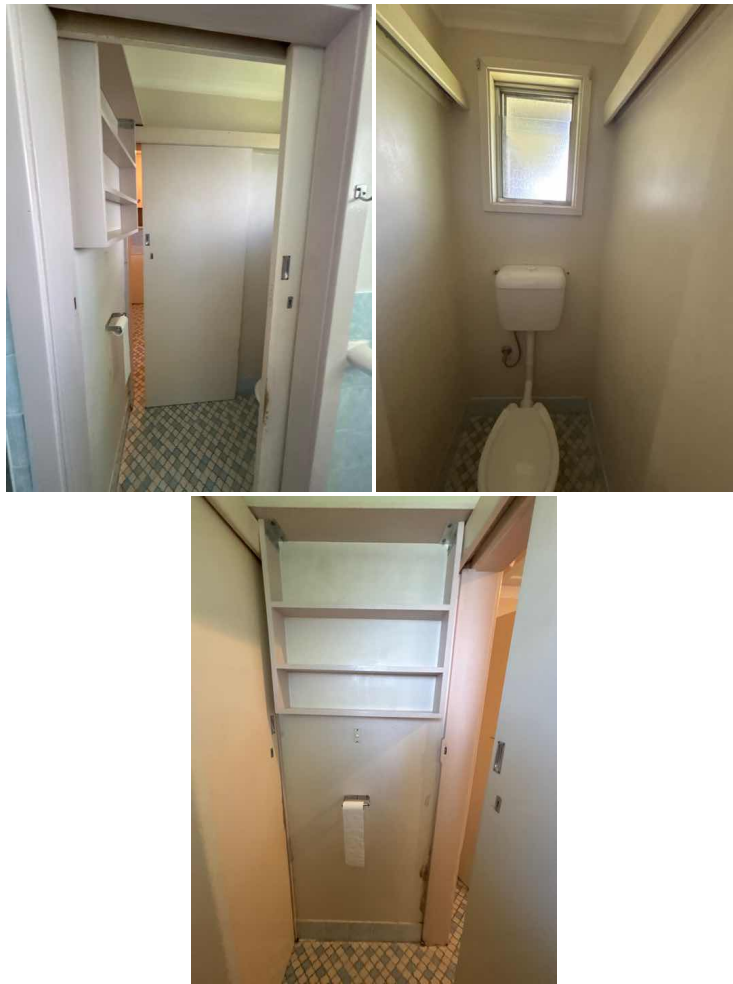
Door

The doors functioned, and the doors, frames, and trims require general maintenance and repair (e.g. patch, paint, adjustment to sliding doors) by a suitably qualified tradesperson.

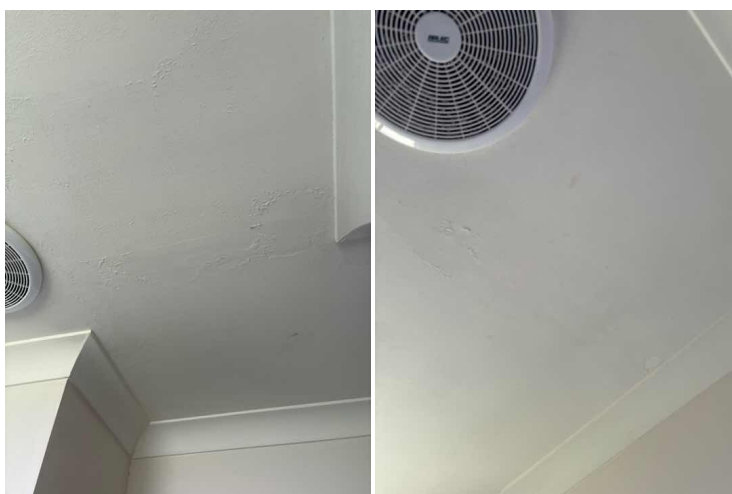
Ceiling paint flake/deterioration is evident. General maintenance / painting as required.

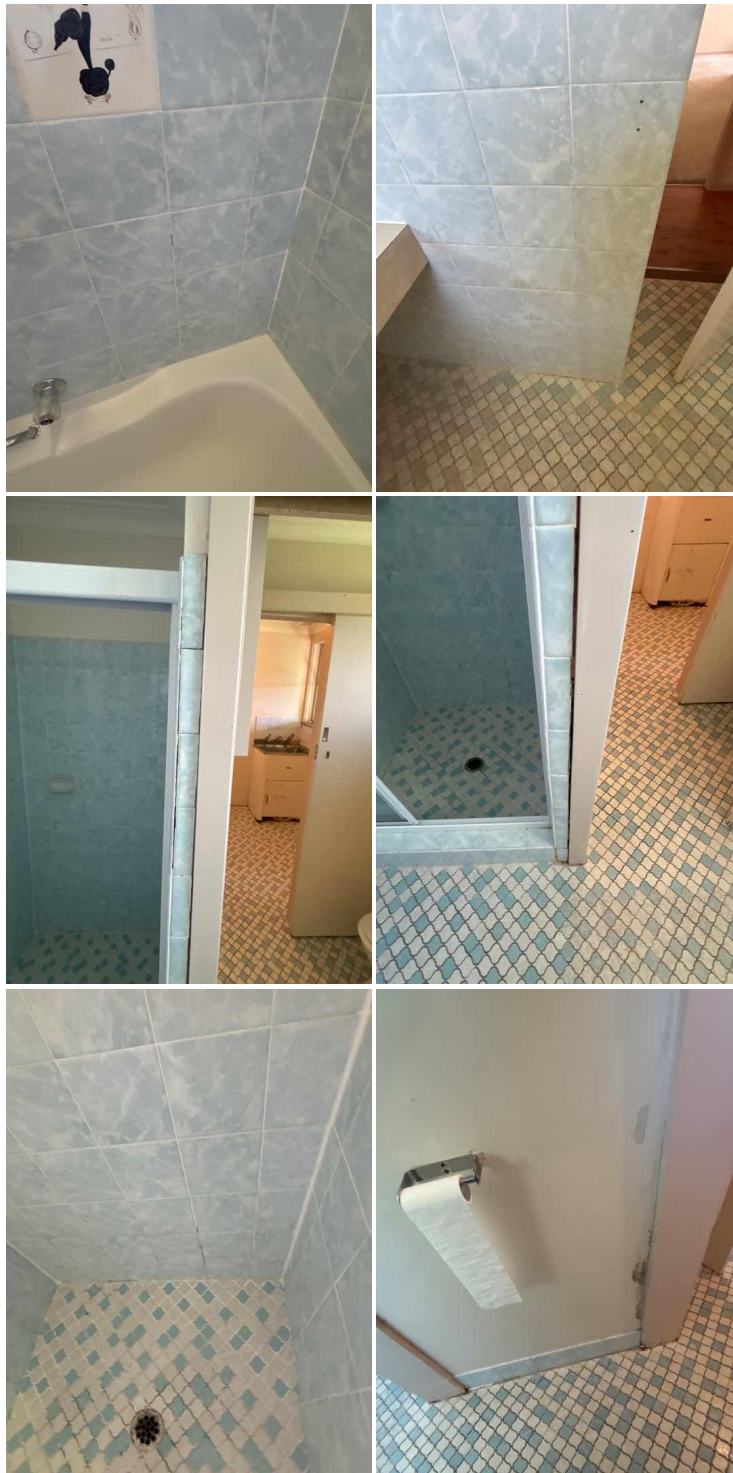
Cracked tiling was observed. A licensed tiler should be engaged for advice and recommendations.

Deteriorated/spalling grout observed. This should be repaired as this could lead to water ingress/humidity under the tiles causing uplifting and possible water penetration.

Some areas of tiling were inadequately fixed. Recommend repair as necessary by a suitably qualified tradesperson.

Bubbled paint, paint flake, deterioration was observed to some areas (particularly adjacent to the shower recess). Recommend further evaluation to ascertain the cause and repair as necessary by a suitably qualified tradesperson.

Silicone sealant has been applied to the interface of the floor and walls in the bathroom in an apparent attempt to prevent water penetration to surrounding areas. This method of repair can only be considered to be temporary. Further waterproofing may be necessary.

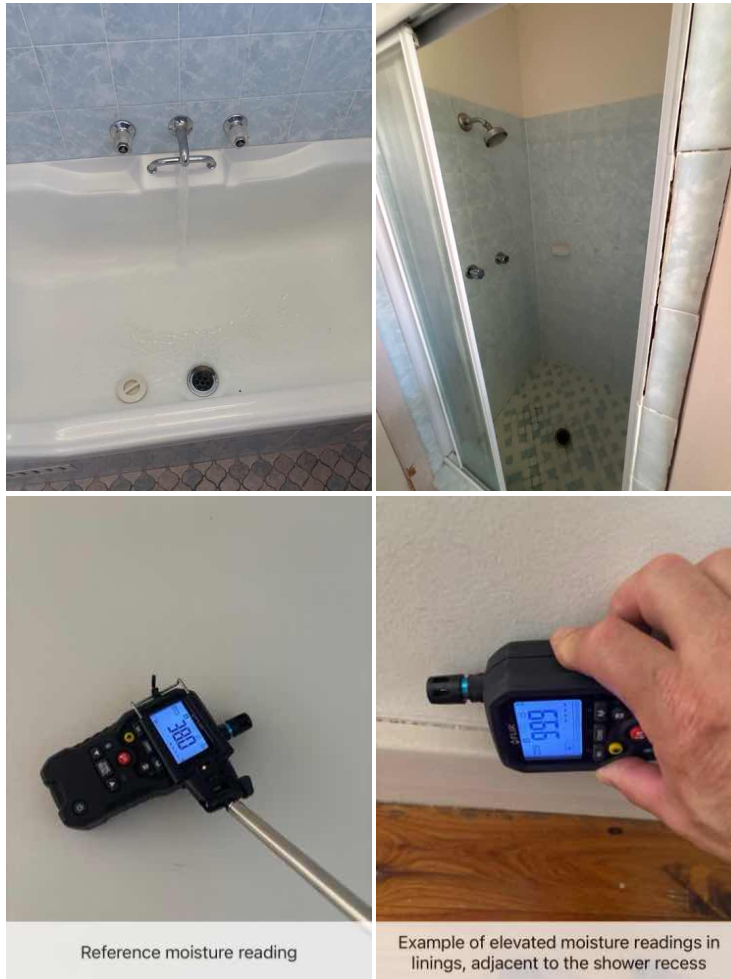
Evidence suggests the shower recess is leaking. Continued leakage may allow damage to surrounding components. Rectification will be required and the extent of works should be determined by a Licensed Builder.

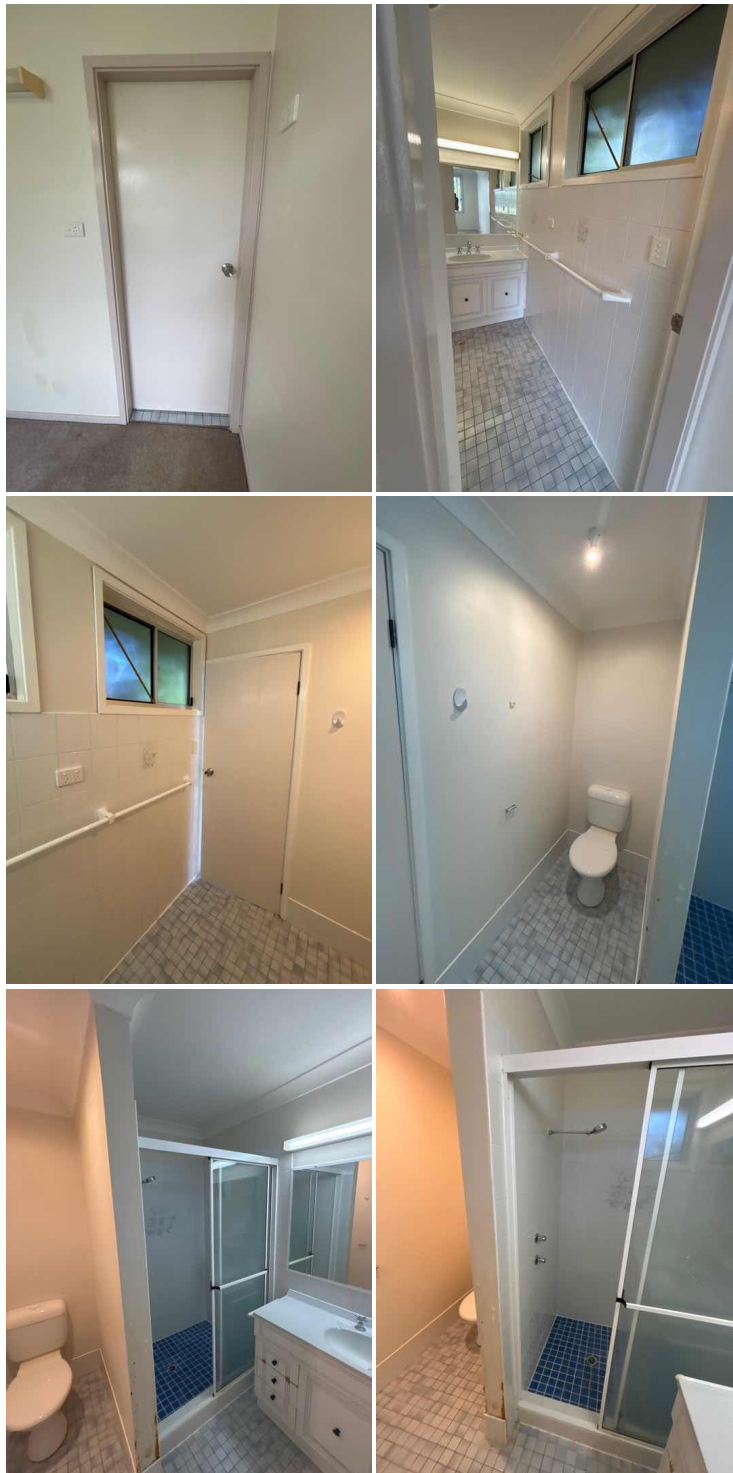
The door functioned, and the door, frame, and trims were in fair condition but require general maintenance and touch-up.

General age and wear deterioration or the like is evident on wall linings. There was also moisture damage. Recommend a suitably qualified tradesperson be engaged for general maintenance and repair as necessary (e.g. patch and paint). Note: There may be some further deterioration to timbers concealed by linings.

Settlement Cracks Noted . These are typical and generally patch and paint will suffice, however Monitoring these cracks advised for 12 months and if become wider or longer, you will need to contact a structural engineers to assess.

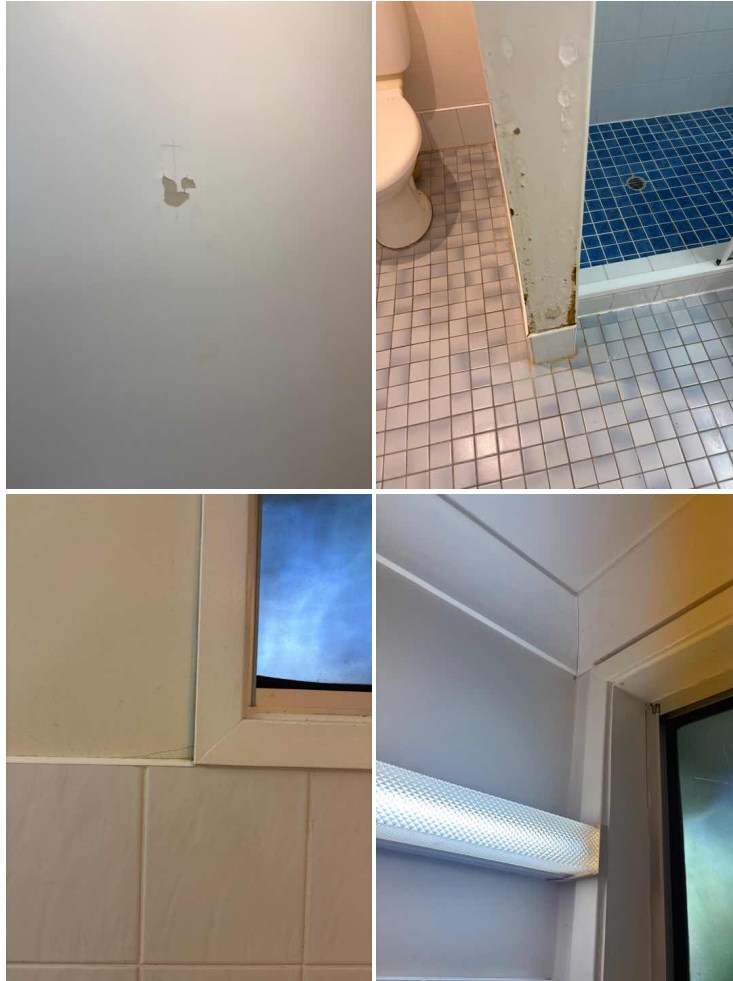
Drummy / inadequately fixed tiles observed. Contact a qualified tiler for repairs and recommendation.

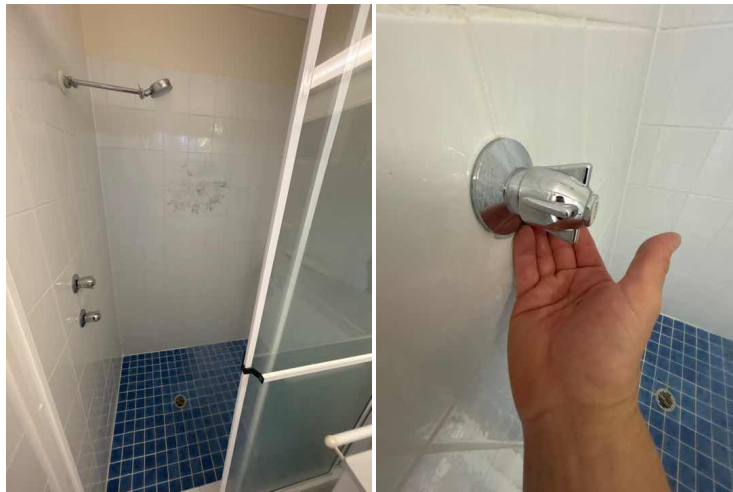
The shower tap set is leaking and will require maintenance or repair.

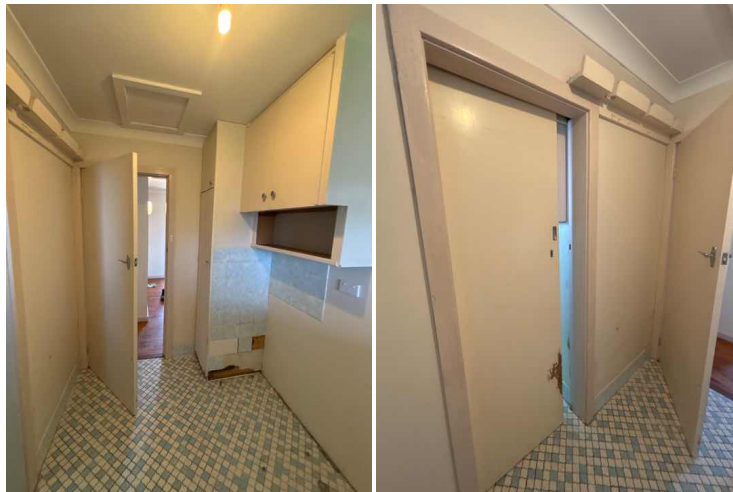
Door, frame, and trims require general maintenance and repair (e.g. patch and paint).

Binding door - Doors that bind on the frame can relate to some differential settlement, frame movement, age, expansion, shrinkage or poor hanging. A qualified carpenter should be engaged for repairs.

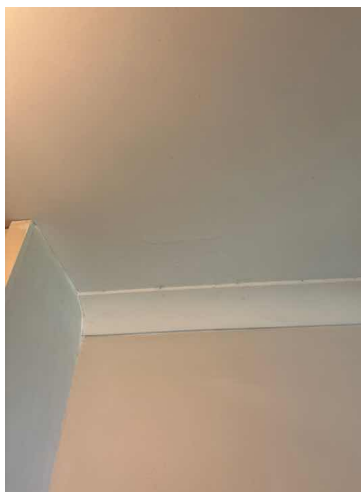
General age and wear deterioration or the like is evident on wall linings. Recommend a suitably qualified tradesperson be engaged for general maintenance and repair as necessary (e.g. patch and paint).

Cracking, spalling grout, and inadequately fixed areas observed in tiling. A licensed tiler should be engaged for advice and rectification.

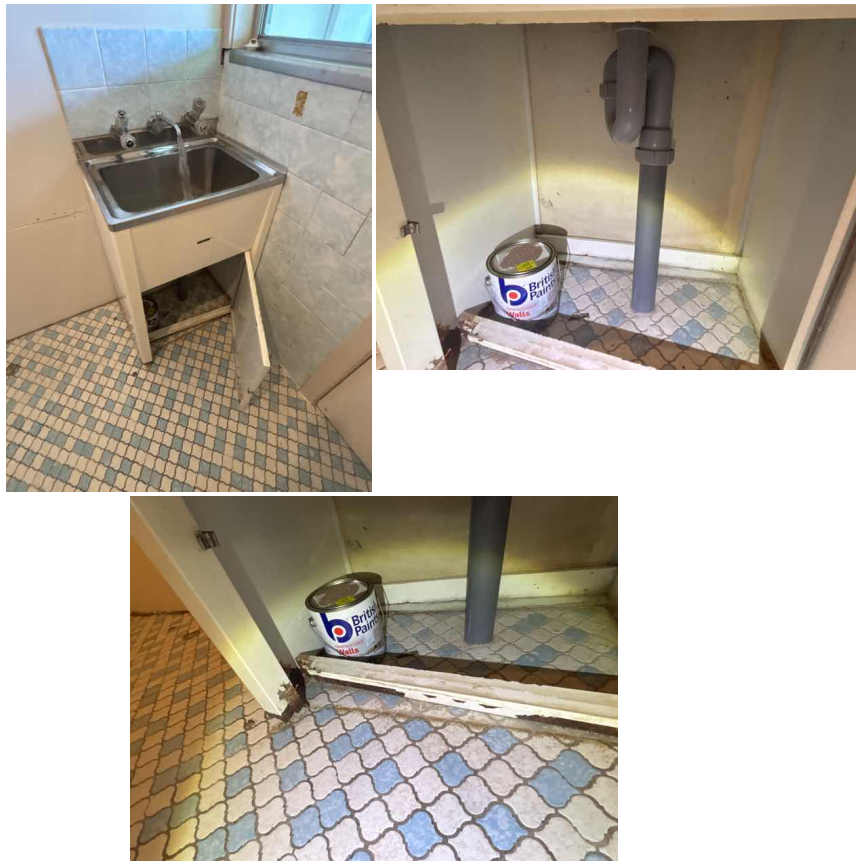
There was rust deterioration in the basin cabinet. Recommend repair or replacement as necessary by a suitable qualified tradesperson.

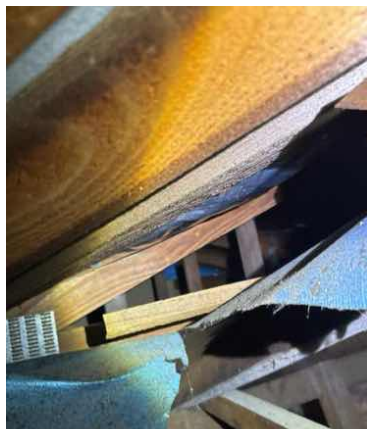
There is storage present throughout the roof void which is preventing a full/thorough visual inspection taking place. It is strongly recommended that full access be granted to enable a thorough inspection to take place as it could be harbouring timber pest activity, damage or defects.

Example of inaccessible sections, photo or the northern part

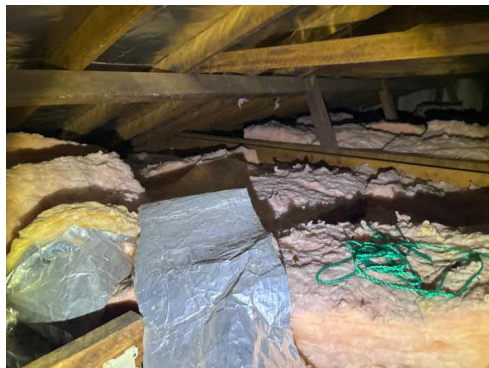
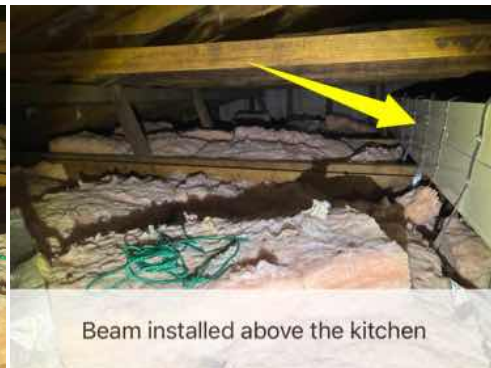
Beam installed above the kitchen

Alterations were observed (e.g. installation of the beam above the kitchen and northern extension). The northern extension was inaccessible. The beam appeared to be bearing its intended load but should be further evaluated, as it may be inadequate for the purpose. The beam had an unsupported span of approximately 6m. The beam appeared to be supporting strutting beams. This does not appear to have adversely affected the overall integrity of the roof frame thus far, however further evaluation is strongly encouraged by a suitably qualified building professional (e.g. structural engineer). Note: This has the potential to escalate.

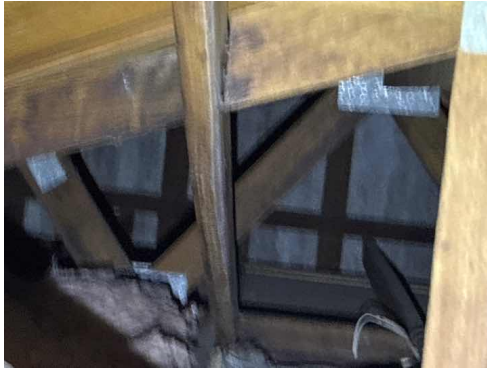
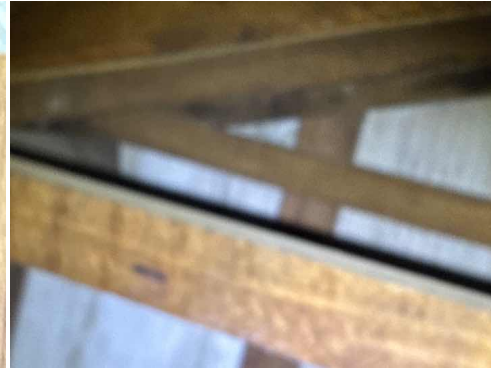
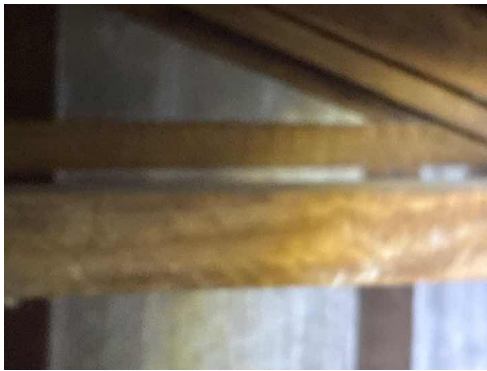
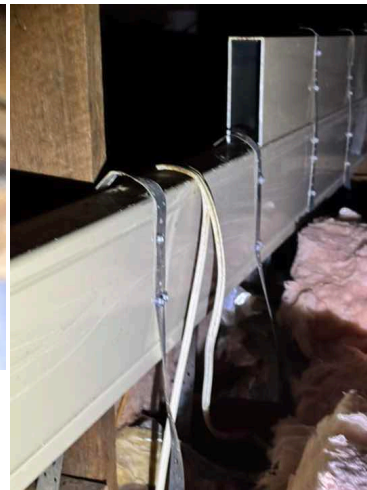
Example of evidence of leaking, photo from above the family / meals

There is evidence to suggest that there is some leakage into the roof void. In the absence of rain it is difficult to determine if this is an old leak or it's active. Monitoring during periods of rain should reveal and leaks, if leaks are active contact a qualified roofing contractor for repairs.

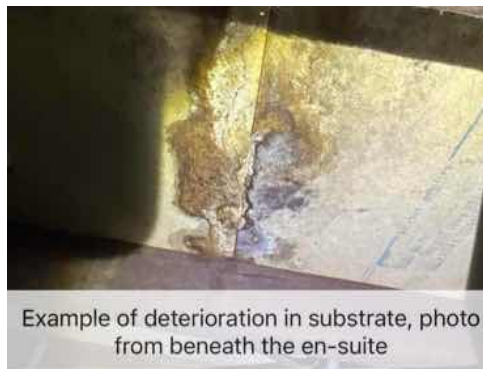
There deterioration to some localised areas of the superstructure and floorboards / substrate. The deterioration appeared to be minor/superficial. Recorded repair as necessary by a suitably qualified tradesperson.

Example of deterioration in substrate, photo from beneath the en-suite

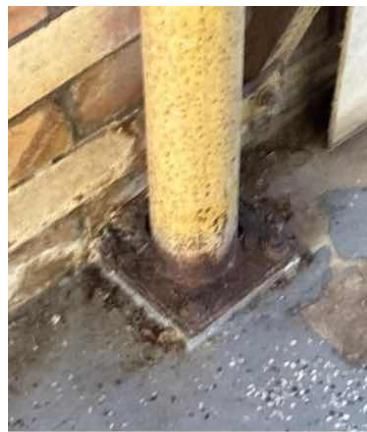
There was corrosion in some metal posts. There were also temporary / supplemental jack posts. Rectification is required to prevent further deterioration. Recommend repair as necessary by a suitably qualified tradesperson.

Example of corroded posts

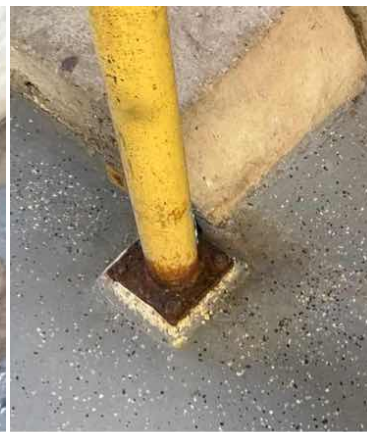
Example of corroded posts

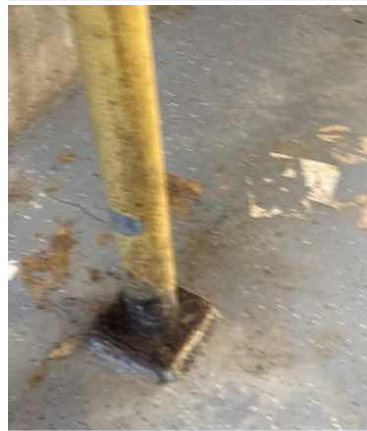
Example of corroded posts

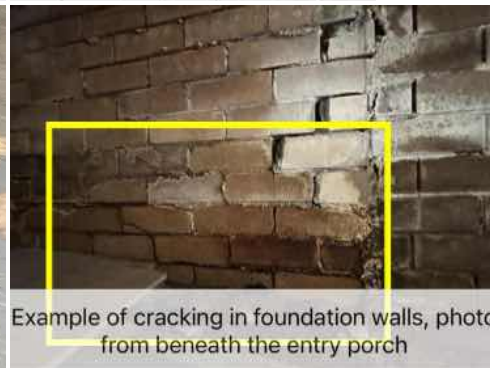
Cracking was evident to the foundation walls. Soil / footings stabilisation may be required to prevent further movement and cracking. We recommend you contact a qualified brick layer and a practicing structural engineer for recommendations and advice.

Example of cracking in foundation walls, photo from beneath the entry porch

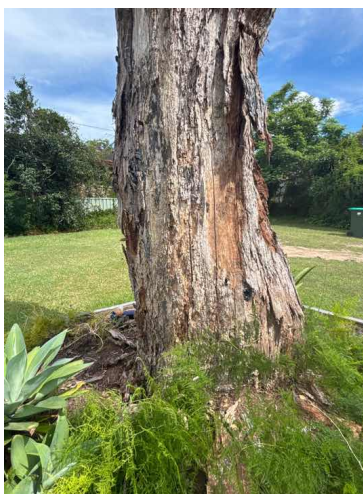
Yes, *anobium punctatum* was found, commonly known as the furniture beetle.

Moderate damage was found in trees.

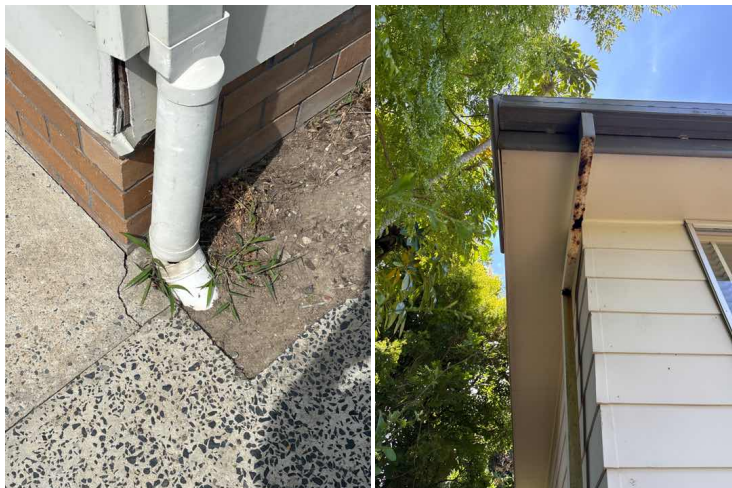
Rust to downpipes. Replacement recommended. Consult a roof plumber for a scope of works and cost of repairs for the issue prior to contracts becoming binding.

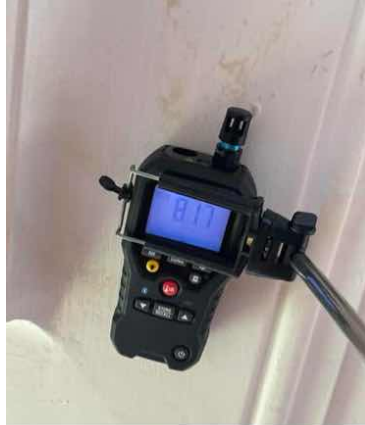
At the time of the inspection moisture readings were high.

Example of elevated moisture r readings in ceilings, photo from the family / meals

High moisture readings can be caused by any one of the following: Poor ventilation, ineffective drainage, leaking pipes, leaking roofs, defective flashing or by concealed termite activity. The areas of high moisture should be investigated by way of an invasive inspection. If high moisture was reported then you must have a building expert investigate the moisture and its cause and determine the full extent of damage and the estimated cost of repairs prior to contracts becoming binding.

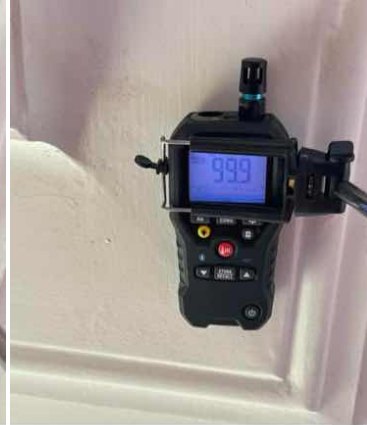
Example of elevated moisture r readings in ceilings, photo from the family / meals

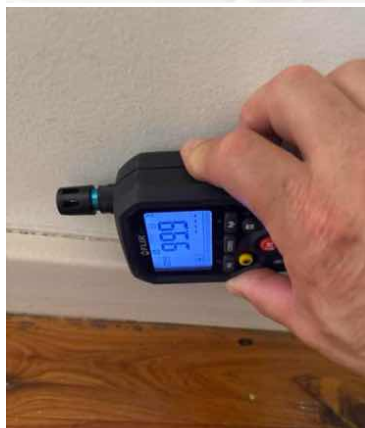
Example of elevated moisture r readings in walls, photo from the hallway near the shower

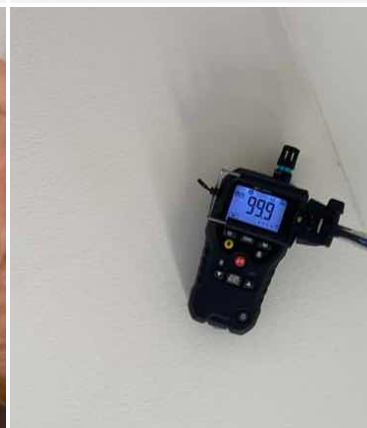
Example of elevated moisture readings in ceilings, photo from the office / study
