# Inspection Report

**Inspectrite Australia Pty Ltd**

**4 Celestial Dr, Morisset Park, 2264**

### Pest And Building Inspection

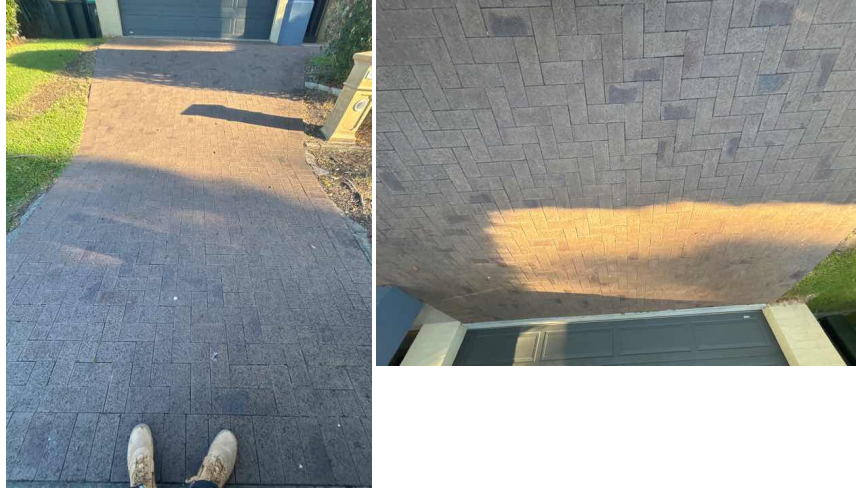
The driveway is paved.

On visual inspection, the general condition of the driveway is serviceable.

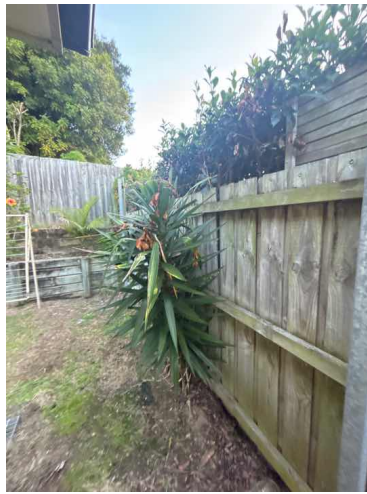
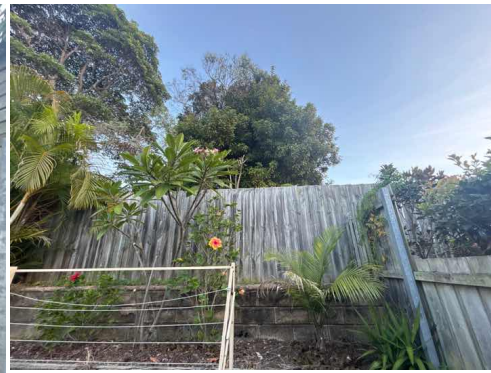
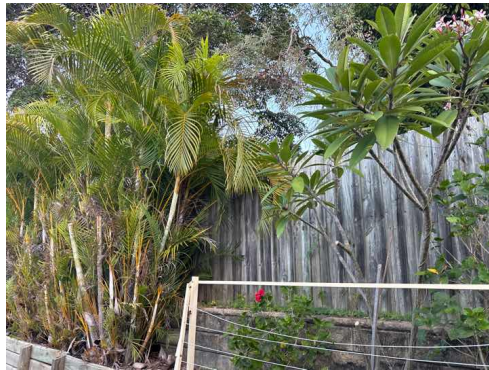
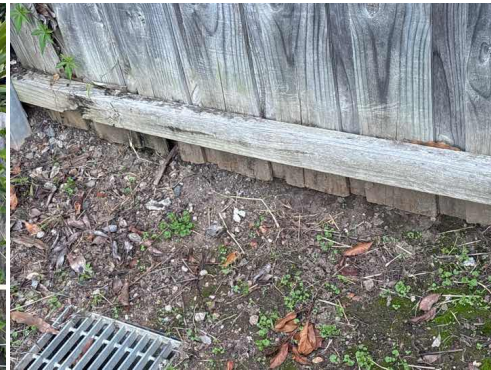
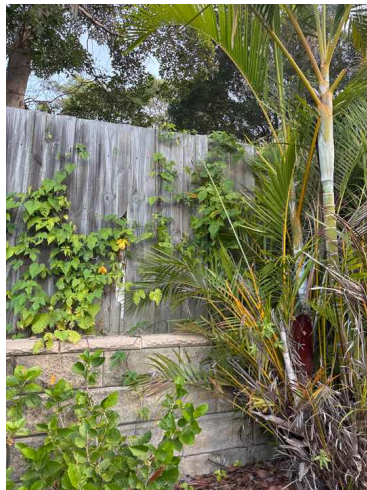
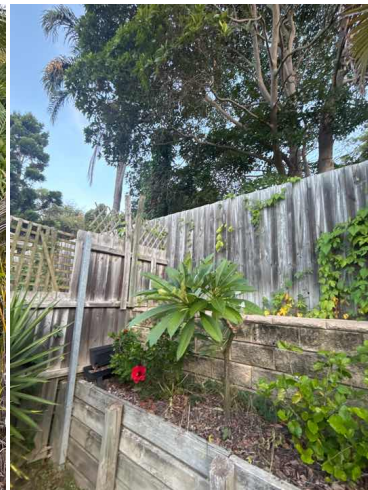
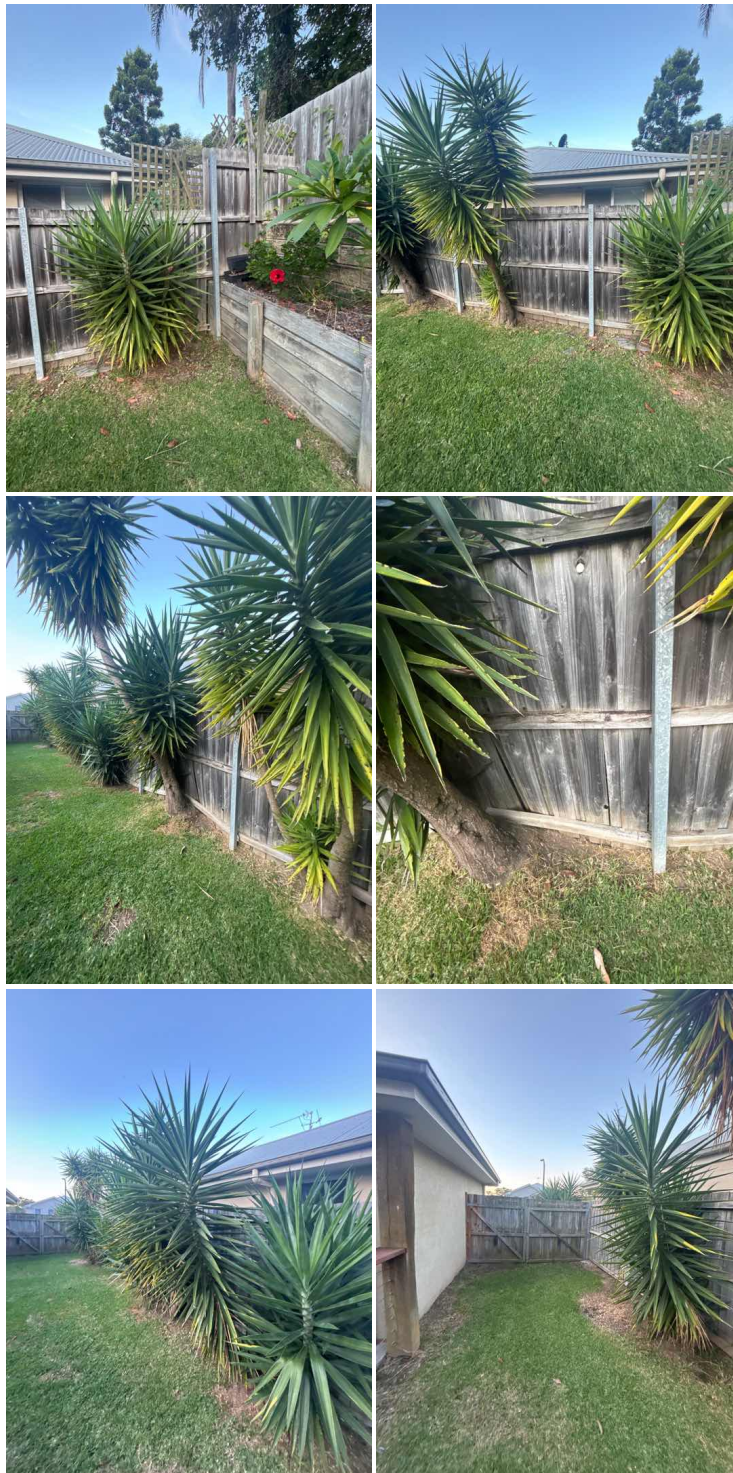
The fences and components had some general age deterioration / weathering and damage. Recommend general maintenance and repair as necessary by a suitably qualified tradesperson.

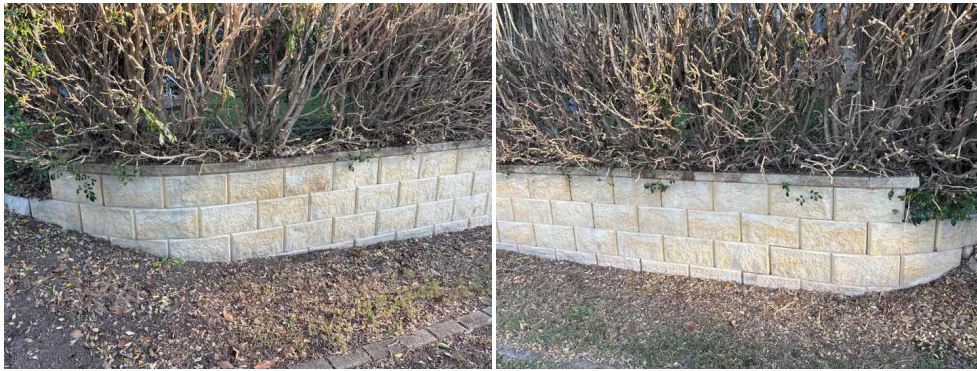
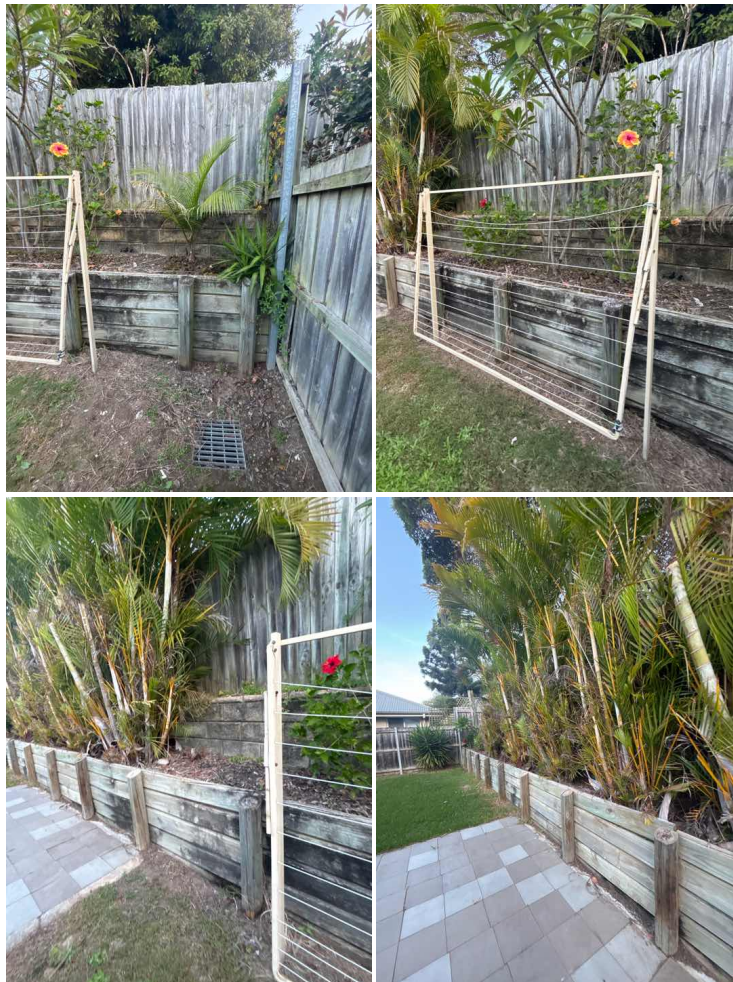
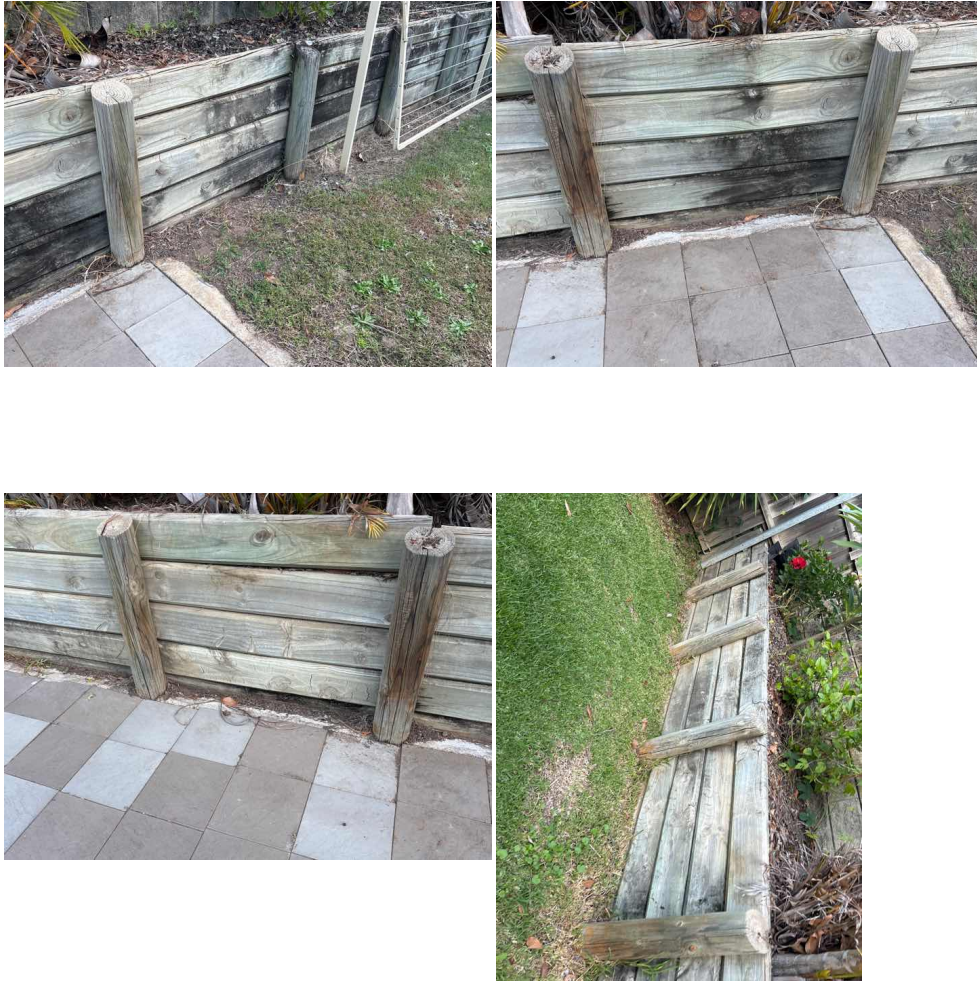
The retaining all is a concrete block construction.

The retaining wall material is wood / timber.

Of the visible areas, the general condition is serviceable or in reasonable condition for age of dwelling.

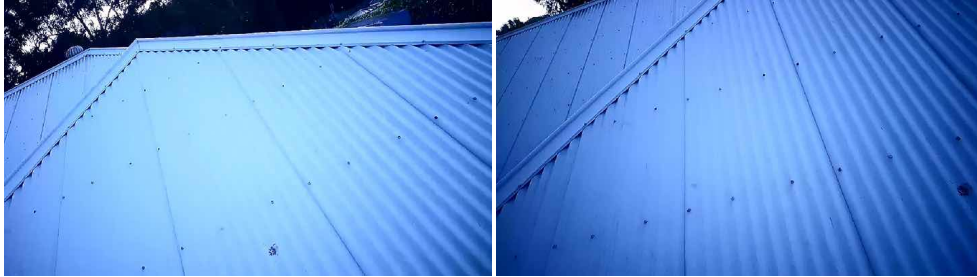
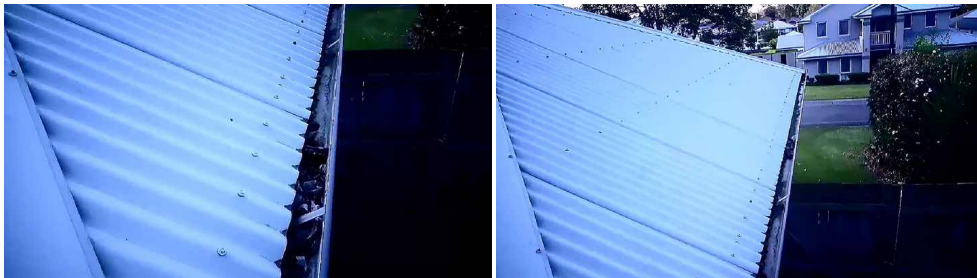
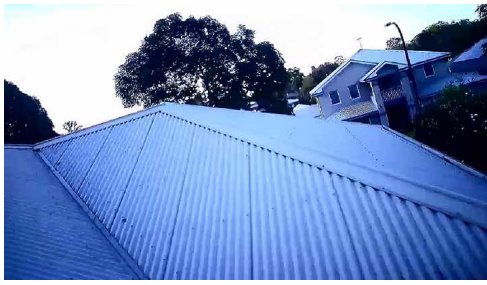
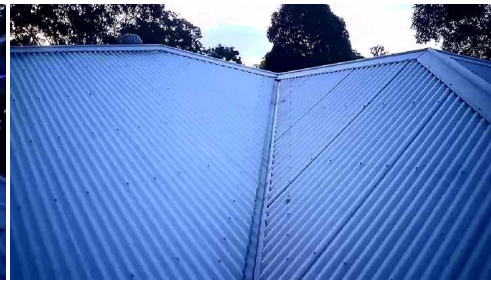
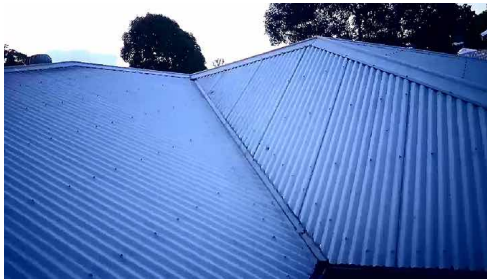
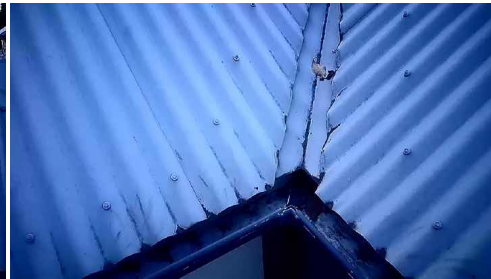
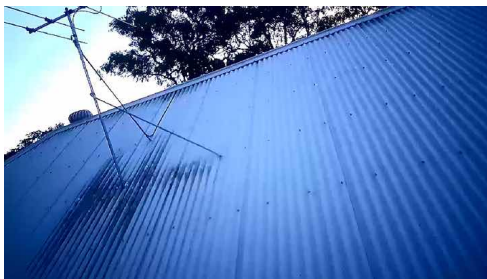
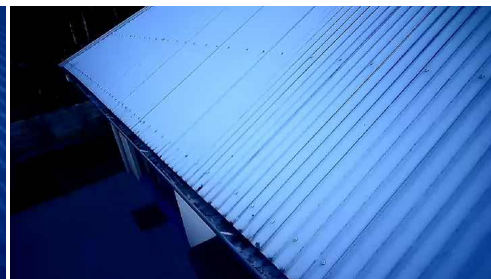
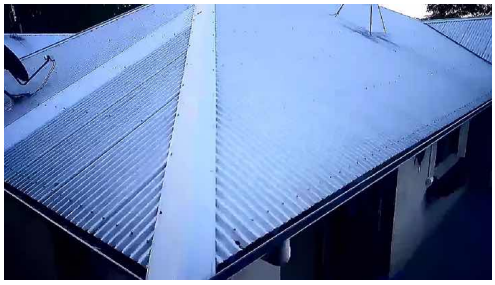
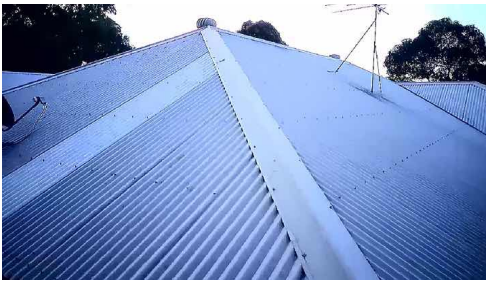
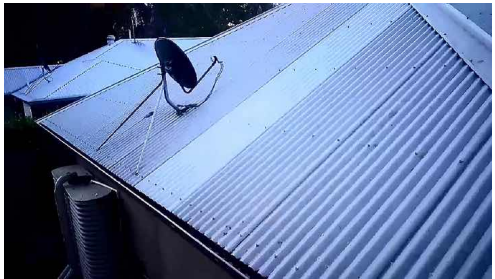
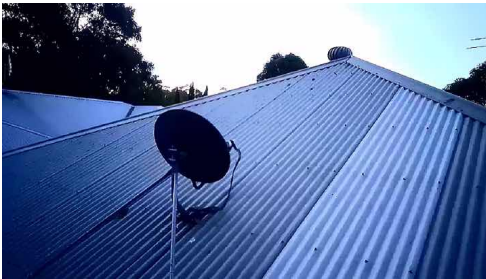
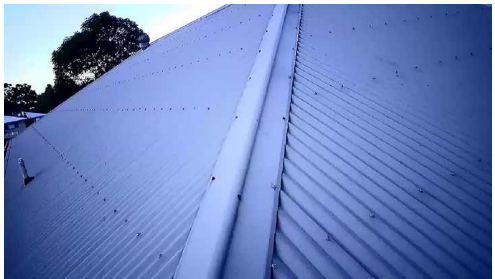
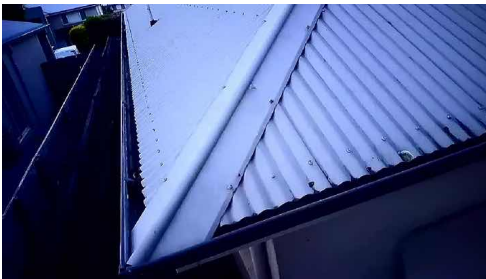
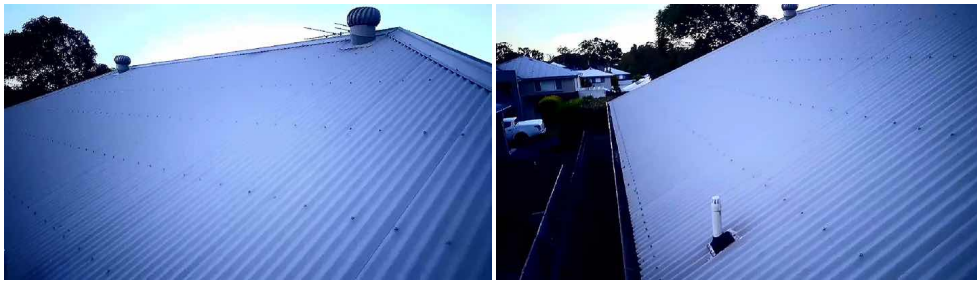
The roof cladding was in generally fair condition, however there were some observations.

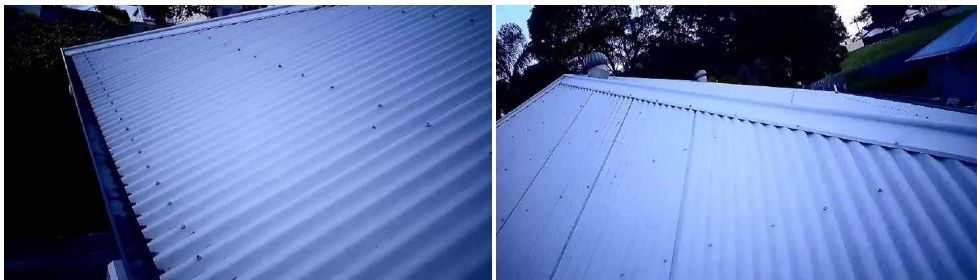
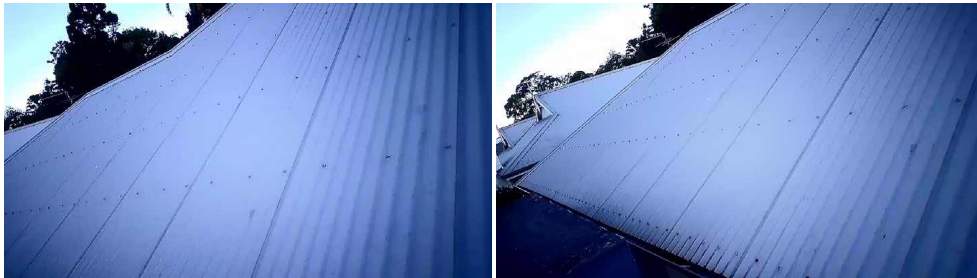
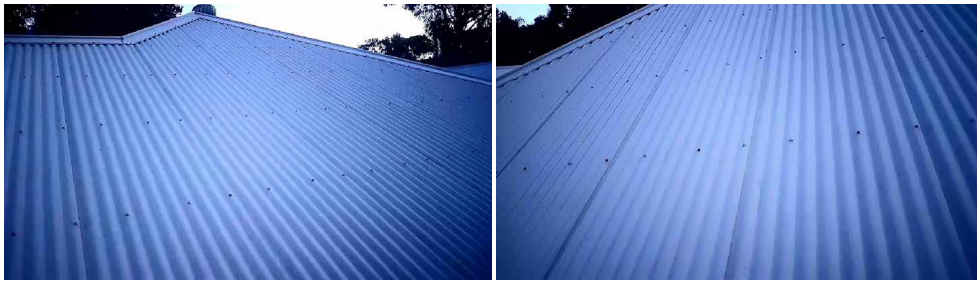
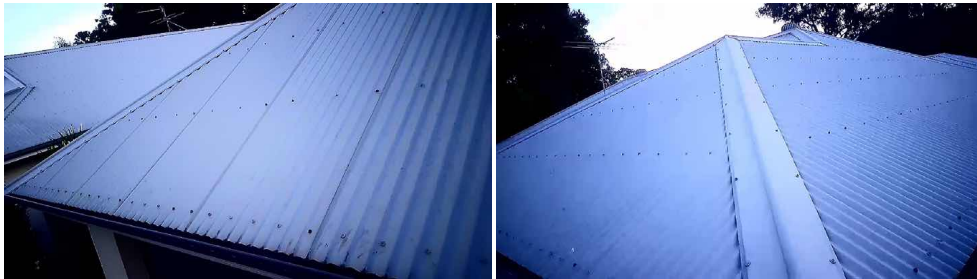
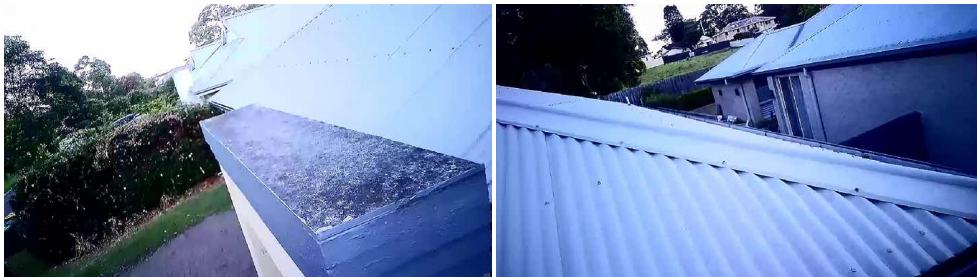
Additional photos.

The roof covering had some repairs (e.g. roof sheets replaced). This was observed particularly above the family meals.

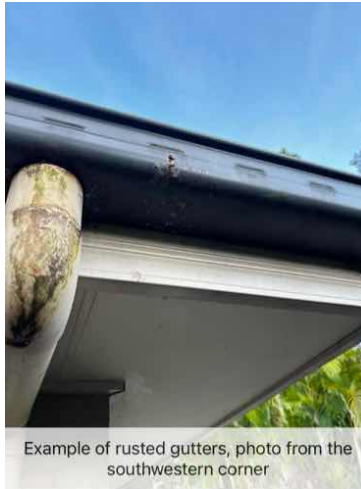
There is evidence of leaking gutters / gutter joins. Contact a roof plumber for advice and repairs.

Guttering has rust (e.g. penetrating in areas) and leaking as a result. The gutters require repair or replacement by a licensed plumber. This can result in excessive water along the perimeter of the building.

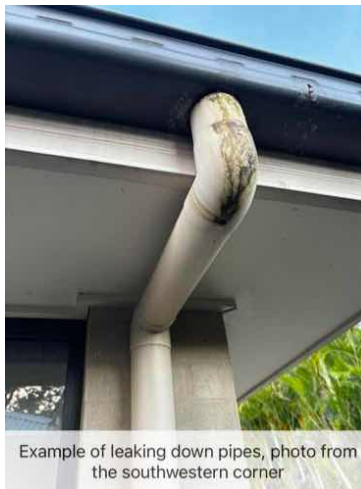
Evidence of leaking from down pipe joins observed. This can be conducive to termite infestation and cause water damage to cladding over time. A licensed plumber should be engaged to repair.

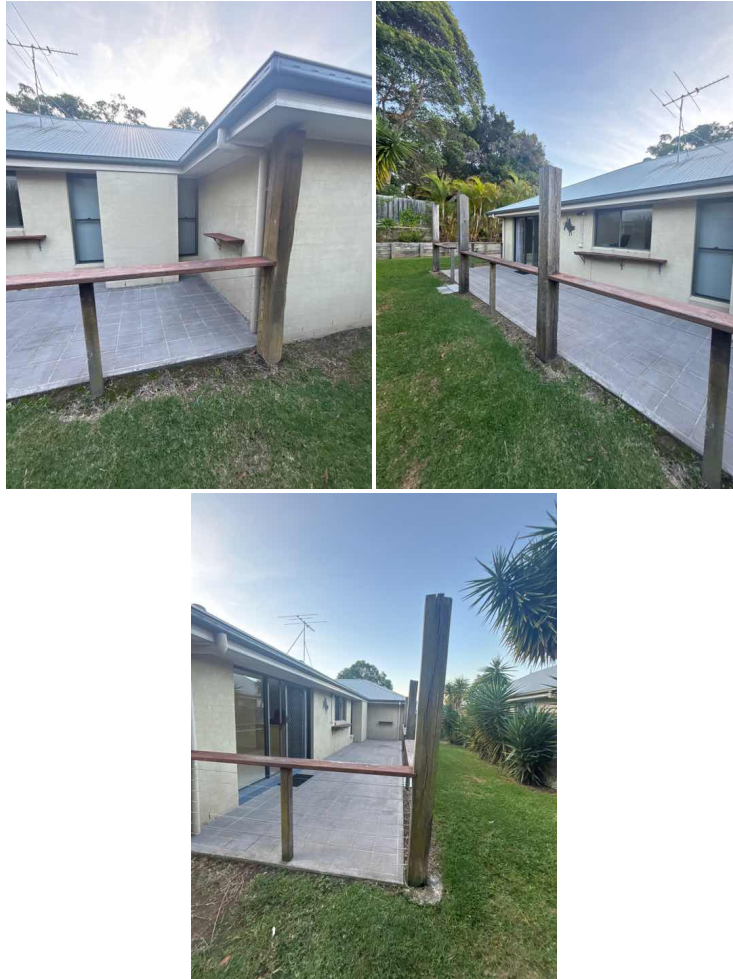
The alfresco area had a generally fair appearance, however there were some observations. Please refer to the following statements.

Post and balustrades had timber fungal decay. Recommend repair as necessary by a suitably qualified tradesperson. It is preferable to keep posts out of contact with ground soil due to decay and also being conducive to timber pest infestation.

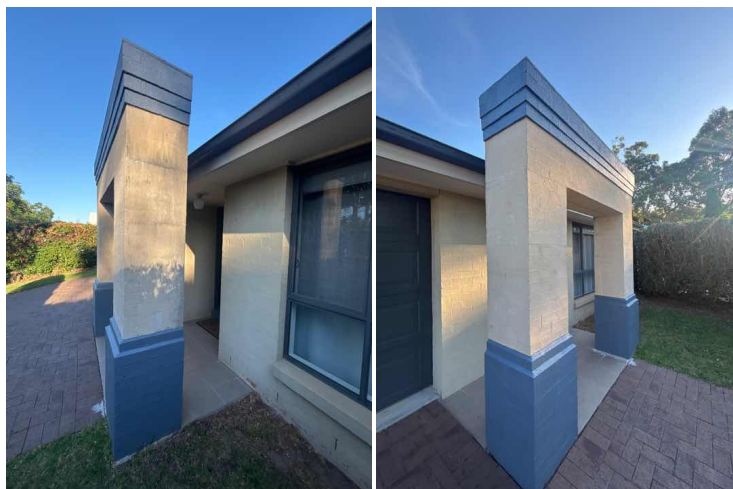
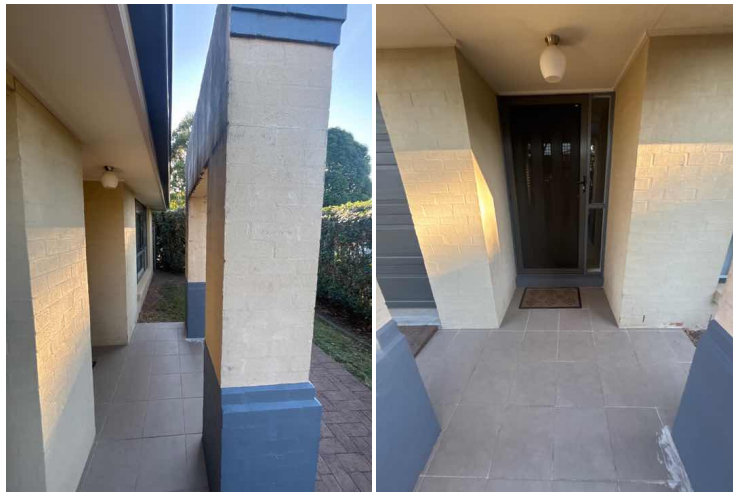
The entry porch / portico area had a generally fair appearance, however there were some observations. Please refer to the following statements.

There was deterioration, staining, and bubbling in the render / bagged finish of the columns and facade. The issue appeared generally superficial, however monitoring is strongly encouraged and there may be some further issues to the masonry beneath the finish. Recommend repairs necessary by a suitably qualified tradesperson.

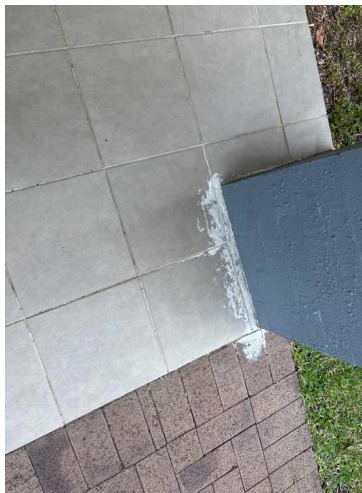
Floor tiling requires cleaning.

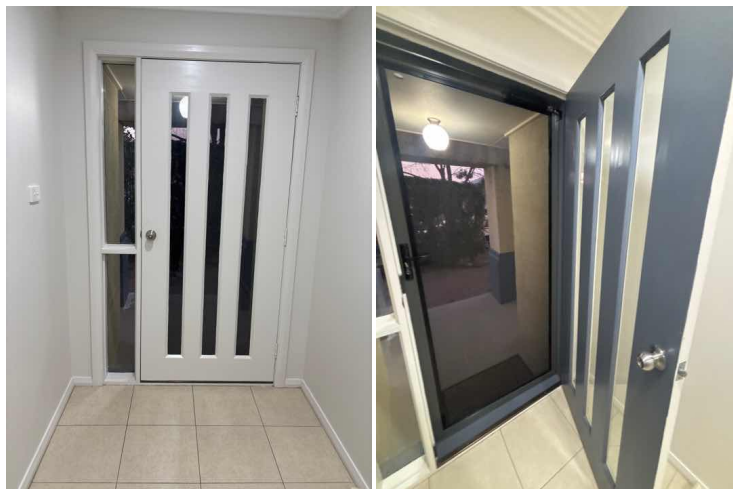
The door appeared to be in generally fair condition.

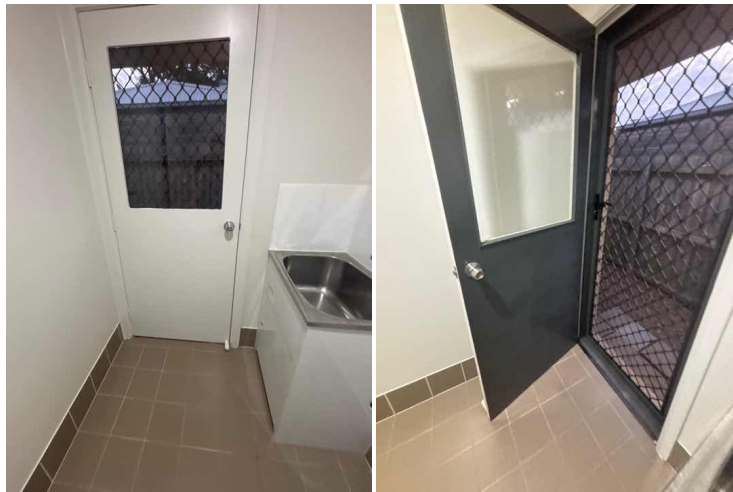
The door appeared to be in generally fair condition.

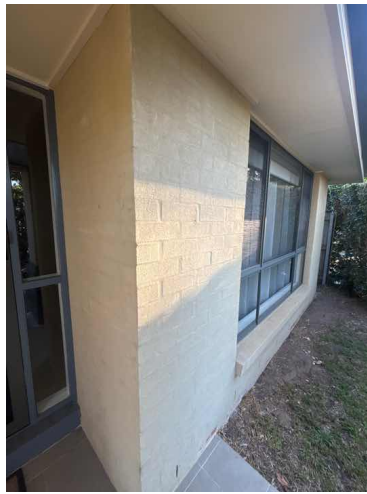
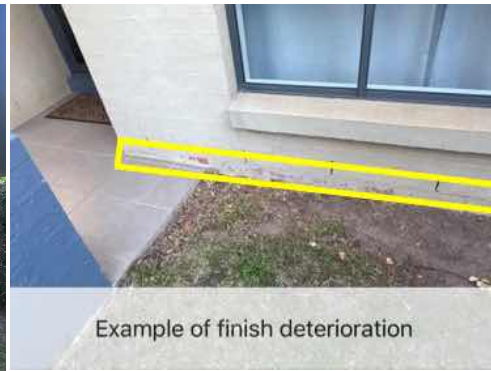
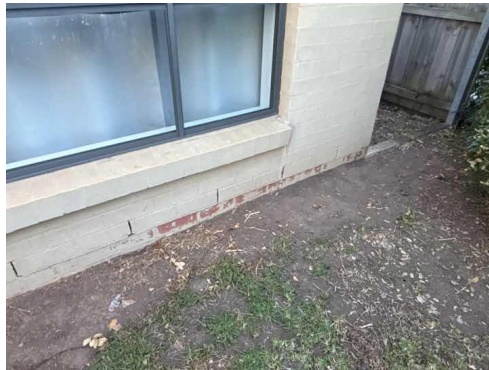
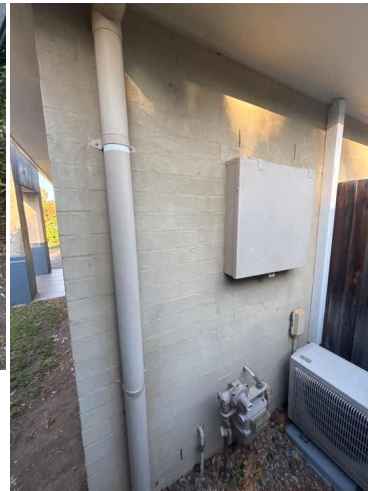
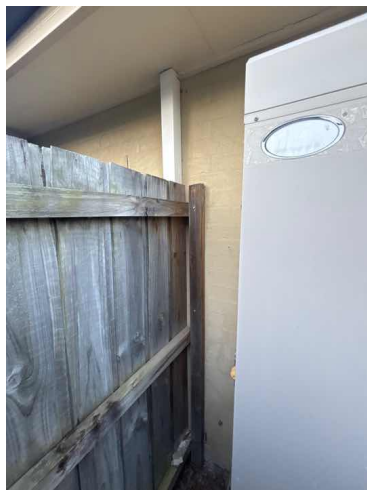
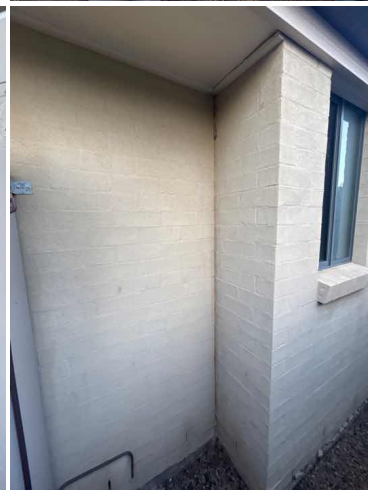
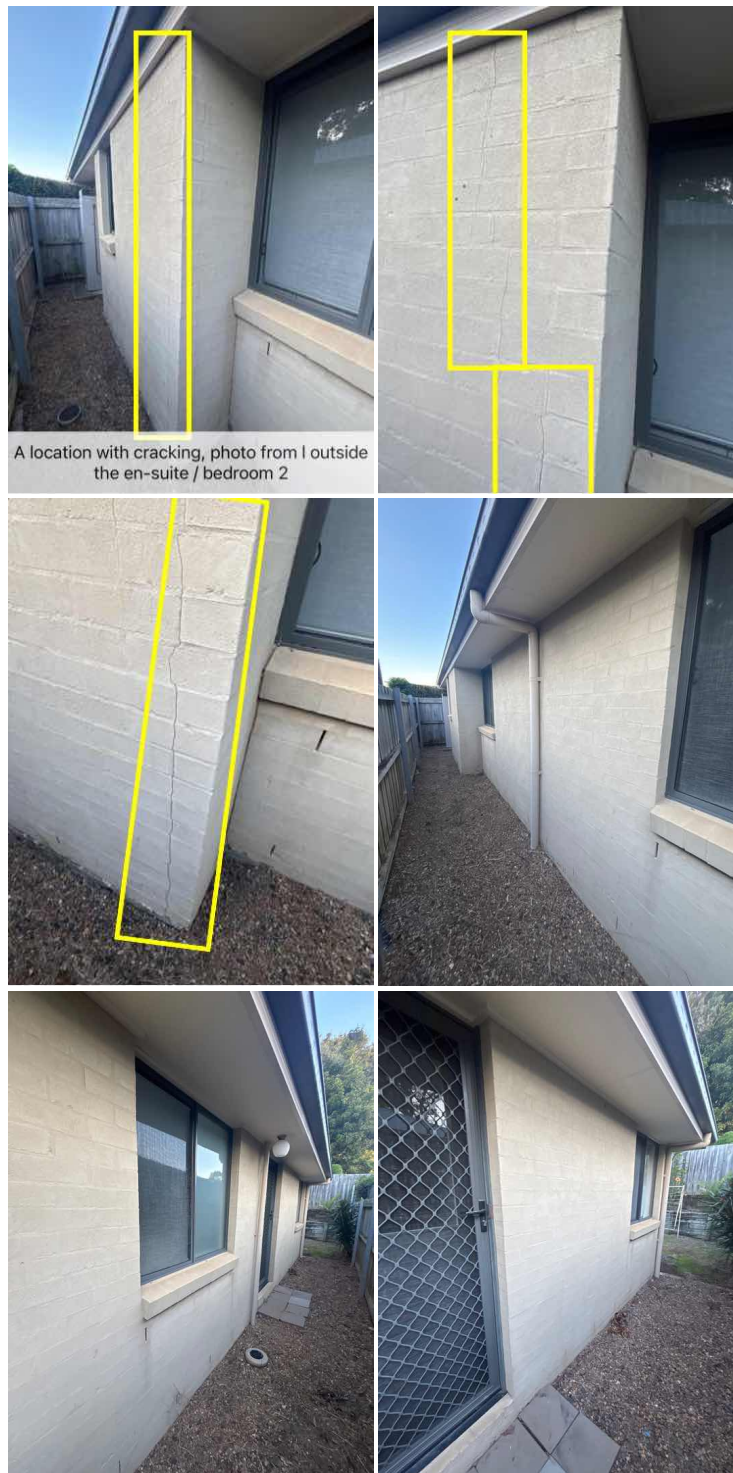
The walls were in generally fair condition overall. However, some general maintenance and repair is required by a suitably qualified tradesperson (e.g. patch render / bagging, paint touch ups). This was observed particularly beneath the damp proof course along the perimeter of the building.

Some penetrations in the external walls were inadequately sealed. Recommend repair as necessary by a suitably qualified tradesperson.

There was minor cracking to the external walls of the building (e.g. western side). The cracking measured was less than 3mm in width). The cracking may be attributed to issues such as but not limited to: settlement or expansion and contraction (likely considering the cracking was quite vertical and on a corner to a wall projection with no expansion / movement joint). Recommend monitoring and if further issues are observed contact a practicing consulting engineer for advice and recommendations.

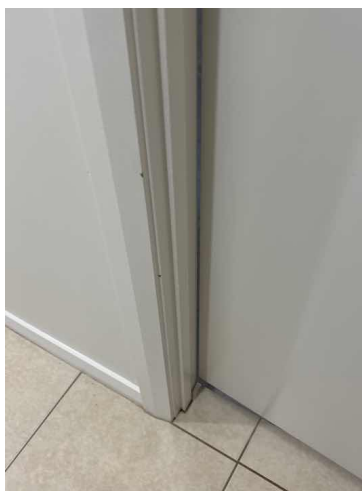
The internal access door, frame, and trims requires general maintenance or repair. (e.g. patch and paint). Recommend repair as necessary by a suitably qualified tradesperson.

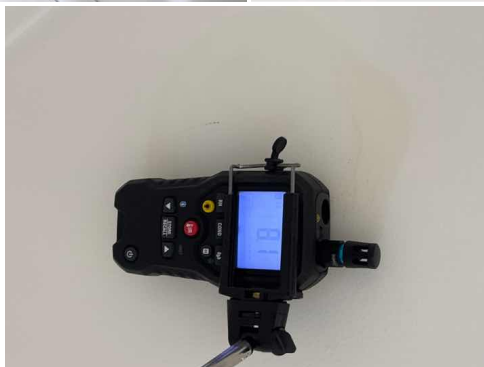
General age and wear deterioration (e.g. dings, marks, scuffs, and the like) in ceiling linings and cornices. Recommend a suitably qualified tradesperson be engaged for general maintenance and repair as necessary (e.g. patch and paint).

There was evidence of leaking from the roof. The areas were tested with electronic impedance moisture testing equipment and / or thermal imaging and found to be dry (consistent with other areas / linings) at the time of inspection. Recommend repair as necessary to deteriorated damaged materials by a suitably qualified tradesperson and monitoring for further issues.

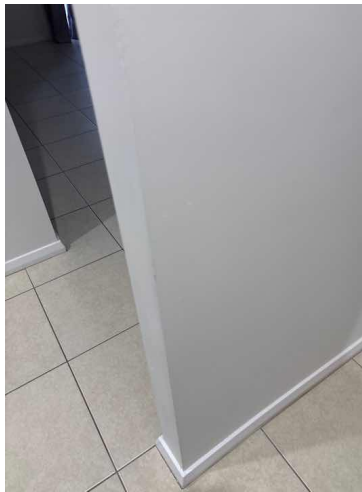
General age and wear deterioration, dings, or the like in wall linings and trims. Recommend a suitably qualified tradesperson be engaged for general maintenance and repair as necessary (e.g. patch and paint)

The wall linings had evidence of patches and minor repairs.

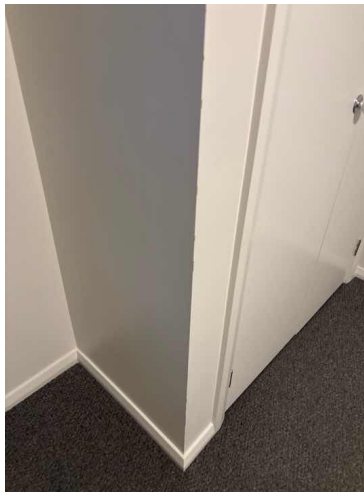
General age and wear deterioration, dings, or the like in wall linings and trims. Recommend a suitably qualified tradesperson be engaged for general maintenance and repair as necessary (e.g. patch and paint)

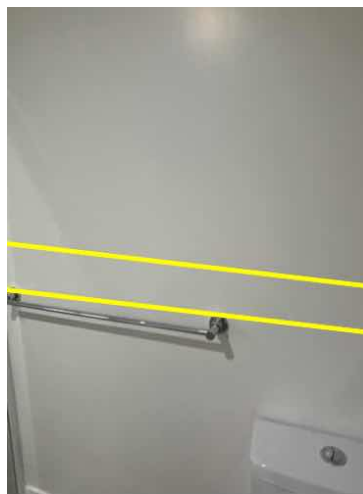
There was cracking (early stage) in the linings, predominately along material joints. Recommend repair as necessary by a suitably qualified tradesperson.

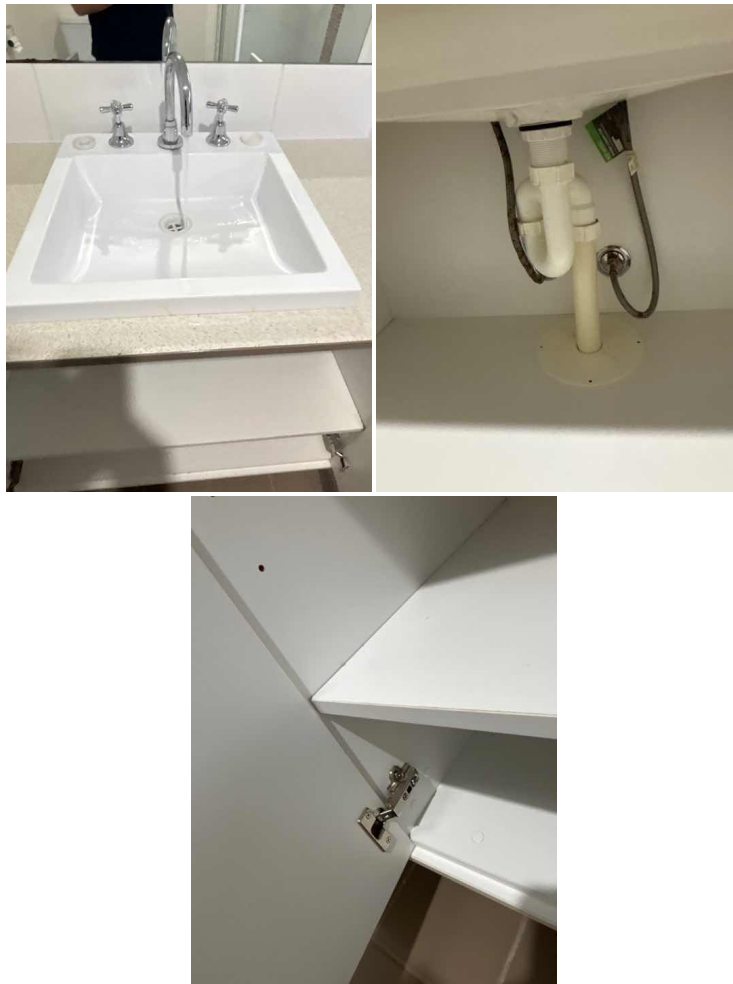
The mirror was desilvering. Recommend repair or replacement as necessary by a licensed glazier.

Some door hardware (e.g. hinges) require repair or replacement by a suitably qualified tradesperson.

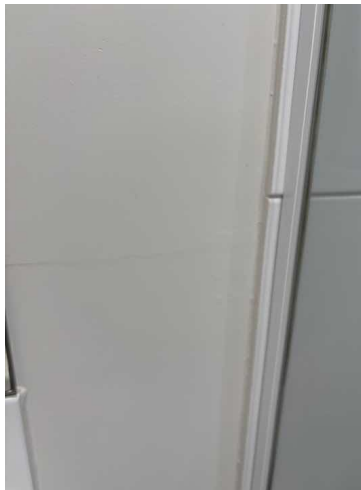
There was cracking in the linings, predominately along material joints. Recommend repair as necessary by a suitably qualified tradesperson.

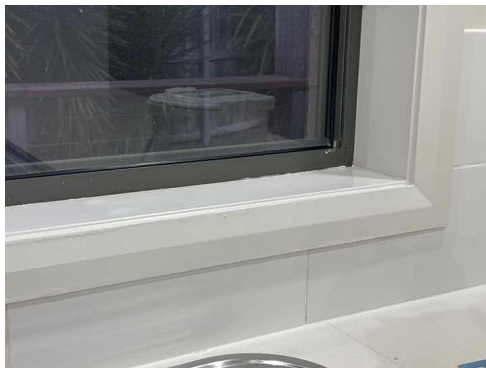
There was deterioration or damage in the window trims and reveals (e.g. moisture damage). Recommend repair as necessary by a suitably qualified tradesperson.

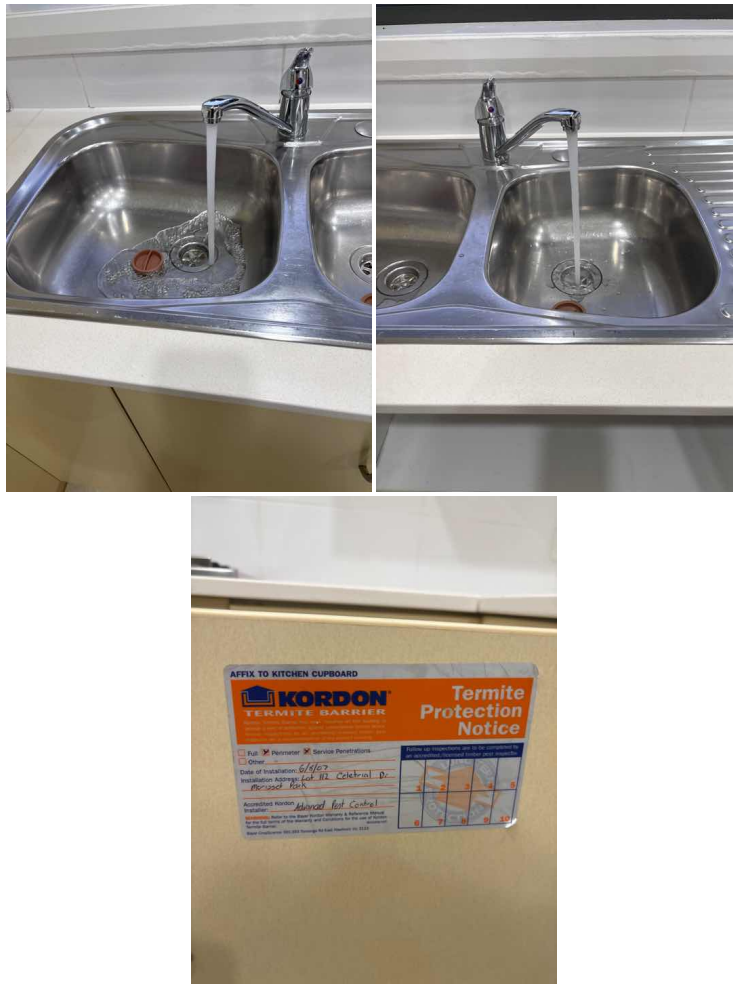
The tap was run and no leaks were observed.

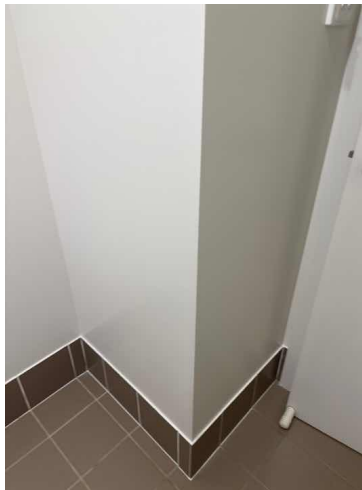
General age and wear deterioration or the like is evident on wall linings. Recommend a suitably qualified tradesperson be engaged for general maintenance and repair as necessary (e.g. patch and paint).

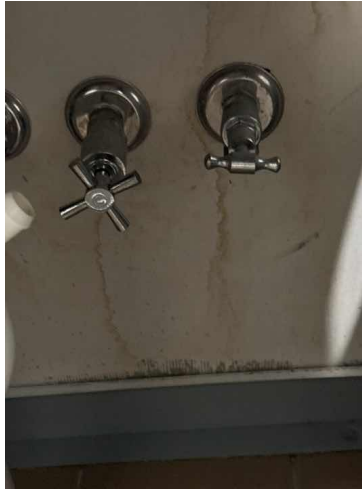
There tap was run and no leaks were observed. However, there was evidence of previous leaking, particularly near the washing machine taps. Recommend monitoring for further issues.

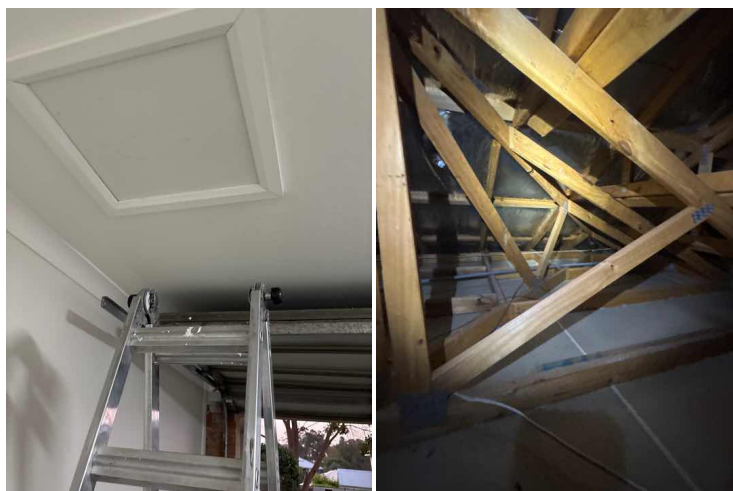
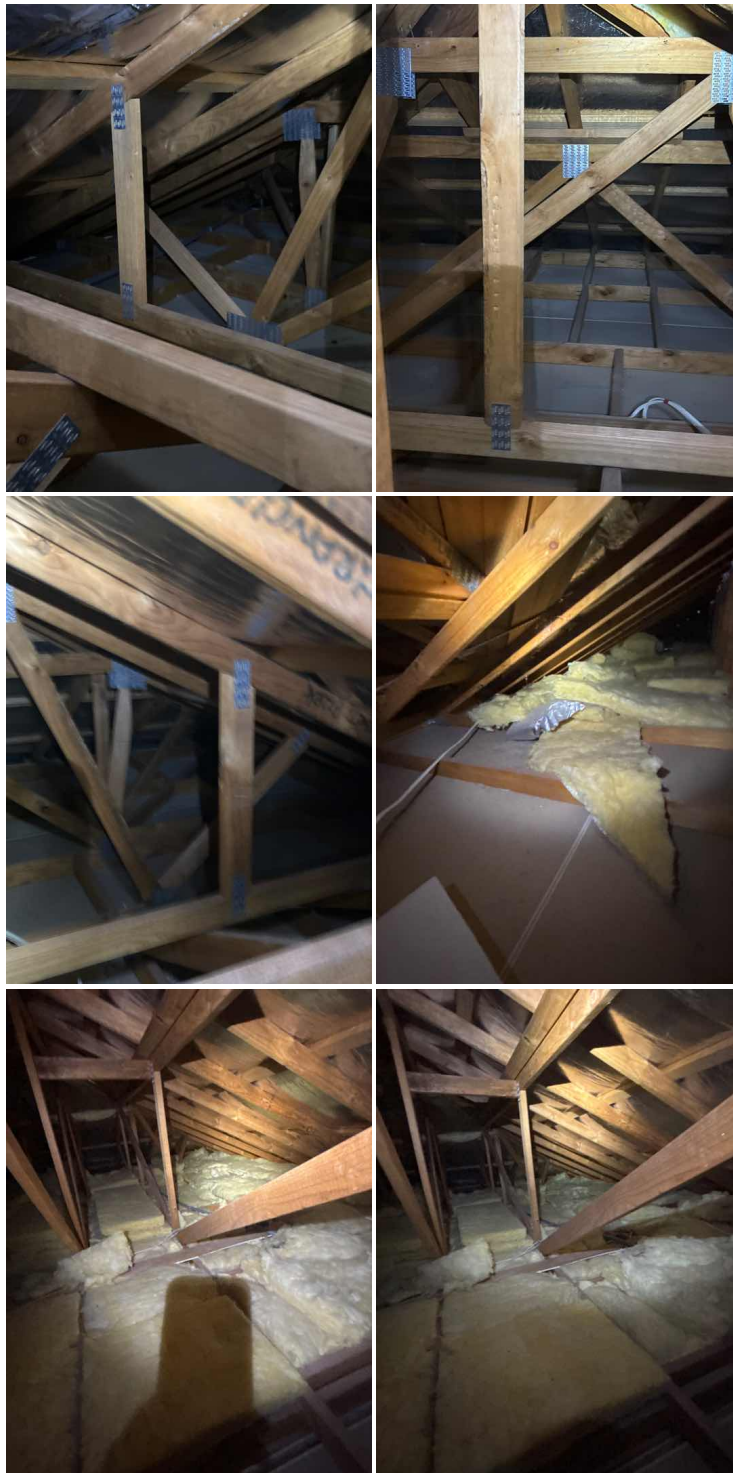
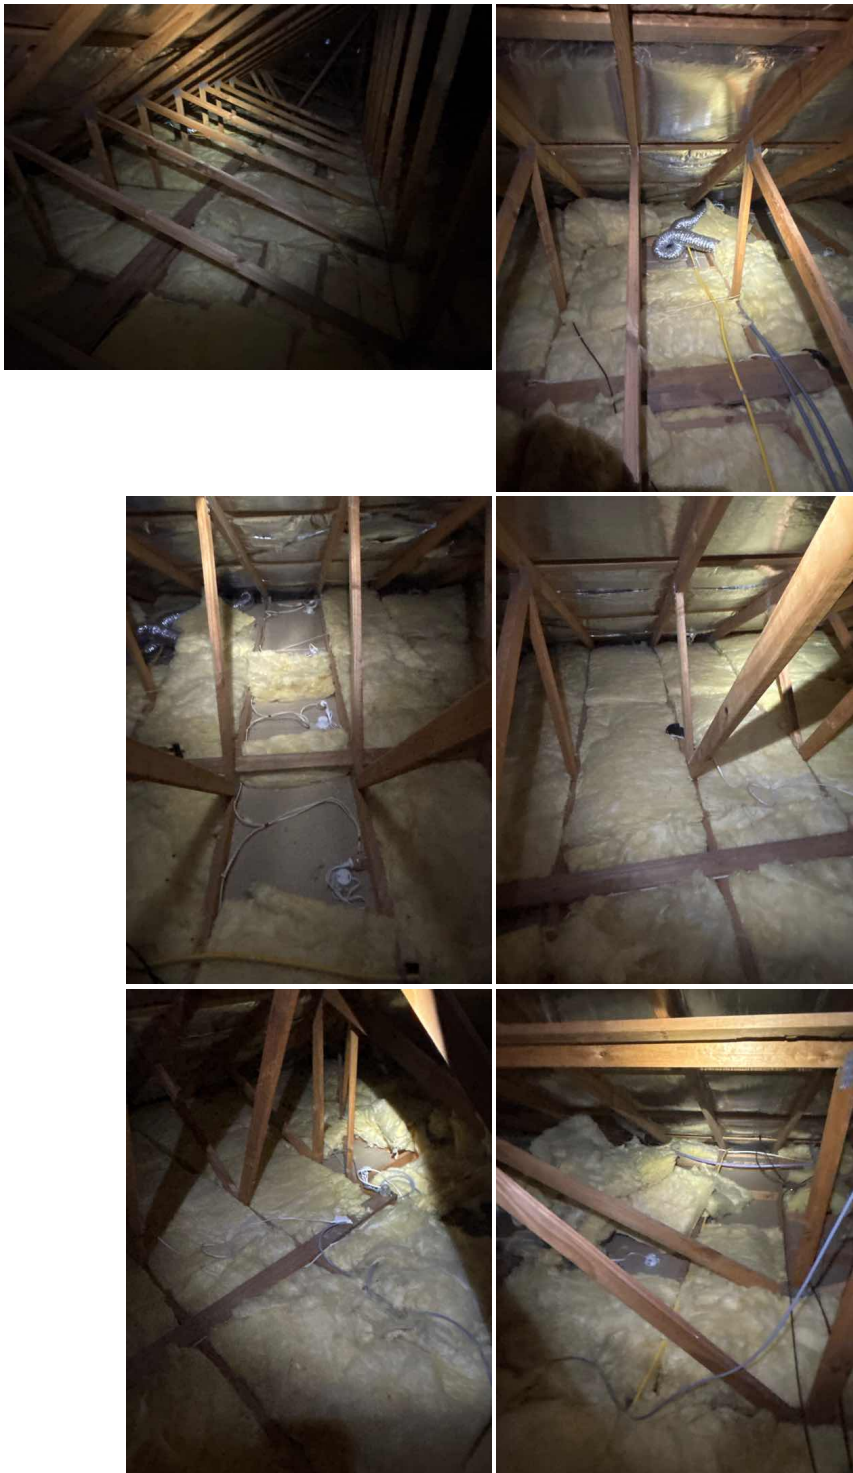
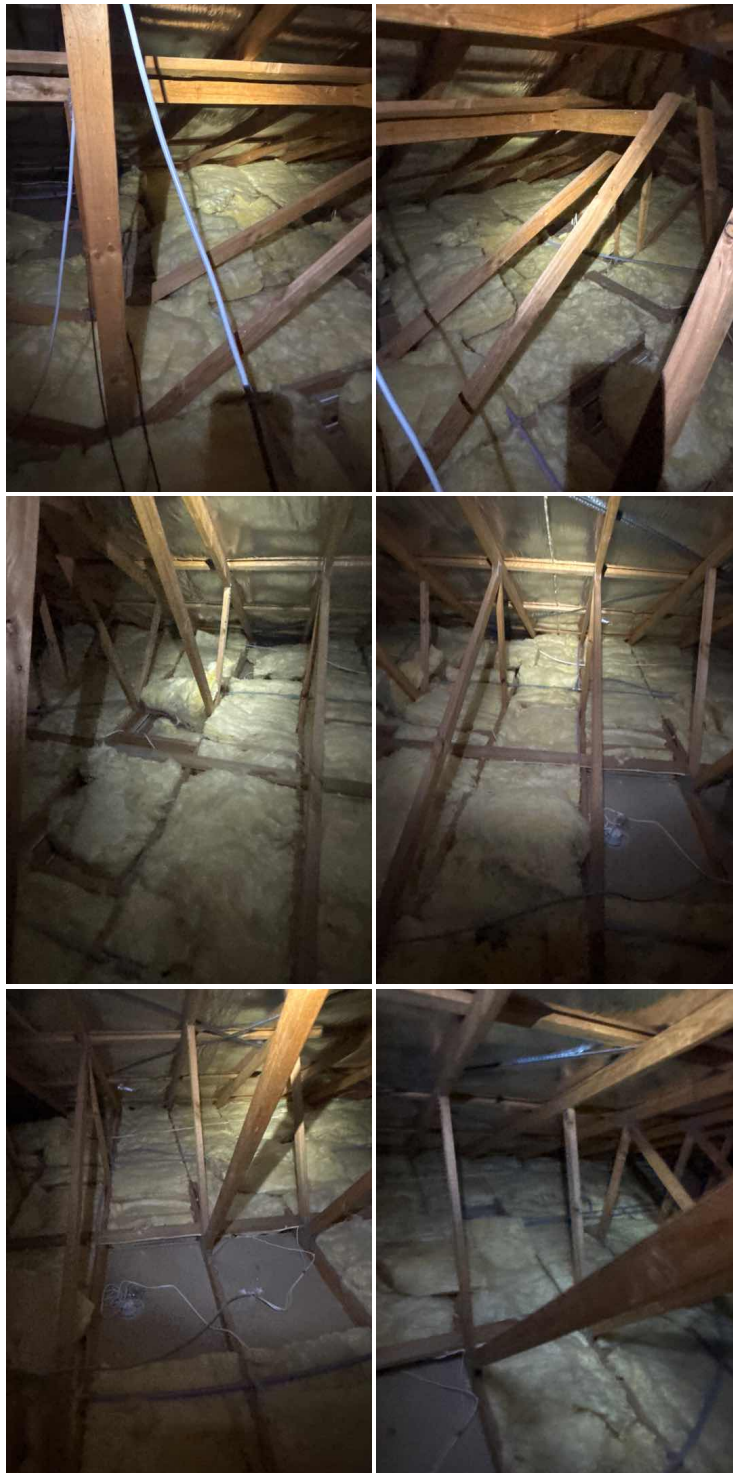
The roof void and frame had some observations but was in generally fair condition overall.

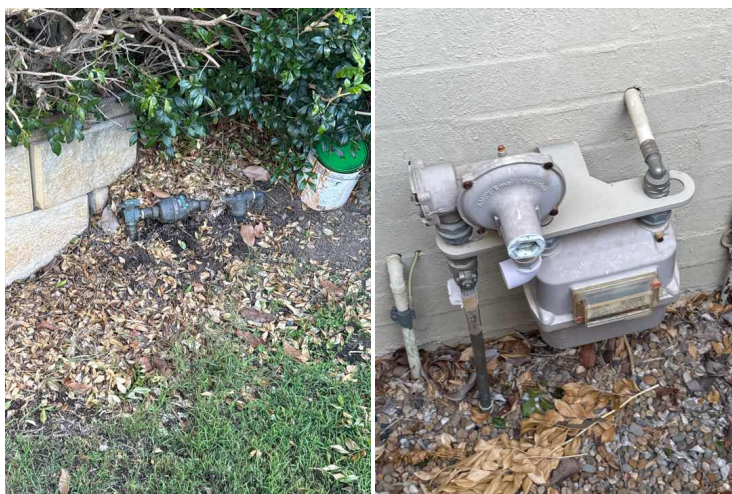
Gas was connected to the house. Connection and shut off valve were located on the northwestern corner.

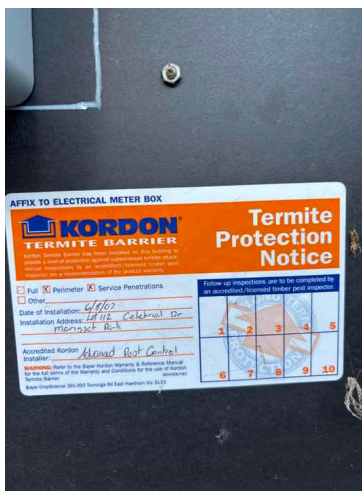
Yes, a durable notice was found in the meter-box during the inspection.

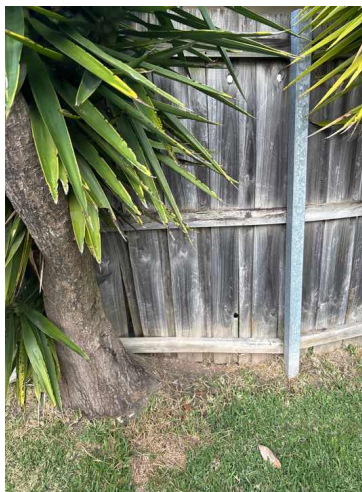
The extent of rot damage is considered to be moderate.

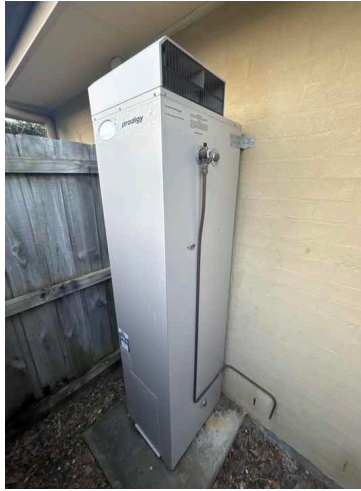
No. Divert hot water overflow away from the building perimeter.

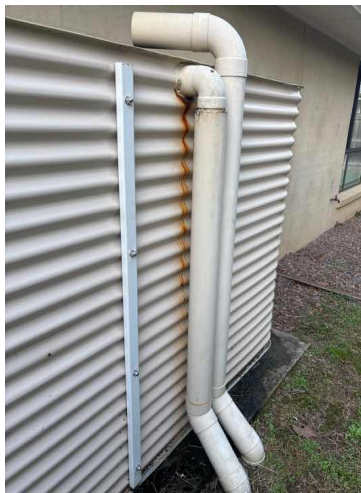
The water tank overflow was leaking or not connected.

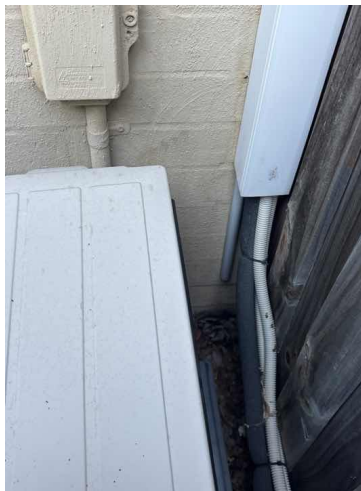
No - Divert A/C overflow away from the building perimeter.
