# Inspection Report

**Inspectrite Australia Pty Ltd**

**4 Celestial Dr, Morisset Park, 2264**

### Pest And Building Inspection

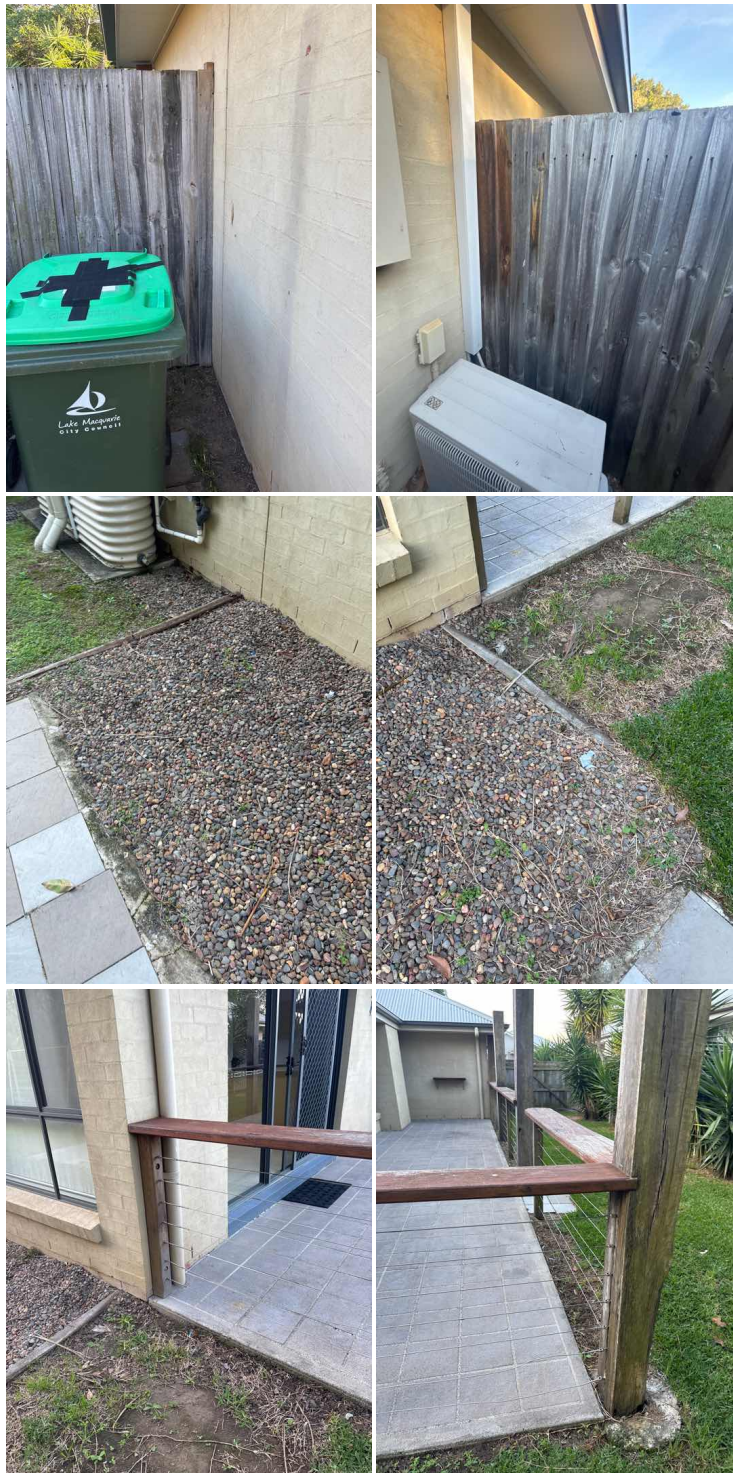
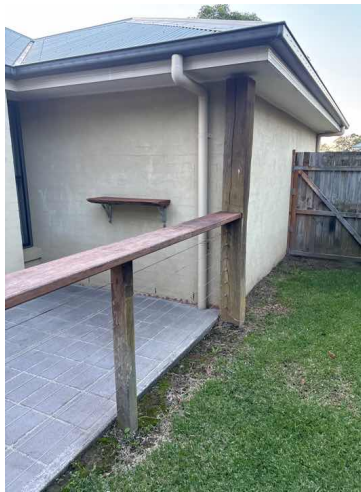
Tree/leafy environment: This property is located in a suburb which is high risk due to the environmental surrounds. It is close to large trees and parkland. A termite management plan/treatment is strongly advised.

There was vegetation on the property.

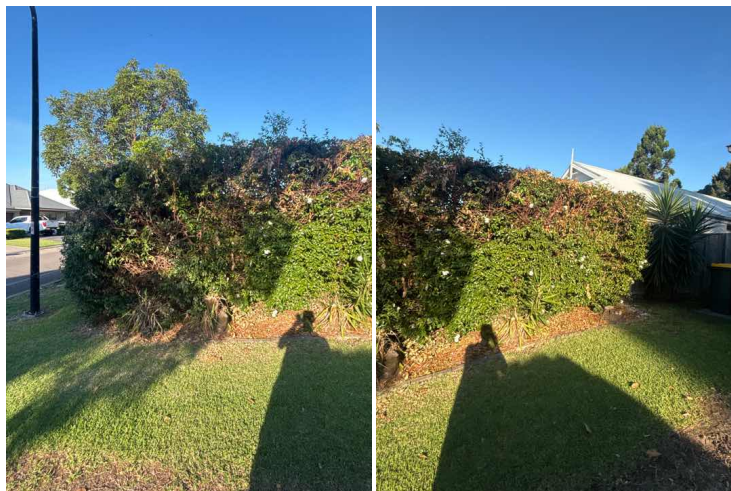
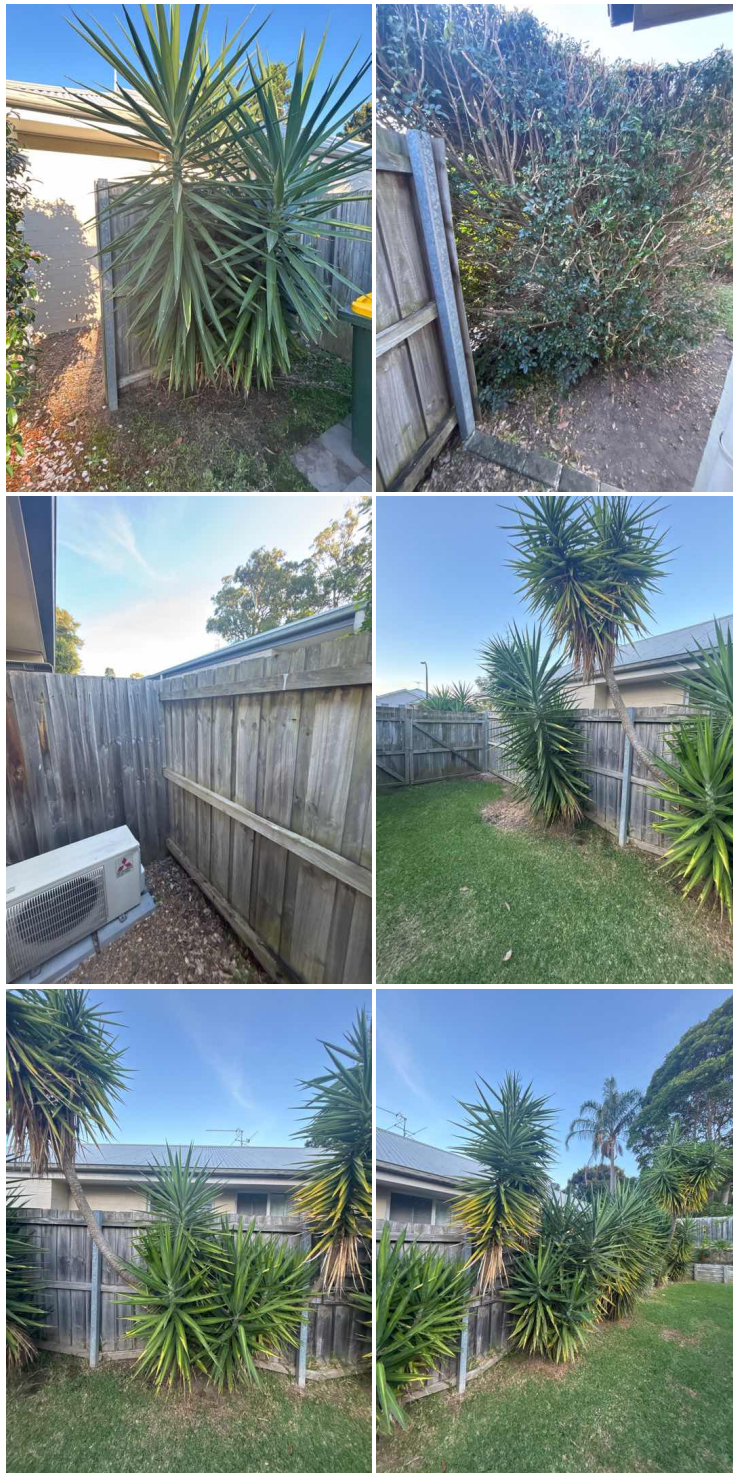
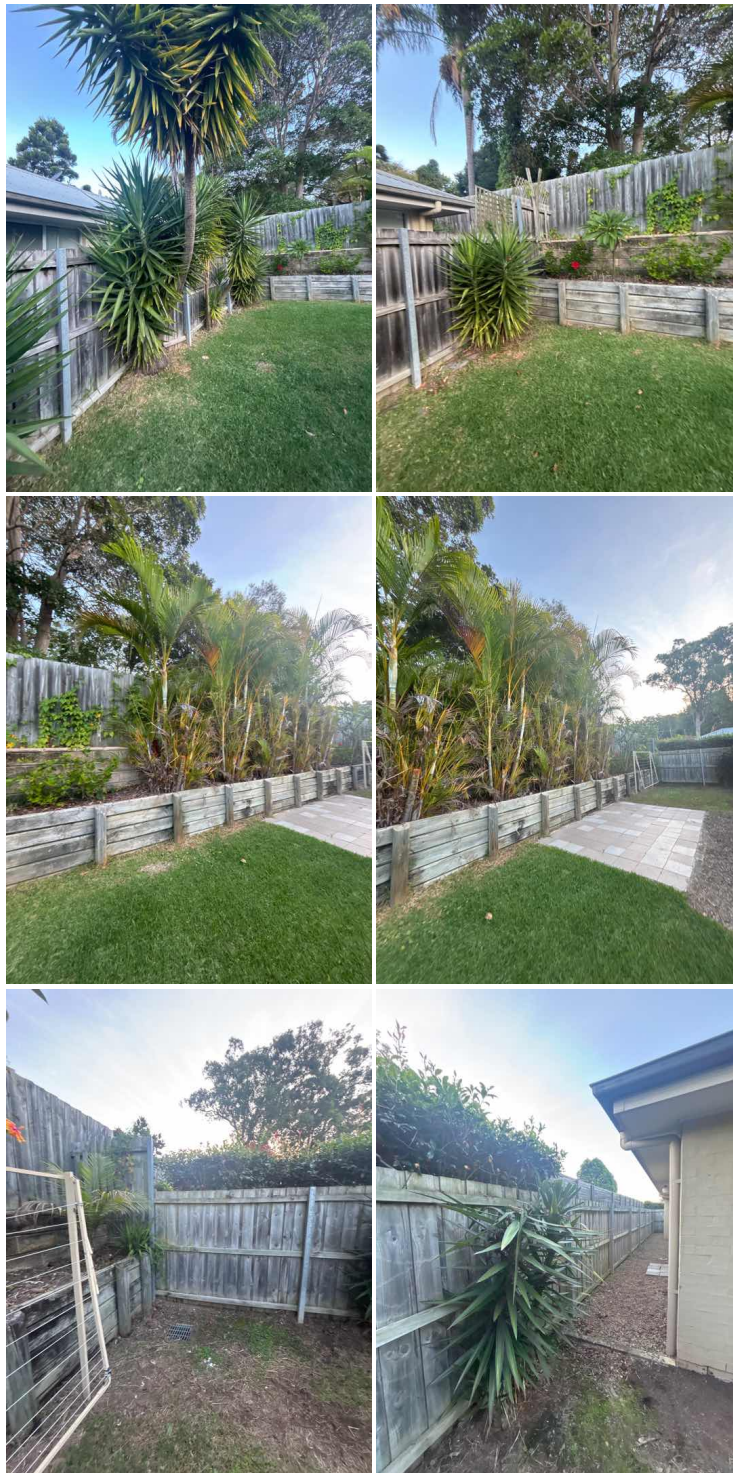
There was vegetation on the property.

The property is adjacent to or in close proximity to wooded areas.
