# Inspection Report

**Inspectrite Australia Pty Ltd**

**395 Newport Rd, Cooranbong, NSW, 2265**

### Pest And Building Inspection

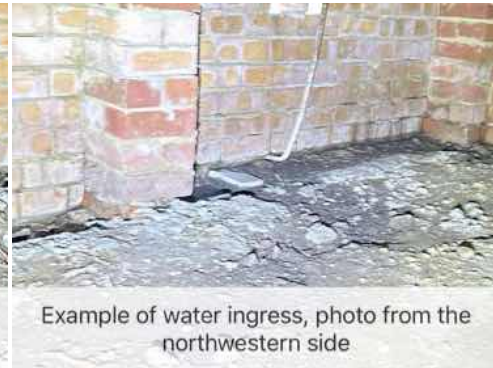
Example of water ingress, photo from the northwestern side

There was water ingress along the northwestern side. This did include some water congregation along the footing. It should be noted that there was substantial rain at the time of inspection and a down pipe connection adjacent to the water ingress was leaking. Recommend repair as necessary by a suitably qualified tradesperson.

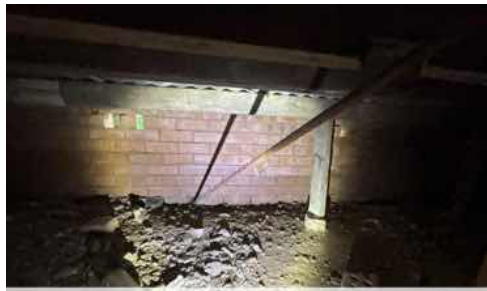
Formwork remains beneath the entry porch

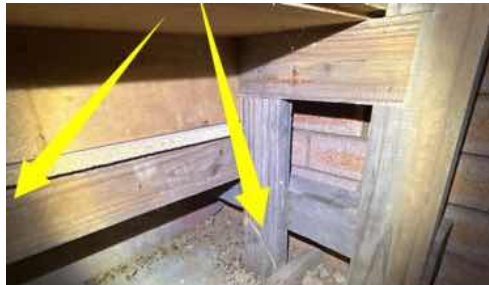
Example of termite workings in stairs adjacent to the bathroom

There was evidence of previous termite activity in the subfloor area, particularly beneath the bathroom and adjacent stairs. The timbers appeared to be bearing their intended load. Recommend further evaluation and repair as necessary by a suitably qualified tradesperson. Some invasive/destructive measures may be required.

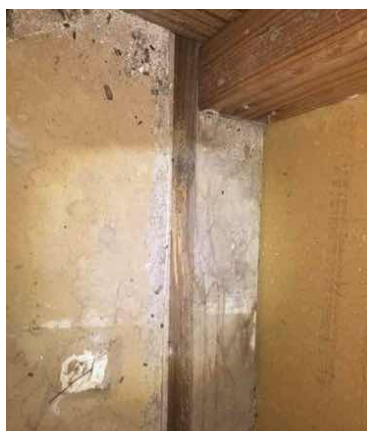
Example of termite workings in top plates, photo from above the bathroom

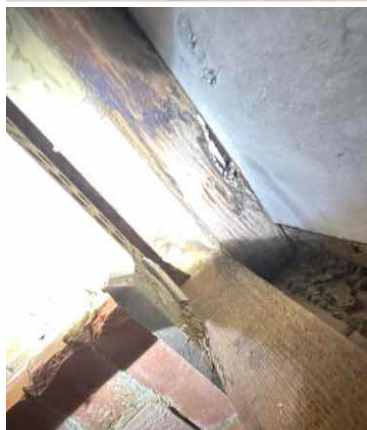
Example of termite workings in joists and sole plates, photo from beneath the bathroom

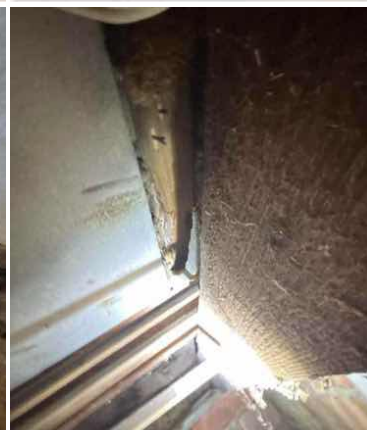
Example of termite workings in sole plates, photo from beneath the bathroom
