Redcliffs Park

Ground Contamination Investigation

Prepared for
Ministry of Education

Prepared by
Tonkin & Taylor Ltd

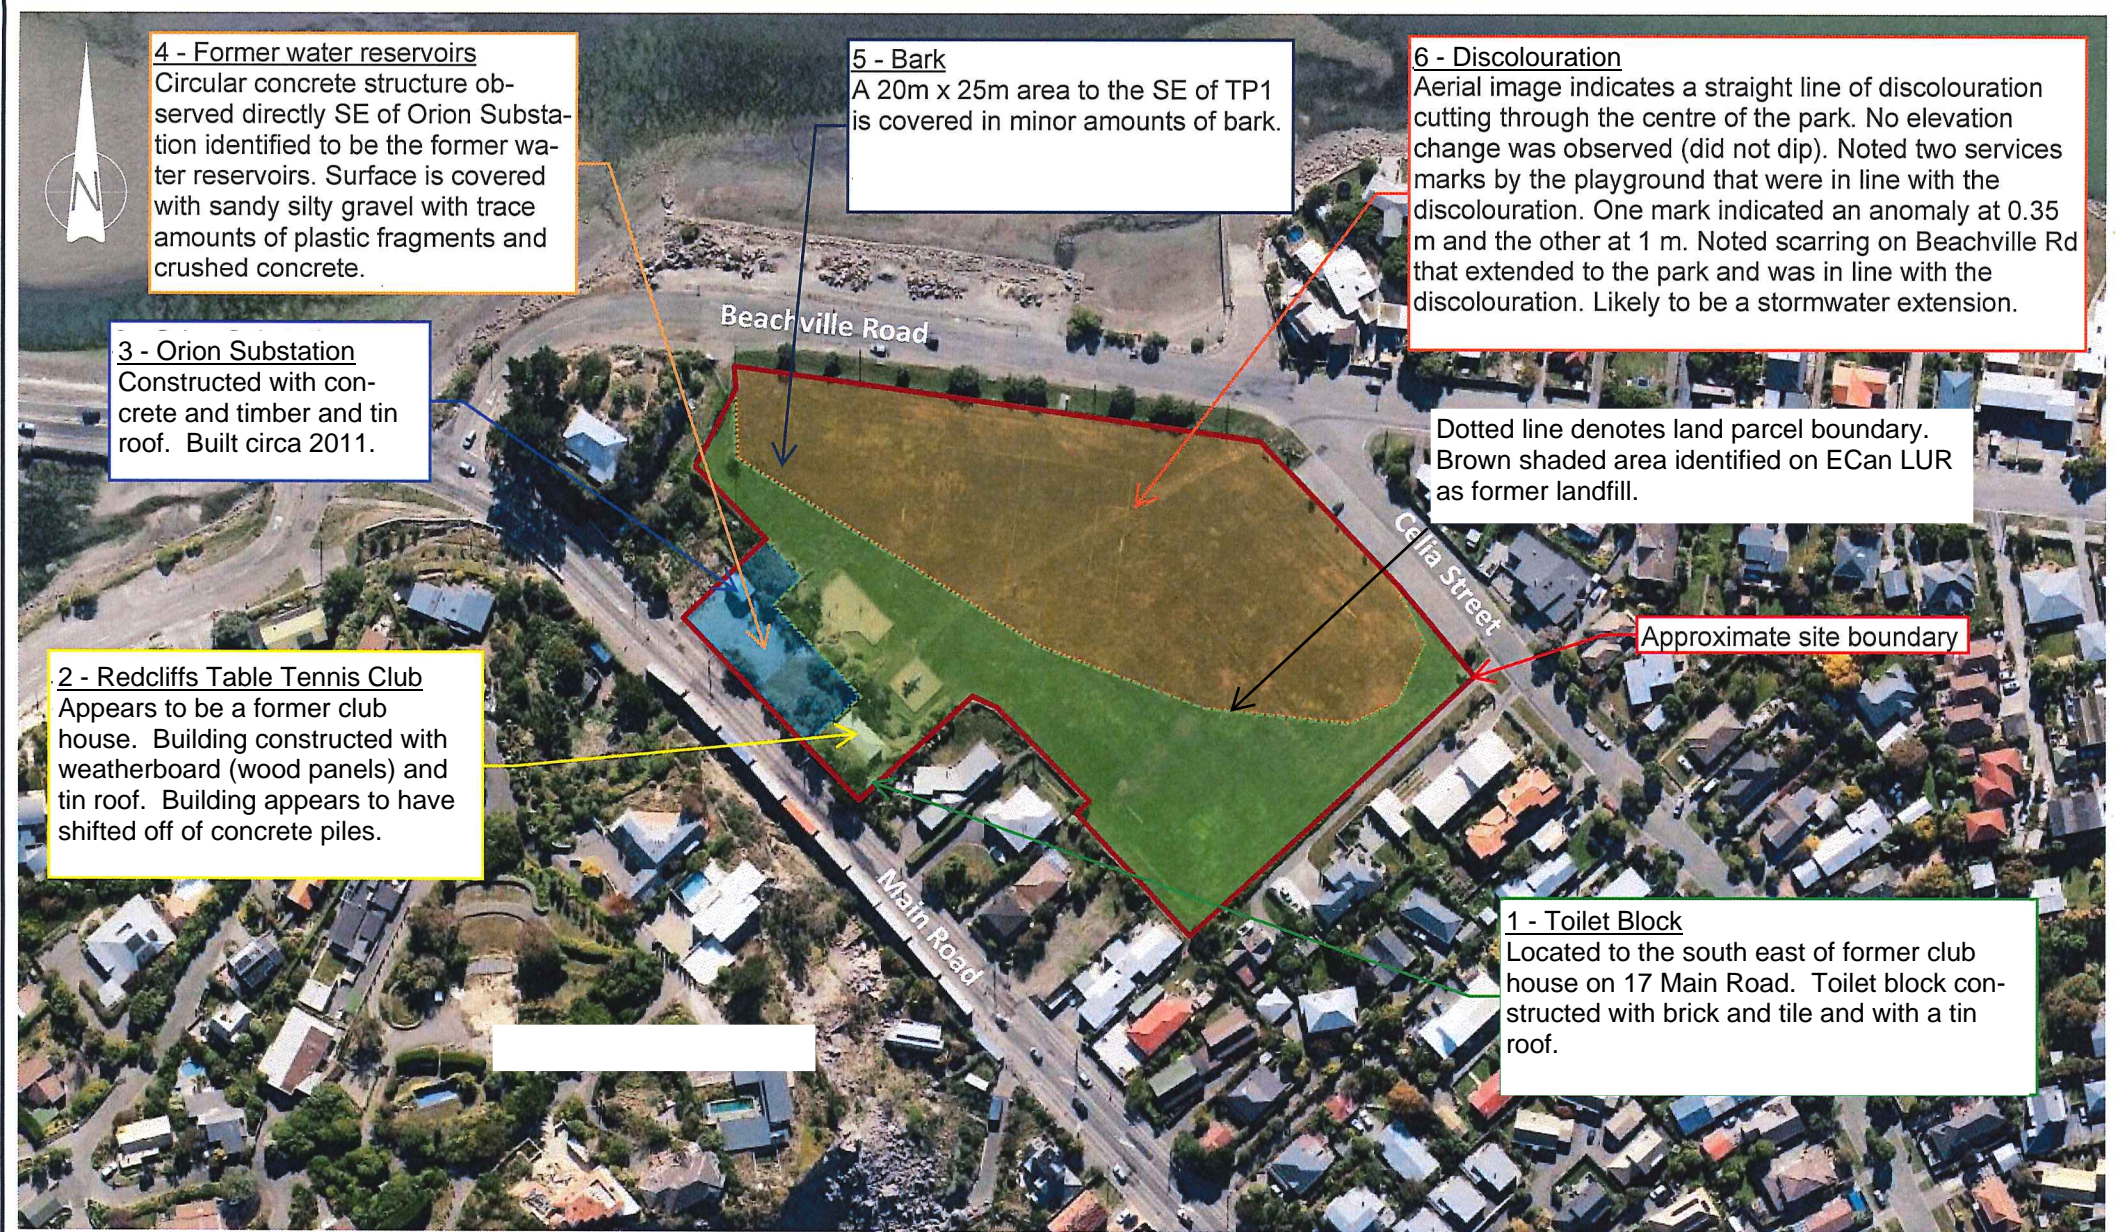
FIG. No. Figure 2

A T+T environmental scientist completed a site walkover on 1 December 2016. Relevant observations made at the time of the inspection are included in **Figure 2, Appendix A** and are summarised in the following sub-sections.

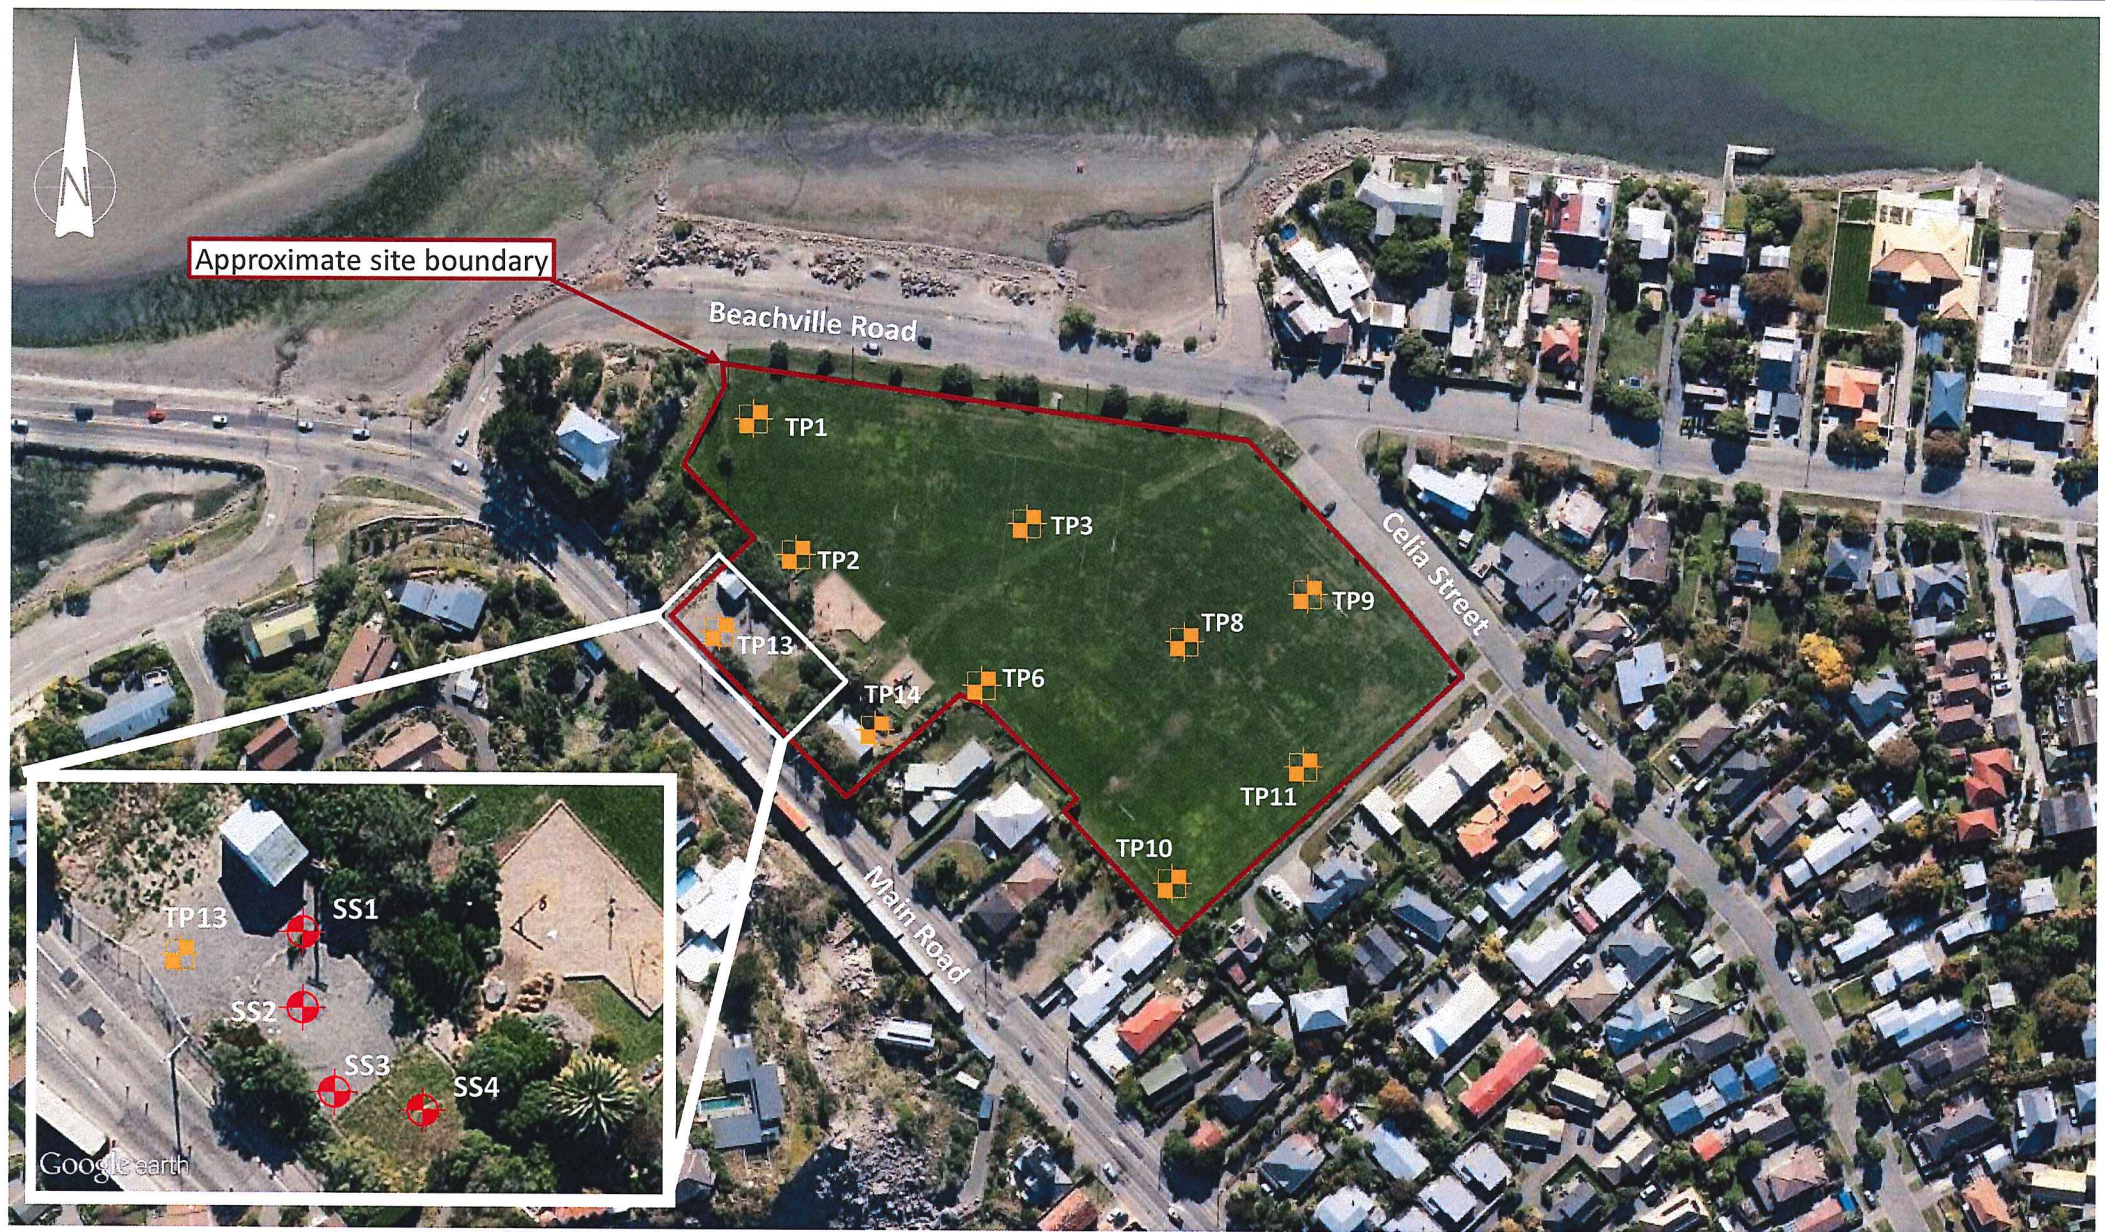
FIG. No. **Figure 3**

Sampling locations are shown on **Figure 3, Appendix A**. All soil sample analyses were completed by an IANZ⁸-accredited laboratory.
