ROOF REPORT

Job: #203504

Address: 14 Mount Street Bonnyrigg Heights 2177 NSW

Event Details: Water damage to garage ceiling

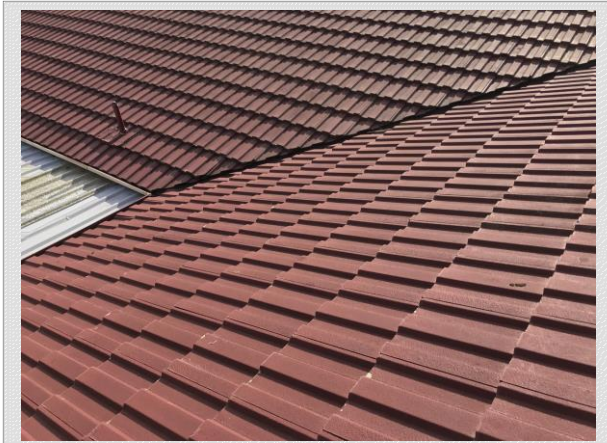
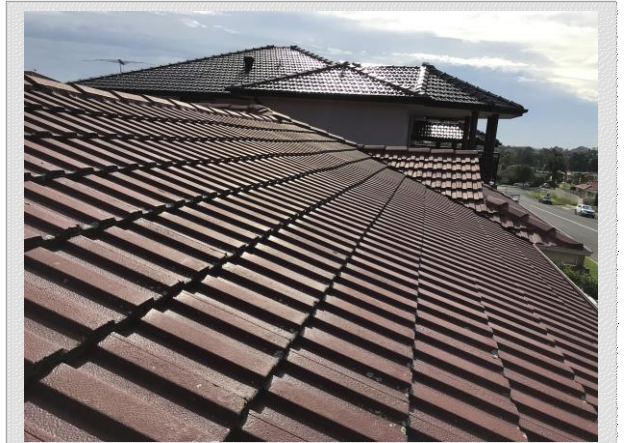
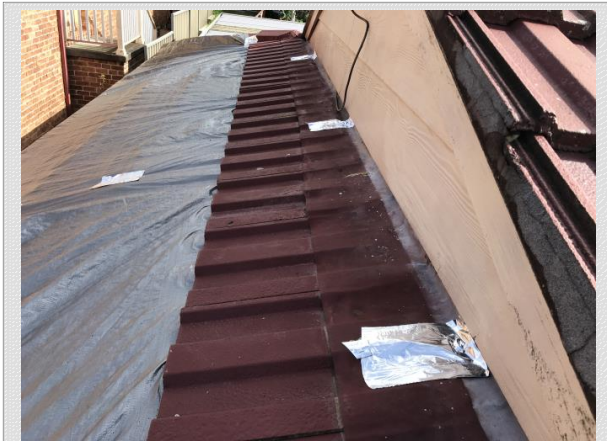
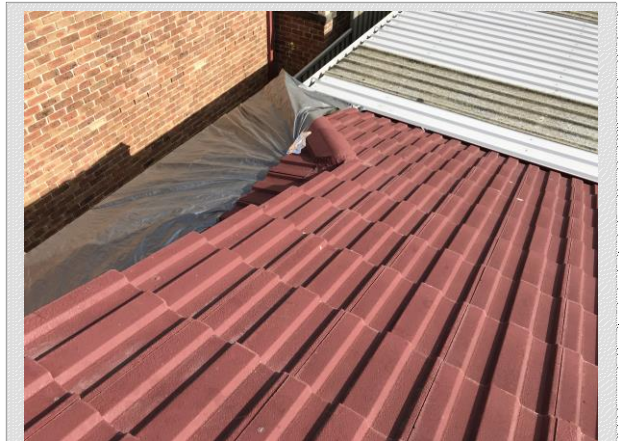
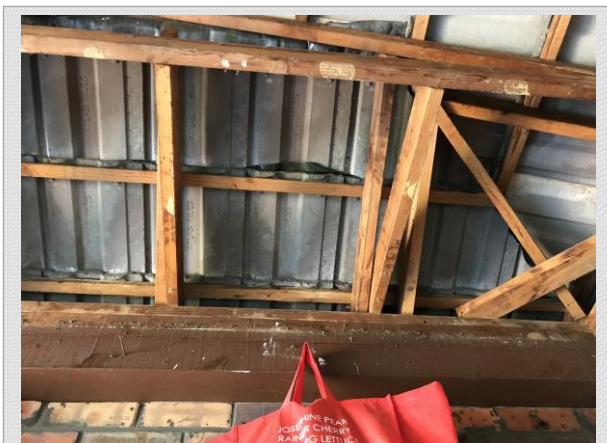
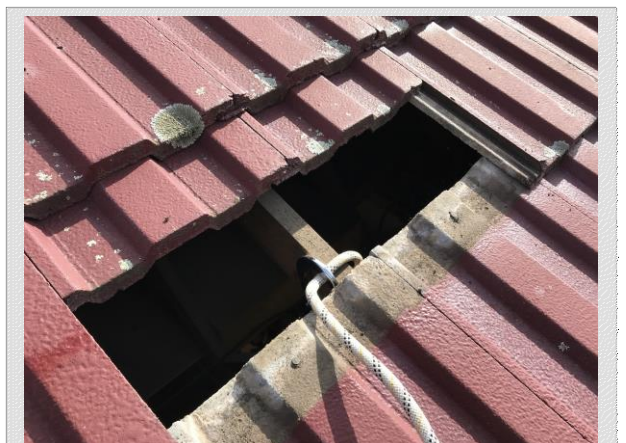
Condition of Pointing: Below average, weathered and cracked

Pointing is weathered and cracked and weep holes have been filled in.

This issue can cause ingress, so we have listed its repair in maintenance.

Roof inspection has not found any storm related damages and we have determined that ingress has occurred due to maintenance issues causing the garage ceiling to collapse.

Insured to appoint roofing specialist to repoint capping tiles, install weep holes in pointing, replace split apron flashing and replace cracked tile.
