Visual Timber Pest Inspection and Report in Accordance with AS 4349.3-2010

392 Brunner Road Adamstown Heights (Eastern Elevation)

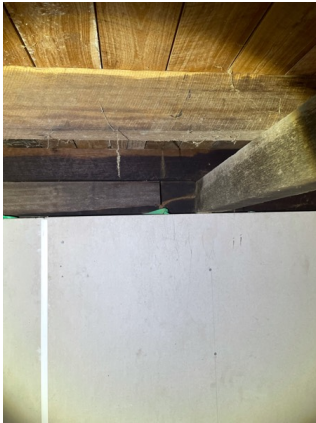
Moisture:	Normal
Termite:	Yes Termite Damage Visible Termite Damage Extent - Moderate Refer to Important Warnings : Invasive Inspection
Borer:	No Borer Identified
Fungal Decay:	No Fungal Decay Identified
Location of Threats Not Limited To:	
Other Comments:	I recommend that you contact a licensed pest control company to undertake a termite management programme to reduce the risk of undetected termite entry.
Is an invasive inspection recommended?	Yes A further invasive inspection gaining full unobstructed access into all restricted and non-accessible areas as these areas could be concealing timber pest activity and or damage.
Are there Major Safety Hazards Related to Timber Pests?	No Important Note: Where a Major Safety Hazard is identified above, it <u>must</u> be attended to and rectified to avoid the possibility of personal injury &/or death.
