Inspection Report

37 Alexander Parade, Charlestown, NSW, 2290

Pest And Building Inspection

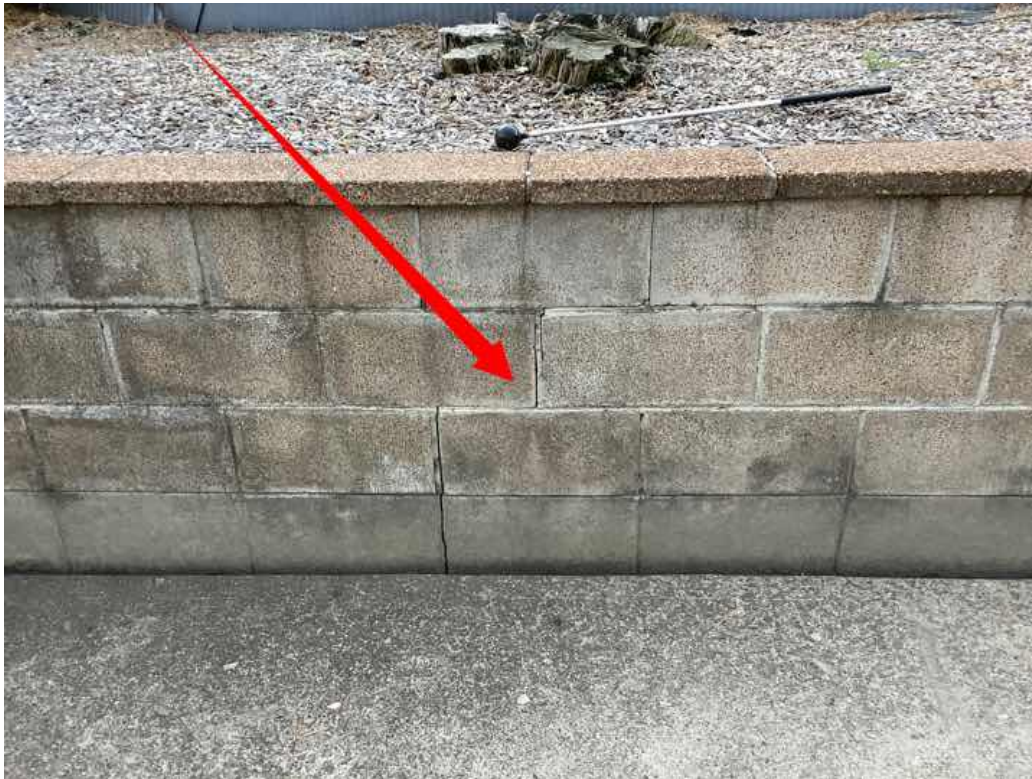
Overall Condition

Retaining wall cracking - Recommendations: A qualified brick layer should be engaged for advice and recommendations.

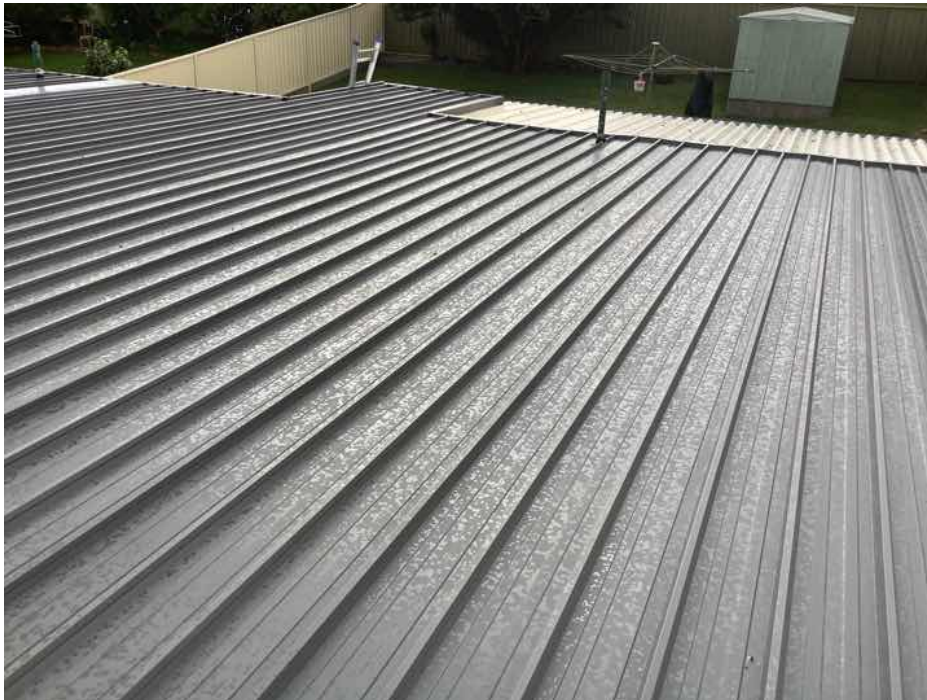
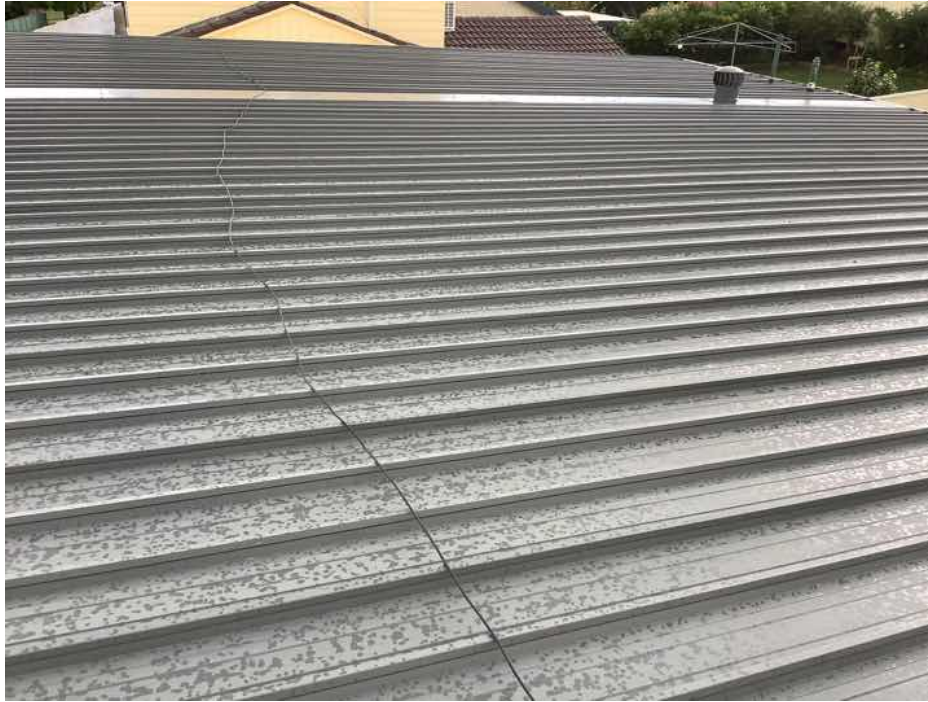
Roof Covering Type

Metal roof cladding

Overall Condition

Of the visible areas, the general condition of the roof is in serviceable condition for the age.
 Note: In the absence of rainfall there is no guarantee that the roof won't leak.

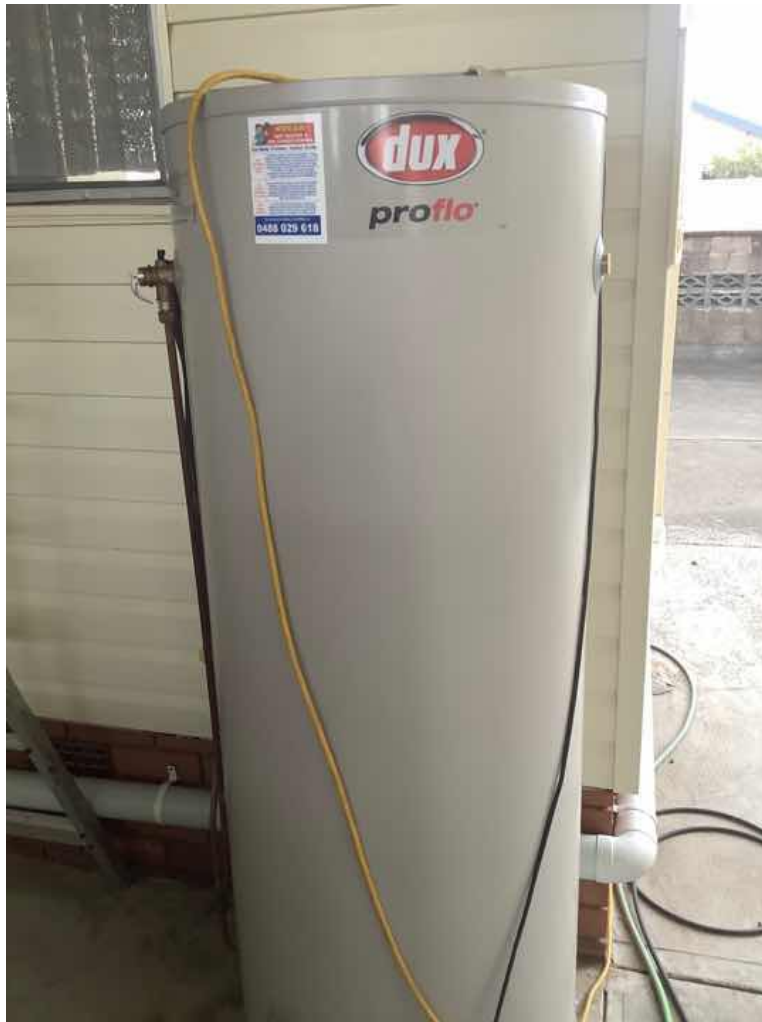
The hot water system appears to be in a serviceable condition. No specific tests other than running the hot water from a tap was carried out. No determination has been made as to the suitability or adequacy of the hot water system in relation to capacity or otherwise.

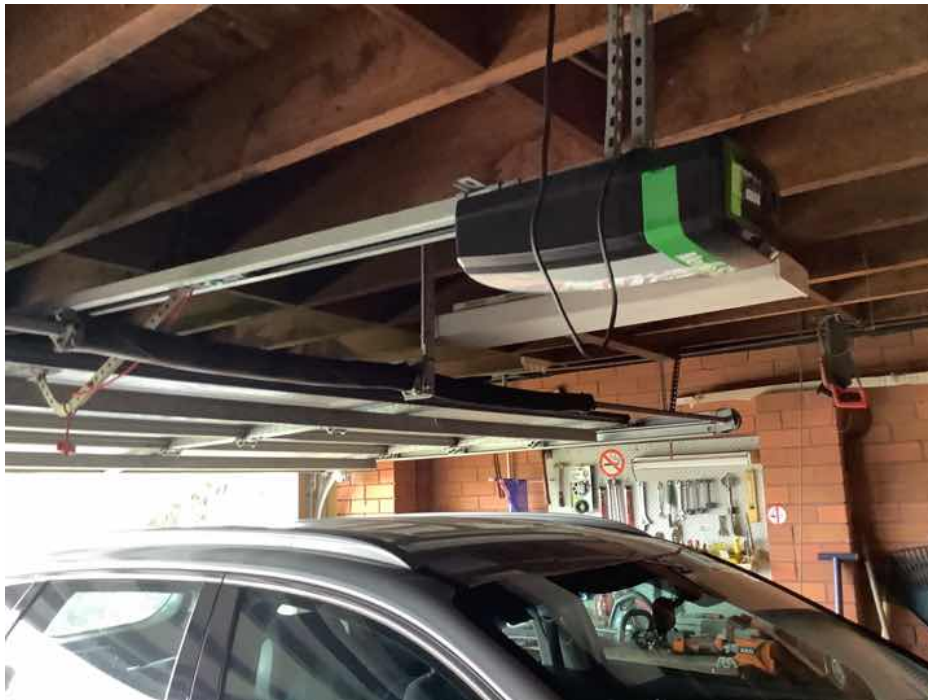
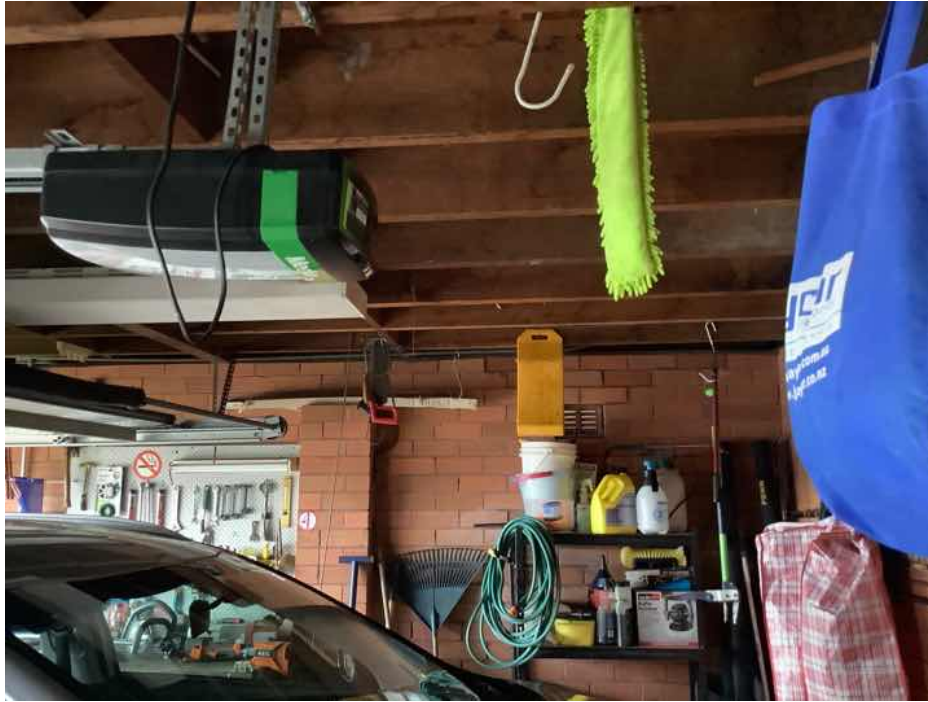
Storage items restricted a full and thorough inspection of this area. Defects may exist in the inaccessible areas. It is strongly recommended that full access be granted to enable a thorough inspection as there may be timber pest activity, damage or defects. Note: Where vehicles and storage has restricted a full inspection it is advised that this area be cleared so a full and unobstructed inspection can be carried out.

On inspection, defects were present that will require further assessing and recommendations by licensed and qualified trades persons, please read below for details.

Walls are below ground level. High moisture levels obtained. Contact a licensed drainage plumber for further advice and recommendations

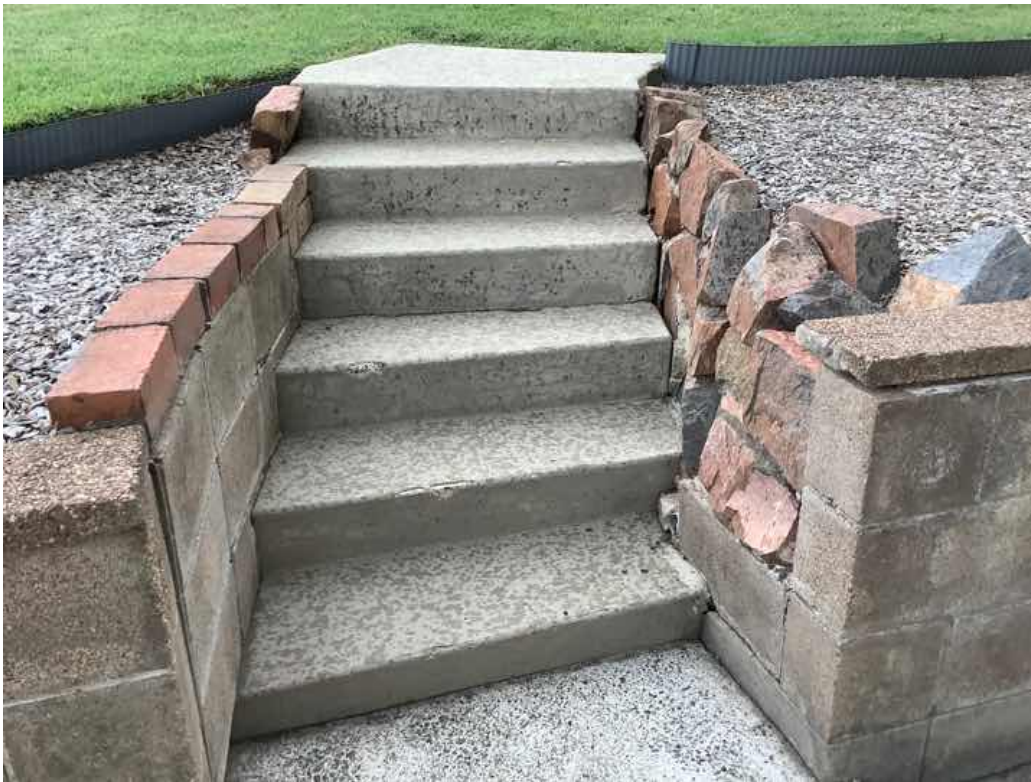
The stairs/steps appear to be serviceable with no notable defects.

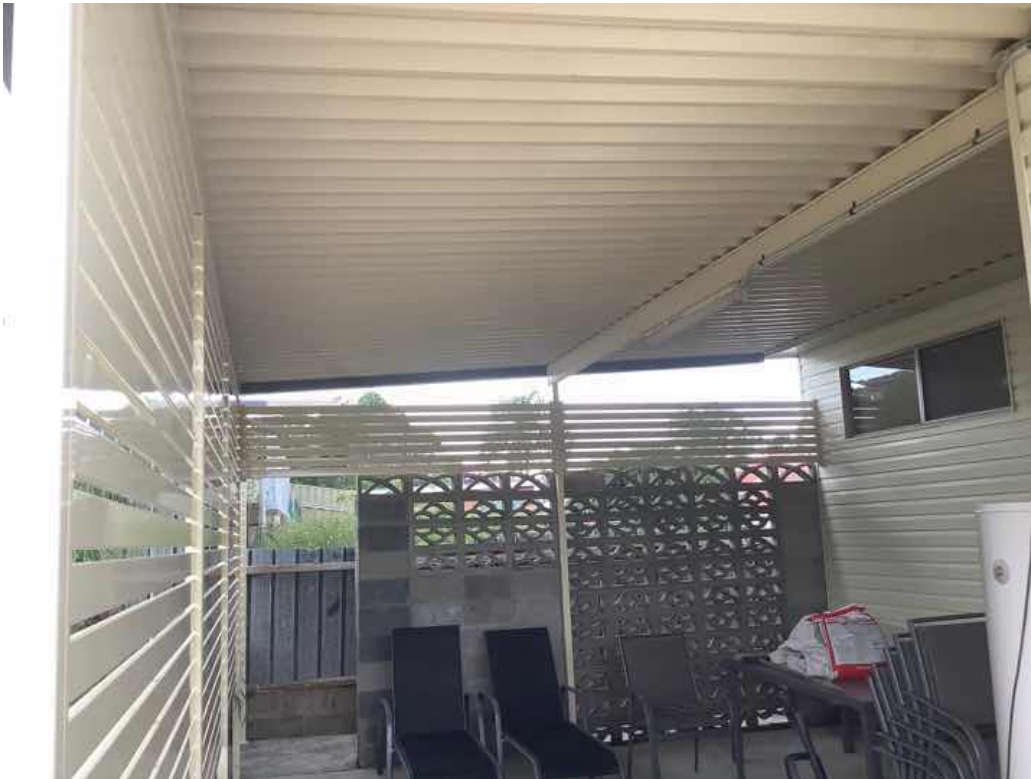
The Pergola is in a serviceable condition with no notable defects sighted.

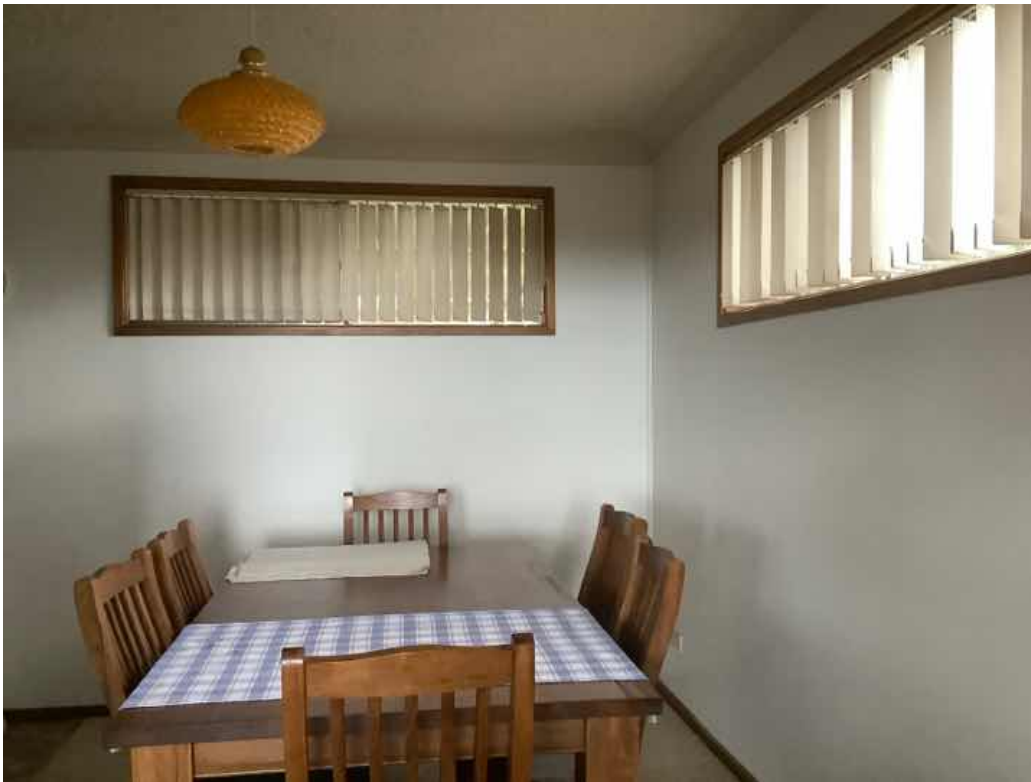
From the visible and accessible areas, the dining room appears to be in a serviceable condition for the age of the property with no notable structural defects sighted.

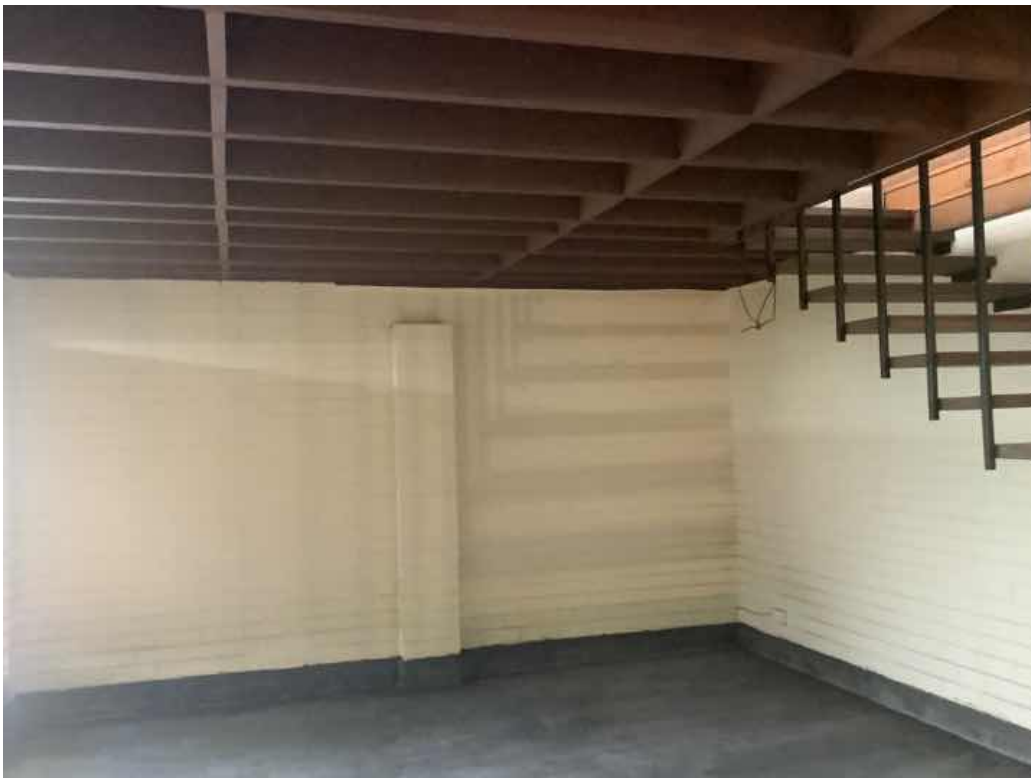
From the visible and accessible areas, the rumpus room appears to be in a serviceable condition for the age of the property with no notable structural defects sighted. New waterproof membrane below DPC installed.

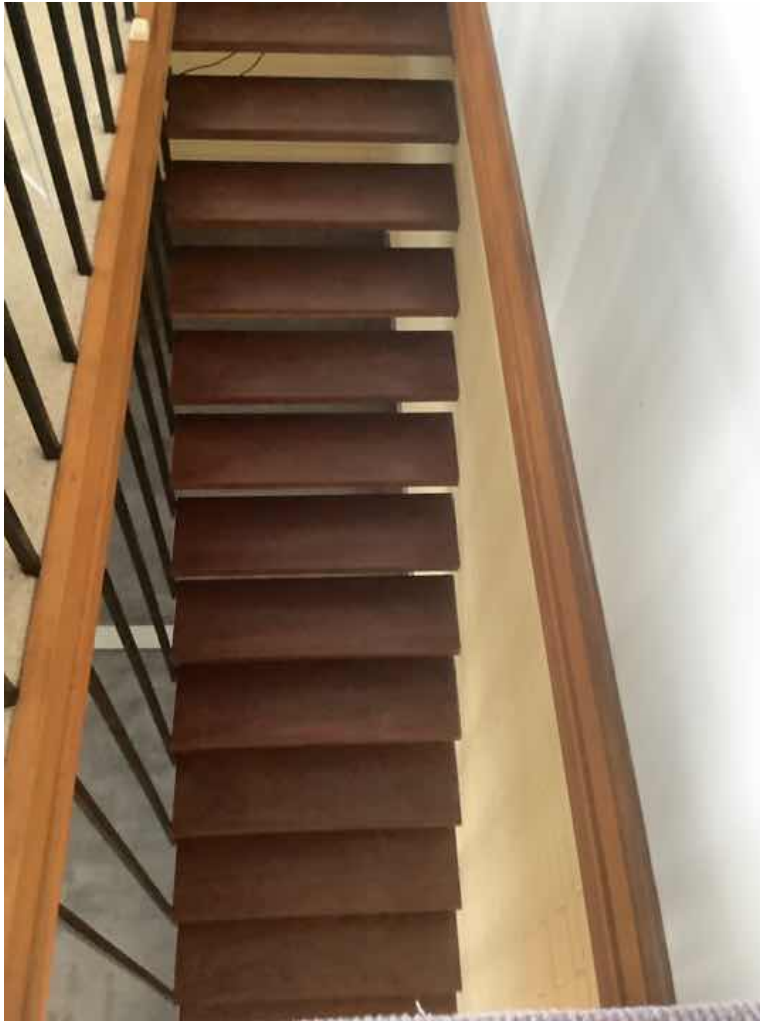
The internal stair case is in a serviceable condition for the age with no notable defects sighted.

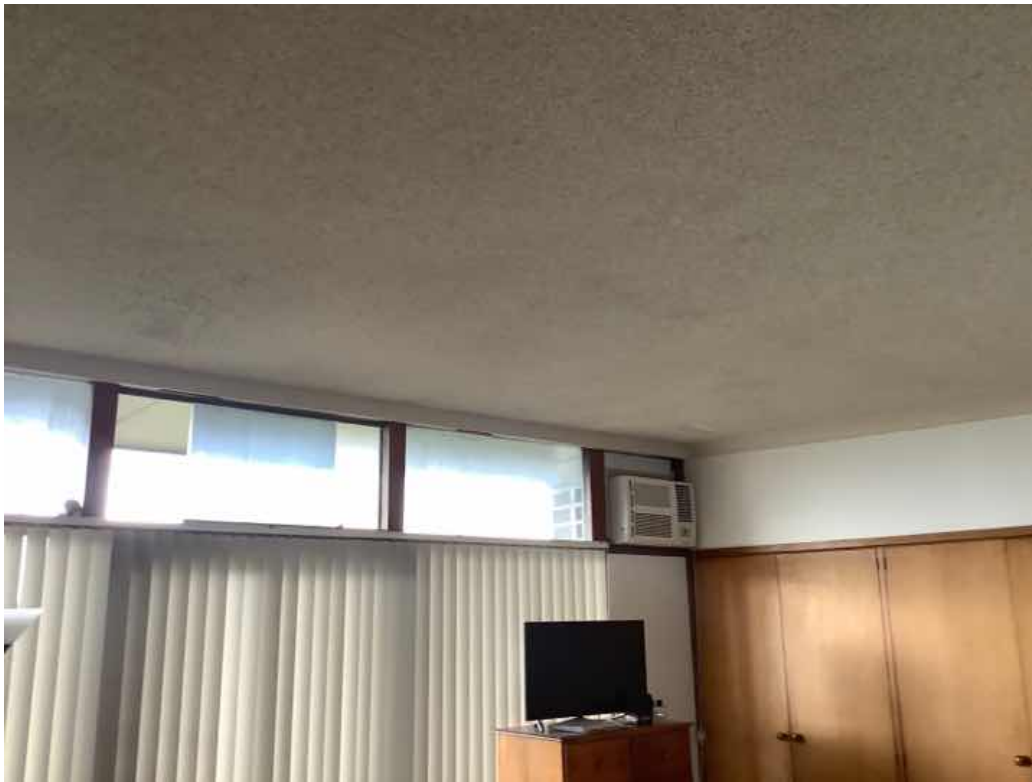
On inspection, defects were present that will require further assessing and recommendations by a qualified trades persons, please read below for details.

Door latch sticking - Recommendations: A qualified carpenter should be engaged for advice and recommendations.

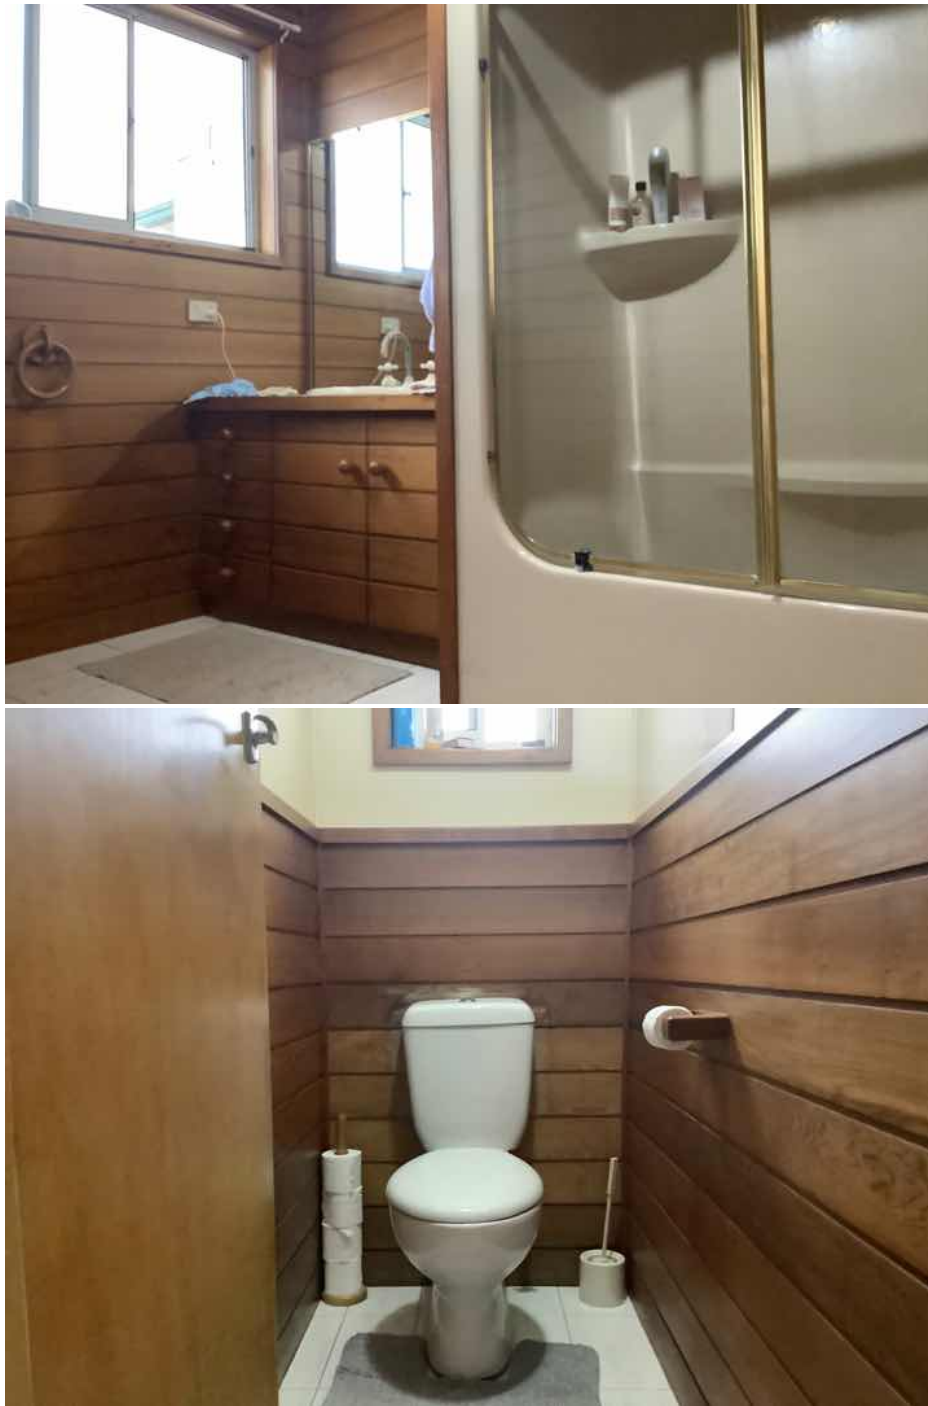
Hall

On inspection, defects were present that will require further assessing and recommendations by licensed and qualified trades persons, please read below for details.

General deterioration and wear to drop in sink. Replacement sink recommended.
The tap / tap head is leaking . A qualified plumber should be engaged for repairs.

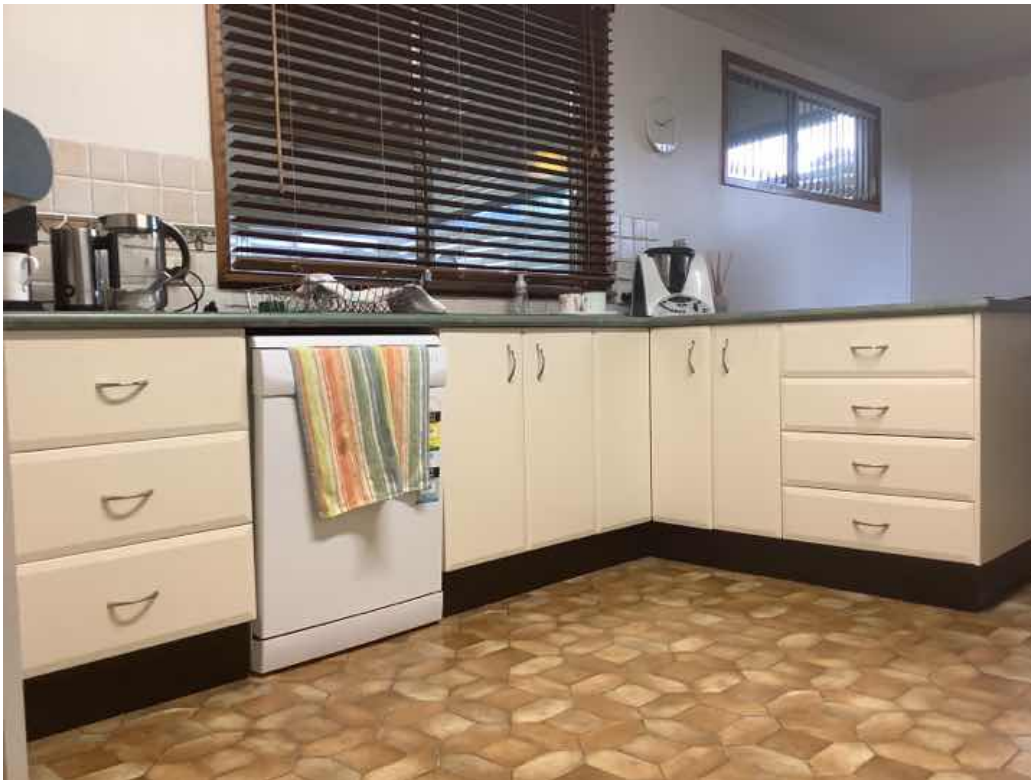
Of the visible areas, the general condition of the kitchen is serviceable or in reasonable condition for age of dwelling.

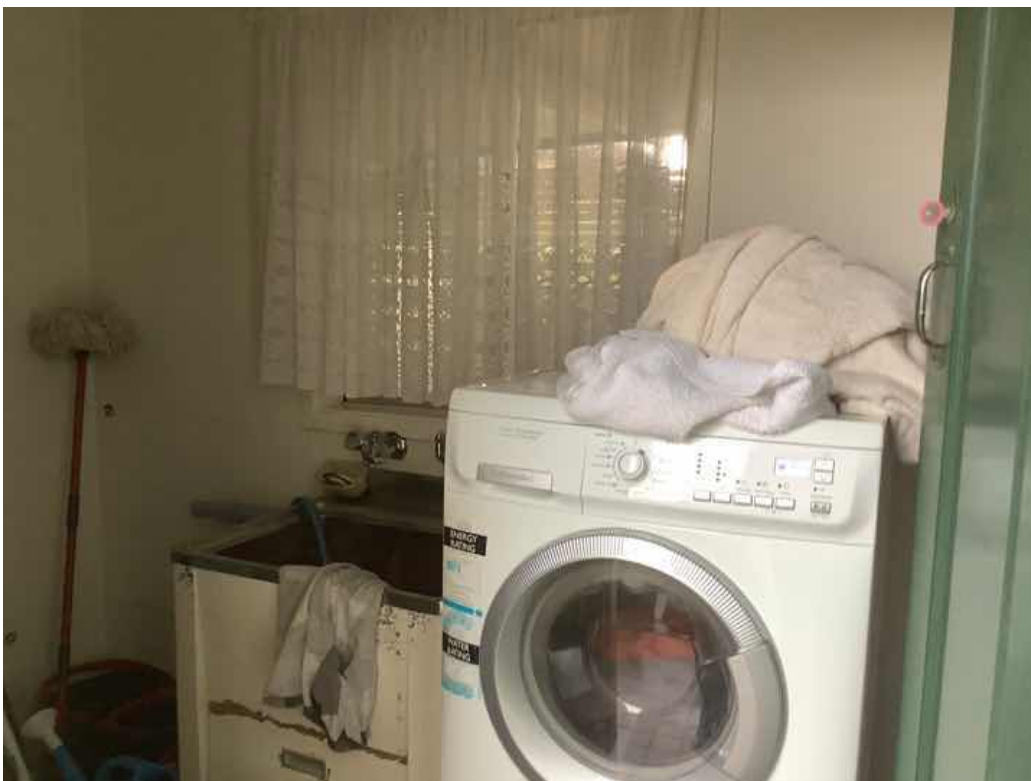
Appliances in the laundry restricted full and unobstructed view. Defects may exist behind same.
