STANDARD RESIDENTIAL BUILDING INSPECTION REPORT

6 PLYMOUTH CLOSE, MACQUARIE HILLS

Property Address: 6 PLYMOUTH CLOSE
MACQUARIE HILLS NSW 2285

Inspection Date/Time: 29/03/2018 8:58 AM

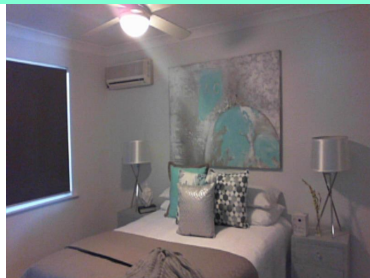
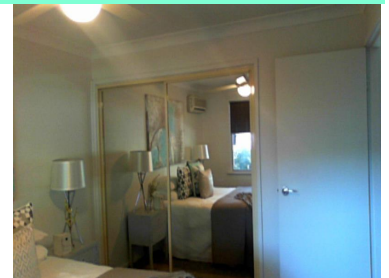
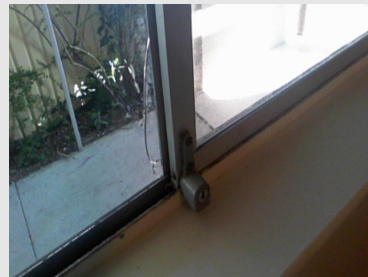
BEDROOM 1

Door	OK, The item described is performing the function it was designed for and its condition is very typical for it's age
Walls	OK, The item described is performing the function it was designed for and its condition is very typical for it's age
Ceiling	OK, The item described is performing the function it was designed for and its condition is very typical for it's age
Floors	OK, The item described is performing the function it was designed for and its condition is very typical for it's age
Window/s	Cracked or broken pane/s will need replacing to reinstate integrity, Loose or broken catch/latch needs repair

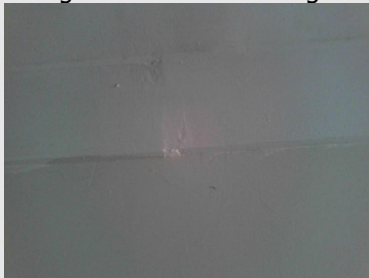
Door	Binding, will need adjusting to ensure correct operation.
Walls	OK, The item described is performing the function it was designed for and its condition is very typical for it's age
Ceiling	Patches are incomplete and or damaged will need finishing to restore appearance

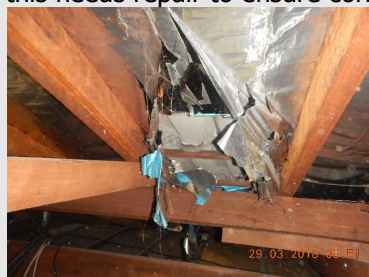
Sarking

Damaged sisalation was noted, this needs repair to ensure correct function

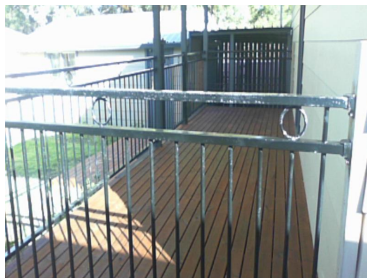
Verandah/s, Pergola/s

Substandard framing will need repair/improving to restore integrity, damage roof sheeting needs repair to restore water tightness and appearance

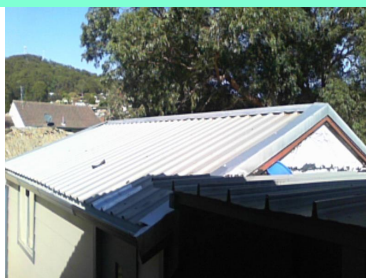
GARAGE No access due to being locked

Door	Not tested due to being locked
Walls	OK, The item described is performing the function it was designed for and its condition is very typical for it's age
Floors	Unable to inspect due to no access
Window/s	Window unable to be opened or tested
Painting	OK, The item described is performing the function it was designed for and its condition is very typical for it's age
Other	
Roofing	Surface rusting will need repair and paint to minimise corrosion, previous repairs to roofing will need monitoring for leaks
Gutters/Downpipes	The downpipes need to be connected into appropriate stormwater drainage
Vehicle Door/s	Not tested due to being locked

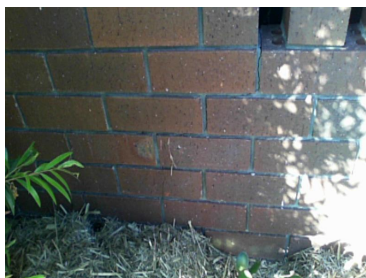
Bricks fretting	NIL, All bricks/blocks appear to be in acceptable condition for their age
Mortar eroding	NIL, All mortar joints appear to be in acceptable condition for their age
Cracking	Minor typical joint cracking only, not considered significant, however this should be monitored annually

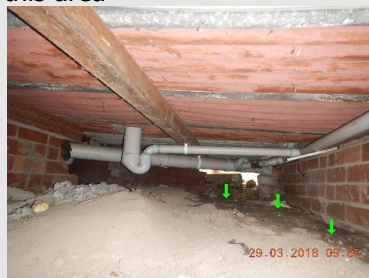
Condition of concrete	Minor cracking was noted, not considered significant, however this should be monitored annually and a structural engineer consulted if deterioration is noted
Dampness	Significant dampness was noted in areas, I recommend the site drainage be improved to help minimise dampness in this area
Drainage	Inadequate, I recommend the subfloor drainage is improved, improving the site drainage may also help limit the dampness in this area

Ventilation	This sub floor area has limited cross flow ventilation
Cracked or leaking pipes	NIL, No cracked or leaking pipes were noted at the time of the inspection, however this should be monitored periodically

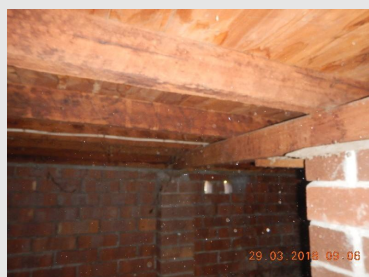
Piers/Stumps

Some evidence of typical pier subsidence and should be repacked to ensure stability
