# **STANDARD RESIDENTIAL BUILDING INSPECTION REPORT**

**43 DELAWARE DRIVE, MACQUARIE HILLS**

**Property Address:** 43 DELAWARE DRIVE  
MACQUARIE HILLS NSW 2285

**Inspection Date/Time:** 23/03/2020 1:48 PM

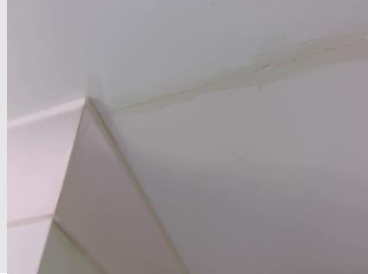
**BEDROOM 1****UPPER LEVEL**

Ceiling Typical cracking, will need repair and re-finish to improve appearance

Floors Squeaks and out of level in one or various areas, will need minor maintenance to eliminate squeaks and restore levels

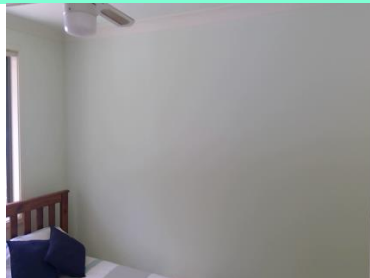
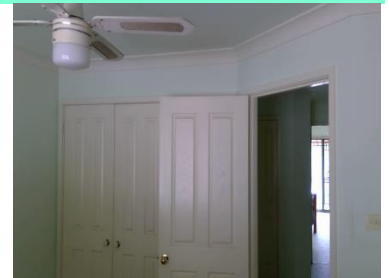
**BEDROOM 2**

Ceiling Cornice cracking needs repairs to improve appearance

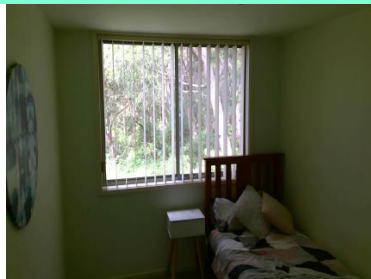
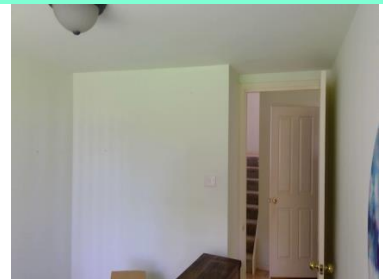
**BEDROOM 4**

Door	OK, The item described is performing the function it was designed for and its condition is very typical for it's age
Walls	Small hole/s need repair to restore appearance
Ceiling	OK, The item described is performing the function it was designed for and its condition is very typical for it's age
Floors	OK, The item described is performing the function it was designed for and its condition is very typical for it's age
Window/s	OK, The item described is performing the function it was designed for and its condition is very typical for it's age
Painting	OK, The item described is performing the function it was designed for and its condition is very typical for it's age
Other	
Robes	NIL, The item described is not present at the time of the inspection

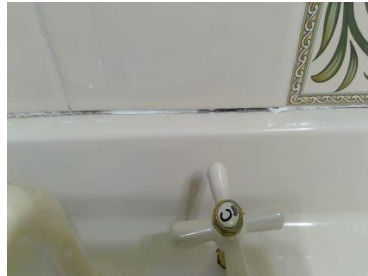
Tile grouting is missing or stained and will need repair/re-sealing to ensure water tightness and restore appearance

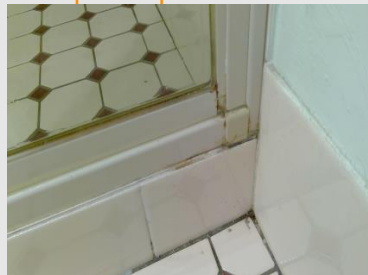
The screen is leaking and will need repair to prevent water damage

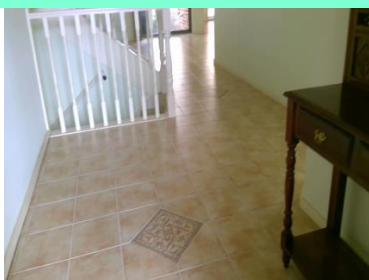
**ENTRY**

Door	OK, The item described is performing the function it was designed for and its condition is very typical for it's age
Walls	Typical plaster cracking, will need repair and re-finish to improve appearance

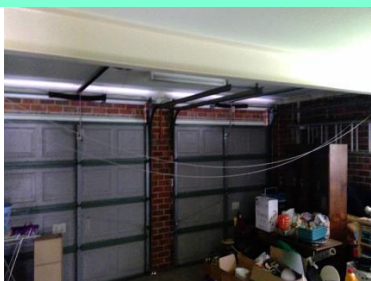
**GARAGE**

**Walls** As tested, there was high moisture readings recorded on sections of the internal walls

**Floors** Minor concrete cracking was noted and should be monitored regularly, a structural engineer should be consulted if further deterioration is noted

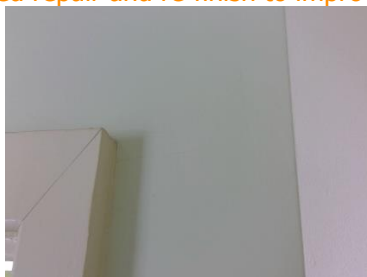
**Walls** Typical plaster cracking, will need repair and re-finish to improve appearance

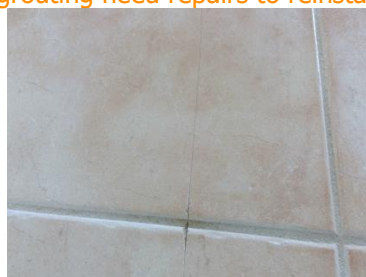
Floors	Cracked or broken tiles and/or grouting need repairs to reinstate integrity and appearance
--------	--

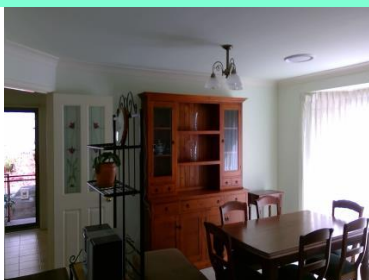
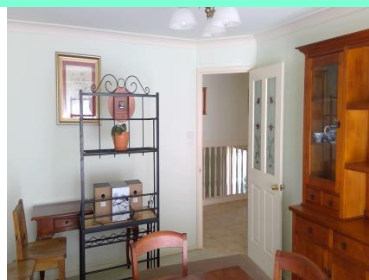
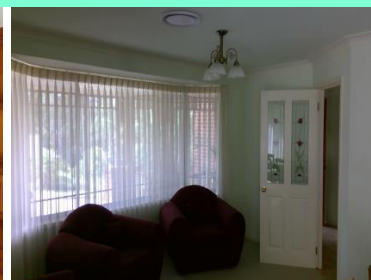
**LOUNGE**

Door	Binding, will need adjusting to ensure correct operation.
Walls	OK, The item described is performing the function it was designed for and its condition is very typical for it's age
Ceiling	Cornice cracking needs repairs to improve appearance
Floors	Out of level and will need rectification to restore correct levels and appearance
Window/s	OK, The item described is performing the function it was designed for and its condition is very typical for it's age
Painting	OK, The item described is performing the function it was designed for and its condition is very typical for it's age
Other

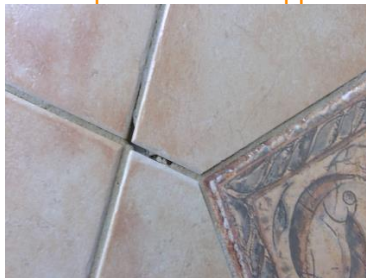
Door	Loose or faulty handle or latch needs repair to restore correct function/operation
Walls	OK, The item described is performing the function it was designed for and its condition is very typical for it's age
Ceiling	OK, The item described is performing the function it was designed for and its condition is very typical for it's age
Floors	Floor tile grout missing and will need repair to restore appearance

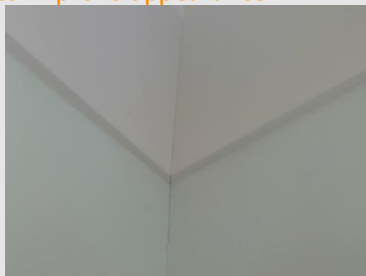
Cornice cracking needs repairs to improve appearance

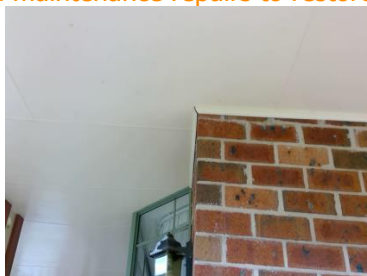
Moulding/s need/s minor typical maintenance repairs to restore appearance

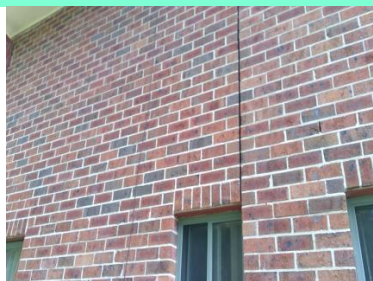
Bricks fretting

NIL, All bricks/blocks appear to be in acceptable condition for their age

Mortar eroding

Minor erosion was noted in parts, if further deterioration is noted repairs will be needed

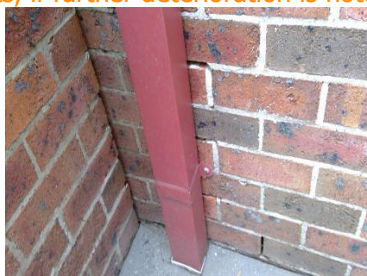
**Cracking**

Minor typical settlement cracking only category 1, not considered significant, however this should be monitored annually

**Damp Damage**

NIL, No significant dampness was noted, however this should be monitored during wet periods

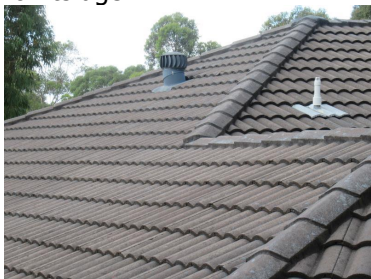
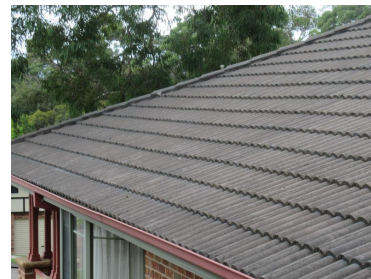
**Fascia/Barge boards**

OK, The item described is performing the function it was designed for and its condition is very typical for its age

**Gutters/Downpipes**

Damaged and will need repair or replacing

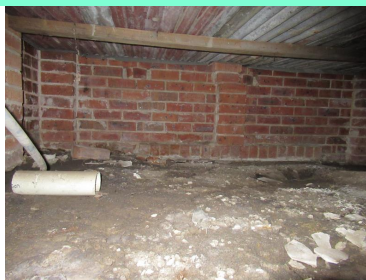
Condition of concrete OK, The item described is performing the function it was designed for and its condition is very typical for it's age

Dampness Significant dampness was noted, I recommend the site drainage be improved to help minimise dampness in this area

Drainage Inadequate, I recommend the subfloor drainage is improved, improving the site drainage may also help limit the dampness in this area

Ventilation Inadequate, I recommend the subfloor ventilation is improved

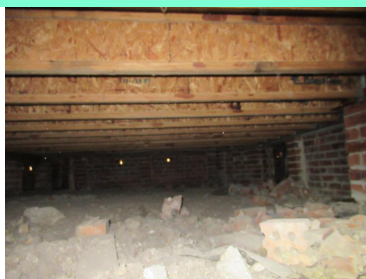
Bearers/Joists OK, The item described is performing the function it was designed for and its condition is very typical for it's age

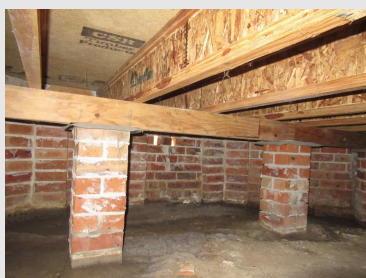
Piers/Stumps OK, The item described is performing the function it was designed for and its condition is very typical for it's age

<b>Dampness</b>	Significant dampness was noted, I recommend the site drainage be improved to help minimise dampness in this area

<b>Drainage</b>	Inadequate, I recommend the subfloor drainage is improved, improving the site drainage may also help limit the dampness in this area	
<b>Ventilation</b>	Limited in areas of the subfloor, ventilation should be improved	
<b>Cracked or leaking pipes</b>	NIL, No cracked or leaking pipes were noted at the time of the inspection, however this should be monitored periodically	
<b>Debris</b>	Timber debris within a subfloor area will form a conducive condition to potential termite attack and must be removed
