Inspection Report

Reliant Pest, Pool And Building

3 Knebworth Grove, Rathmines, NSW, 2283

Pest And Building Inspection

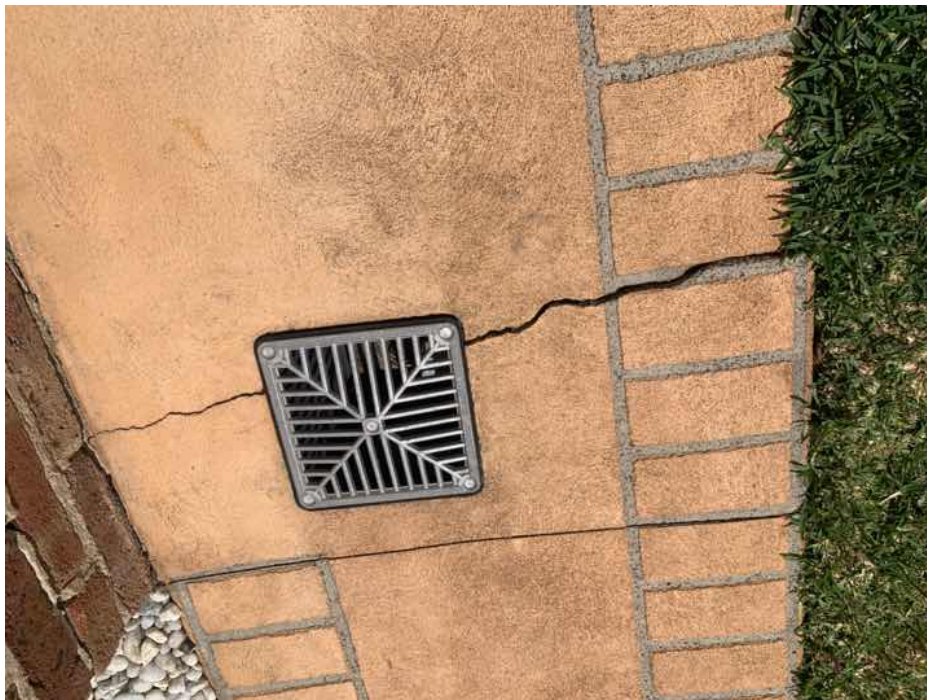
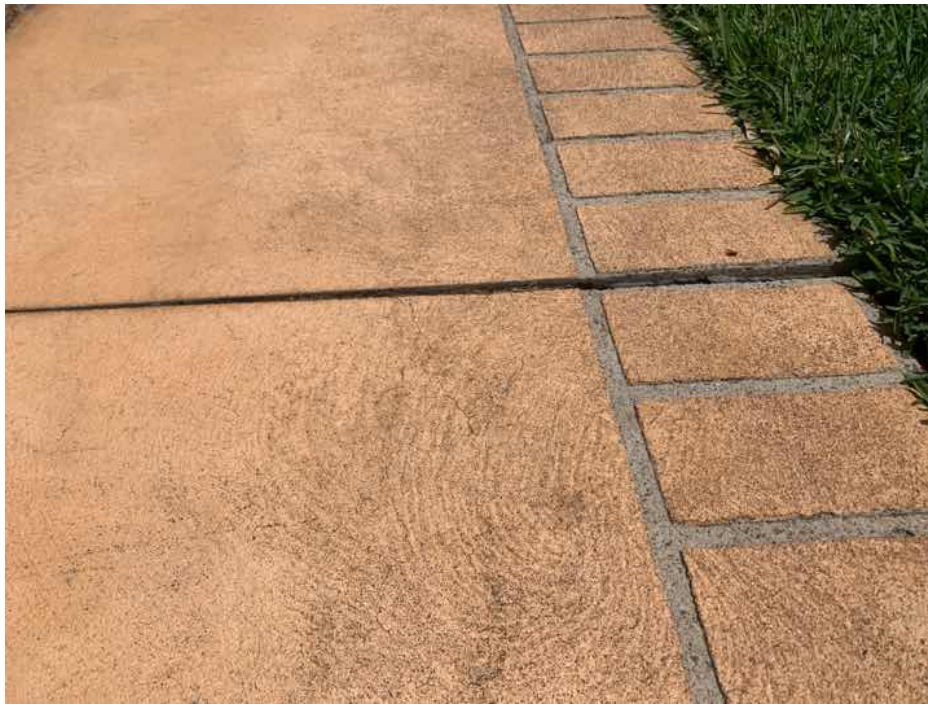
Pathways Condition

Common cracks and settlement were observed on paths. Whilst these cracks appeared to be typical at the time of inspection, we strongly recommend you monitor these cracks and if worsening occurs contact a concreter for further advice.

Surface raised and settled in some areas. This can cause water ponding. Relaying recommended.

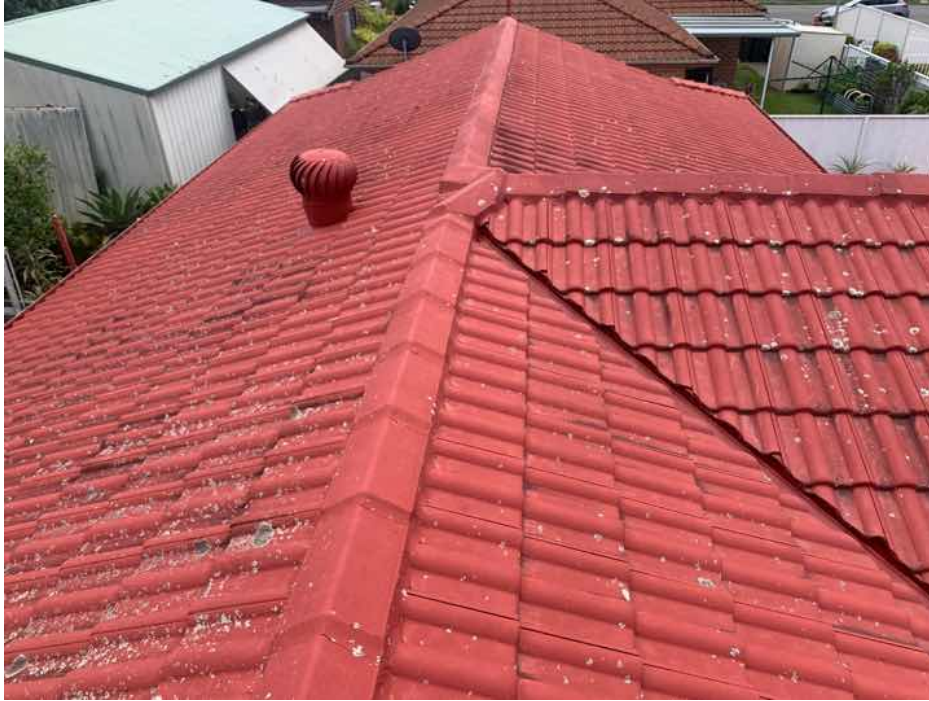
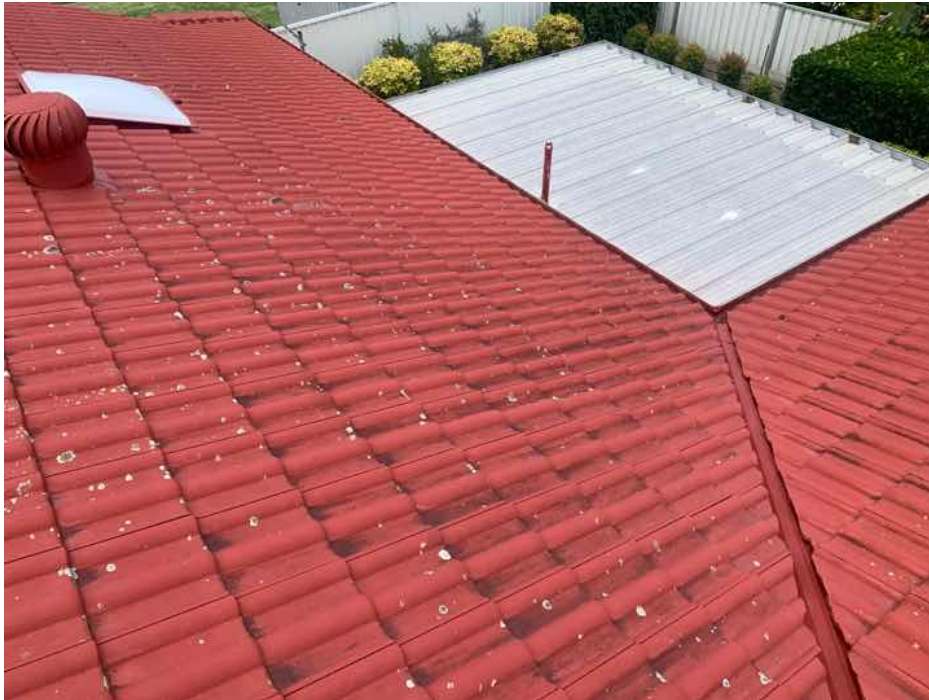
Roof Covering Type

The roofing material is a combination of tile and metal roof sheeting

Of the visible areas, the general condition of the roof is in serviceable condition for the age.

Cracked tiles visible. Contact a roof tiler for repairs. This has potential to become a serious issue if repairs aren't carried out due to water ingress into the roof cavity.

Corrosion noted to the screw fixings of the metal roof. Have these checked and replaced by qualified roofing contractor.

Moss has built up on the tiles over time. It is preferable to have removed / cleaned to prevent deterioration.

Recommendations: A qualified roof restoration contractor should be engaged for advice and recommendations.

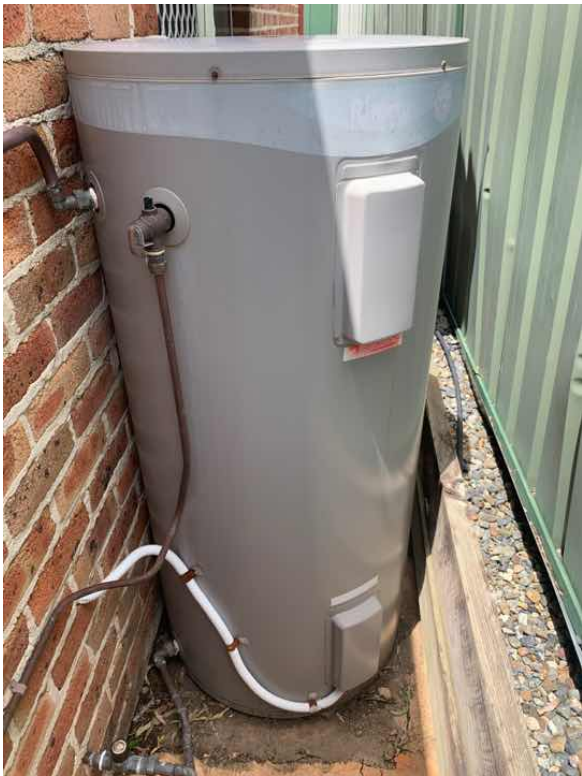
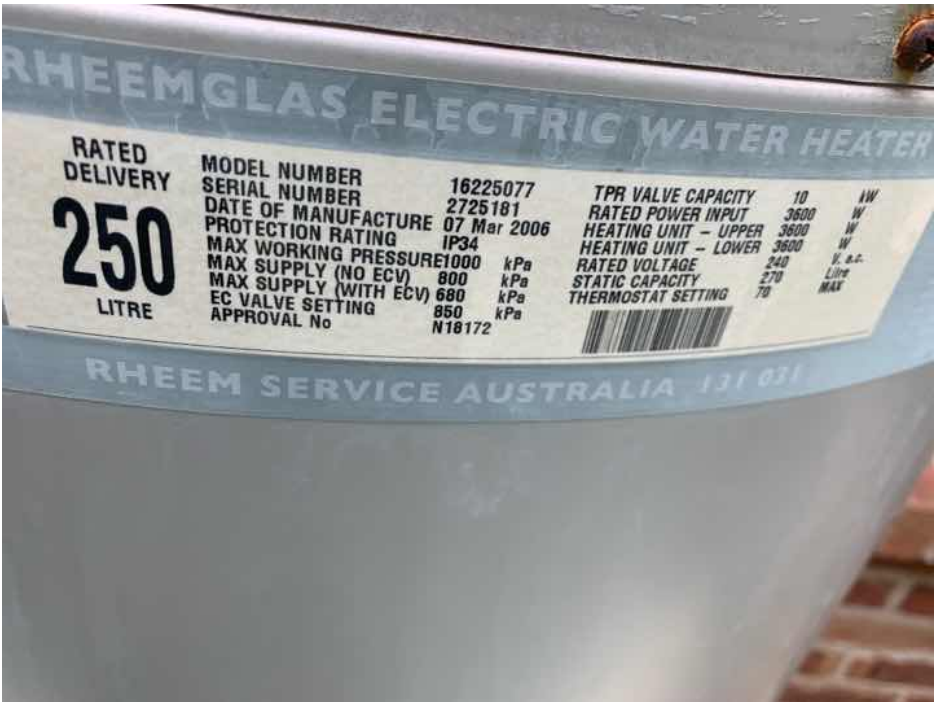
Hot Water Unit Findings

The hot water system appears to be in a serviceable condition. No specific tests other than running the hot water from a tap was carried out. No determination has been made as to the suitability or adequacy of the hot water system in relation to capacity or otherwise.

The hot water unit is located outside.

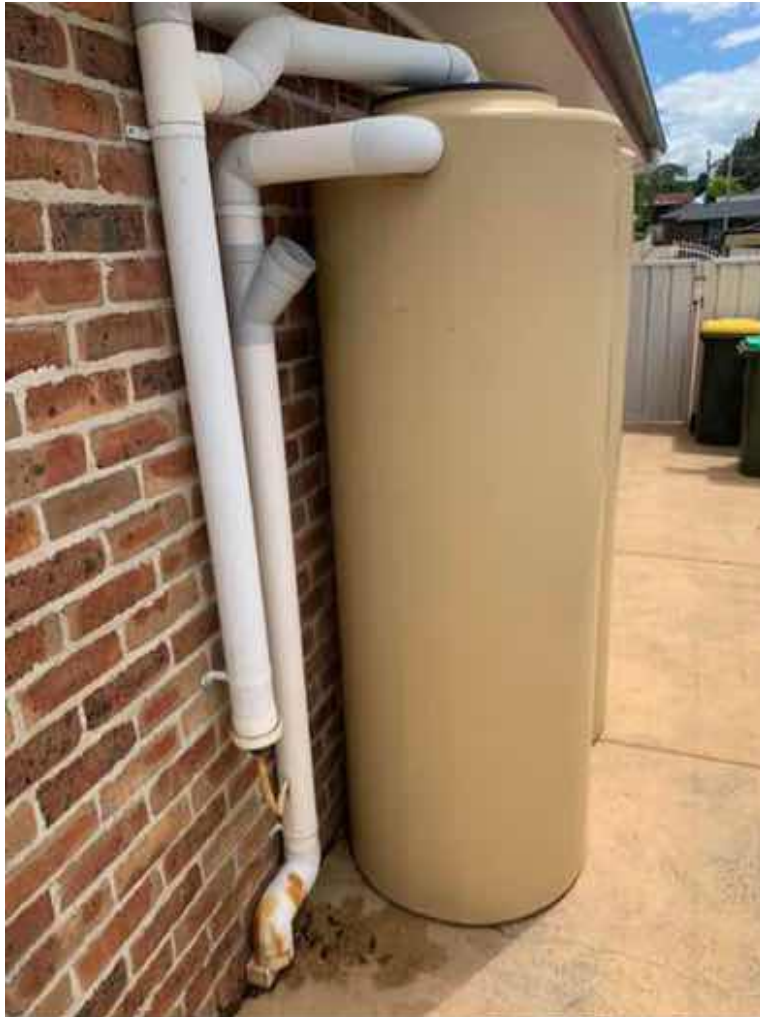
Water Tank**Water Tank Condition**

On Visual Inspection the water tank appears serviceable, but should be checked by a qualified plumber.

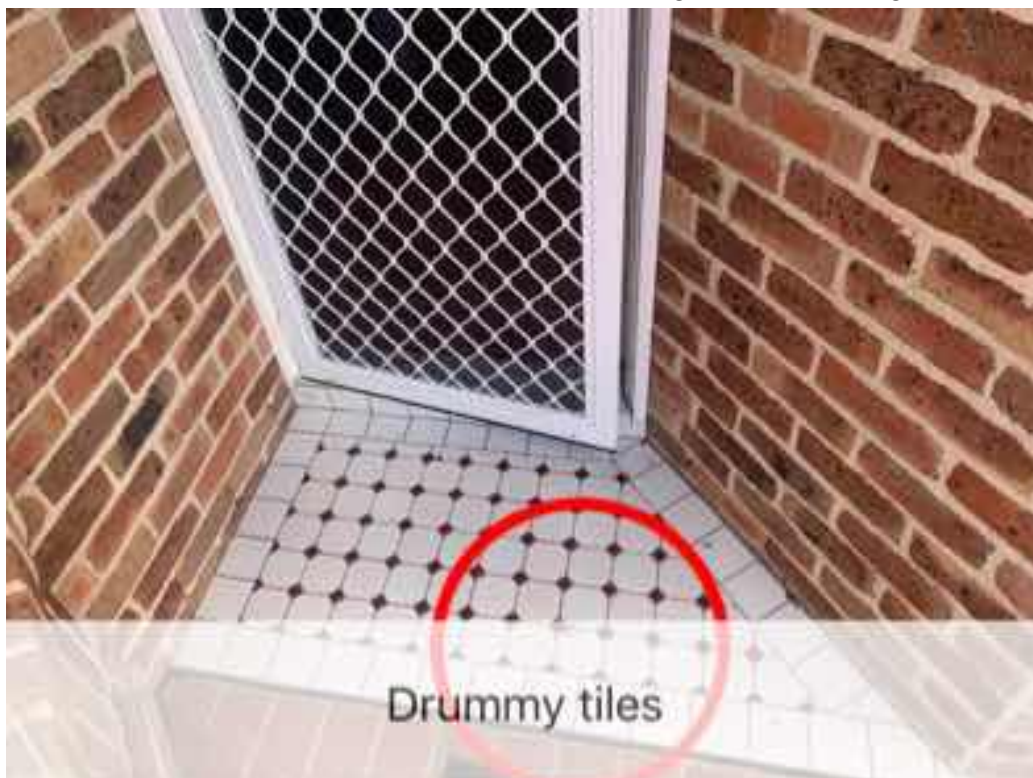
The entry porch serviceable or in reasonable or condition for the age of this dwelling.

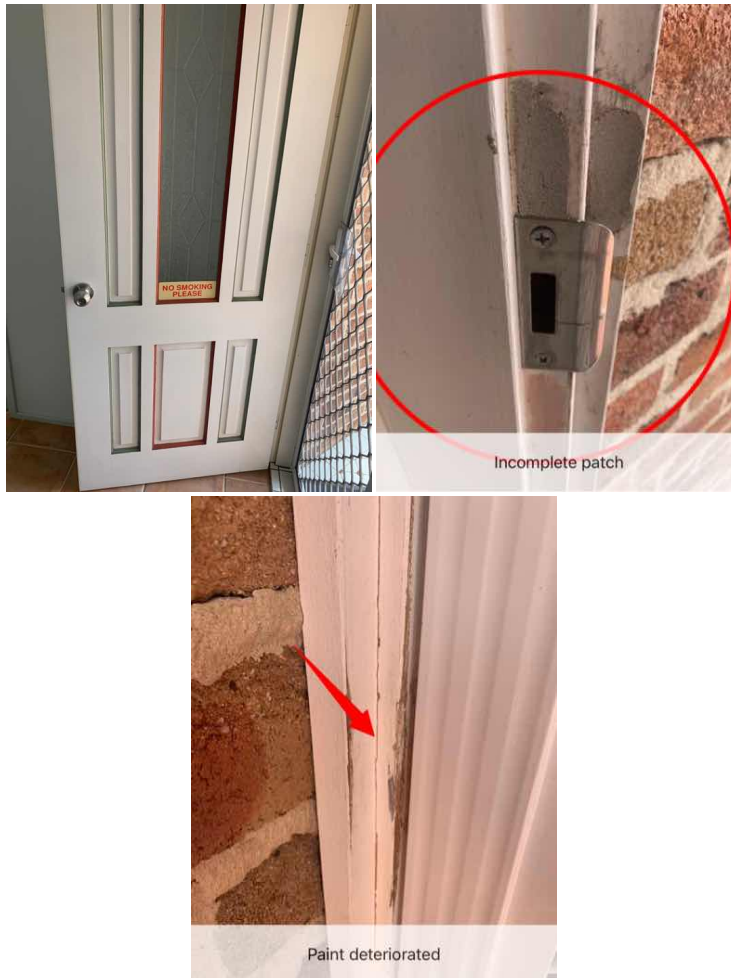
Door Findings

On Visual Inspection the external condition of the doors is serviceable.

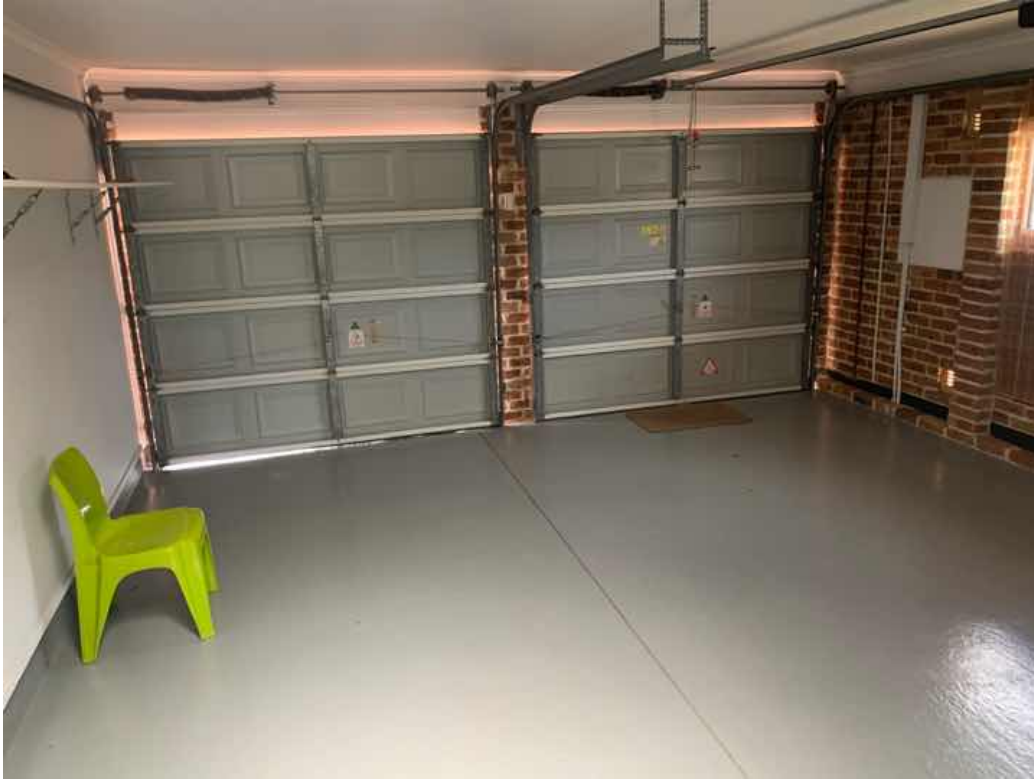
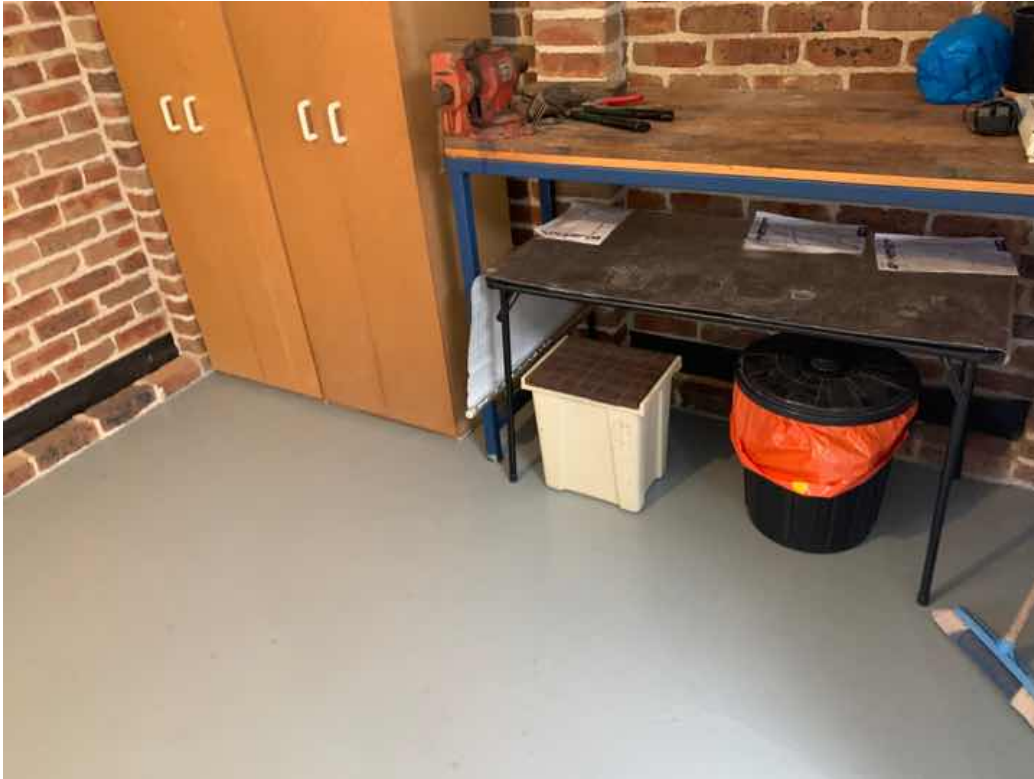
Attached garage.

Stored items restricted a full and thorough inspection of this area. Defects may exist in the obstructed and inaccessible areas. It is strongly recommended that full access be granted to enable a thorough inspection as there may be timber pest activity, damage or defects. Note: Where vehicles and storage has restricted a full inspection it is advised that this area be cleared so a full and unobstructed inspection can be carried out.

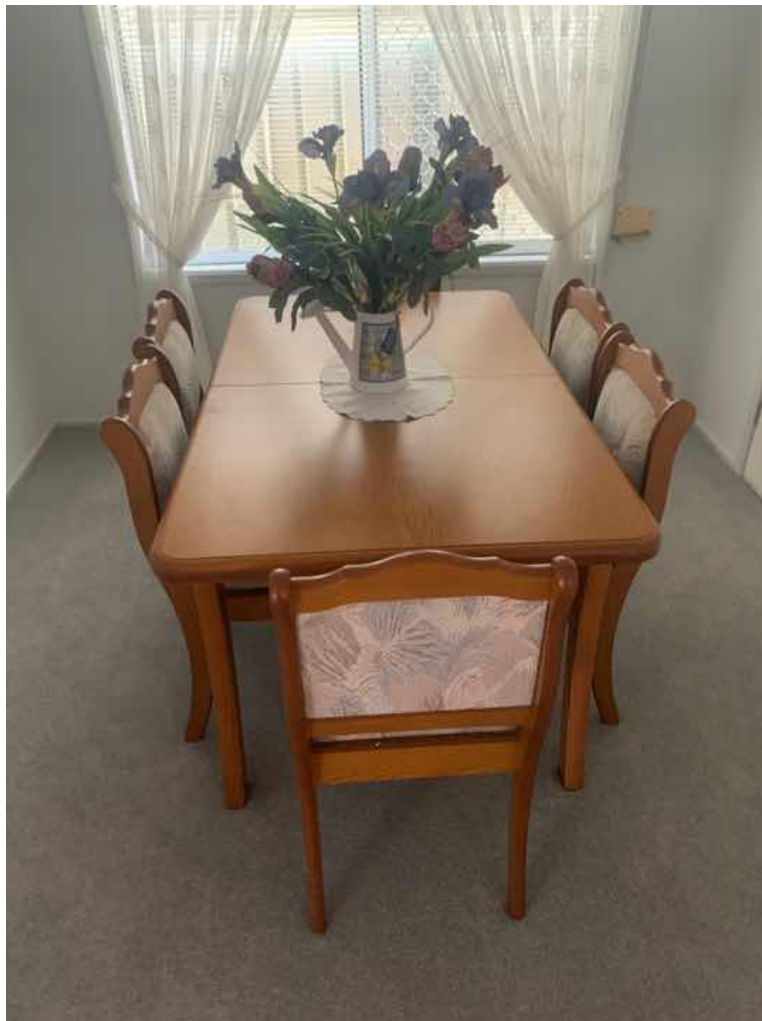
Dining Room

From the visible and accessible areas, this room appears to be in a serviceable condition for the age of the property with no notable structural defects sighted.

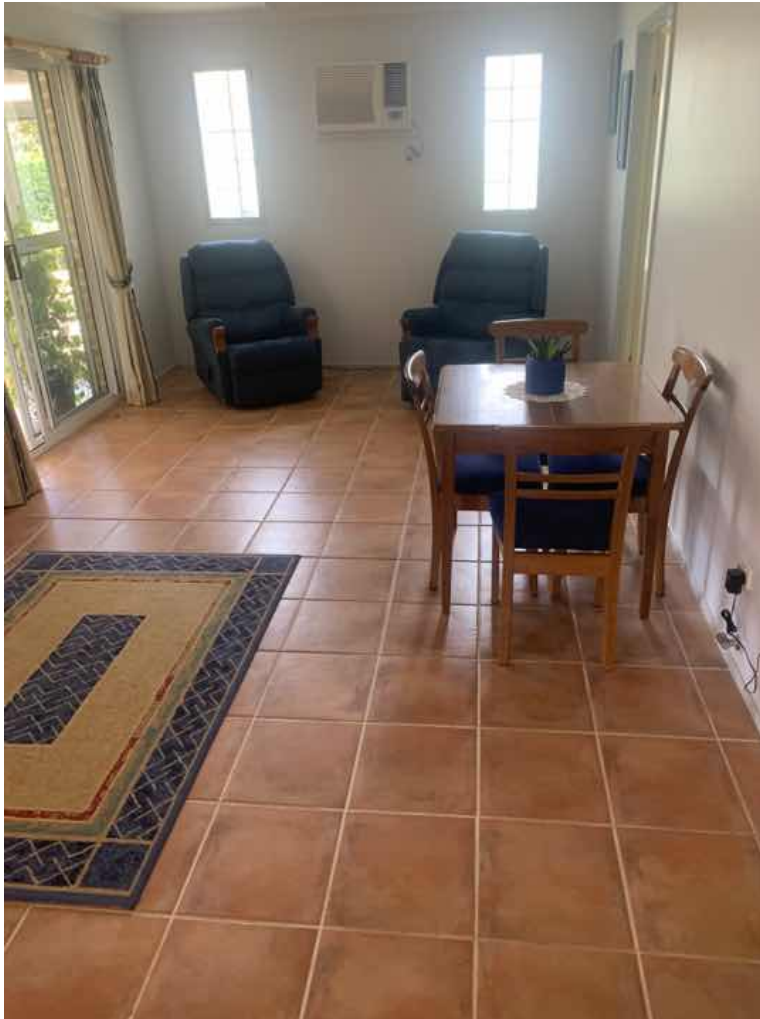
Combined Living & Dining

From the visible and accessible areas, this room appears to be in a serviceable condition for the age of the property with no notable structural defects sighted.

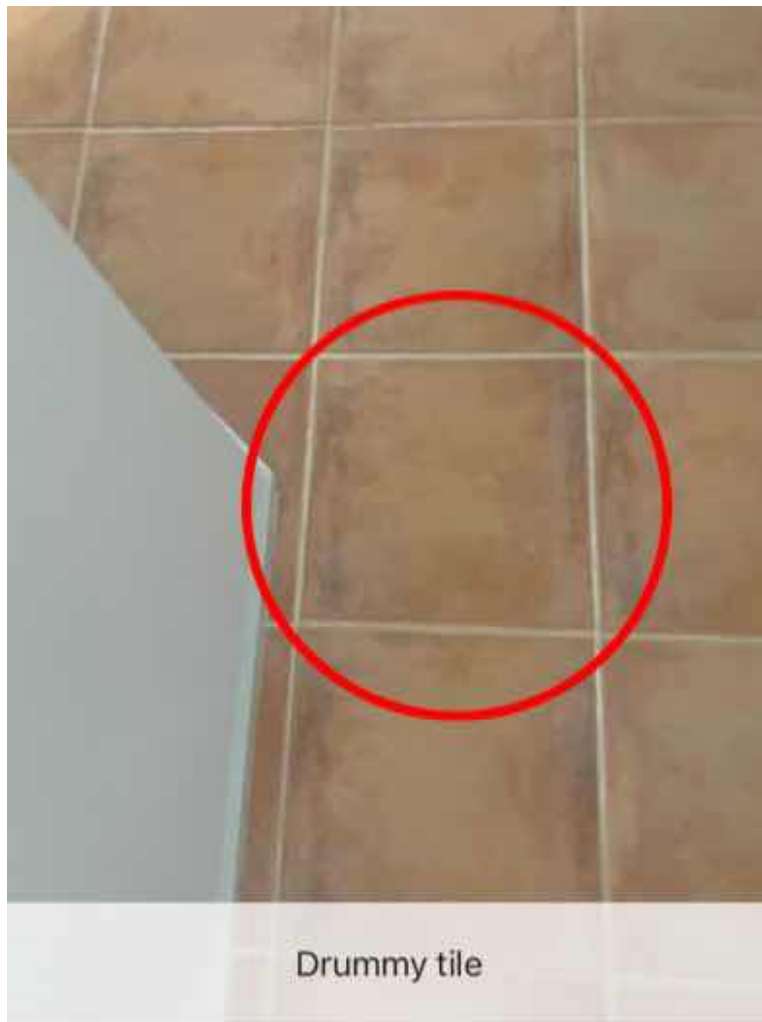
Hallway/s

From the visible and accessible areas, the hallway/s/ appears to be in a serviceable condition for the age of the property with no notable structural defects sighted.

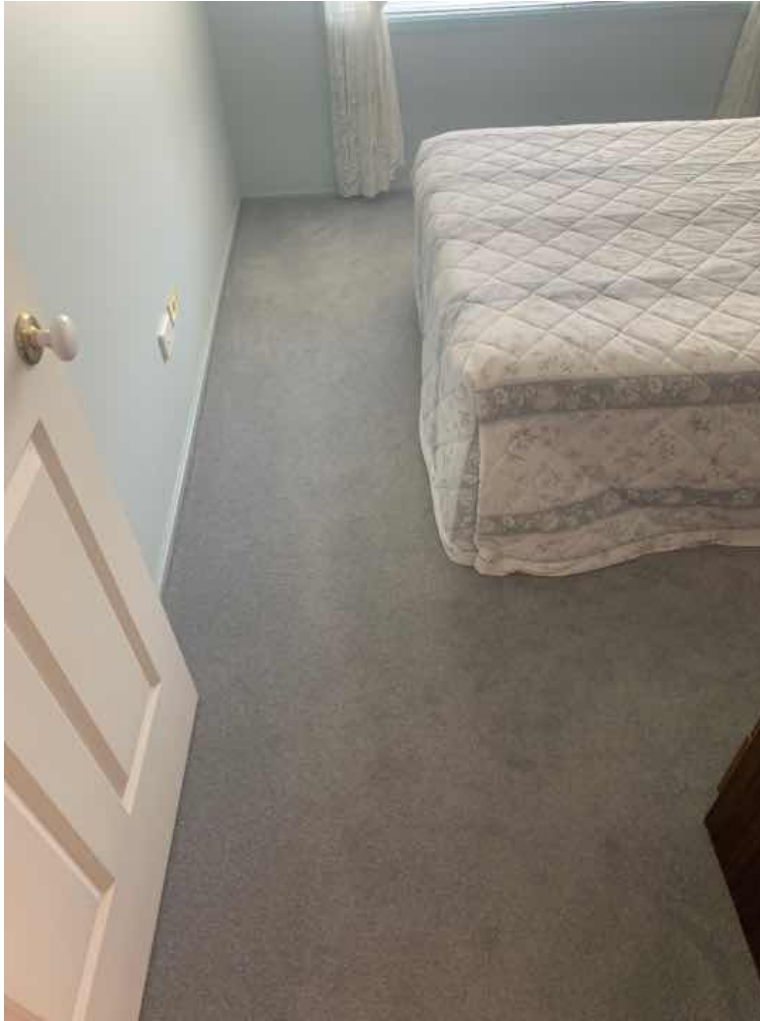
**Bedroom 1****Overall Condition**

From the visible and accessible areas, this bedroom appears to be in a serviceable condition for the age of the property with no notable structural defects sighted.

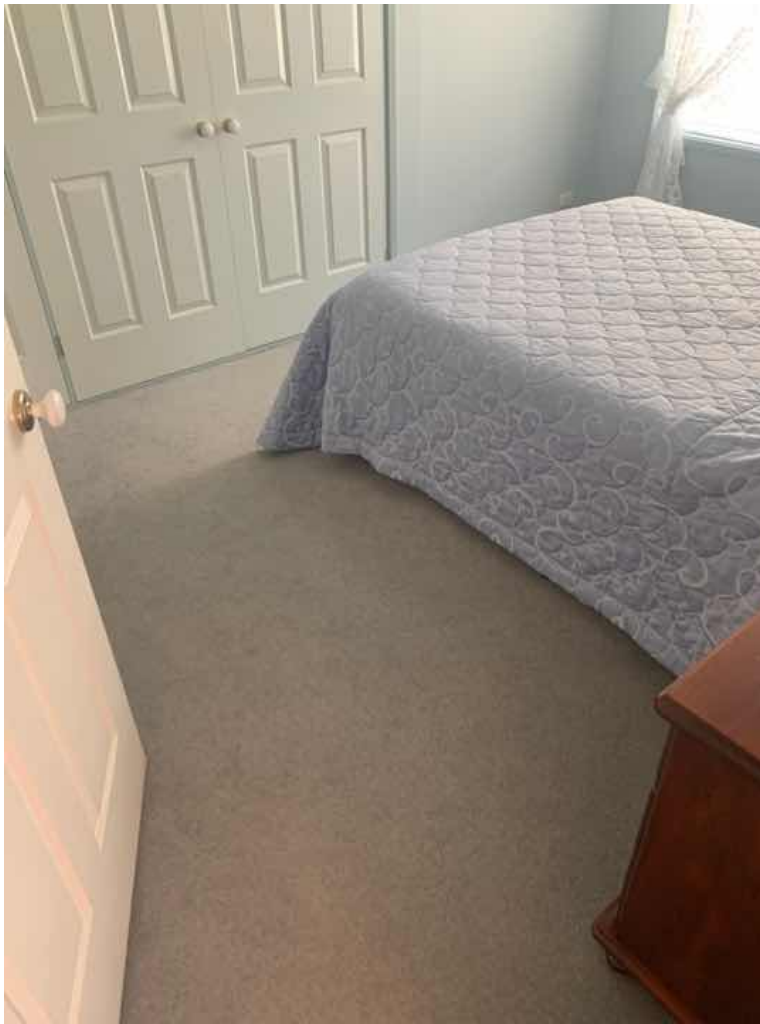
Bedroom 2

From the visible and accessible areas, this bedroom appears to be in a serviceable condition for the age of the property with no notable structural defects sighted.

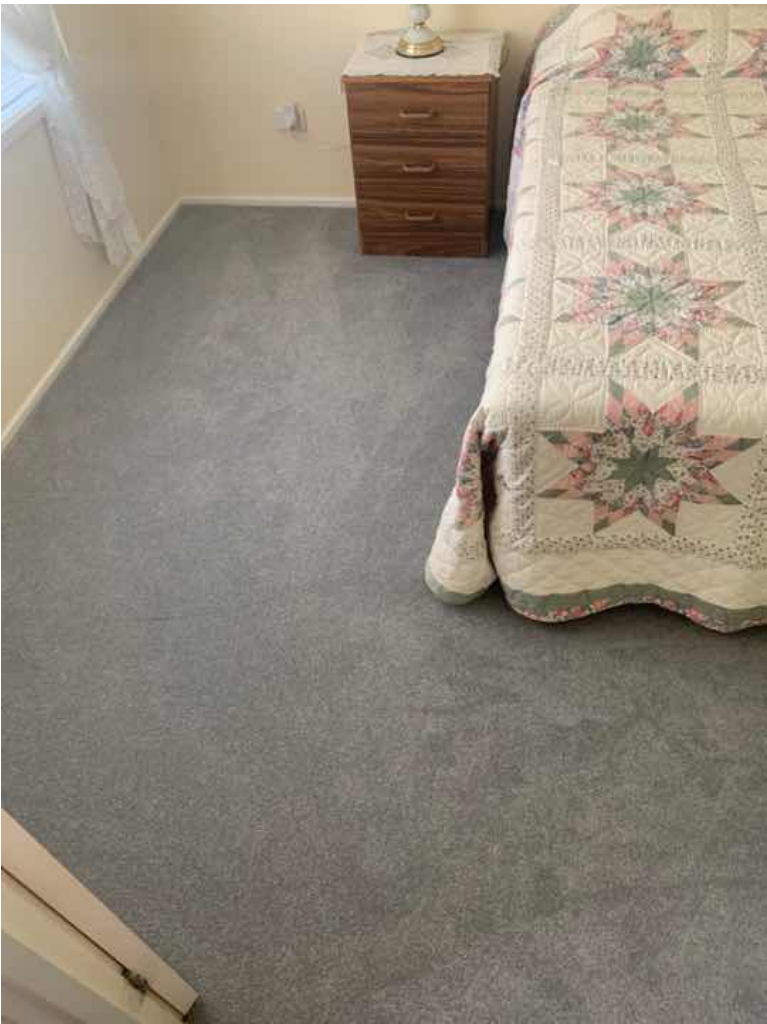
Bedroom 3

From the visible and accessible areas, this bedroom appears to be in a serviceable condition for the age of the property with no notable structural defects sighted.

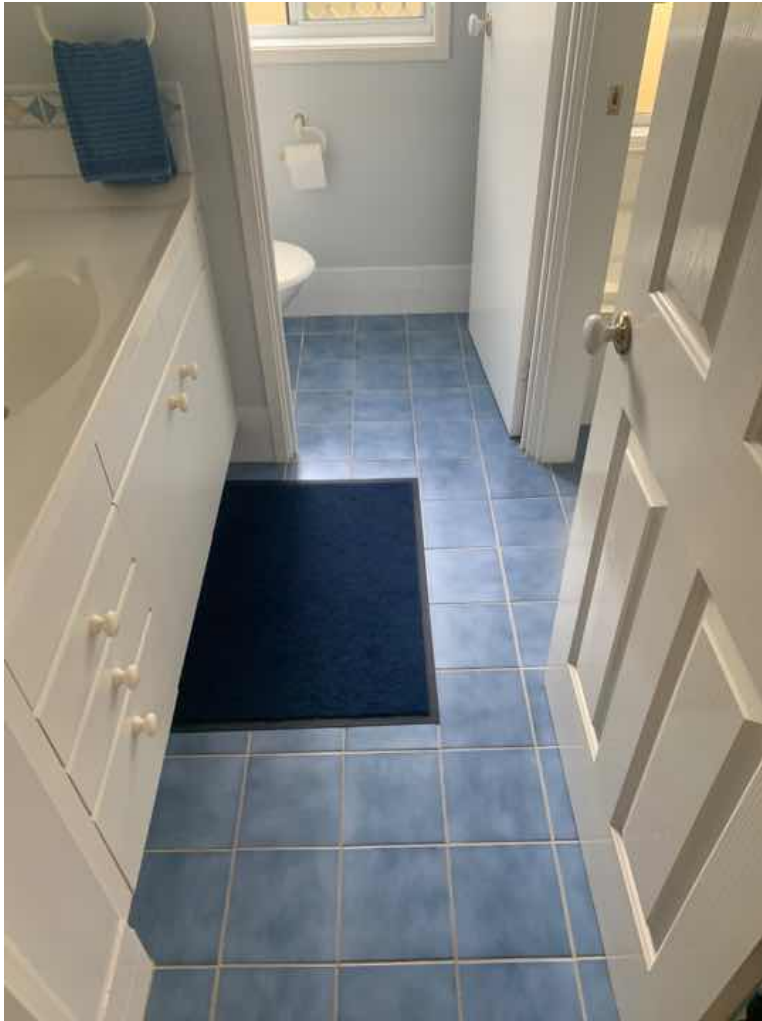
Bathroom 1

This bathroom is located in the hallway.

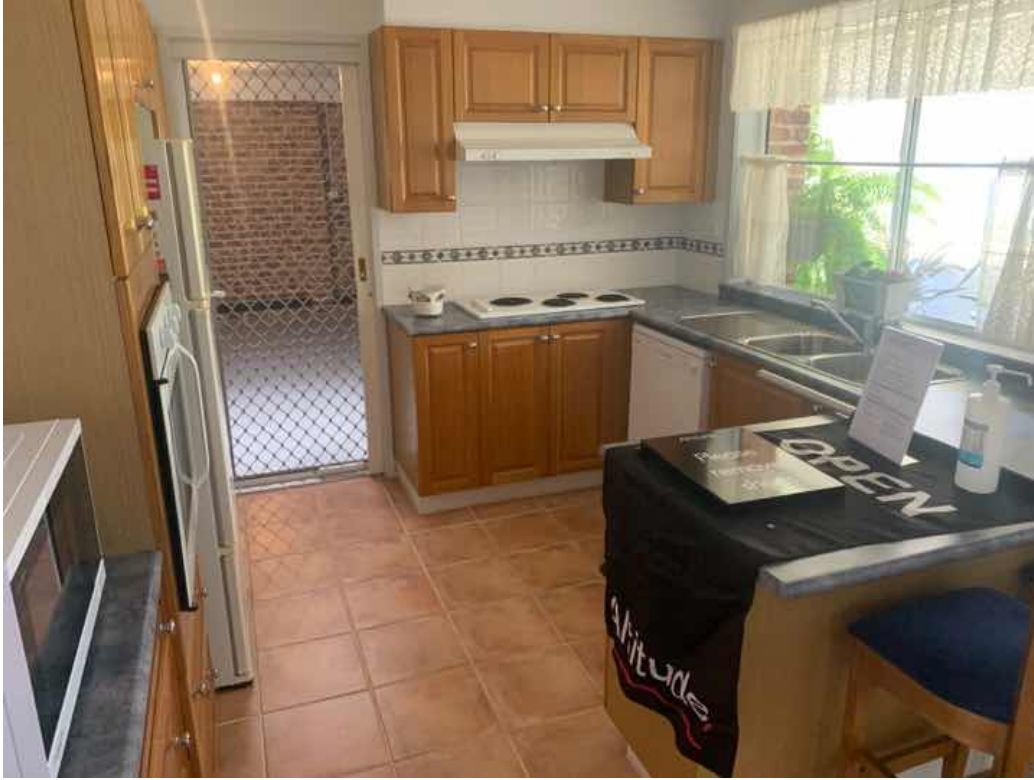
Of the visible areas, the general condition of the kitchen is serviceable or in reasonable condition for age of dwelling.

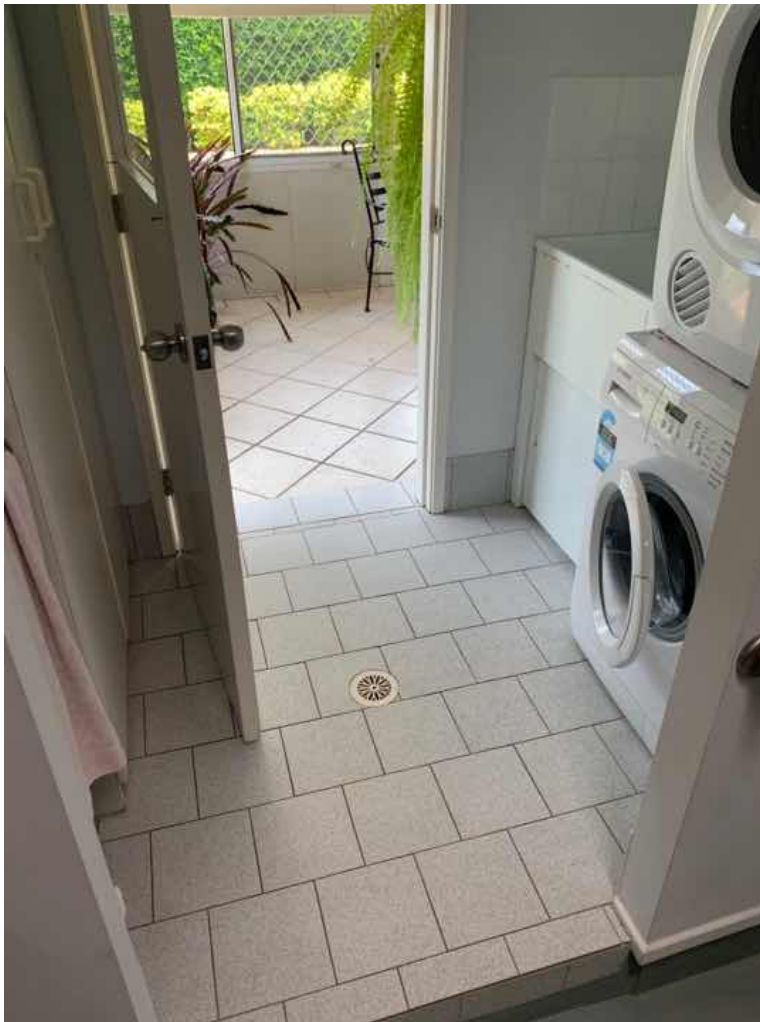
Laundry

Of the visible areas, the general condition of the laundry is serviceable or in reasonable condition for age of dwelling.

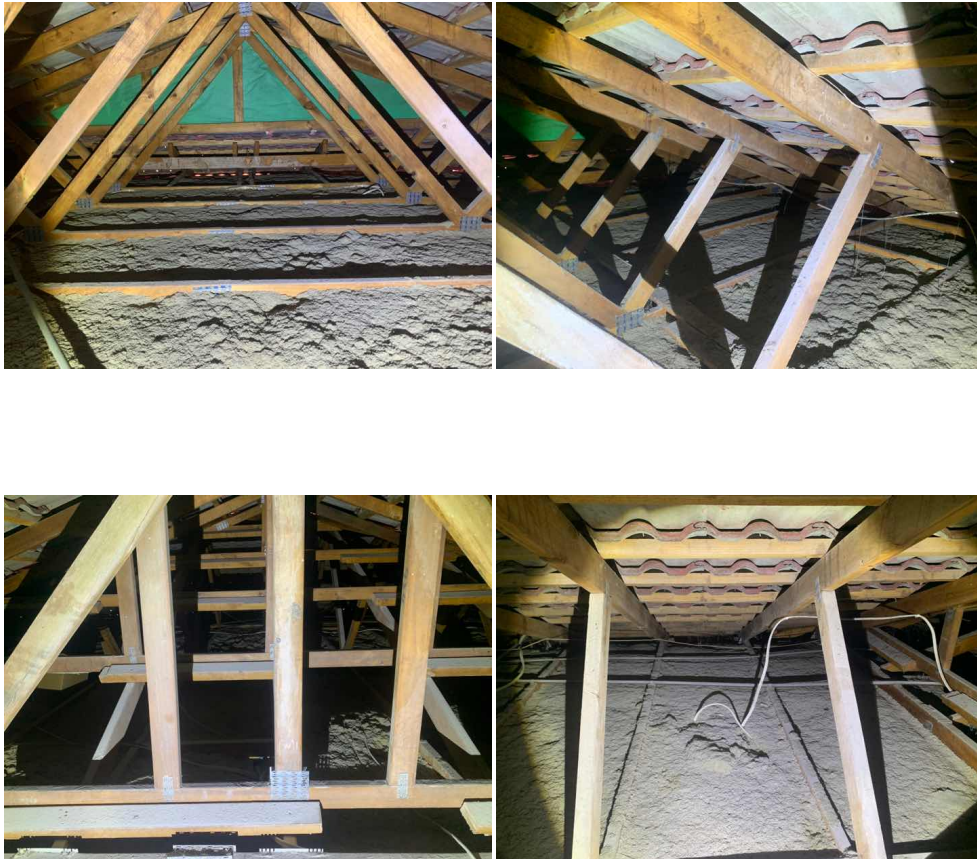
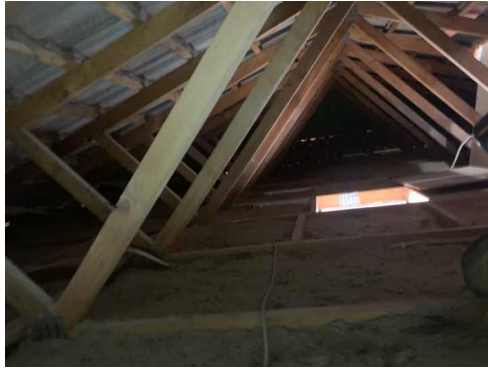
Viewed from out side due to restricted entry. No comment can be made regarding condition

Views from outside due to restricted entry. No comment can be made regarding condition.

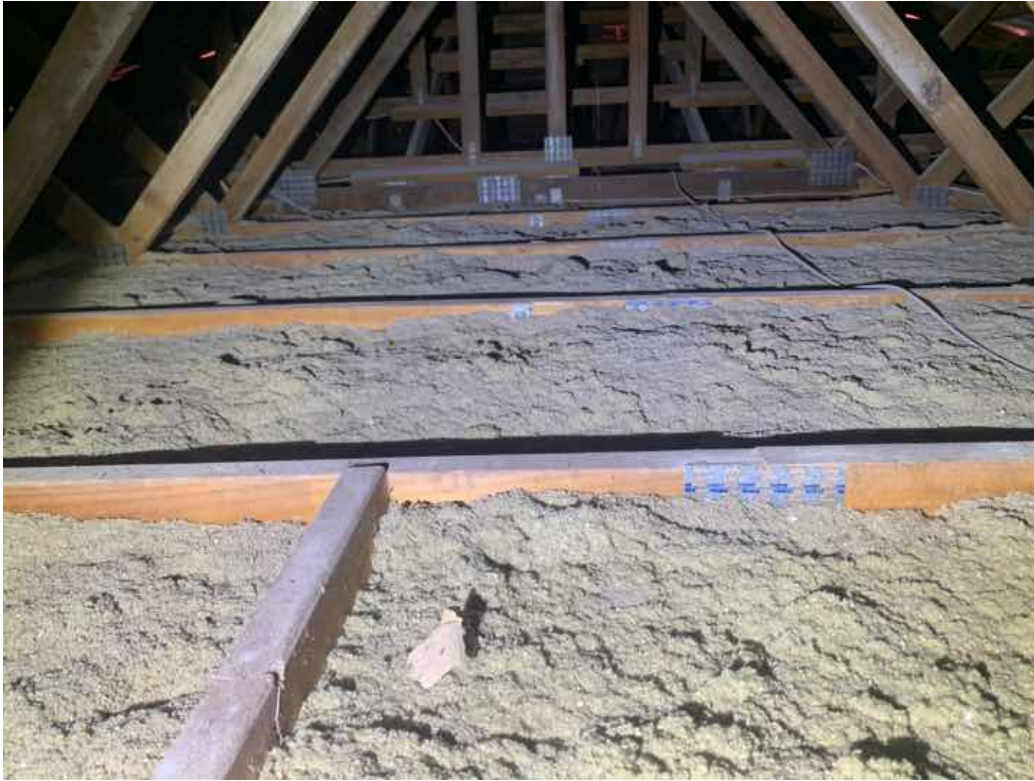
The roof space is insulated with loose fill insulation.

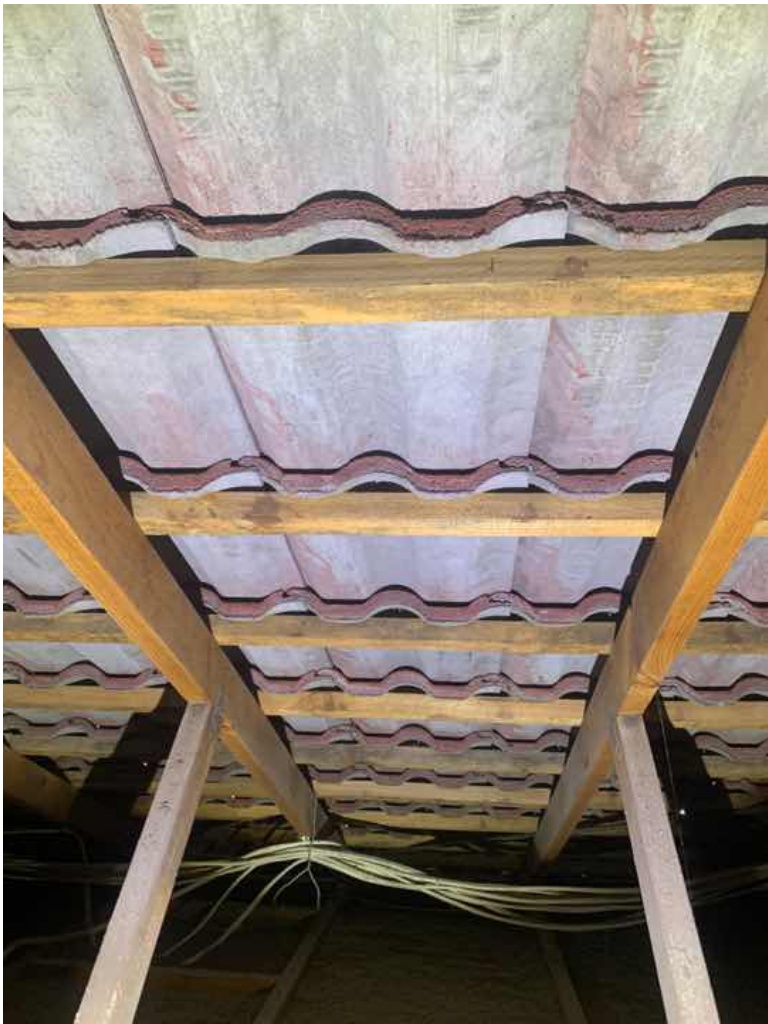
Sarking

sarking is not Installed.

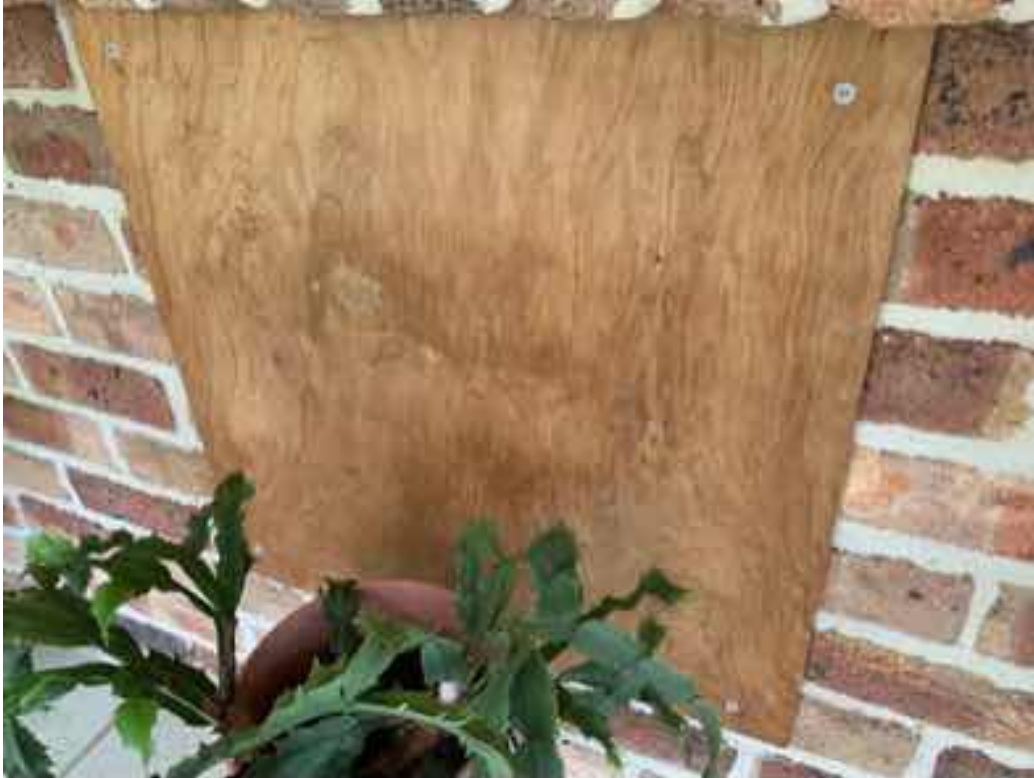
Apparent Concealment of possible defects**Were apparent Concealments seen**

Possible attempts to conceal defects were noticed.

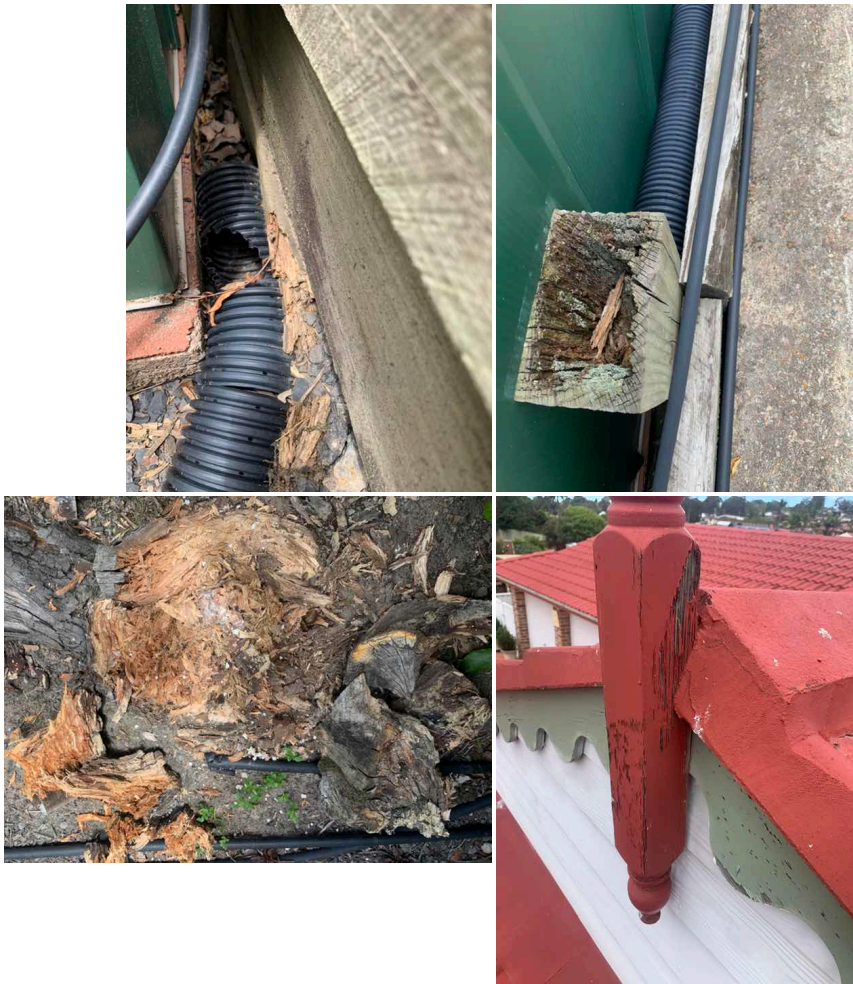
Any Damage caused by Wood Decay, Rot Found

Yes: please read this report in its entirety.

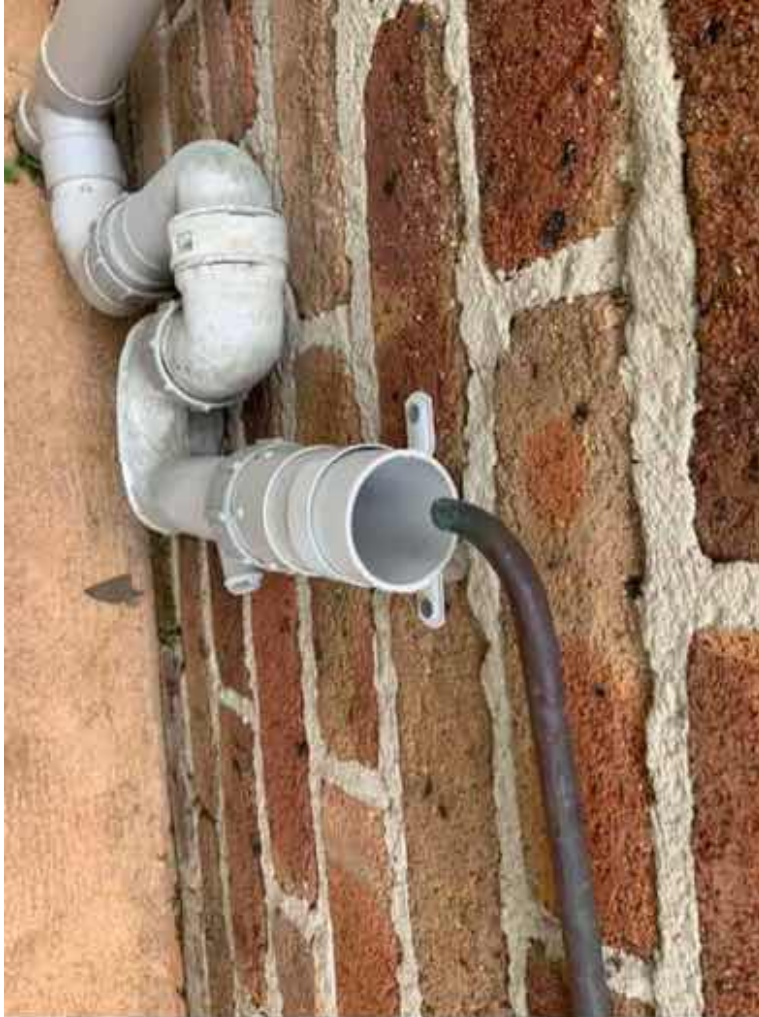
Was the overflow sufficiently drained

Yes. The hot water overflow does not drain to the perimeter of the building.

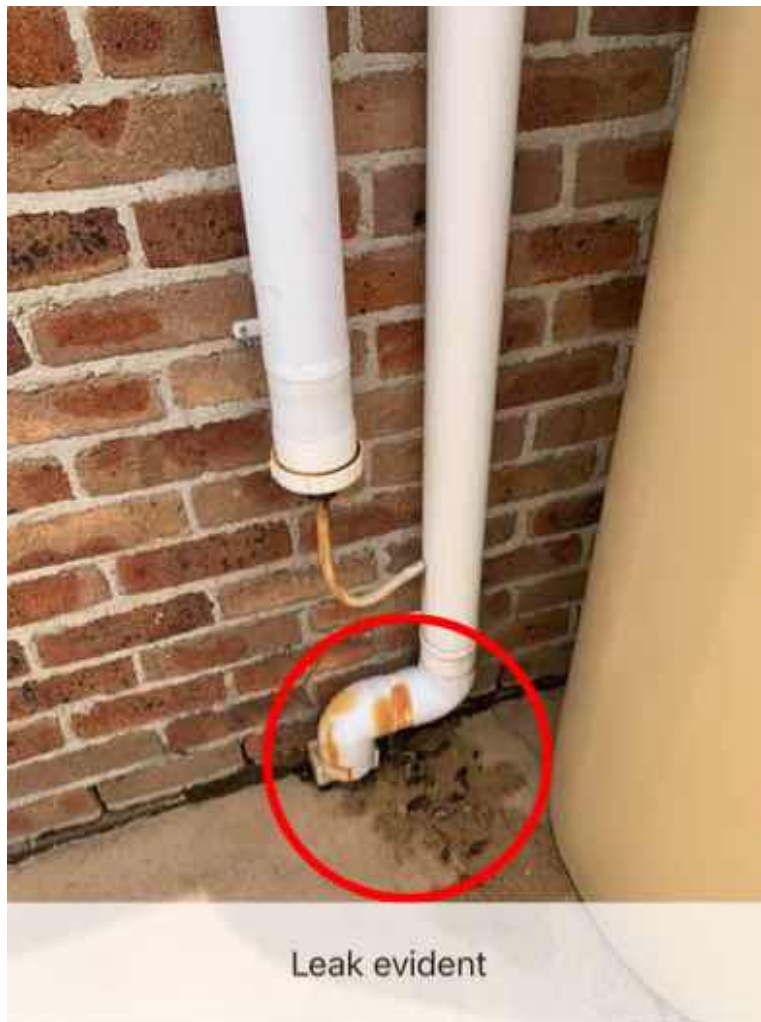
Was the Water tank Overflow connected to Storm

Yes. The overflow does not drain to the perimeter of the building.
