# STANDARD RESIDENTIAL BUILDING INSPECTION REPORT

**70 BOUSFIELD STREET, WALLSEND**

**Property Address:** 70 BOUSFIELD STREET  
WALLSEND NSW 2287

**Inspection Date/Time:** 4/06/2018 1:17 PM

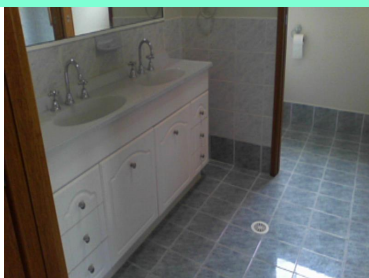
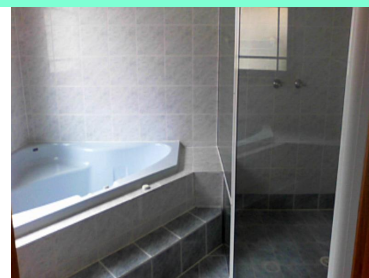
### BATHROOM

Walls	OK, The item described is performing the function it was designed for and its condition is very typical for it's age
Ceiling	Water damage needs repair and re-finish to restore appearance

Floors	As tested there was high moisture readings found in areas of bathroom floor

Painting	OK, The item described is performing the function it was designed for and its condition is very typical for it's age
Other	Loose PC items, toilet roll holder, towel rails or handrails will need repairs to restore integrity
Vanity	Binding cupboard doors/drawers will need adjusting or repair to restore correct function
Basin	OK, The item described is performing the function it was designed for and its condition is very typical for it's age
Taps	OK, The item described is performing the function it was designed for and its condition is very typical for it's age
Waste Traps	OK, The item described is performing the function it was designed for and its condition is very typical for it's age

Splashbacks	OK, The item described is performing the function it was designed for and its condition is very typical for it's age
Bath	OK, The item described is performing the function it was designed for and its condition is very typical for it's age
Shower	OK, The item described is performing the function it was designed for and its condition is very typical for it's age
Screen/Curtain	Damaged or stained screen/door and or screens will need repair to restore integrity and appearance

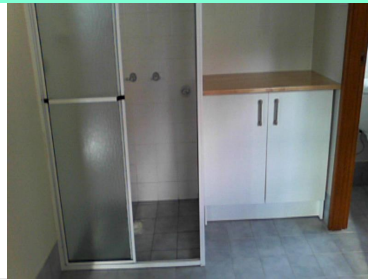
**BATHROOM 2**

Door Cavity door frame is water damaged needs repairs to ensure integrity

Floors As tested there was high moisture readings found in areas of bathroom floor

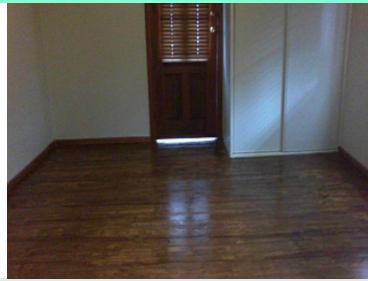
**BEDROOM 1**

Door	OK, The item described is performing the function it was designed for and its condition is very typical for it's age
Walls	OK, The item described is performing the function it was designed for and its condition is very typical for it's age
Ceiling	Cornice cracking may need repairs to improve appearance
Floors	Borer damage was evident to flooring boards refer to a pest inspection report for further details, flooring out of level may need repairs to restore correct levels
Window/s	OK, The item described is performing the function it was designed for and its condition is very typical for it's age
Painting	OK, The item described is performing the function it was designed for and its condition is very typical for it's age
Other	Ceiling fan appears ok
Robes	OK, The item described is performing the function it was designed for and its condition is very typical for it's age

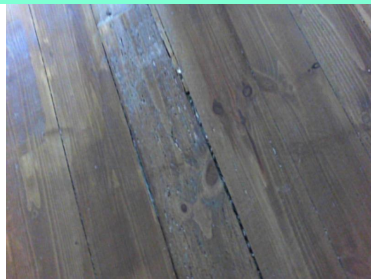
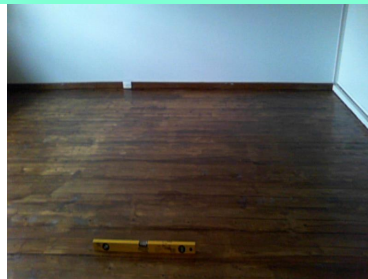
**BEDROOM 2**

Door	OK, The item described is performing the function it was designed for and its condition is very typical for it's age
Walls	Minor joint cracking needs repair and re-finish to restore appearance, loose skirt board noted
Ceiling	OK, The item described is performing the function it was designed for and its condition is very typical for it's age
Floors	Out of level and may need repair to restore acceptable levels and appearance and borer damage noted to boards refer to pest inspector and report
Window/s	OK, The item described is performing the function it was designed for and its condition is very typical for it's age
Painting	OK, The item described is performing the function it was designed for and its condition is very typical for it's age
Other	Air-conditioning unit not tested
Robes	OK, The item described is performing the function it was designed for and its condition is very typical for it's age

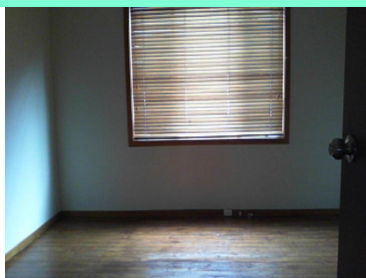
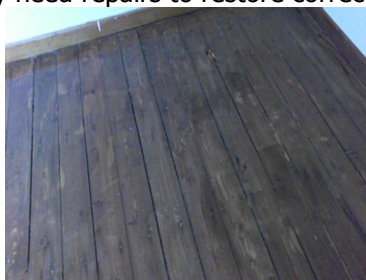
**BEDROOM 3**

Door	OK, The item described is performing the function it was designed for and its condition is very typical for it's age
Walls	OK, The item described is performing the function it was designed for and its condition is very typical for it's age
Ceiling	OK, The item described is performing the function it was designed for and its condition is very typical for it's age
Floors	Borer damage was evident to flooring boards refer to a pest inspection report for further details, out of level flooring may need repairs to restore correct levels

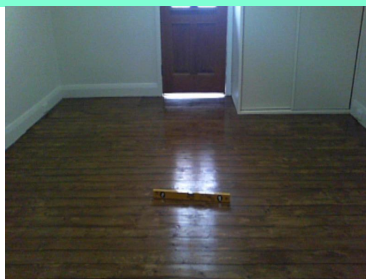
**BEDROOM 4**

Door	Binding, will need adjusting to ensure correct operation.
------	-----------------------------------------------------------

Borer damage was evident to flooring boards refer to a pest inspection report for further details

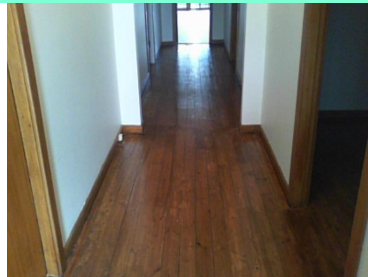
**ENTRY****INCLUDING HALLWAY**

Damaged outside face will need repair to improve appearance, binding noted

Out of level and may need repair to restore acceptable levels and appearance

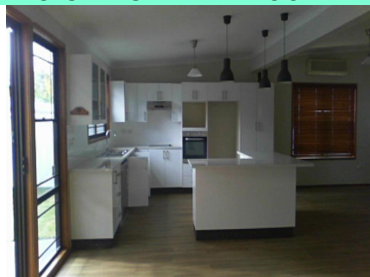
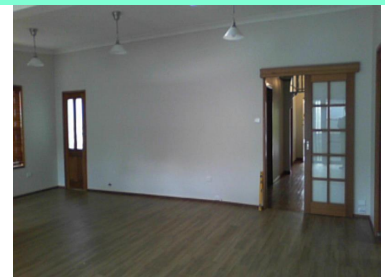
**KITCHEN****INCLUDING FAMILY ROOM**

Screen/Security door is damaged and will need repair to restore integrity and appearance

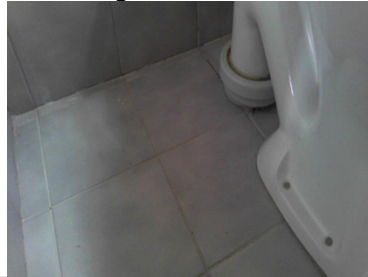
**WC / TOILET 2**

Door	OK, The item described is performing the function it was designed for and its condition is very typical for it's age
Walls	OK, The item described is performing the function it was designed for and its condition is very typical for it's age
Ceiling	OK, The item described is performing the function it was designed for and its condition is very typical for it's age
Floors	As tested there was high moisture readings found in areas of floor

Window/s	OK, The item described is performing the function it was designed for and its condition is very typical for it's age
Painting	OK, The item described is performing the function it was designed for and its condition is very typical for it's age
Other	
Cistern	Rear of cistern is leaking and will need repair to prevent further water damage by licensed plumber

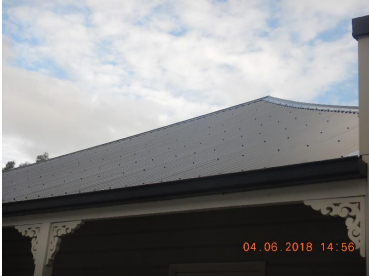
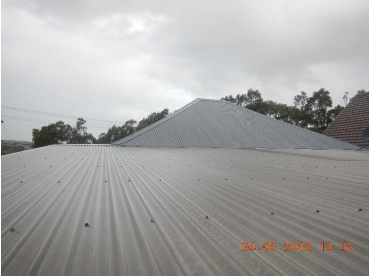
**ROOF EXTERIOR** Limited access due to excess heights only accessible areas reported on

Fascia/Barge boards Timber fascia/barge boards need repair and paint to prevent further damage

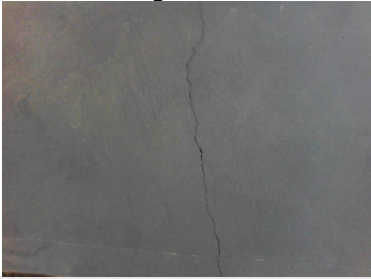
Off street parking	Adequate areas for parking have been provided	
Retaining walls	OK, The item described is performing the function it was designed for and its condition is very typical for it's age	
Clothes Line	OK, The item described is performing the function it was designed for and its condition is very typical for it's age	
Boundary Fences / Gates	Some components of the fences are rotten and will need repair or replacing to reinstate its integrity
