Case Study

Cape Flattery Silica Mine Wharf Pile Repairs 2001

Client Name: Transfield Construction

Description of Works: PMG were contracted to seal holes in 142 piles at the Cape Flattery Silica Mine Wharf, using underwater welding techniques.

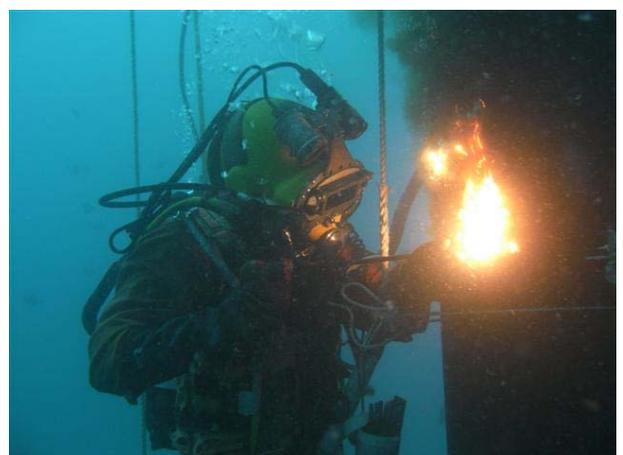
A portable dive spread, decompression chamber, underwater welding spread and Broco ultrathermic cutting spread were utilised for the project.
