Abbot Point  
Stormwater Return Dam  
(EPBC 2010/5561)  
2013 Water Quality Monitoring  
Report  
28 January 2014

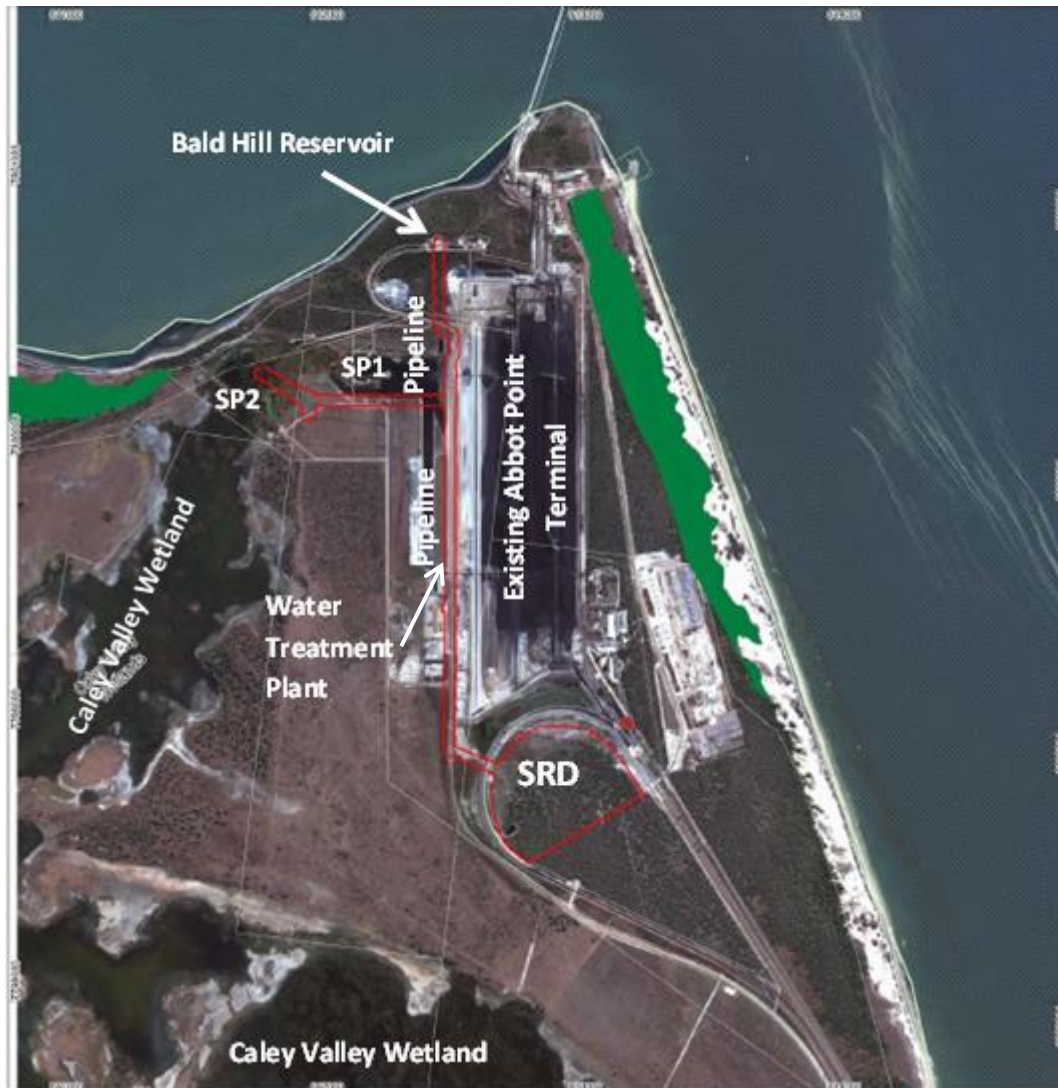
**Figure 1 – Abbot Point Stormwater Return Dam**

As part of the expansion of T1 to 50 Mtpa annual throughput capacity (X50 Project), stormwater augmentation works were proposed to increase the capacity of the stormwater management network on site. The works included the construction of a high density polyethylene (HDPE) lined 565 mega-litre capacity SRD and the following associated infrastructure (refer to Figure 1):

- Sediment Pond No.2 (SP2) intake platform and channel (located within the bounds of the existing SP2);
- SRD water treatment plant (SRD WTP); and
- Two primary pipelines including:
  - A water return pipeline connecting the SP2 intake platform and channel with the SRD WTP and SRD; and
  - A supply water pipeline, connecting the SRD with the existing Bald Hill reservoir.
