YARA PILBARA BUND INTEGRITY PROJECT

KARRATHA, WA

MAINTENANCE - PROTECTIVE COATINGS

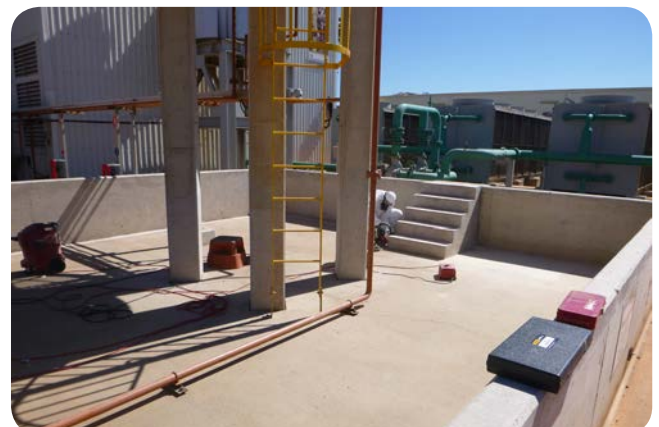
- ▶ Overview of ammonia manufacturing complex.
- ▶ Bund prior to remediation.
- ▶ Completed bund coatings.

The scope included the safe disposal of all residual processing materials followed by pressurised water washing and degreasing. After a thorough inspection of the bunds to identify cracks on the concrete walls and floors, the defects were repaired and a primer and two coats of epoxy applied.
