WELLS ROAD BRIDGE REHABILITATION WORKS

CITY OF KINGSTON, VIC

MAINTENANCE - CONCRETE REPAIRS

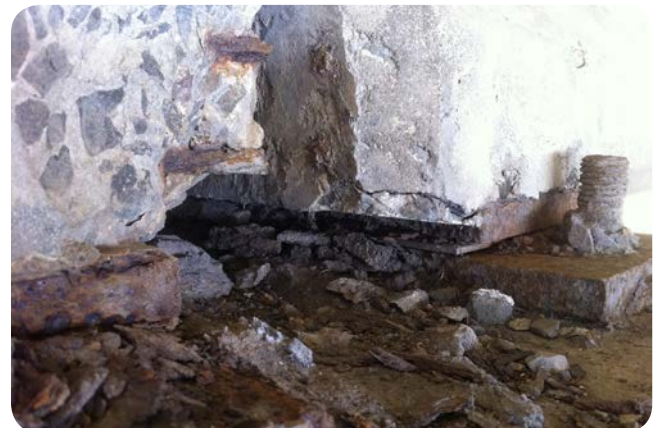
- ▶ Overview of the bridge.
- ▶ Beam and bearing typical repair type.
- ▶ Completed repair.

- ▶ Erection of scaffolding with full encapsulation to bridge bearings.
- ▶ Concrete breakout to all 200 identified areas.
- ▶ Abrasive blast steel bearing plates and steel reinforcement within concrete repair areas.
- ▶ Application of primer coat to steel bearing plates and steel reinforcement within patch repairs.
- ▶ Application of top coats to steel bearing pads.
- ▶ Completion of concrete patch repairs.
- ▶ Crack injection to nominated areas.
- ▶ Backfilling to northern abutment wall.
