CANAL BRIDGE REMEDIATION

CONCRETE REPAIRS - BRIDGES

Mulwala and Deniboota Canal Bridge Remediation

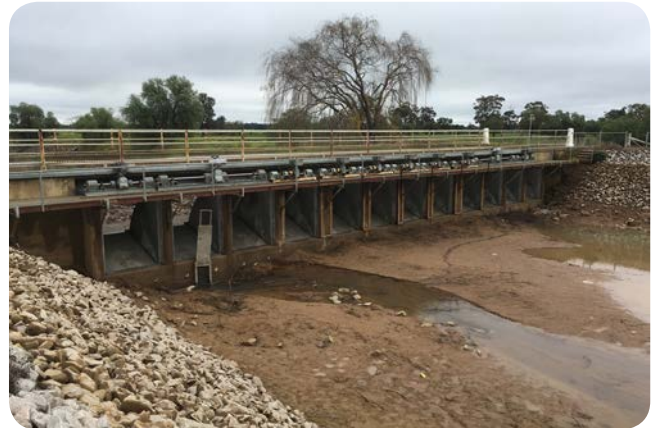
- ▶ Typical bridge structure.
- ▶ Steel augmentation to soffit.
- ▶ Complete abutment repair.
