RAAF BASE PEARCE BUILDING WORKS

BULLSBROOK, WA

BUILDING UPGRADES

RAAF Base Pearce Building Works

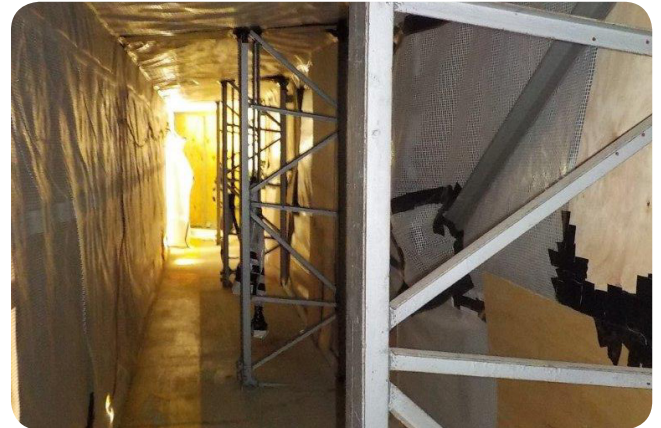
- ▶ Inside the hangar column encapsulation.
- ▶ Completed set of columns, girts, fly braces and cladding.
- ▶ Blasted hanger door being prepared for painting.

- ▶ Steelwork refurbishment works including replacing missing bolts, fabrication and installation of new steel members, replacement of deformed/corroding steel members, removal of corrosion and strengthening of weakened steel members using the plate and bolt technique.
