FAIRBAIRN DAM SPILLWAY IMPROVEMENT

ANCHORING SERVICES

Provision of Anchoring Services for Fairbairn Dam Spillway Improvement Project

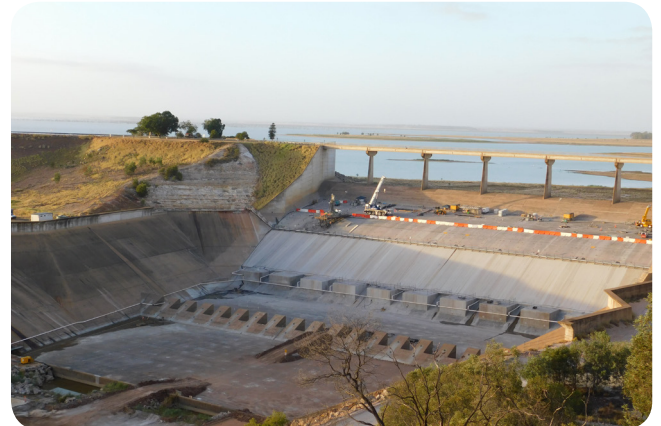
- ▶ Overview of works.
- ▶ Slope access system.
- ▶ Anchor drilling in progress.
