# Do Non-Complying Bull-Bars Increase the Injury Risk to Occupants of Other Vehicles?

SURATNO Basuki<sup>1</sup>, BLACK David<sup>2</sup>, DAL NEVO Ross<sup>2</sup>, PAINE Michael<sup>3</sup> and SIMMONS Keith<sup>1</sup>

<sup>1</sup>NSW Centre for Road Safety, Transport for NSW, 18 Lee Street, Chippendale, NSW 2008

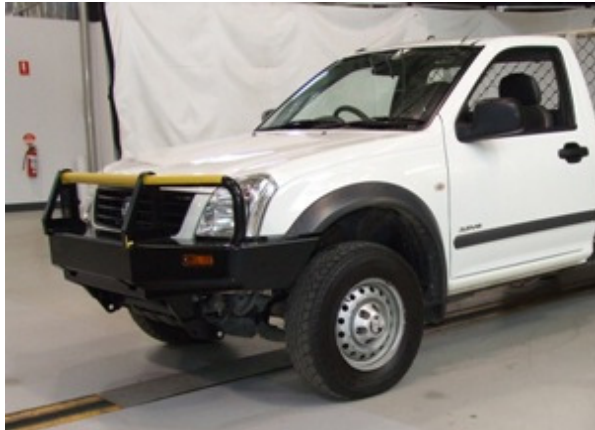
**Figure 1.** 4WD vehicle fitted with geometrically complying bull-bar

AS 4876.1-2002 requires that bull-bars have “a profile that generally conform to the shape, in plan view, front view and side view, of the front of the vehicle to which it is fitted”. Examples of “geometrically” complying and non-complying bull-bars are shown in Figure 1 and Figure 2 respectively.

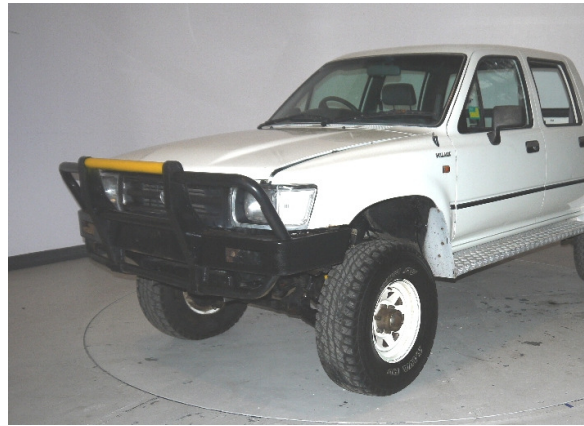
**Figure 2.** 4WD vehicle fitted with geometrically non-complying bull-bar

Two different types of full width steel bull-bars were examined, designated as a geometrically “complying” bull-bar in which the direction of the top part was rearward facing and a geometrically “non-complying” bull-bar where the top of the bar protrudes forward (see Figure 2). These designs represent the common types of bull-bars fitted to 4WD vehicles in Australia.

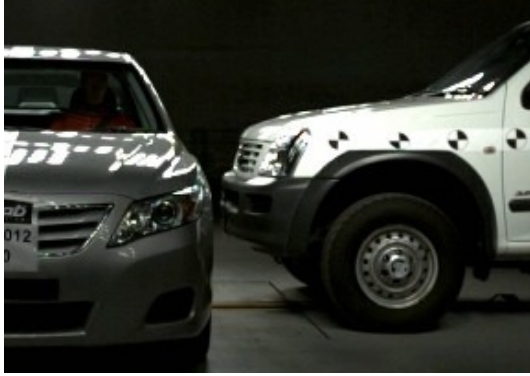
Figure 3. Test 2 Configuration

The test configurations for Tests 2 to 5 are presented in Figure 3 to Figure 6.

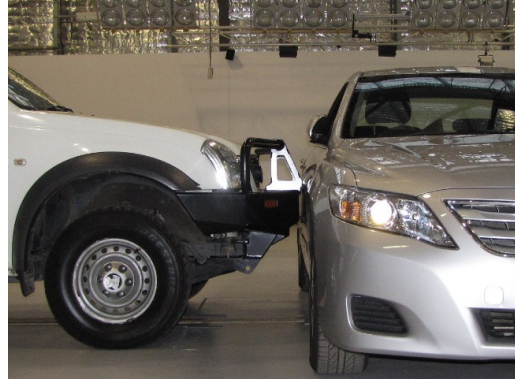
Figure 4. Test 3 Configuration

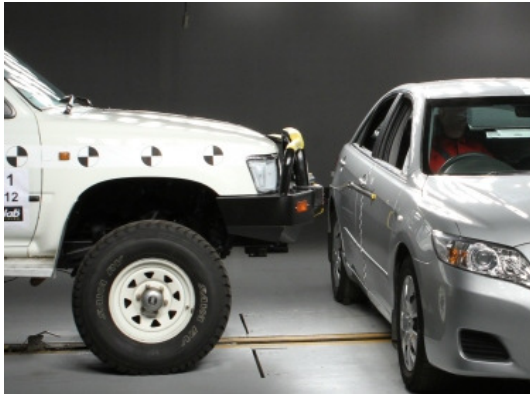
Figure 5. Test 4 Configuration

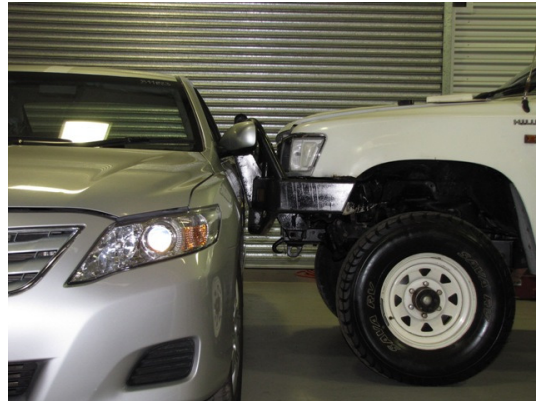
Figure 6. Test 5 Configuration

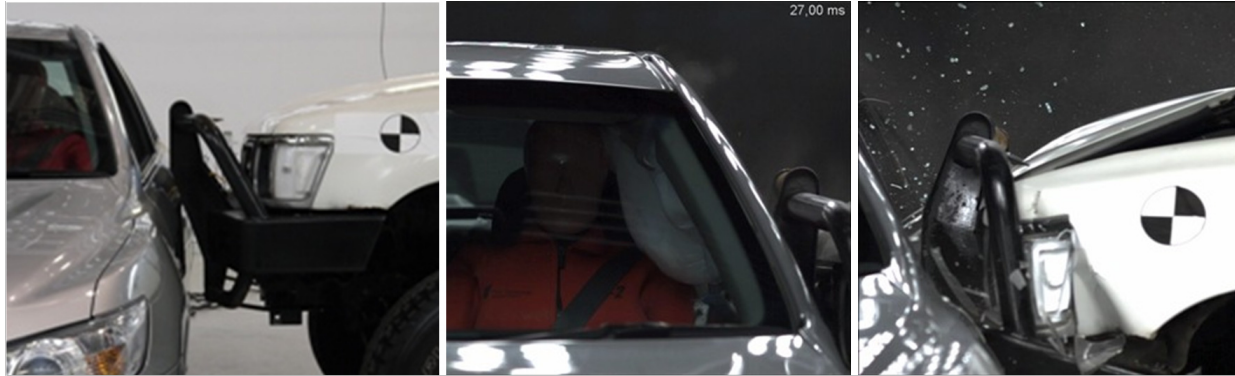
Detailed observations on rib compression and viscous criterion indicated that both measurements increased toward the lower part the occupant's thorax. This could be attributed to rotation of the bar during the impact as seen in Figure 7

**Figure 7. Series of front view of test 5 showing bull-bar rotated backward**
