BREAKOUT CREEK RESERVE PLAYGROUND

V05 22.03.17

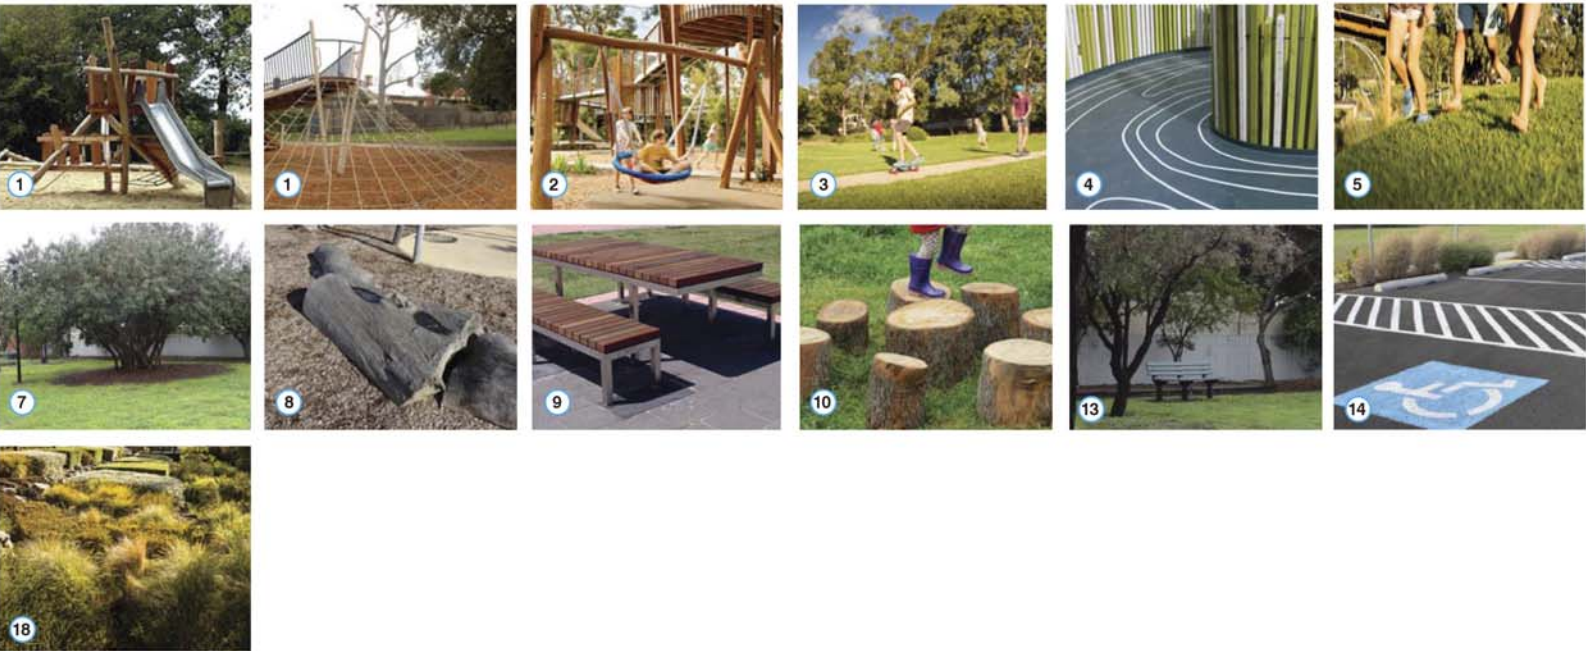
| 1 Timber platform with slide, rope net and climb wall | 11 Rubbish bin | 21 Quarry fines mulch |
| 2 Basket swing | 12 Existing light posts retained | 22 Softfall mulch |
| 3 Bitumen loop riding/scooting track | 13 Existing bench seat retained | 23 Recycled plastic edging |
| 4 Line markings | 14 New disabled car park with shared use space & wheel stops | 24 Brushed concrete path |
| 5 Turf mounds | 15 New entry to playground | 25 Irrigated turf |
| 7 Existing climbing tree retained | 16 Remove existing knee rails | 26 Rubber Soft Fall |
| 8 Sitting/ balancing log | 17 Existing path | 27 New chicane entry to existing fence |
| 9 New picnic setting | 18 Buffer planting | 28 Existing BBQ and picnic bench removed |
| 10 Timber seating circle | 19 Existing trees | 29 New drinking fountain & dog bowl |
| | 20 New shade trees | 30 Existing turf retained 'kick-about' lawn |

Accessibility is provided through the pathway network, rubber softfall adjacent equipment and the new disabled carpark to the carpark side entry to the playground.

Quieter areas for exploration and socialisation have been provided through a log seating circle and new picnic setting under the existing shade trees. Raised lawn mounds within the playground allows for elevated views and informal gathering as well as creating an undulating surface for the riding and scooting track.

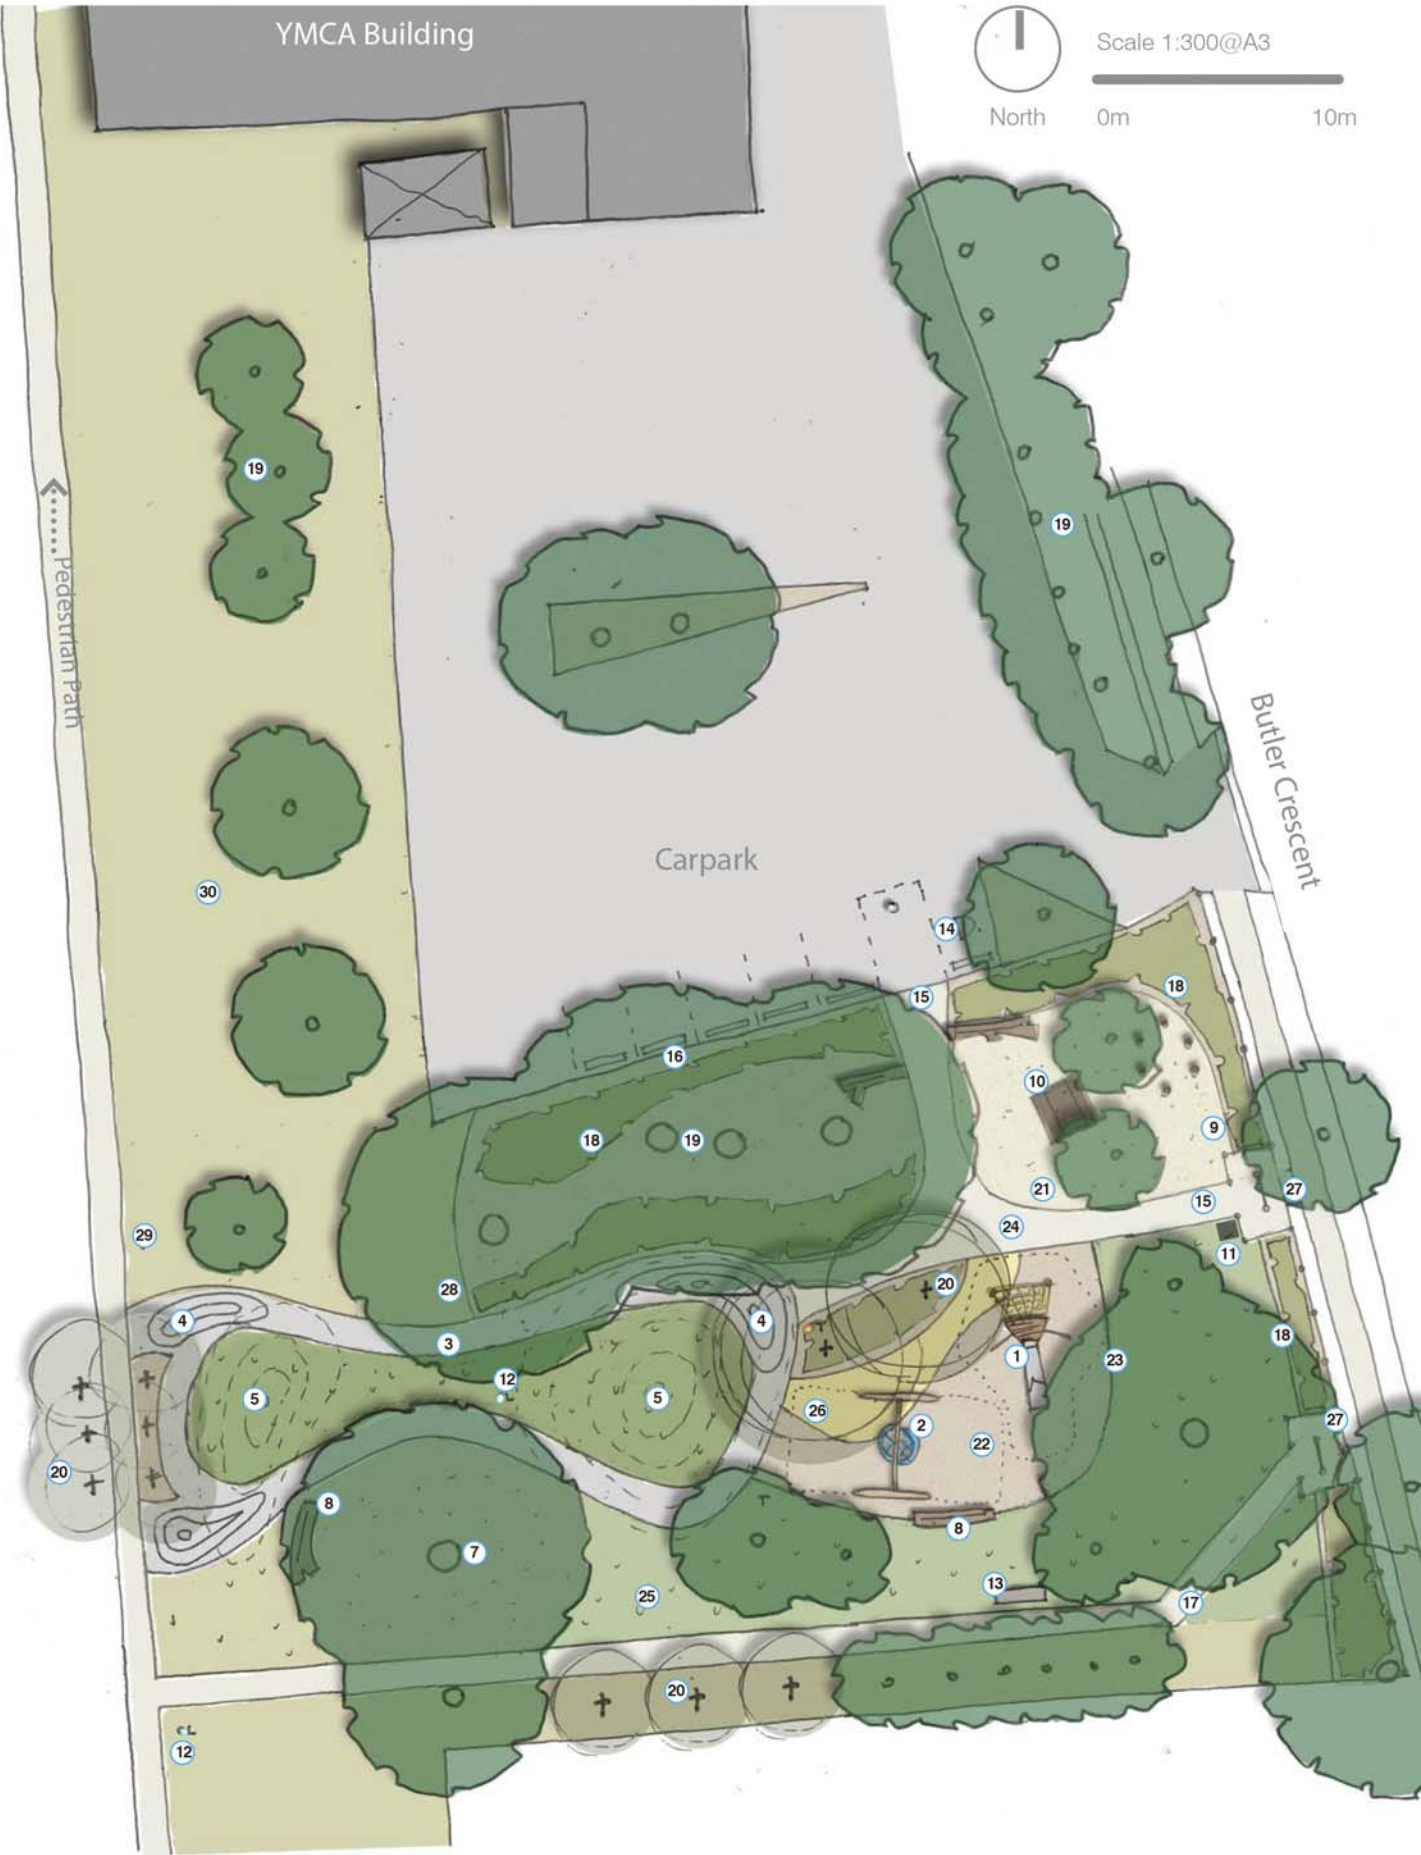
LEGEND

The playground has been designed to reflect the adjacent YMCA association and arterial path connecting to the Mike Turtur bikeway through the layout of the playground pathway access and equipment selections. The learners riding and scooting track connects the existing arterial pathway into the playground, whilst a secondary path entering from Butler Crescent has been provided to the edge of the playground for dog walkers.

Buffer planting to Butler Crescent and the carpark will assist in separating the playground from the adjacent roadways whilst the modifications to the fence along Butler Crescent will increase connectivity whilst maintaining a physical barrier.
