Contaminated Soils Removal Progress Report

Clarence Valley Council Depot

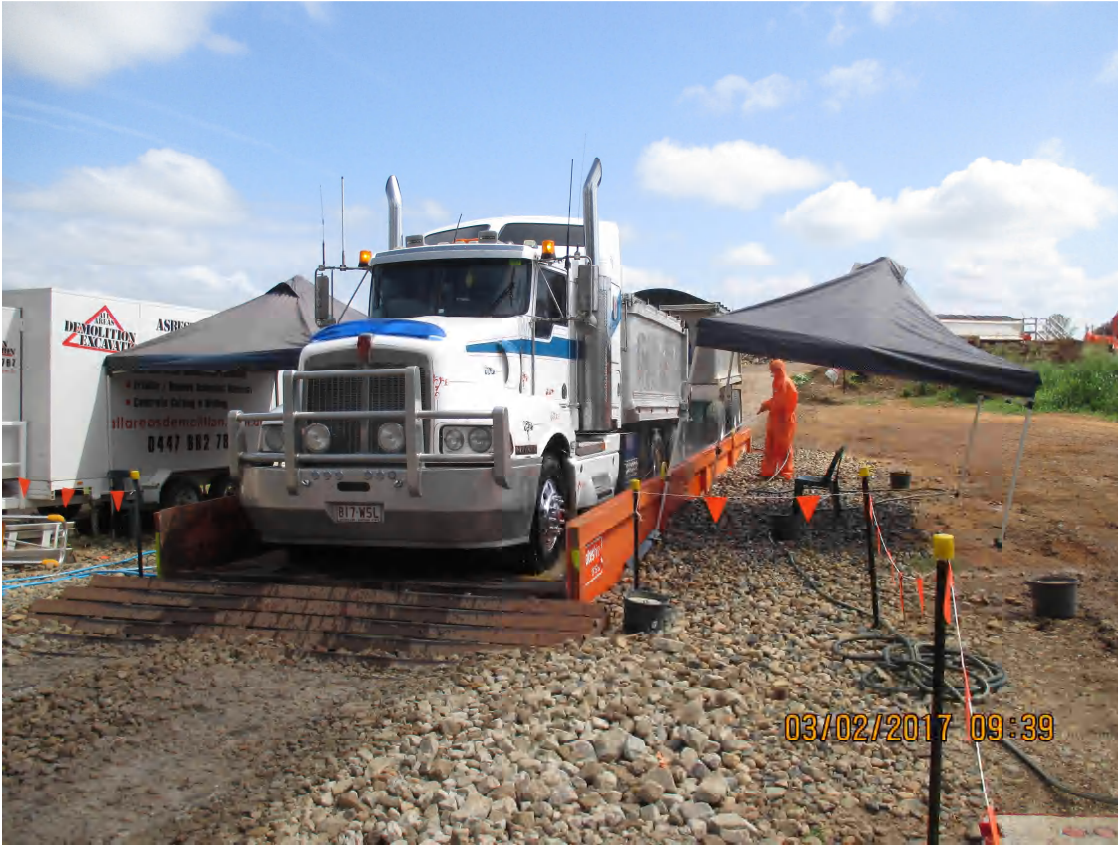
Truck Wash:

All trucks are required to be decontaminated prior to leaving site, they are hosed, cleaned and pass through a wheel wash.

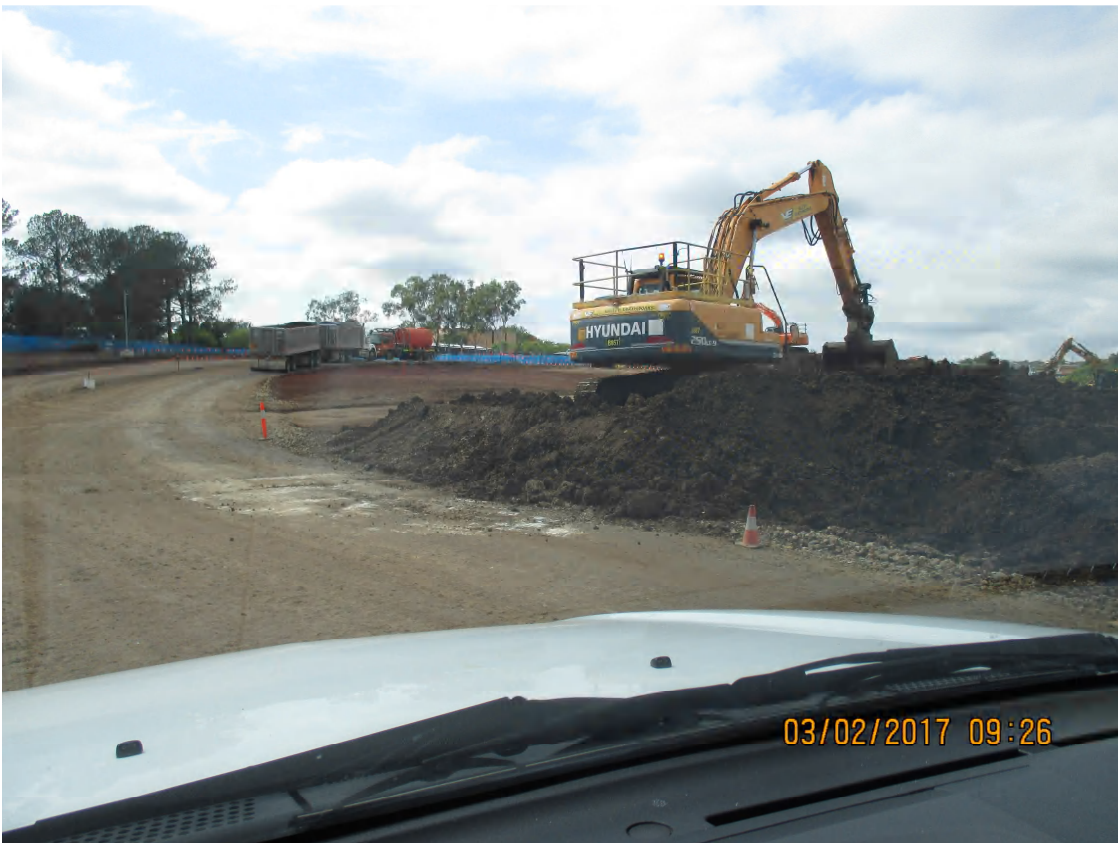
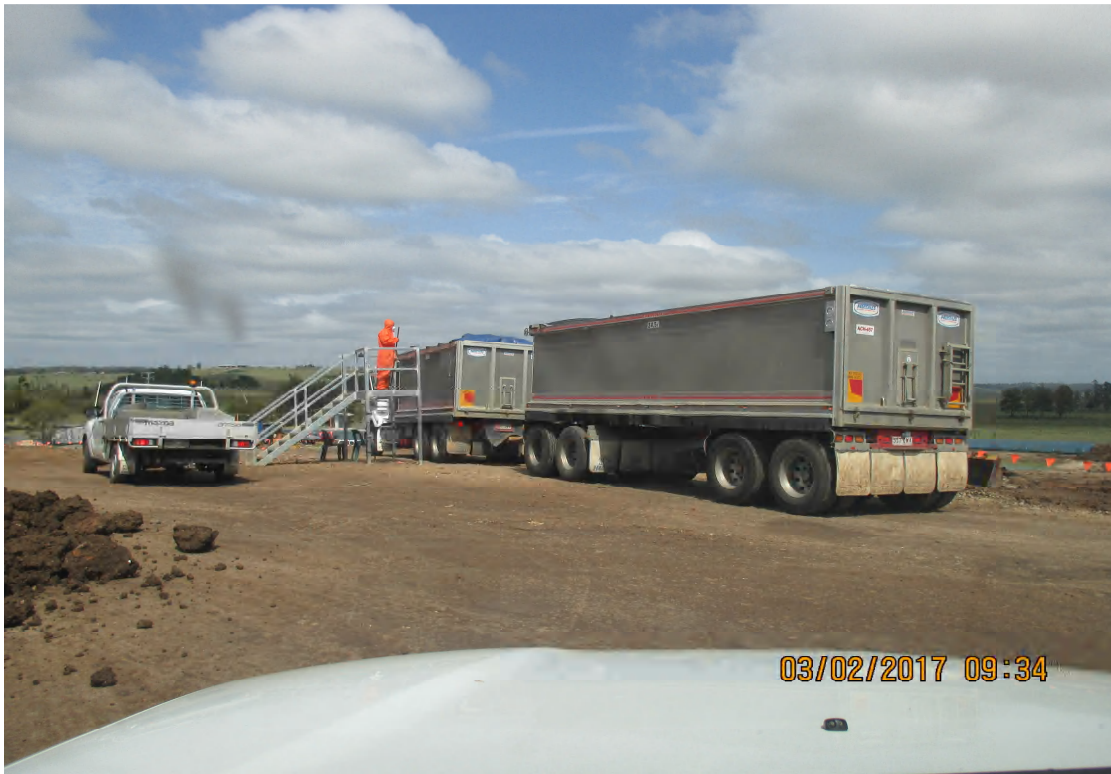
Site Haulage Roads – All Weather

Onsite watering is conducted continually; one water truck is allocated to the general site, whilst another operates at source of contaminated soils removal. Continued inspections have ascertained that over the past two months and there has been no evidence of any dust plume. All weather haul roads were constructed mitigating dust creation by the trucks traversing through site.

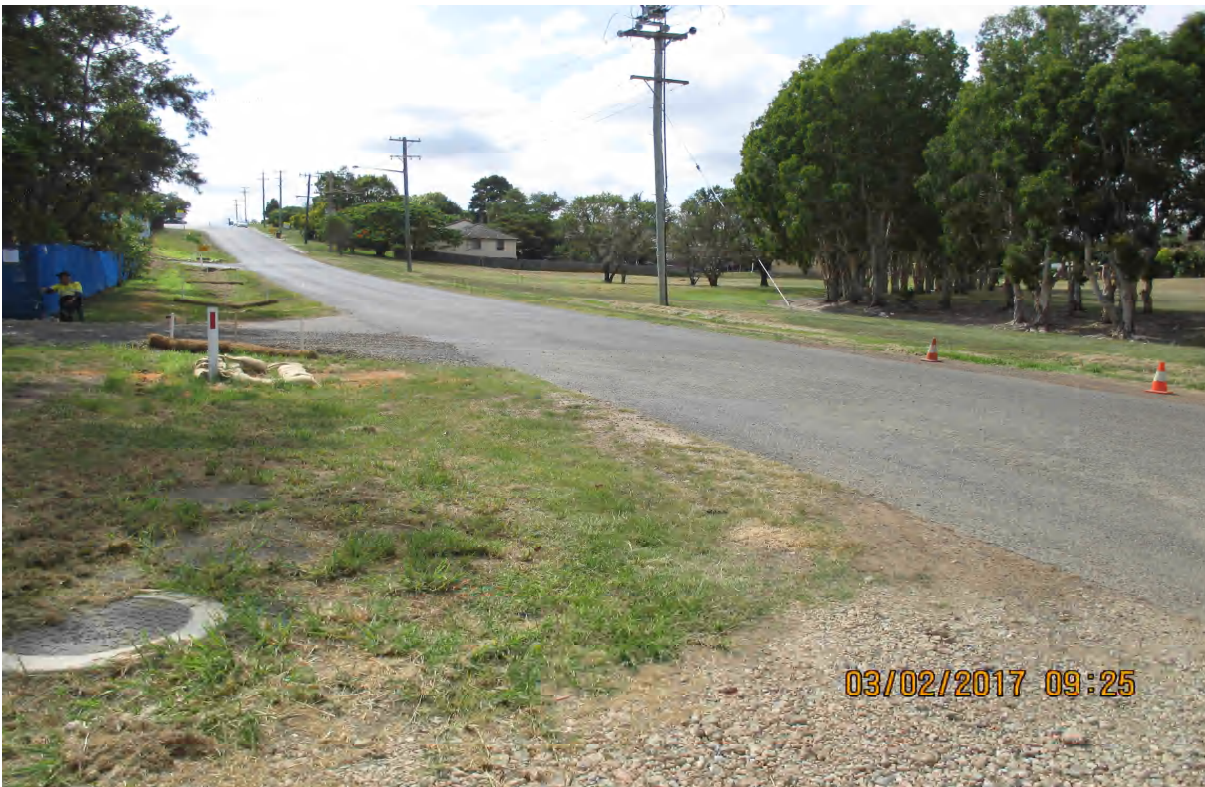
Public roadway condition:

Tyson and Skinner Streets are being washed down daily on numerous occasions as required.

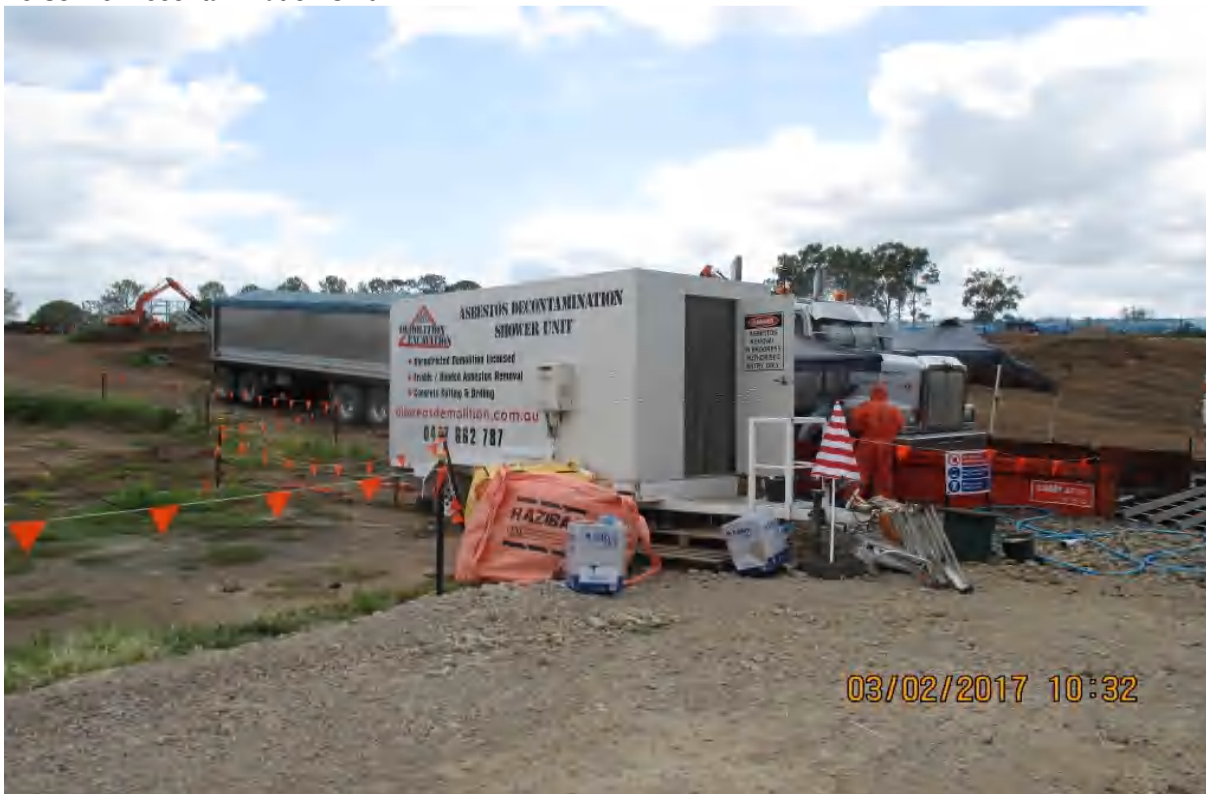
Personnel Decontamination Unit:

A Decontamination Unit has been implemented to allow site personnel the ability to decontaminate and place PPE on commencement and completion of works. The Asbestos Removal Supervisor is ensuring decontamination processes are being adhered to by the site personnel.
