## Contaminated Soils Removal Progress Report

### Clarence Valley Council Depot

Revision Number	Date	Author
B	13/01/2017	Rita Mann – Quality & Environment Manager

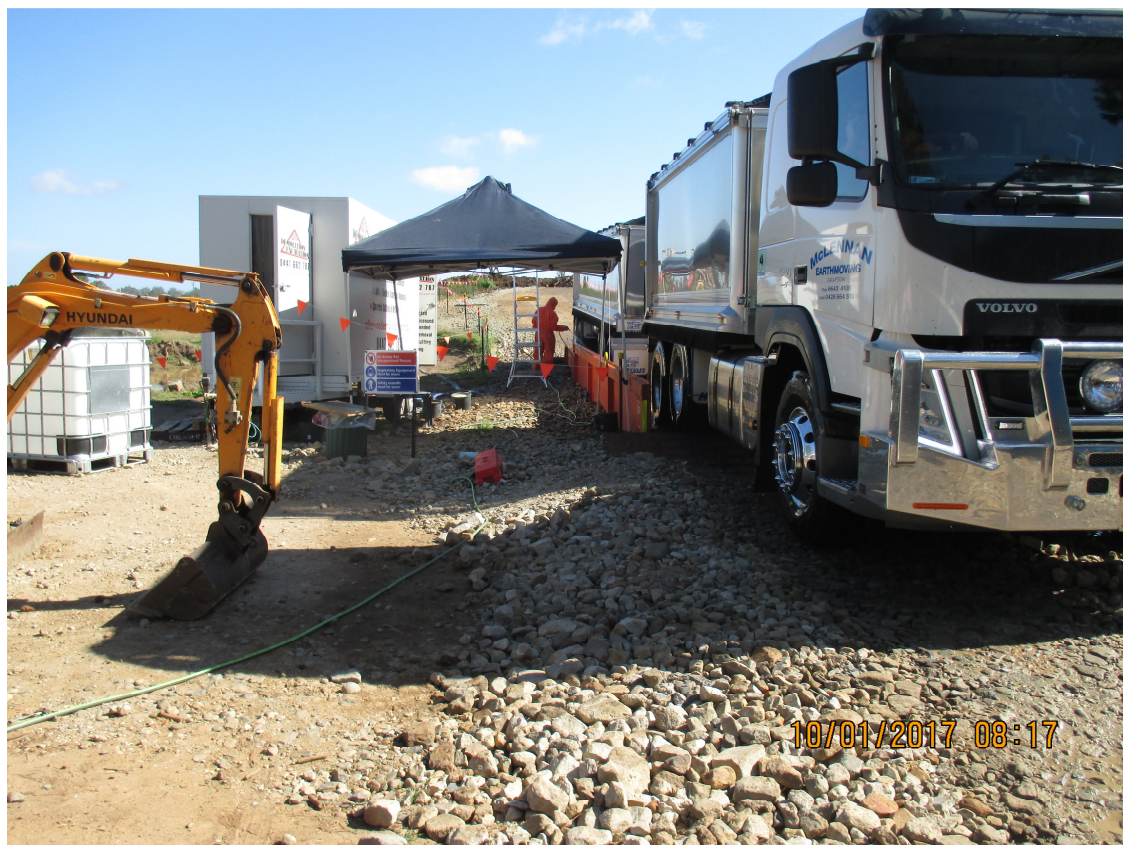
### Truck Wash:

All trucks are required to be decontaminated prior to leaving site, they are hosed, cleaned and pass through a wheel wash.

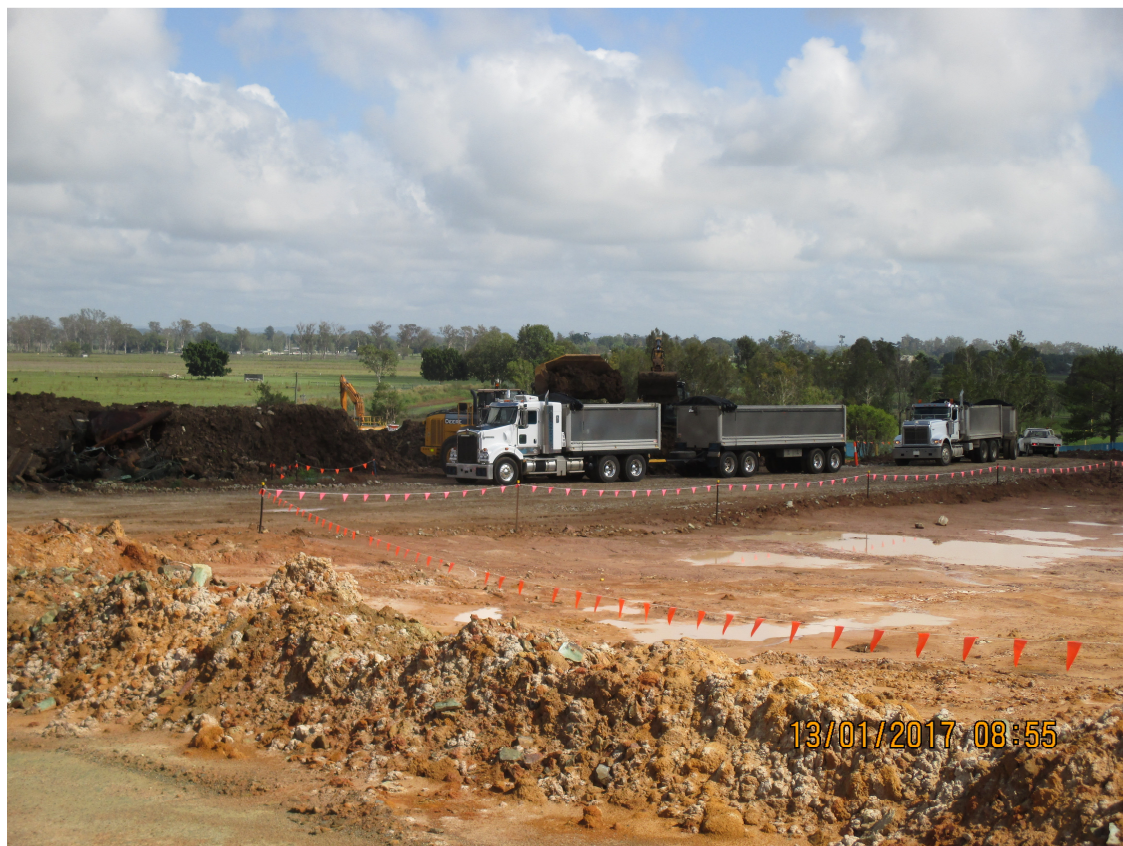
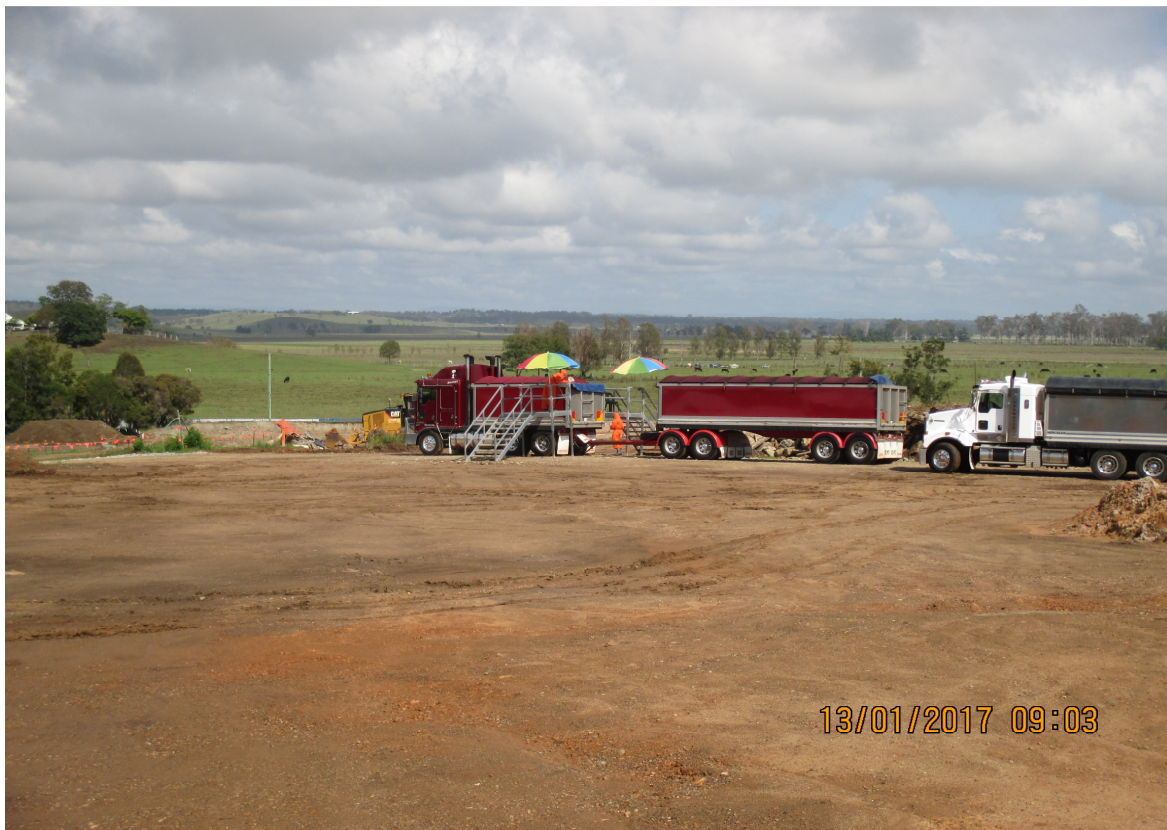
#### Site Haulage Roads – All Weather

Onsite watering is conducted continually; one water truck is allocated to the general site, whilst another operates at source of contaminated soils removal. Continued inspections have ascertained that over the past month and there has been no evidence of any dust plume. All weather haul roads were constructed mitigating dust creation by the trucks traversing through site.

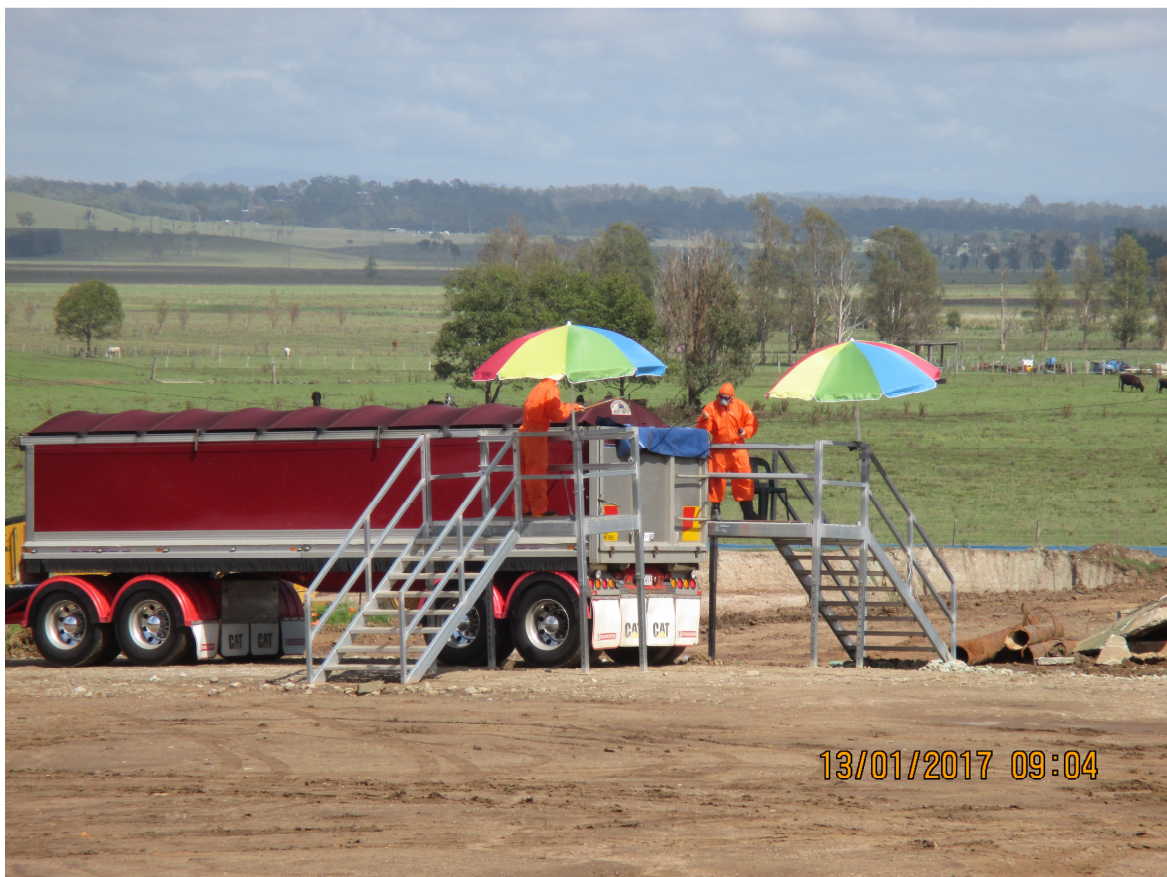
**Tarp Tie down Procedure prior to entering wash bay:**

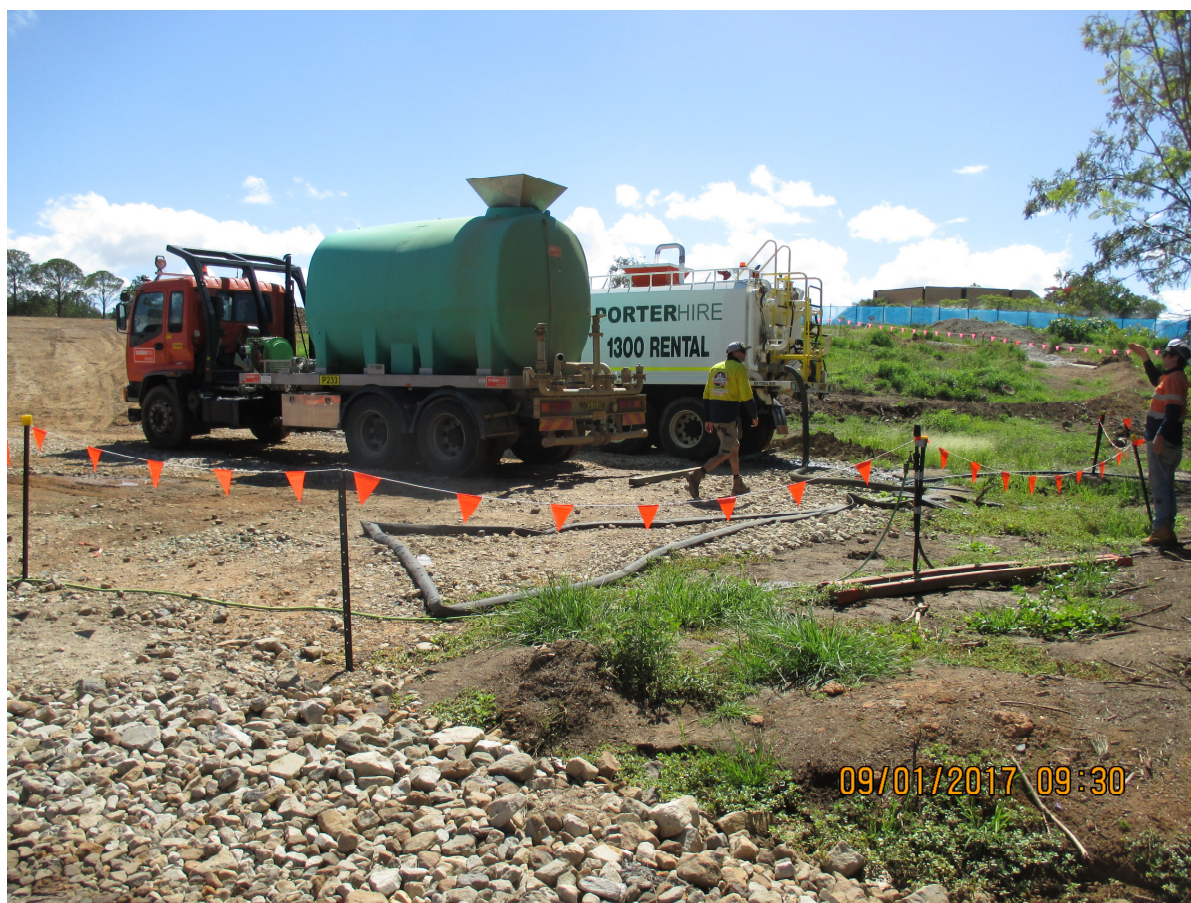
**Dust Suppression, water trucks being refilled:**

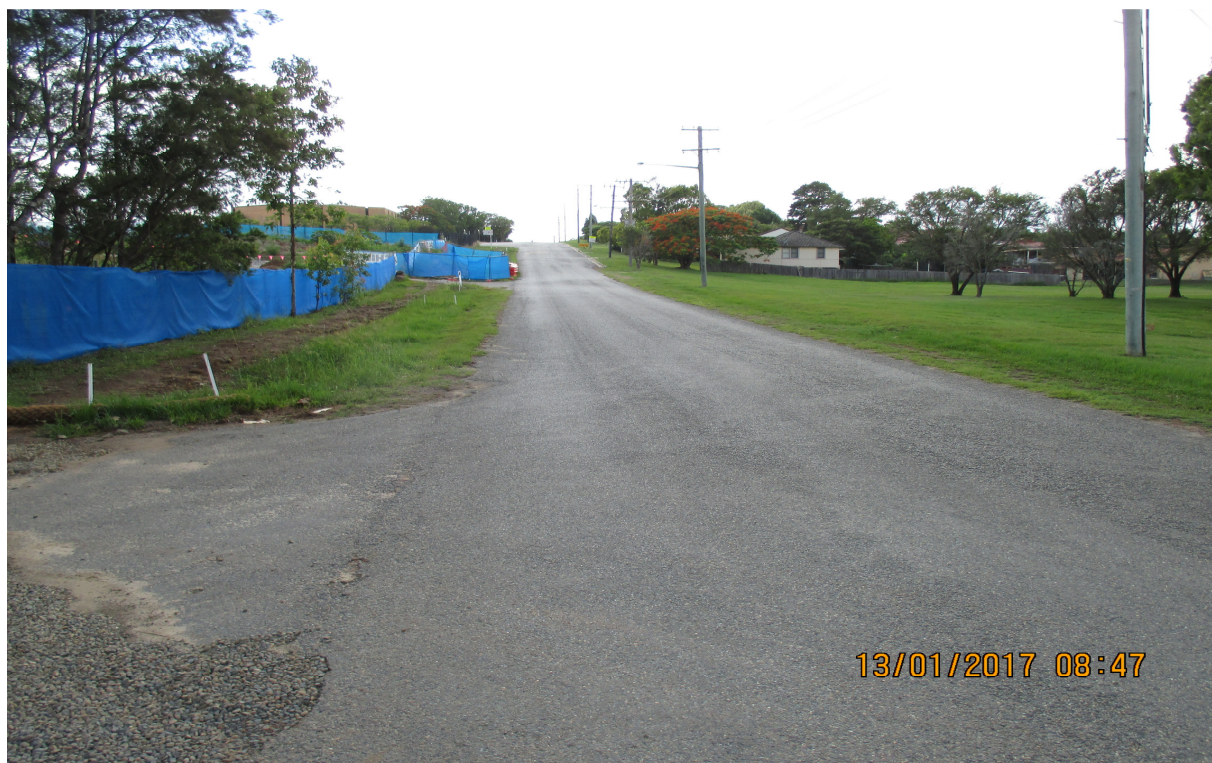
Tyson and Skinner Streets are being washed down daily on numerous occasions as required.

**Public roadway condition:**

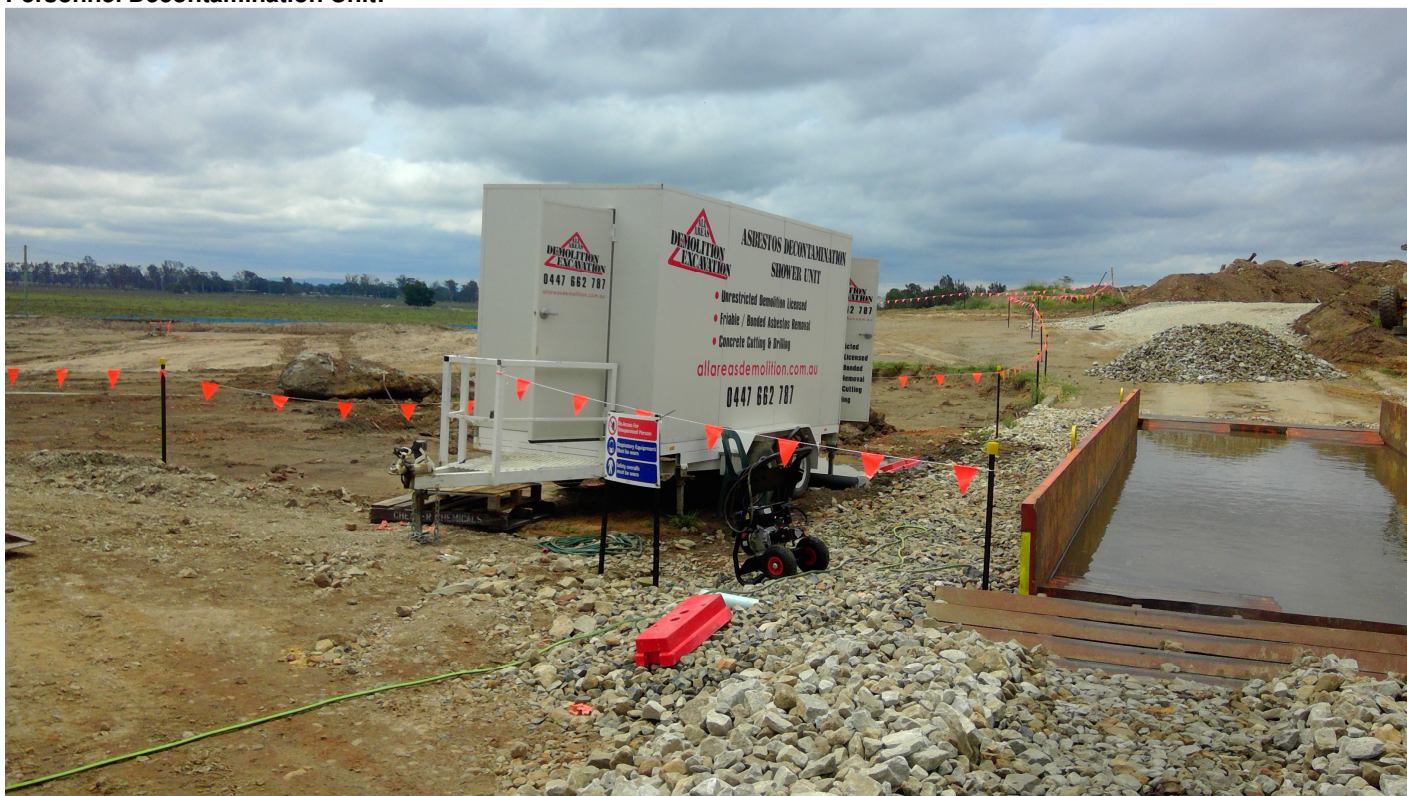
### Personnel Decontamination Unit:

A Decontamination Unit has been implemented to allow site personnel the ability to decontaminate and place PPE on commencement and completion of works. The Asbestos Removal Supervisor is ensuring decontamination processes are being adhered to by the site personnel.

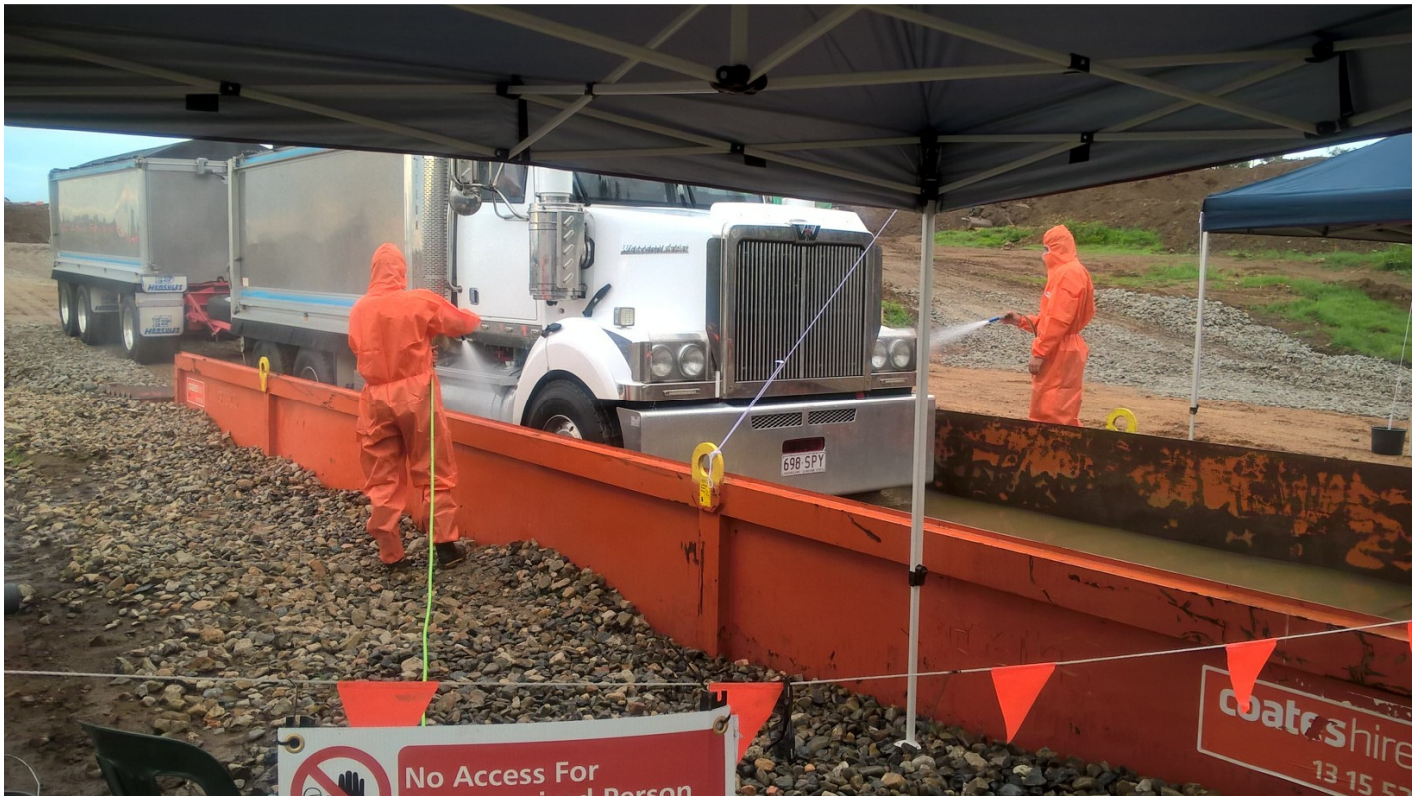
### Truck Wash:

Hygienist is attending site daily, the licenced Asbestos Removal Supervisor is remaining on site during all operations and is reviewing all processes including truck departure (confirming decontamination and secured loads).
