**Public Works**  
Manly Hydraulics Laboratory

MHL  
Report 2157

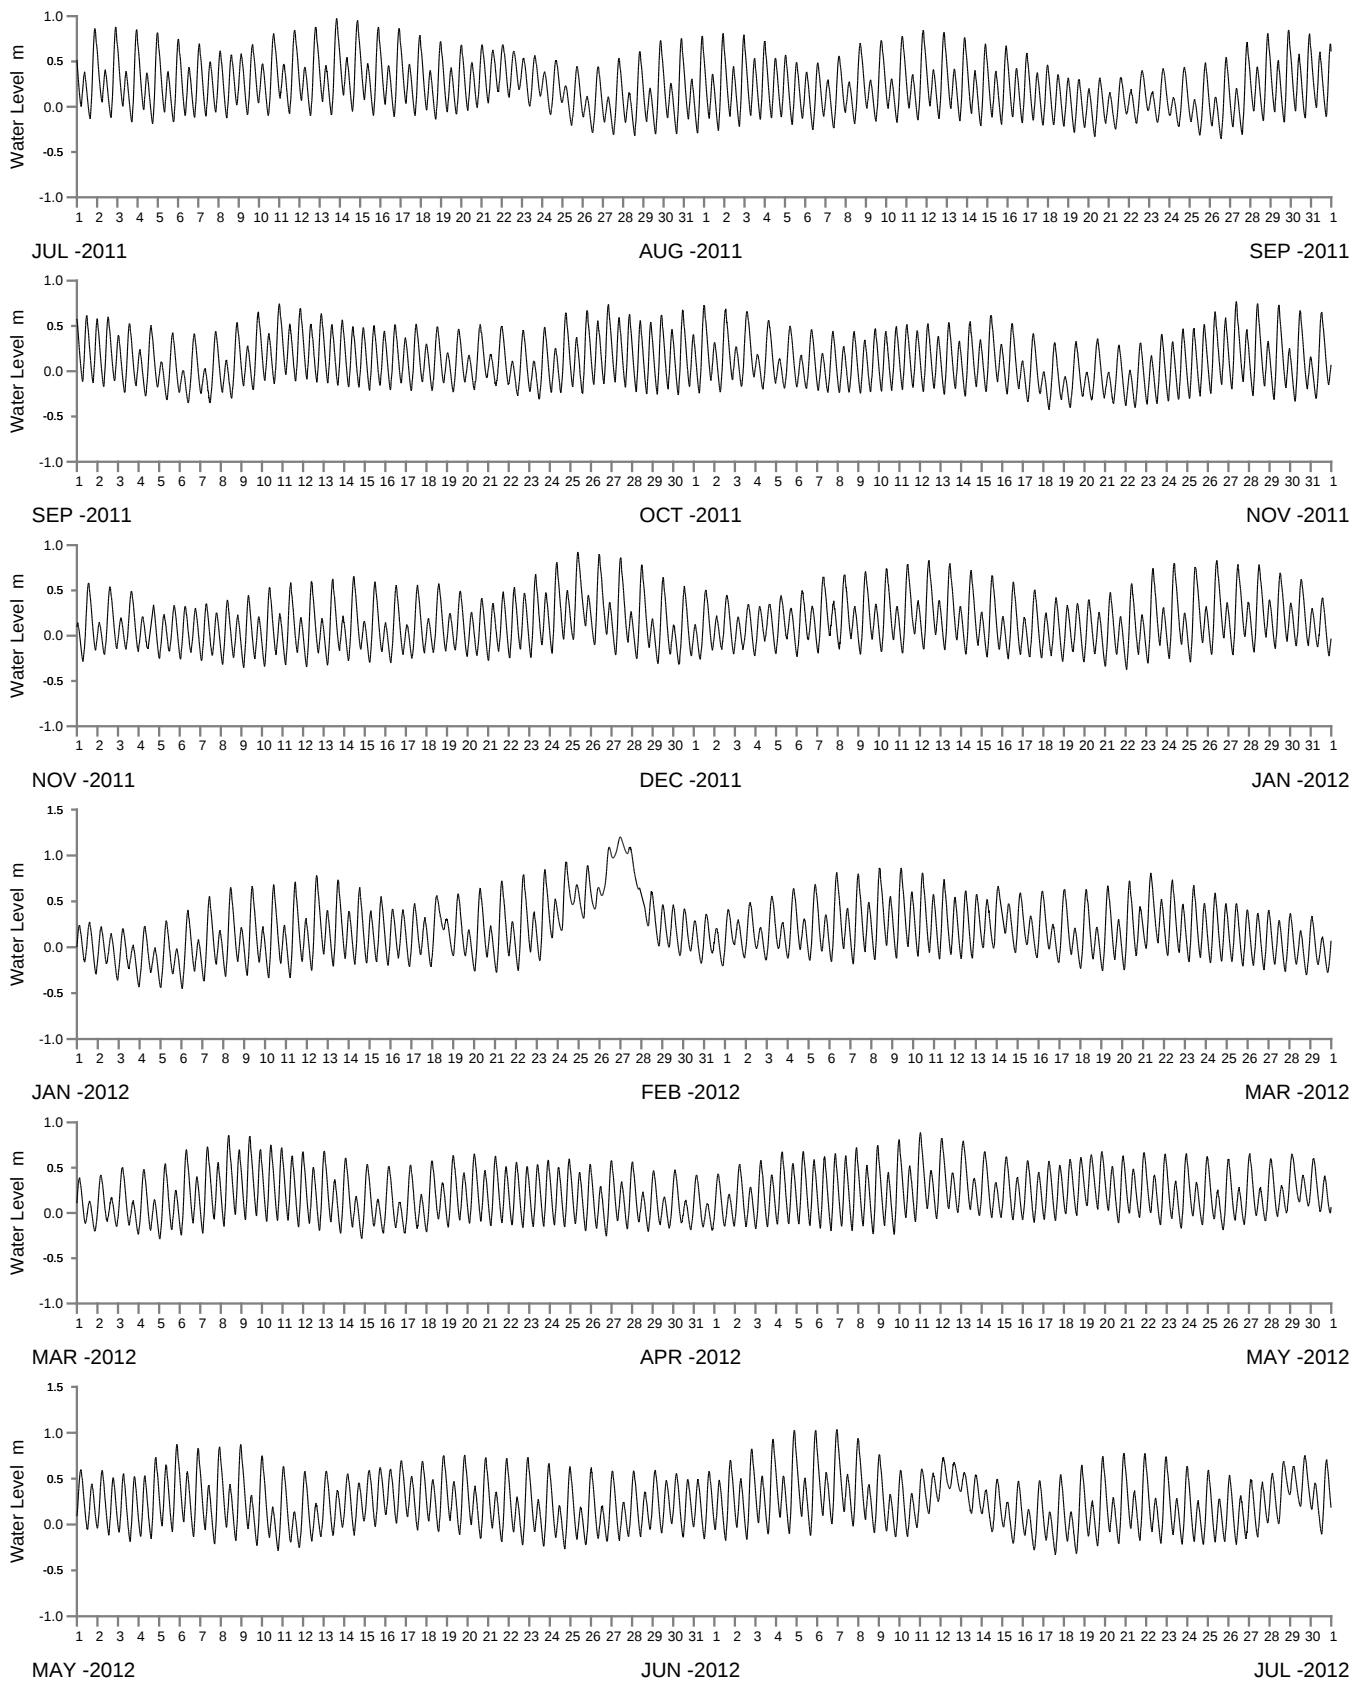
Figure  
**54**

WATER LEVEL REFERENCED TO AUSTRALIAN HEIGHT DATUM

**WOOLI RIVER AT WOOLI CARAVAN PARK**  
**2011-2012**

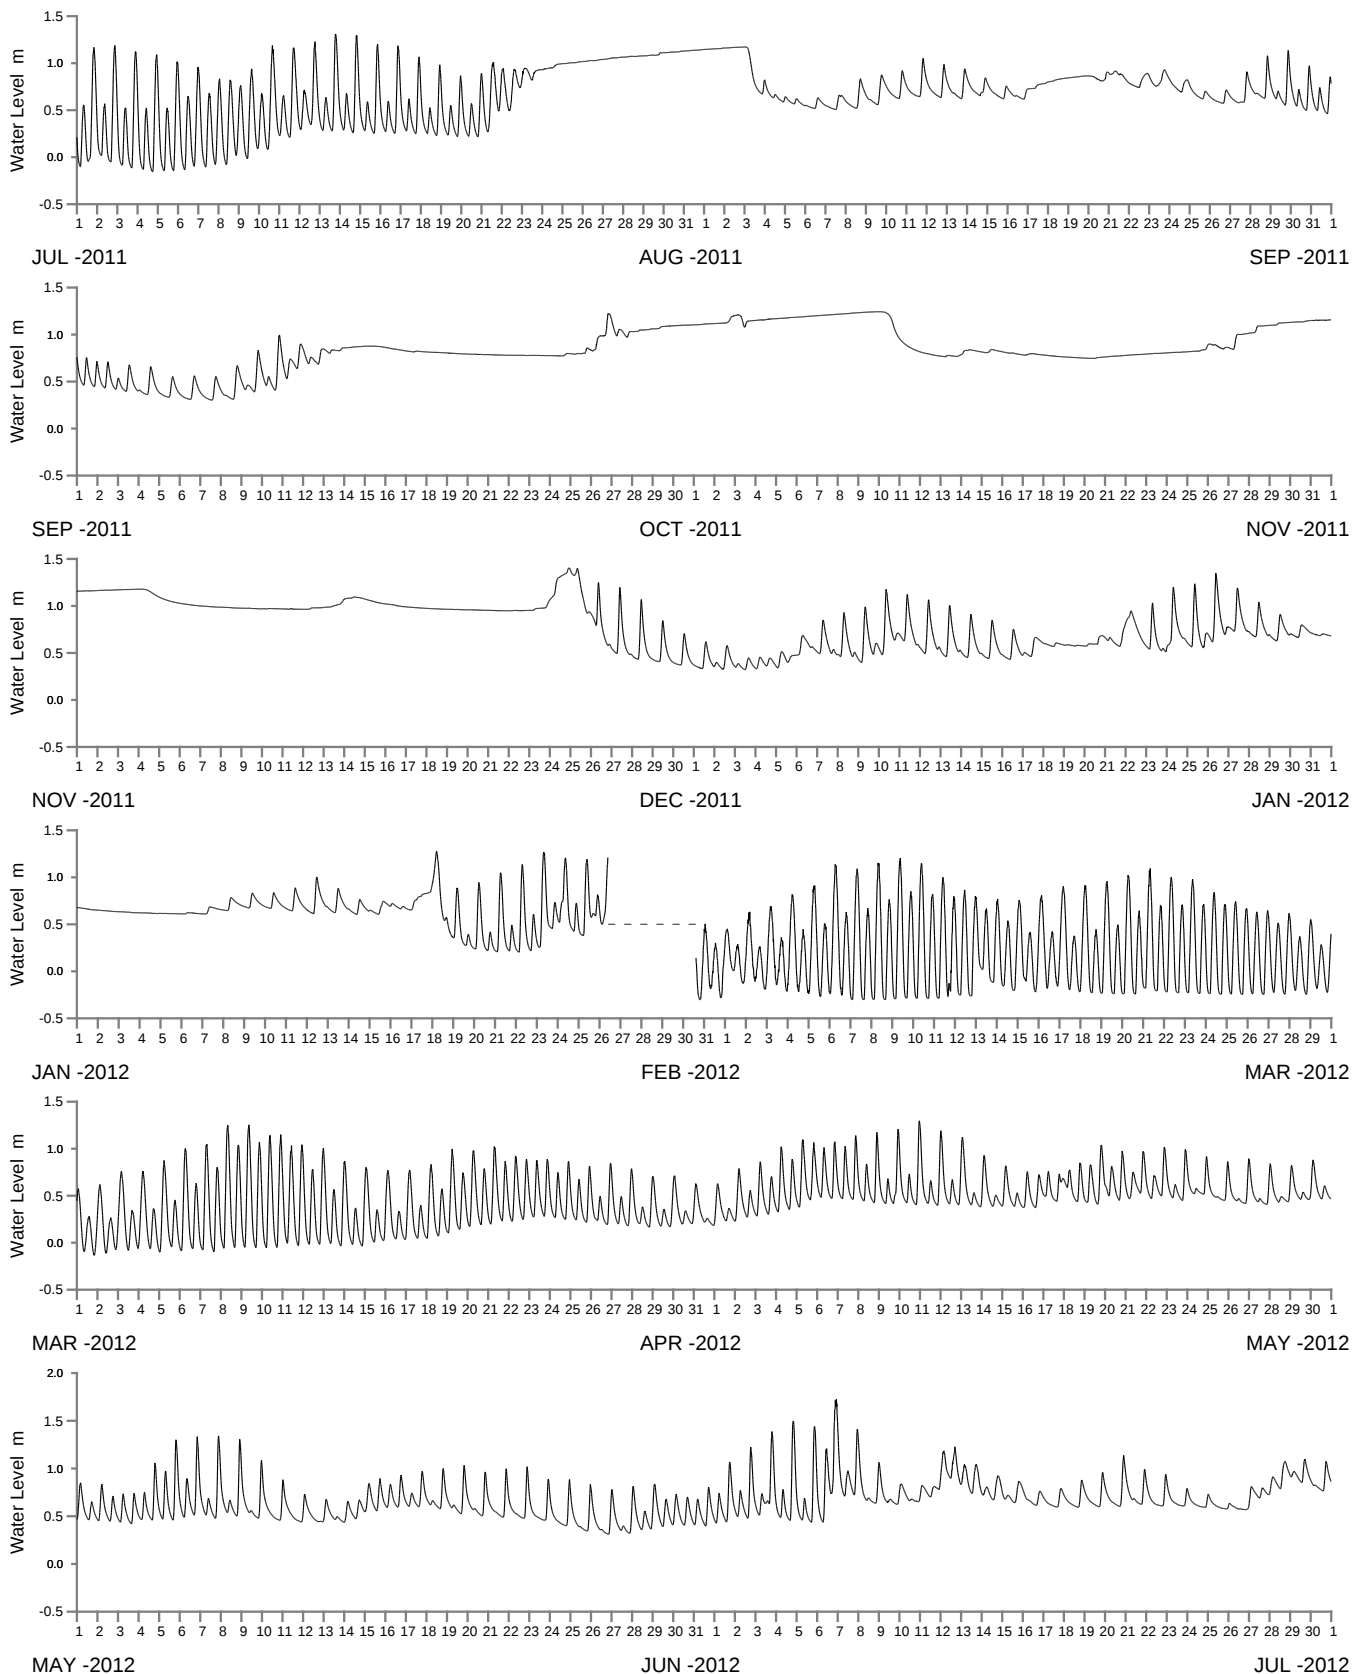
Figure

WATER LEVEL REFERENCED TO AUSTRALIAN HEIGHT DATUM

**WOOLGOOLGA LAKE AT WOOLGOOLGA LAKE**  
**2011-2012**

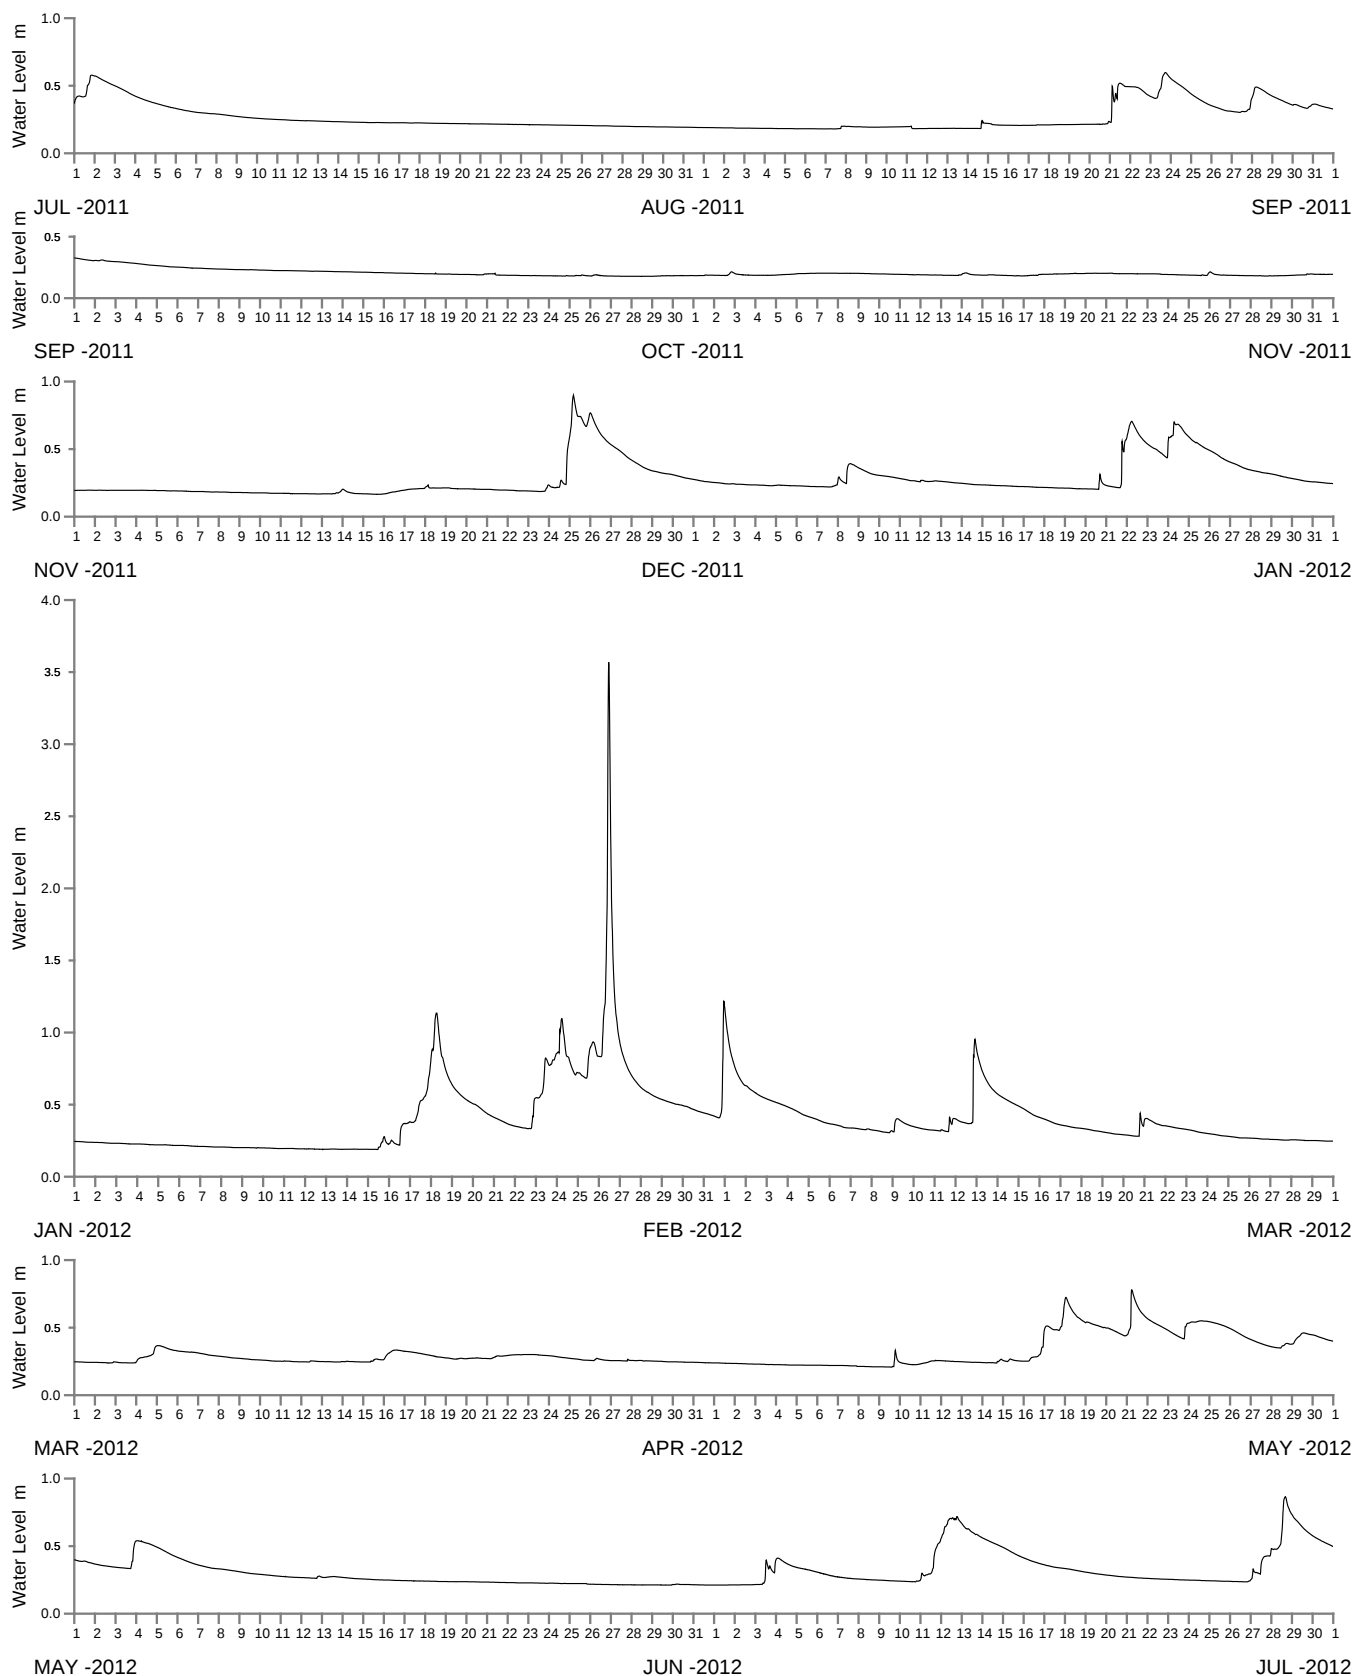
Figure

WATER LEVEL REFERENCED TO CTF OF CONTROL STRUCTURE

**WOOLGOOLGA CREEK AT WOOLGOOLGA**  
**2011-2012**

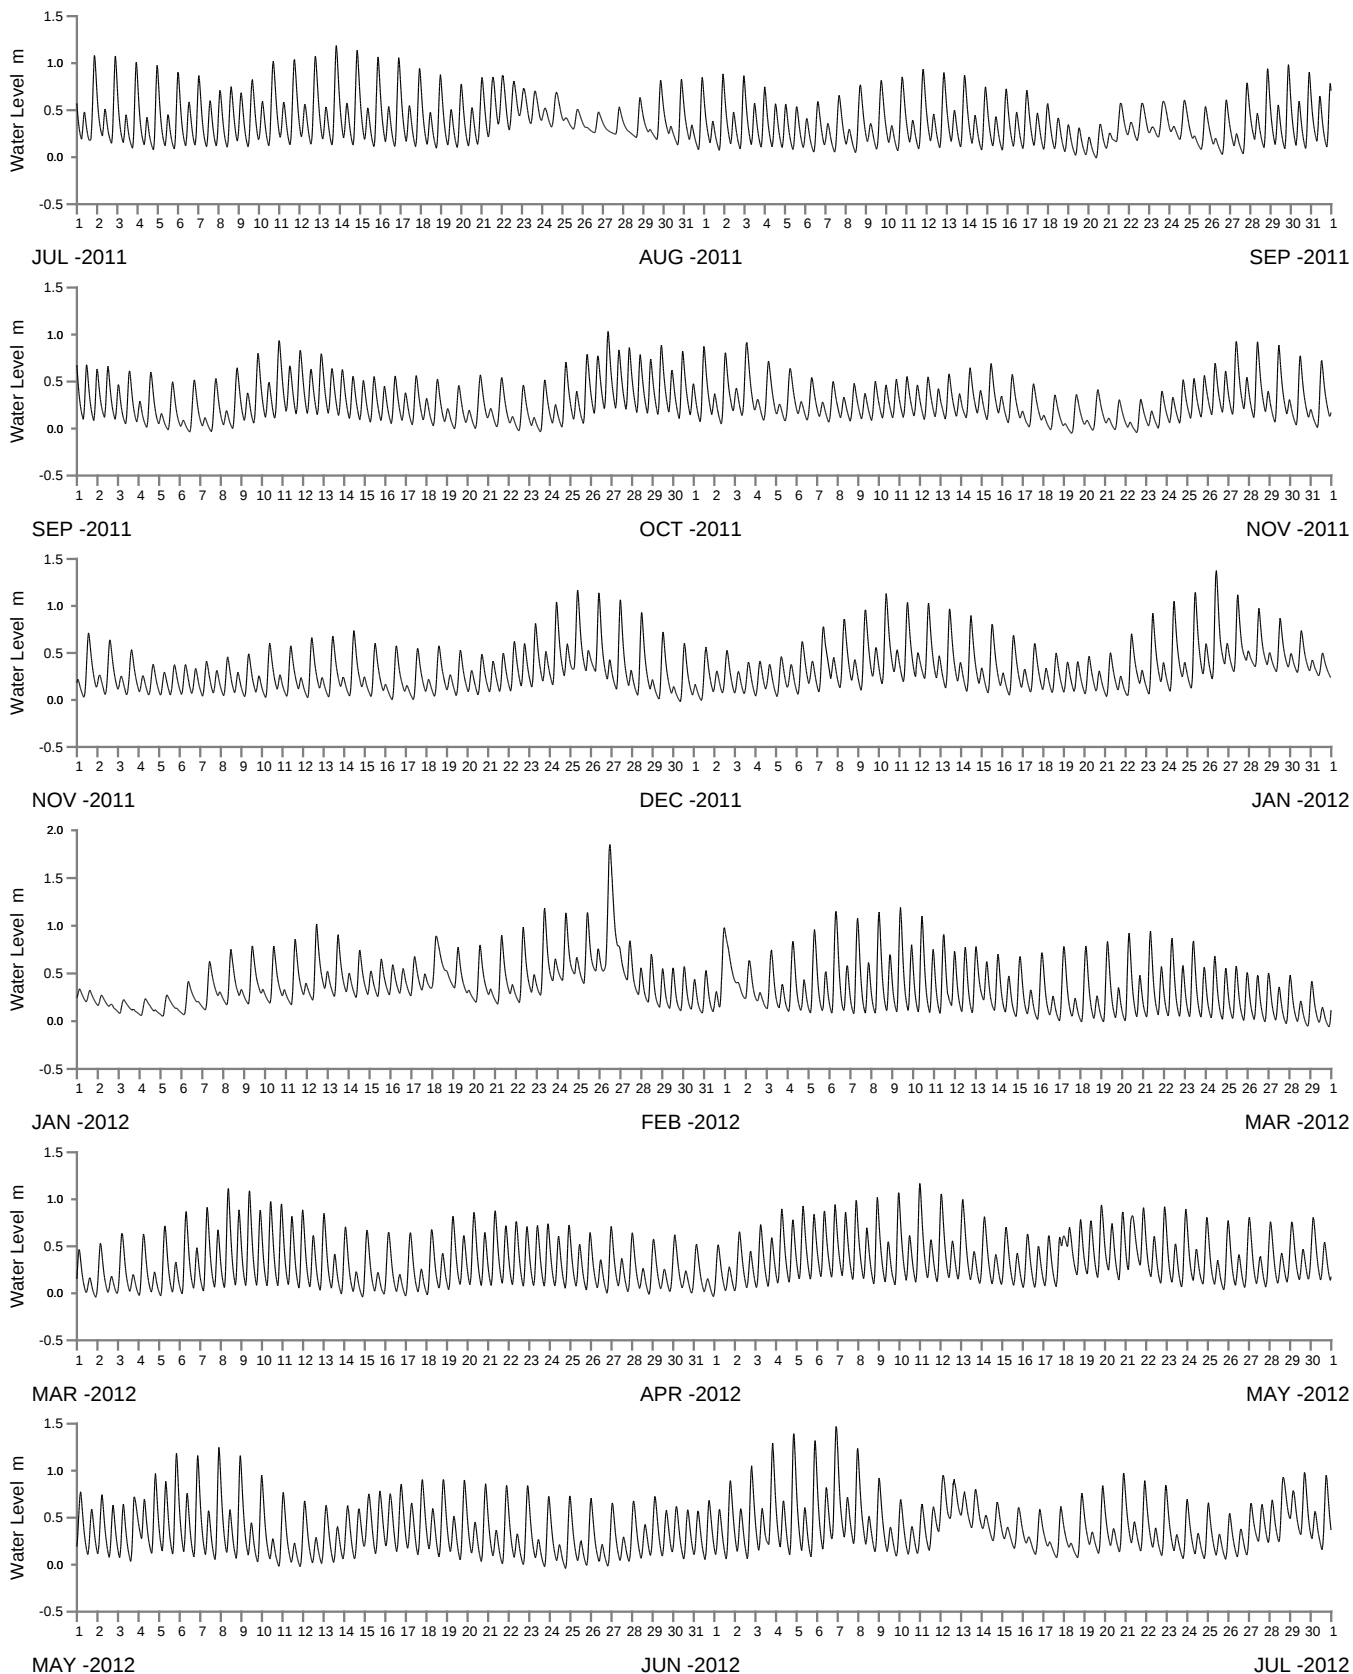
Figure  
**58**

WATER LEVEL REFERENCED TO AUSTRALIAN HEIGHT DATUM

**MOONEE CREEK AT MOONEE CREEK**  
**2011-2012**

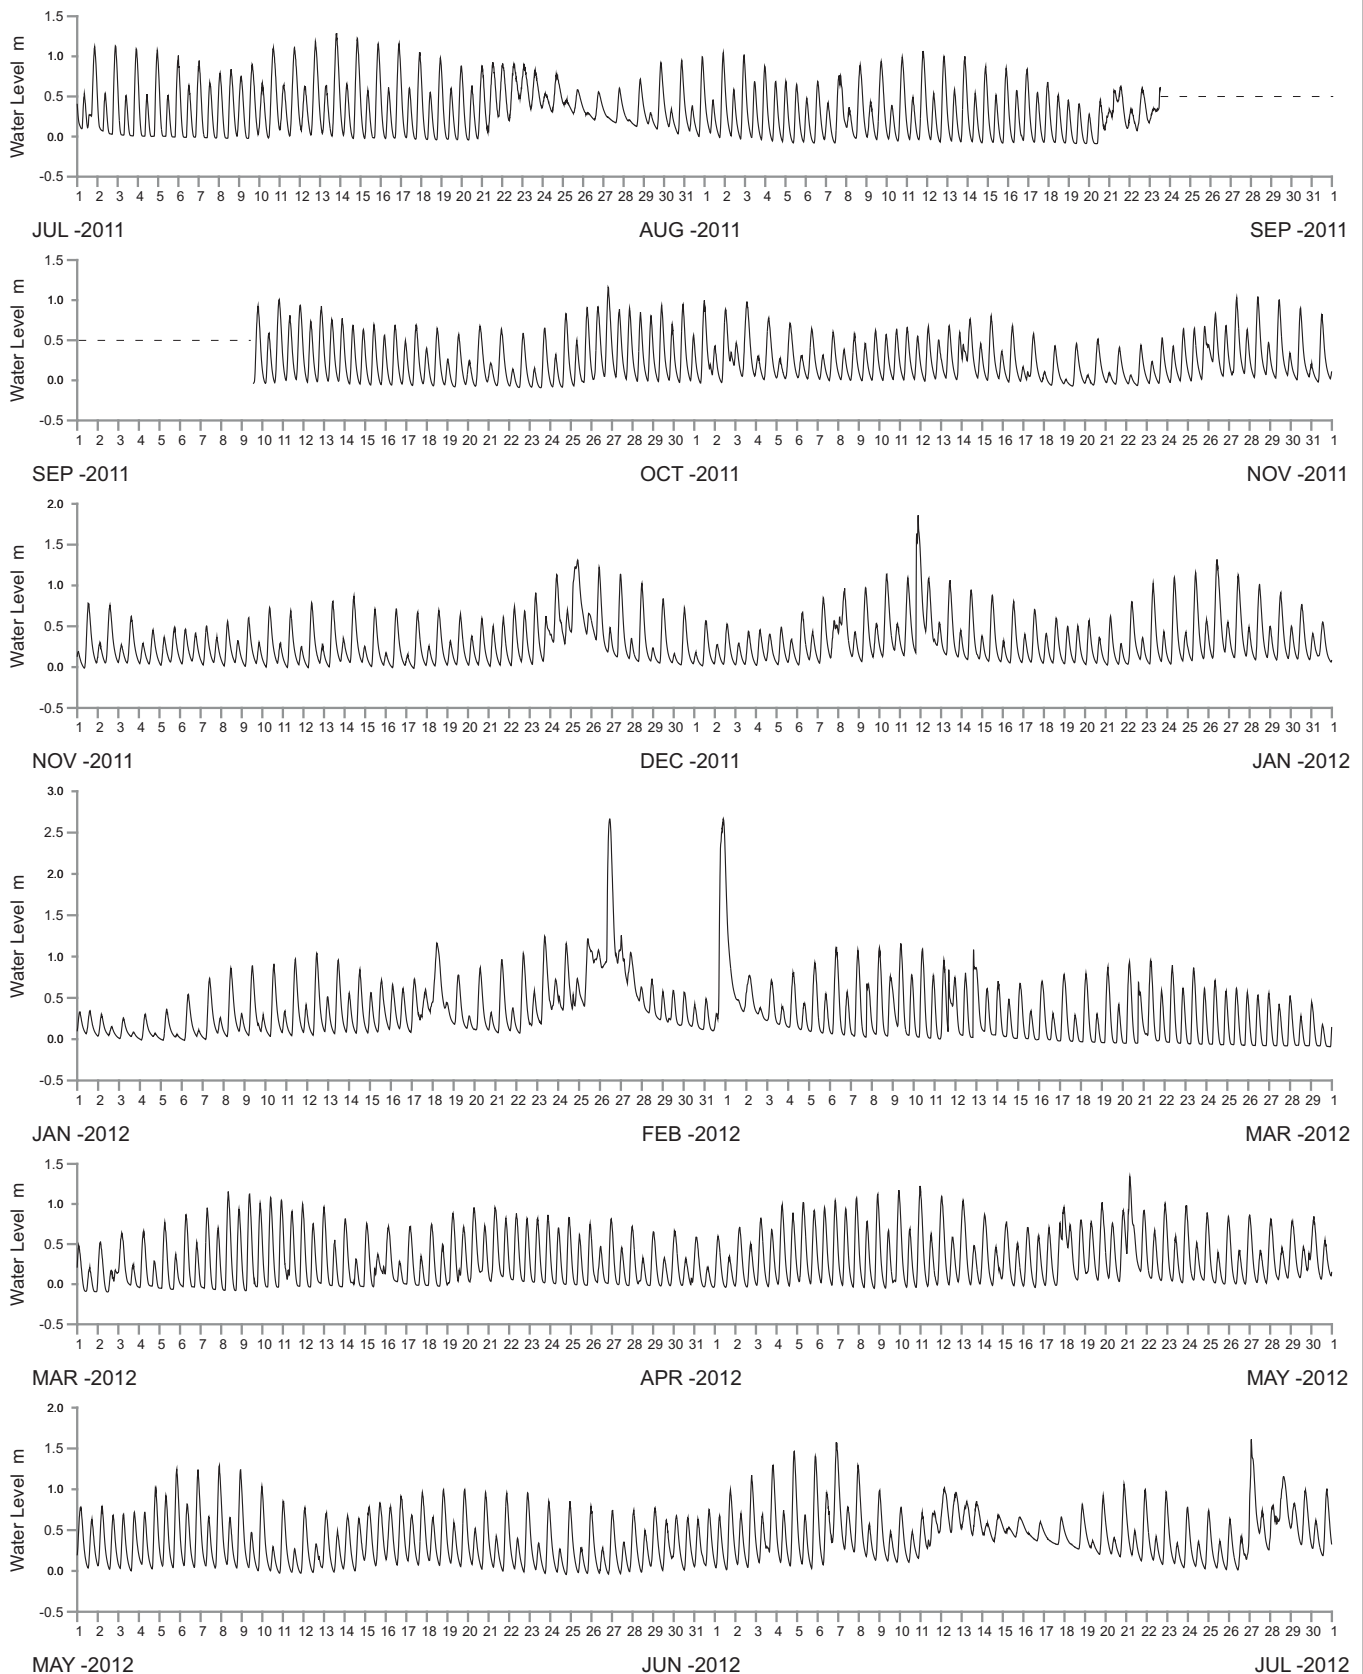
Figure  
**60**

WATER LEVEL REFERENCED TO AUSTRALIAN HEIGHT DATUM

**COFFS CREEK AT COFFS CREEK HIGHWAY BRIDGE**  
**2011-2012**

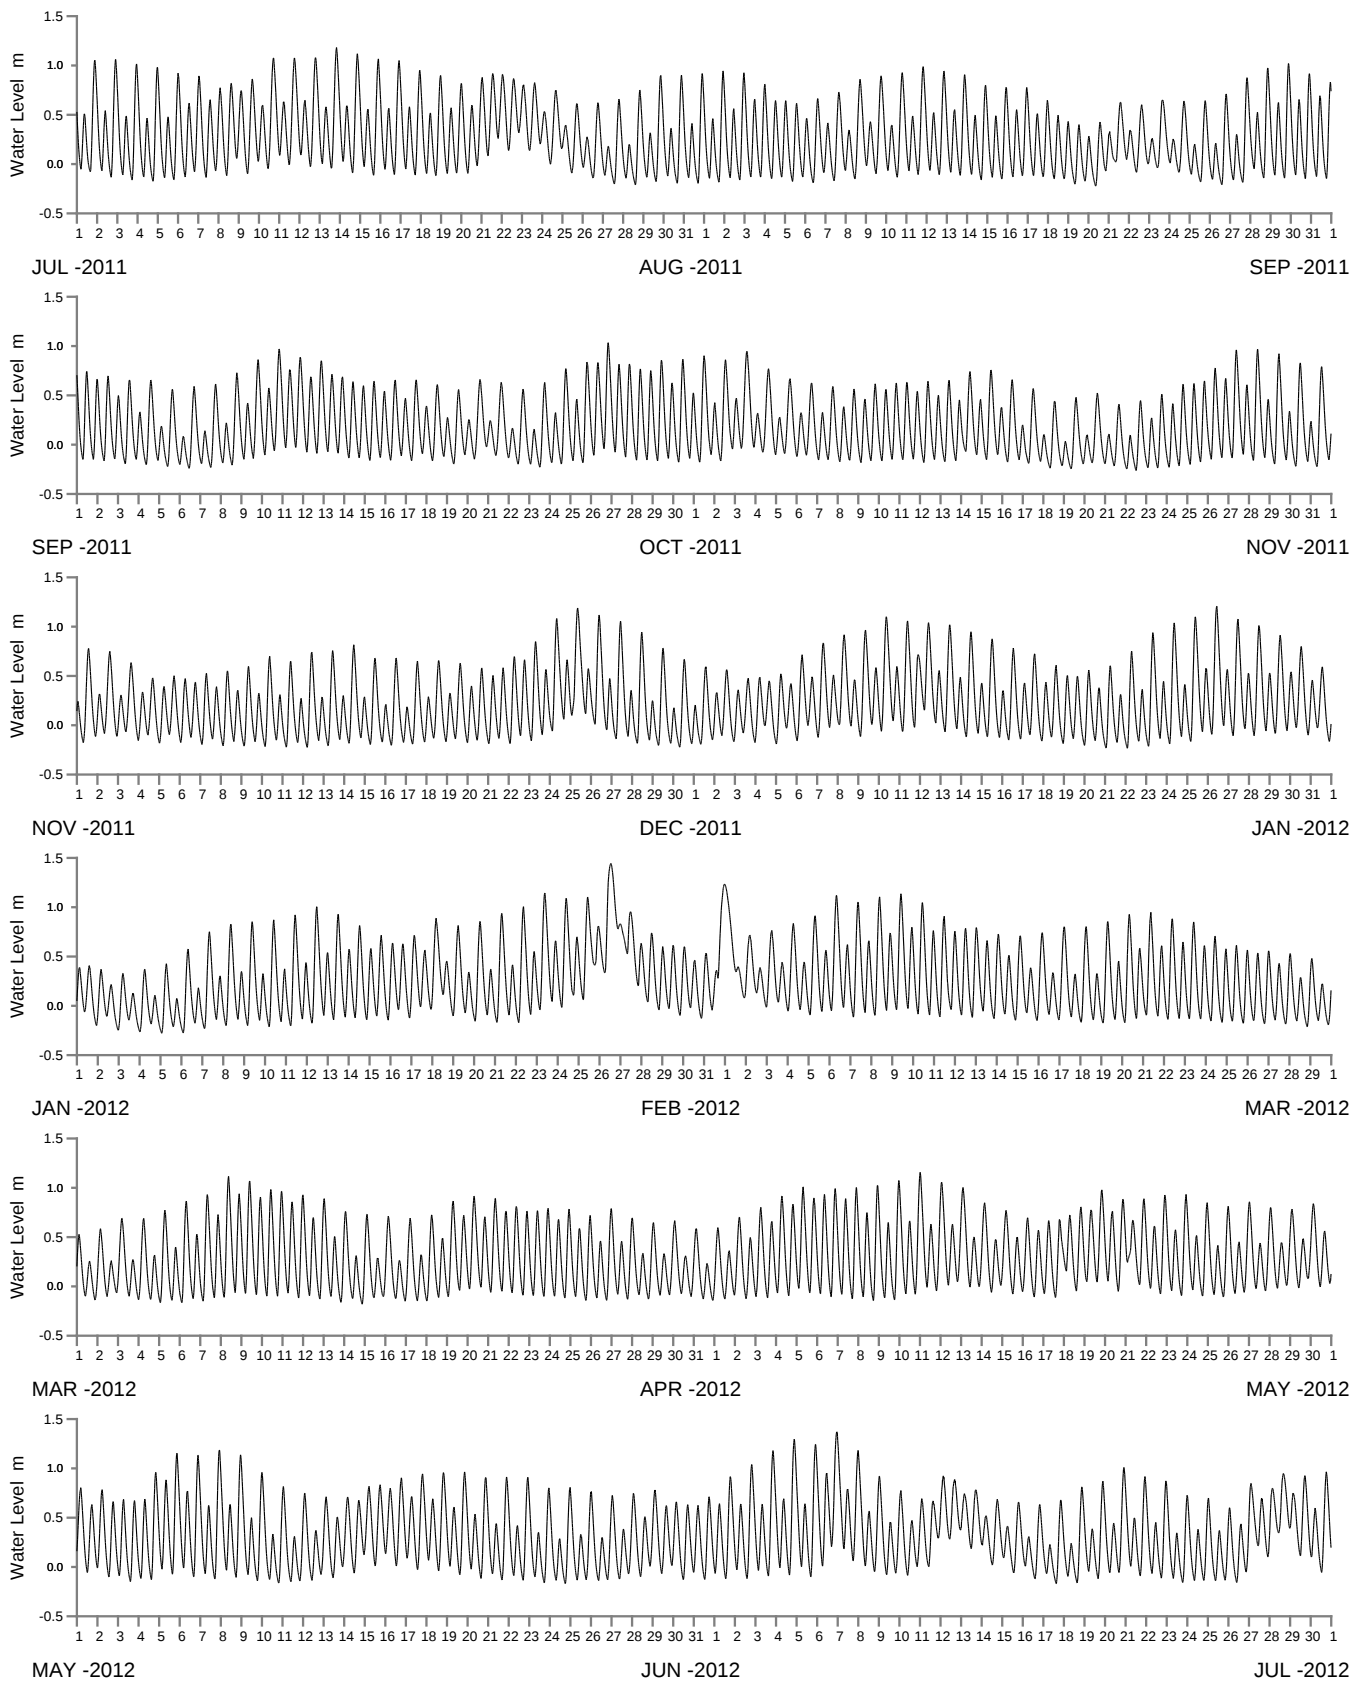
Figure  
**61**

WATER LEVEL REFERENCED TO AUSTRALIAN HEIGHT DATUM

**NEWPORTS CREEK AT NEWPORTS CREEK**  
**2011-2012**

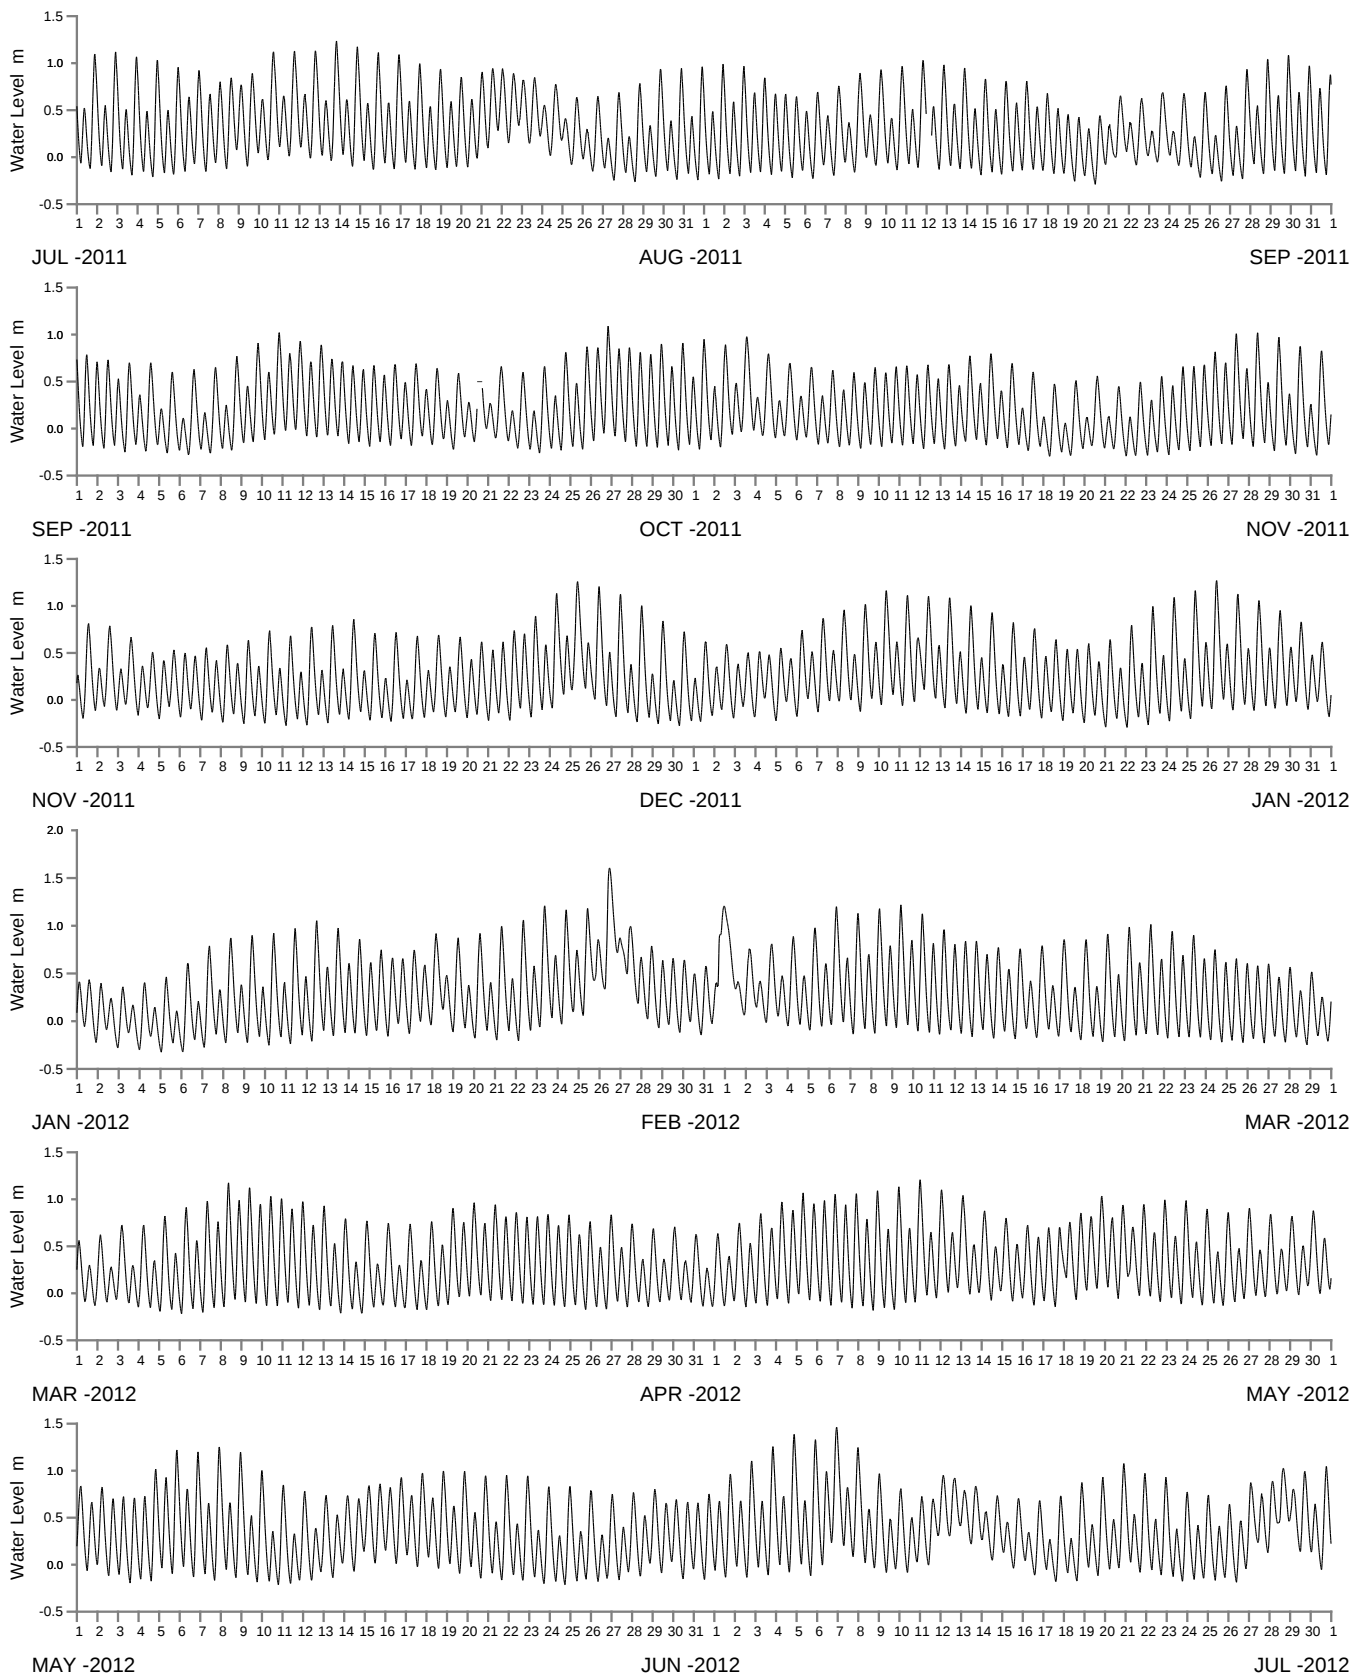
Figure  
**62**

WATER LEVEL REFERENCED TO AUSTRALIAN HEIGHT DATUM

**BOAMBEE CREEK AT BOAMBEE**  
**2011-2012**

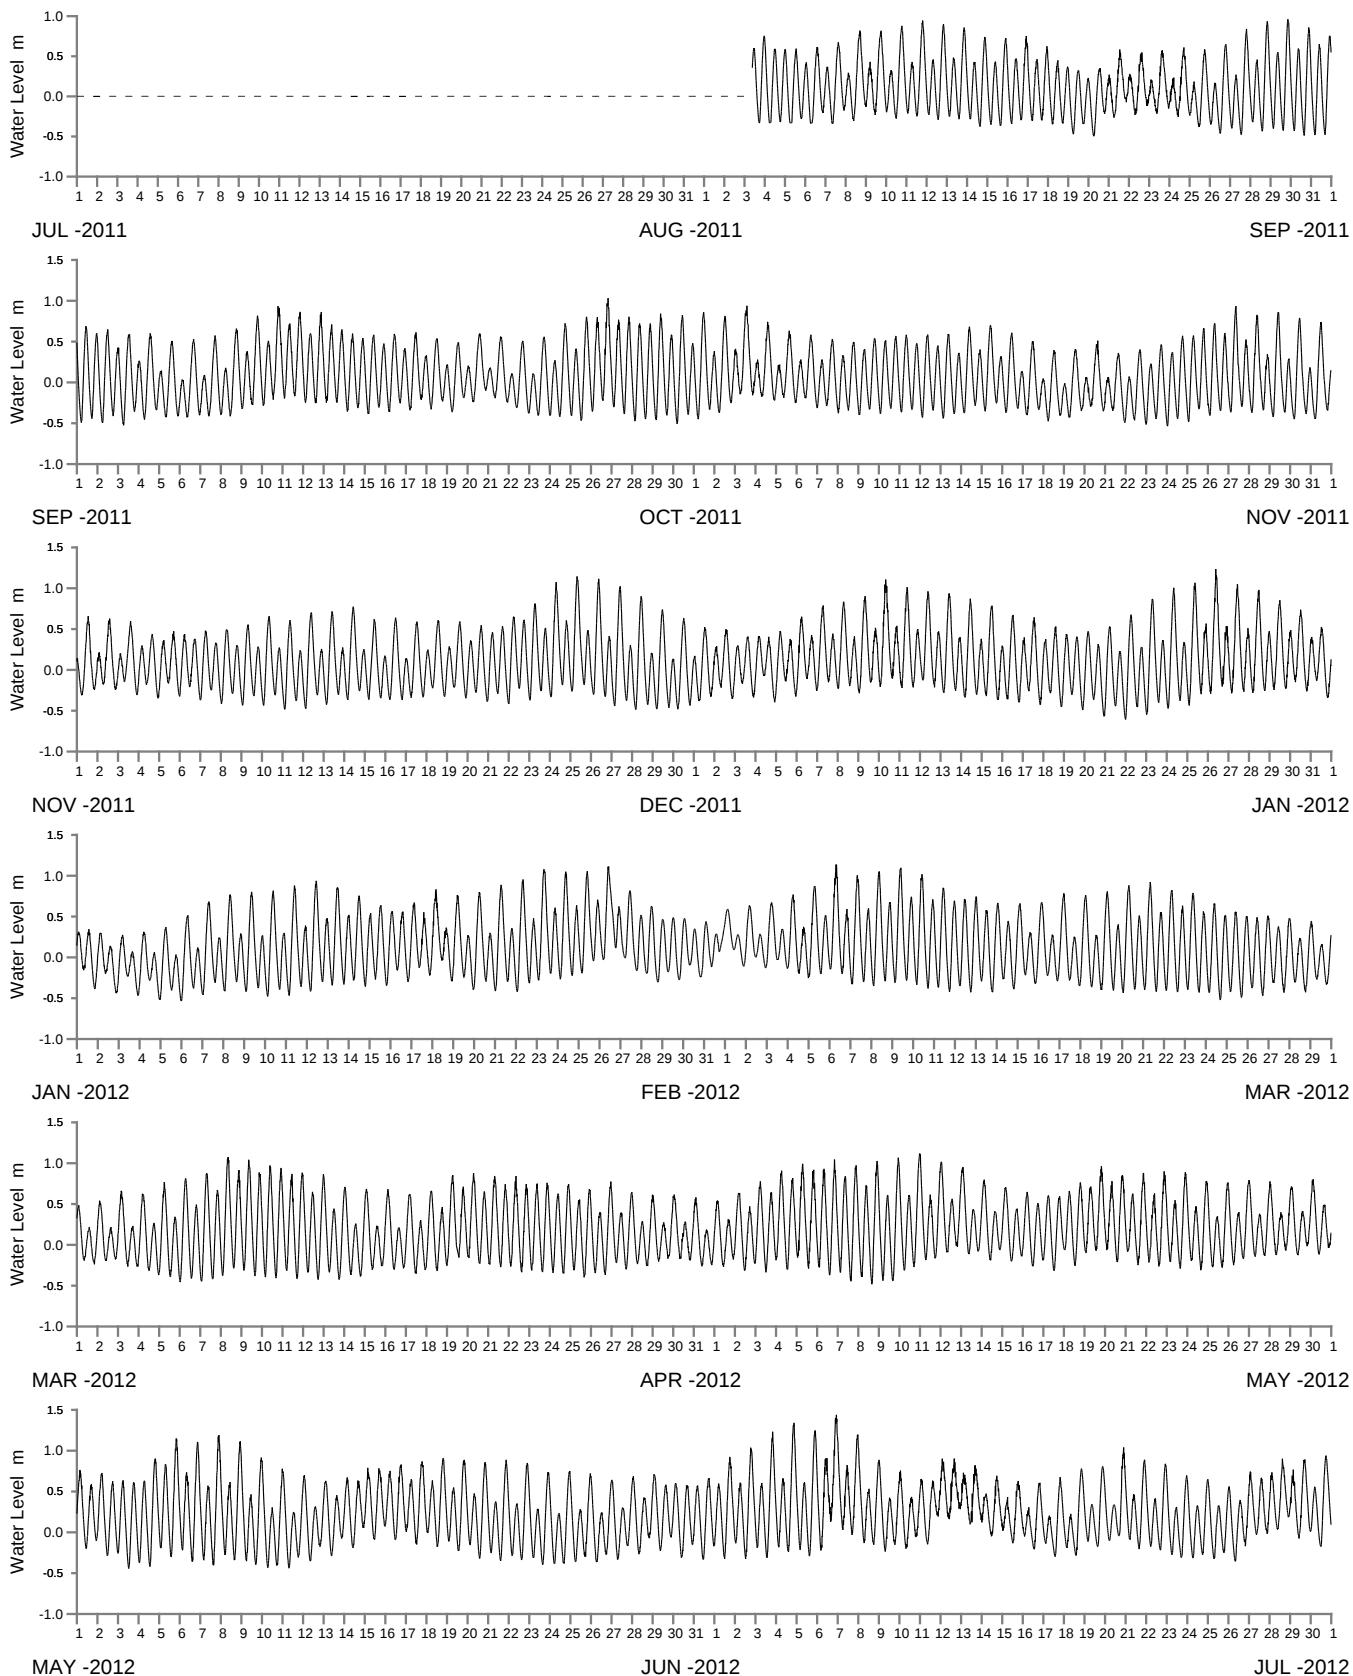
Figure  
**63**

WATER LEVEL REFERENCED TO AUSTRALIAN HEIGHT DATUM

**BOAMBREE CREEK AT BOAMBREE ENTRANCE**  
**2011-2012**

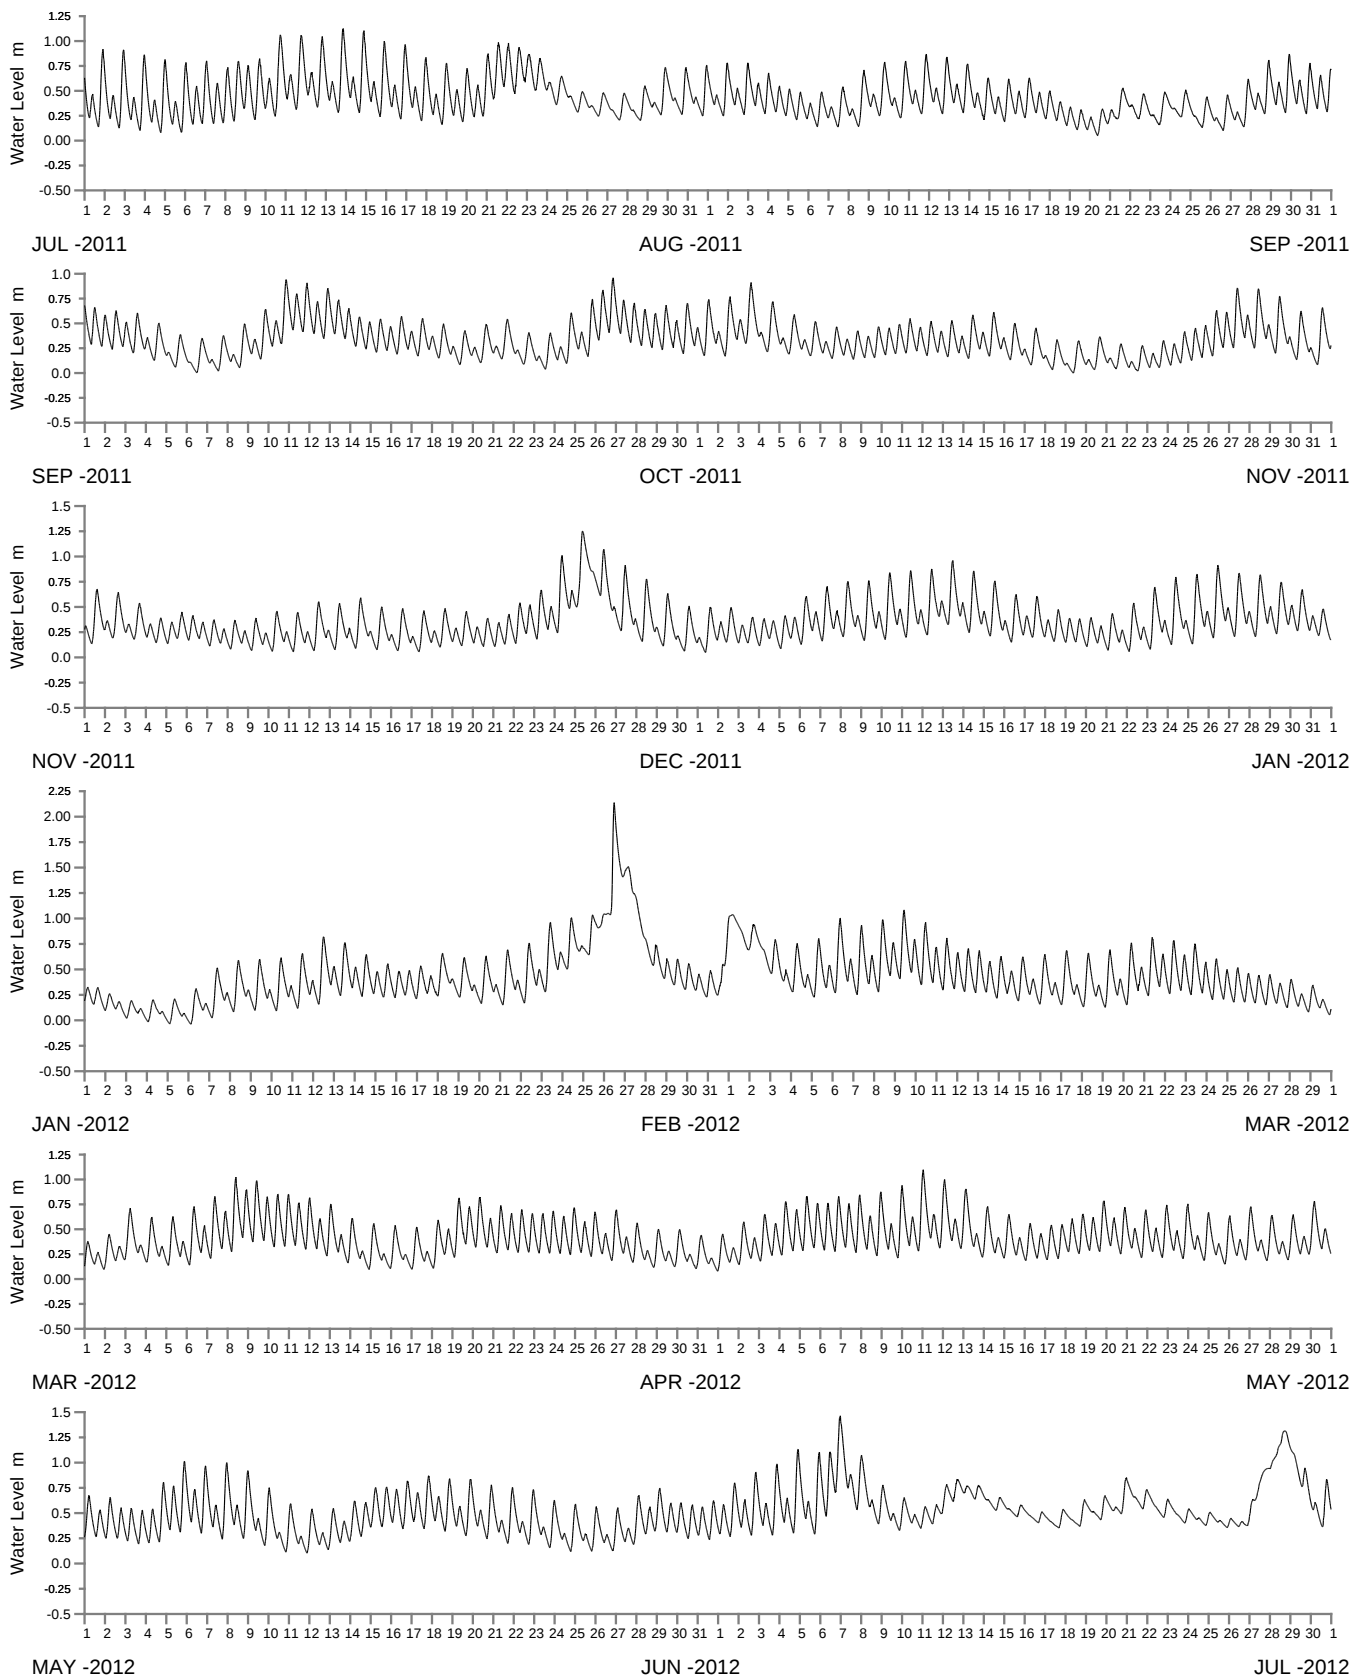
Figure  
**65**

WATER LEVEL REFERENCED TO AUSTRALIAN HEIGHT DATUM

**BONVILLE CREEK AT BONVILLE**  
**2011-2012**

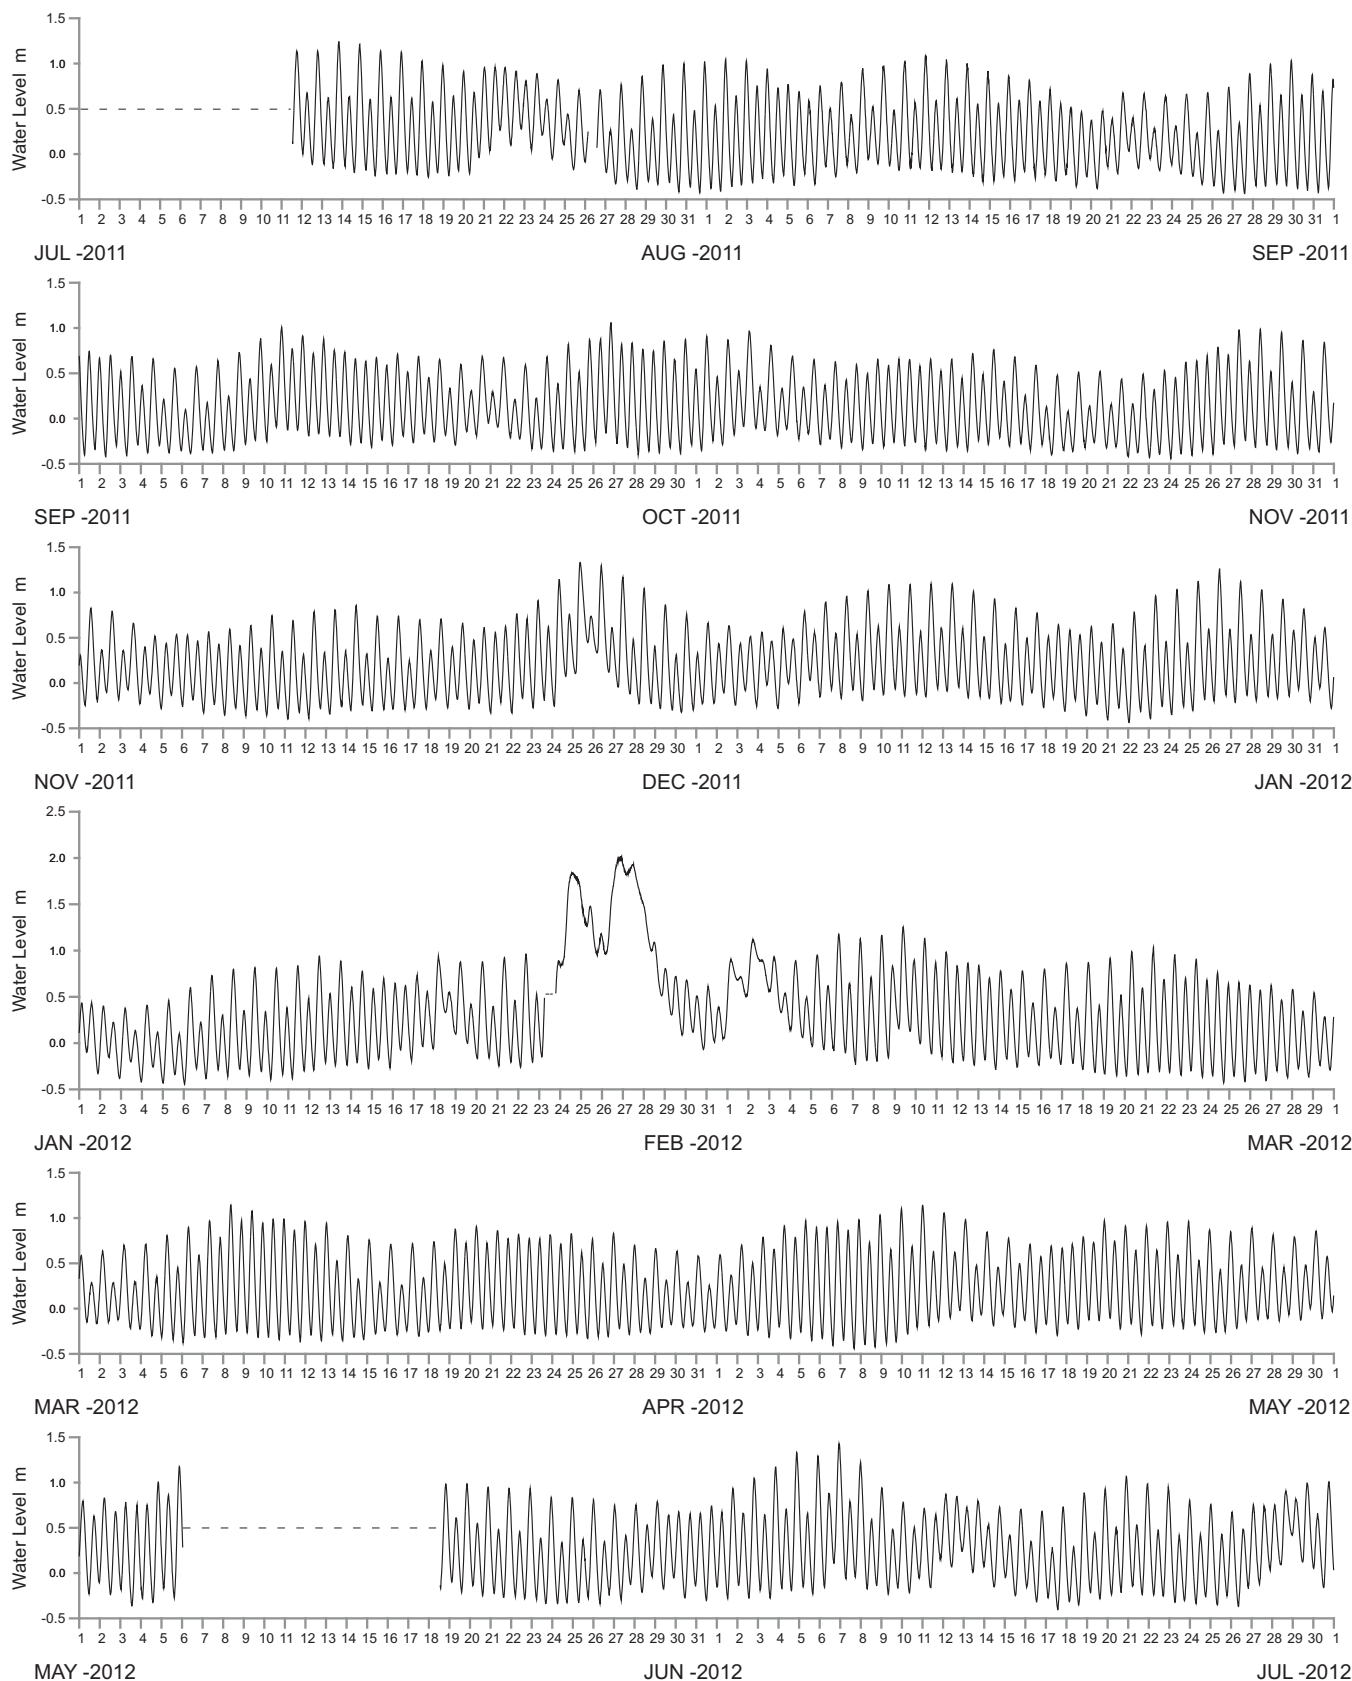
Figure  
**66**

WATER LEVEL REFERENCED TO AUSTRALIAN HEIGHT DATUM

**BELLINGER RIVER AT REPTON**  
2011-2012
