**Public Works**  
Manly Hydraulics Laboratory

MHL  
Report 2157

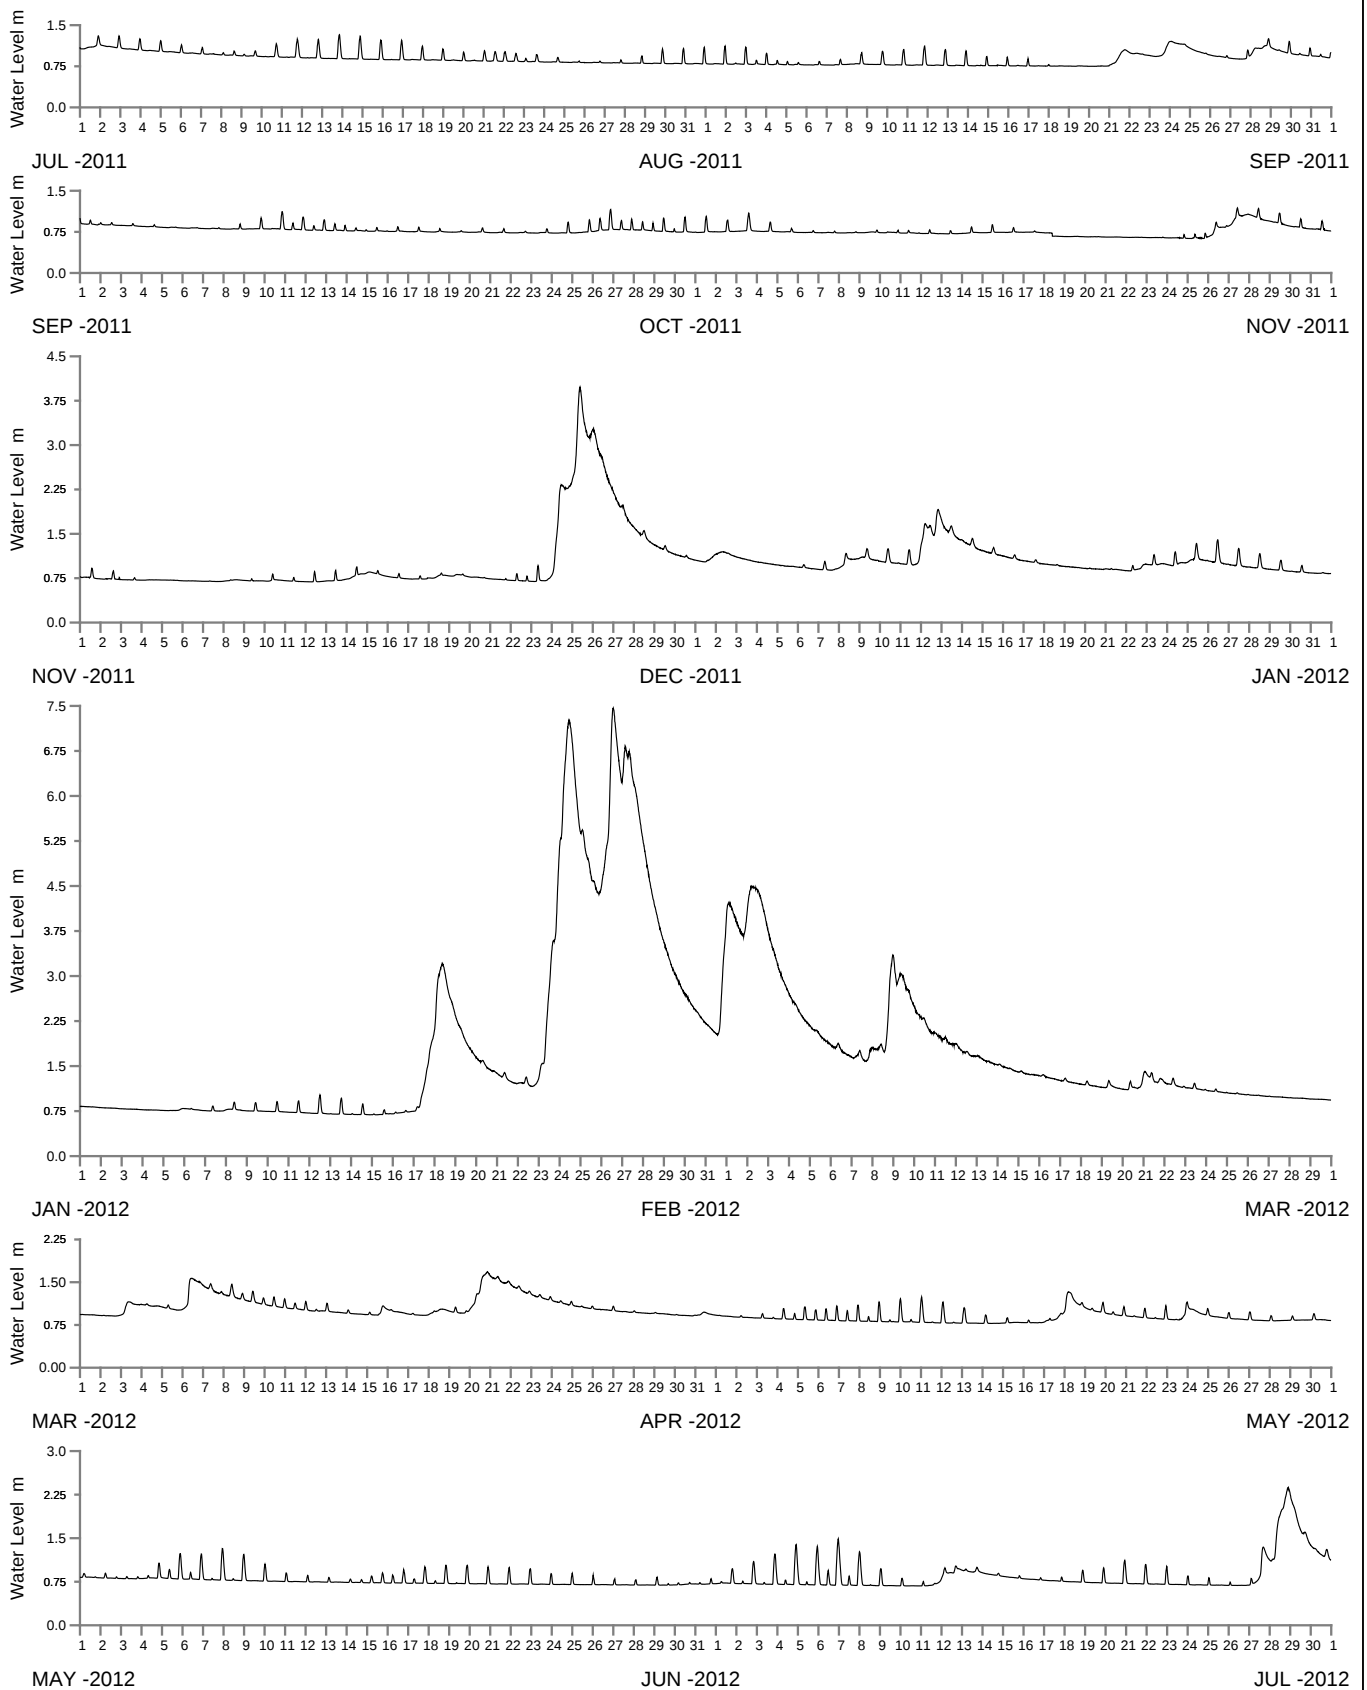
Figure  
**67**

WATER LEVEL REFERENCED TO AUSTRALIAN HEIGHT DATUM

## BELLINGER RIVER AT BELLINGEN BRIDGE 2011-2012

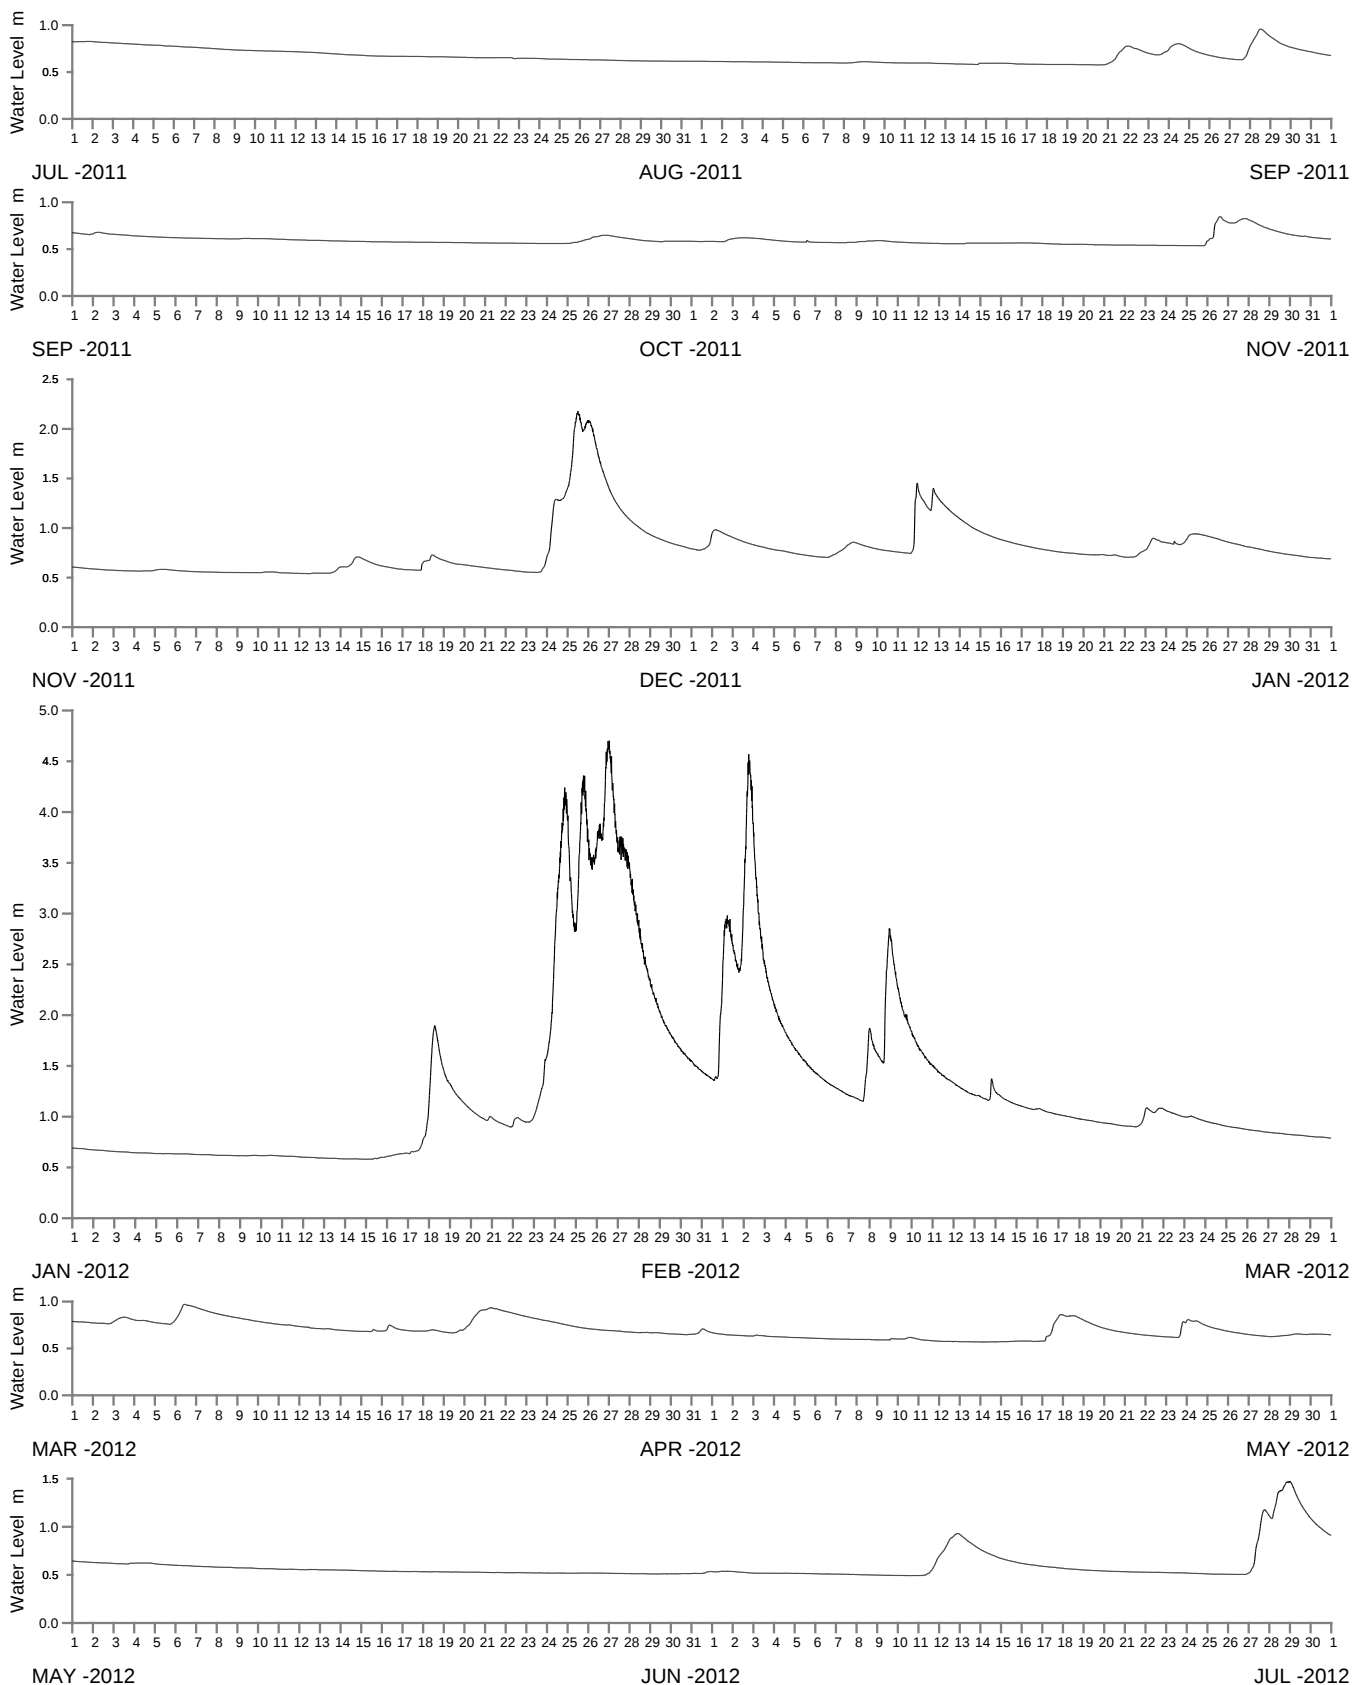
Figure  
**70**

WATER LEVEL REFERENCED TO ASSUMED DATUM

**KALANG RIVER AT KOOROOWI**  
**2011-2012**

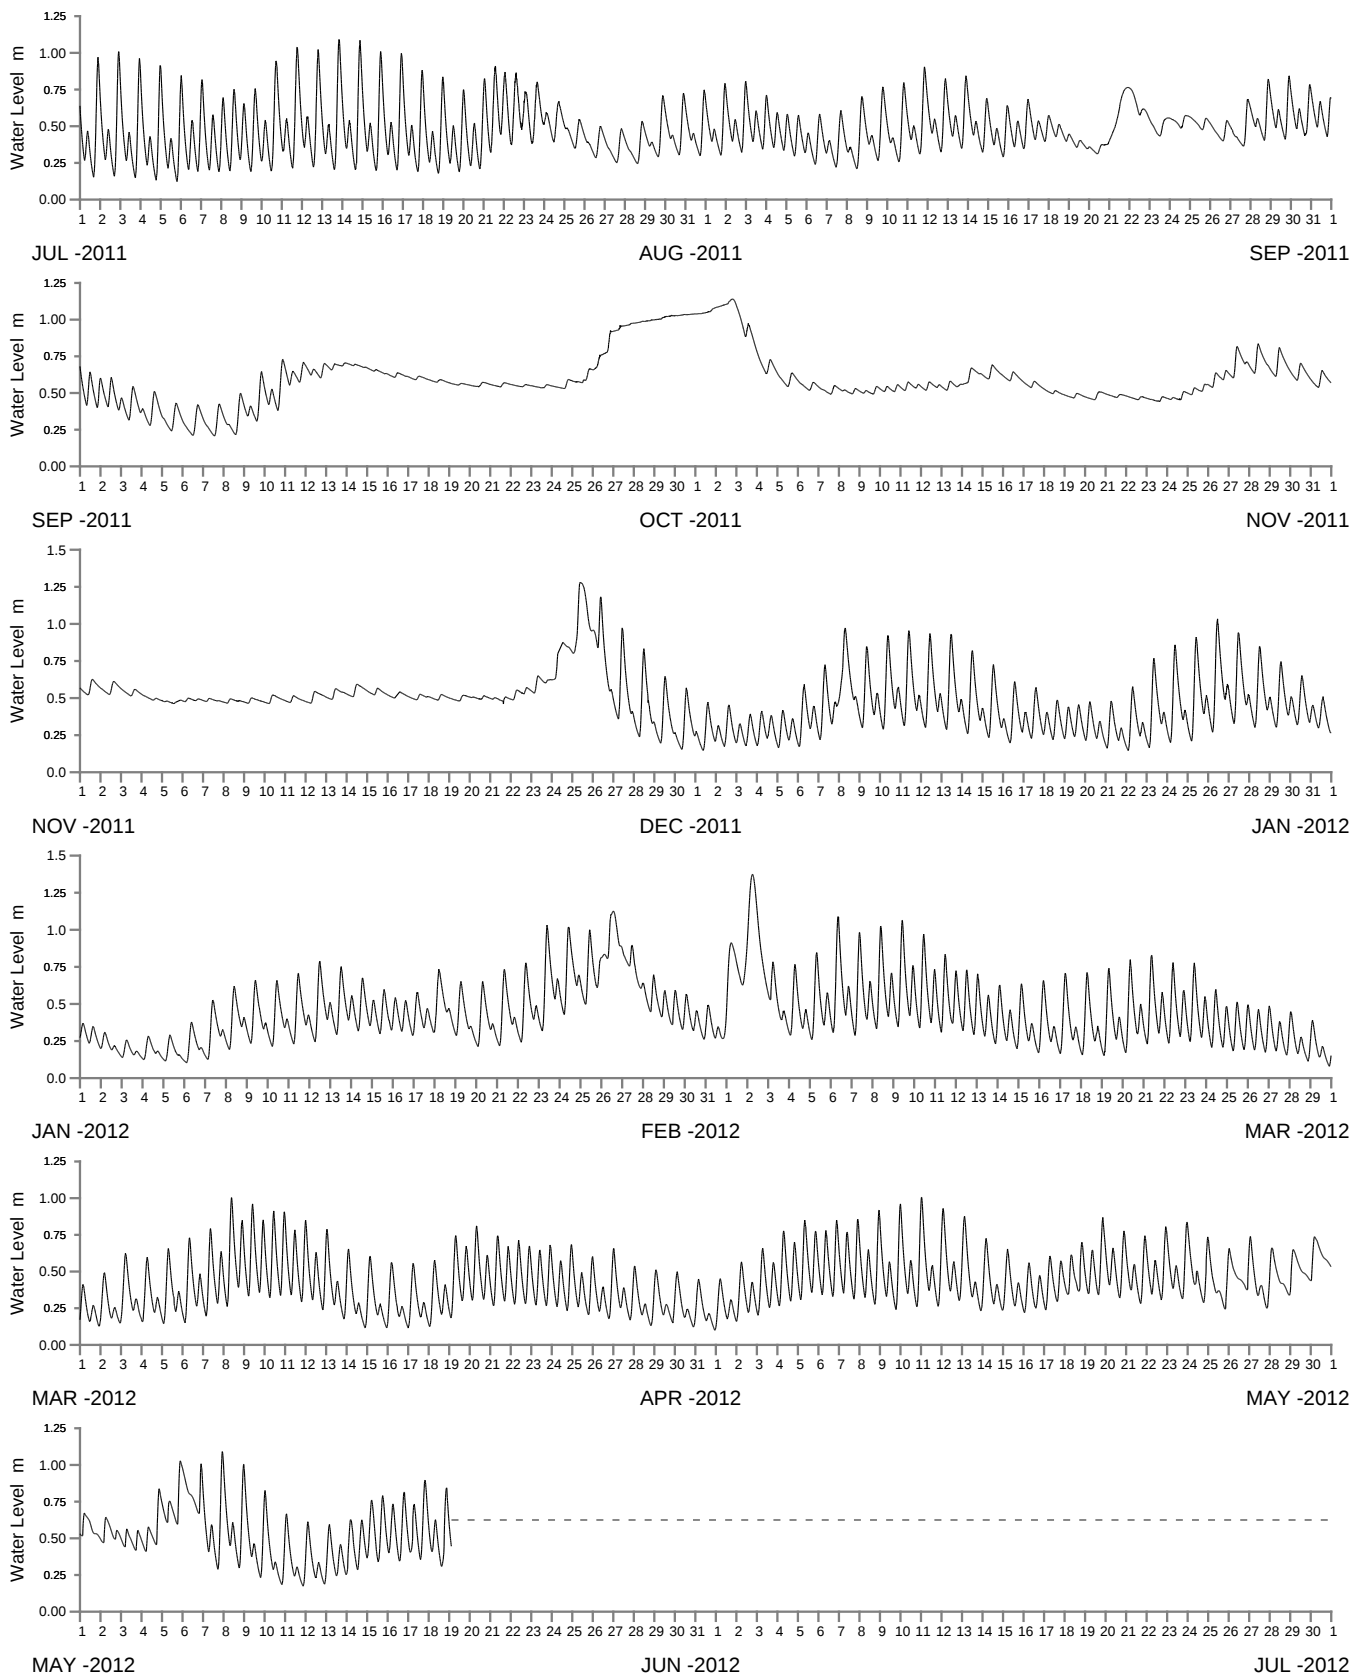
Figure  
**72**

WATER LEVEL REFERENCED TO AUSTRALIAN HEIGHT DATUM

**DEEP CREEK AT DEEP CREEK**  
**2011-2012**

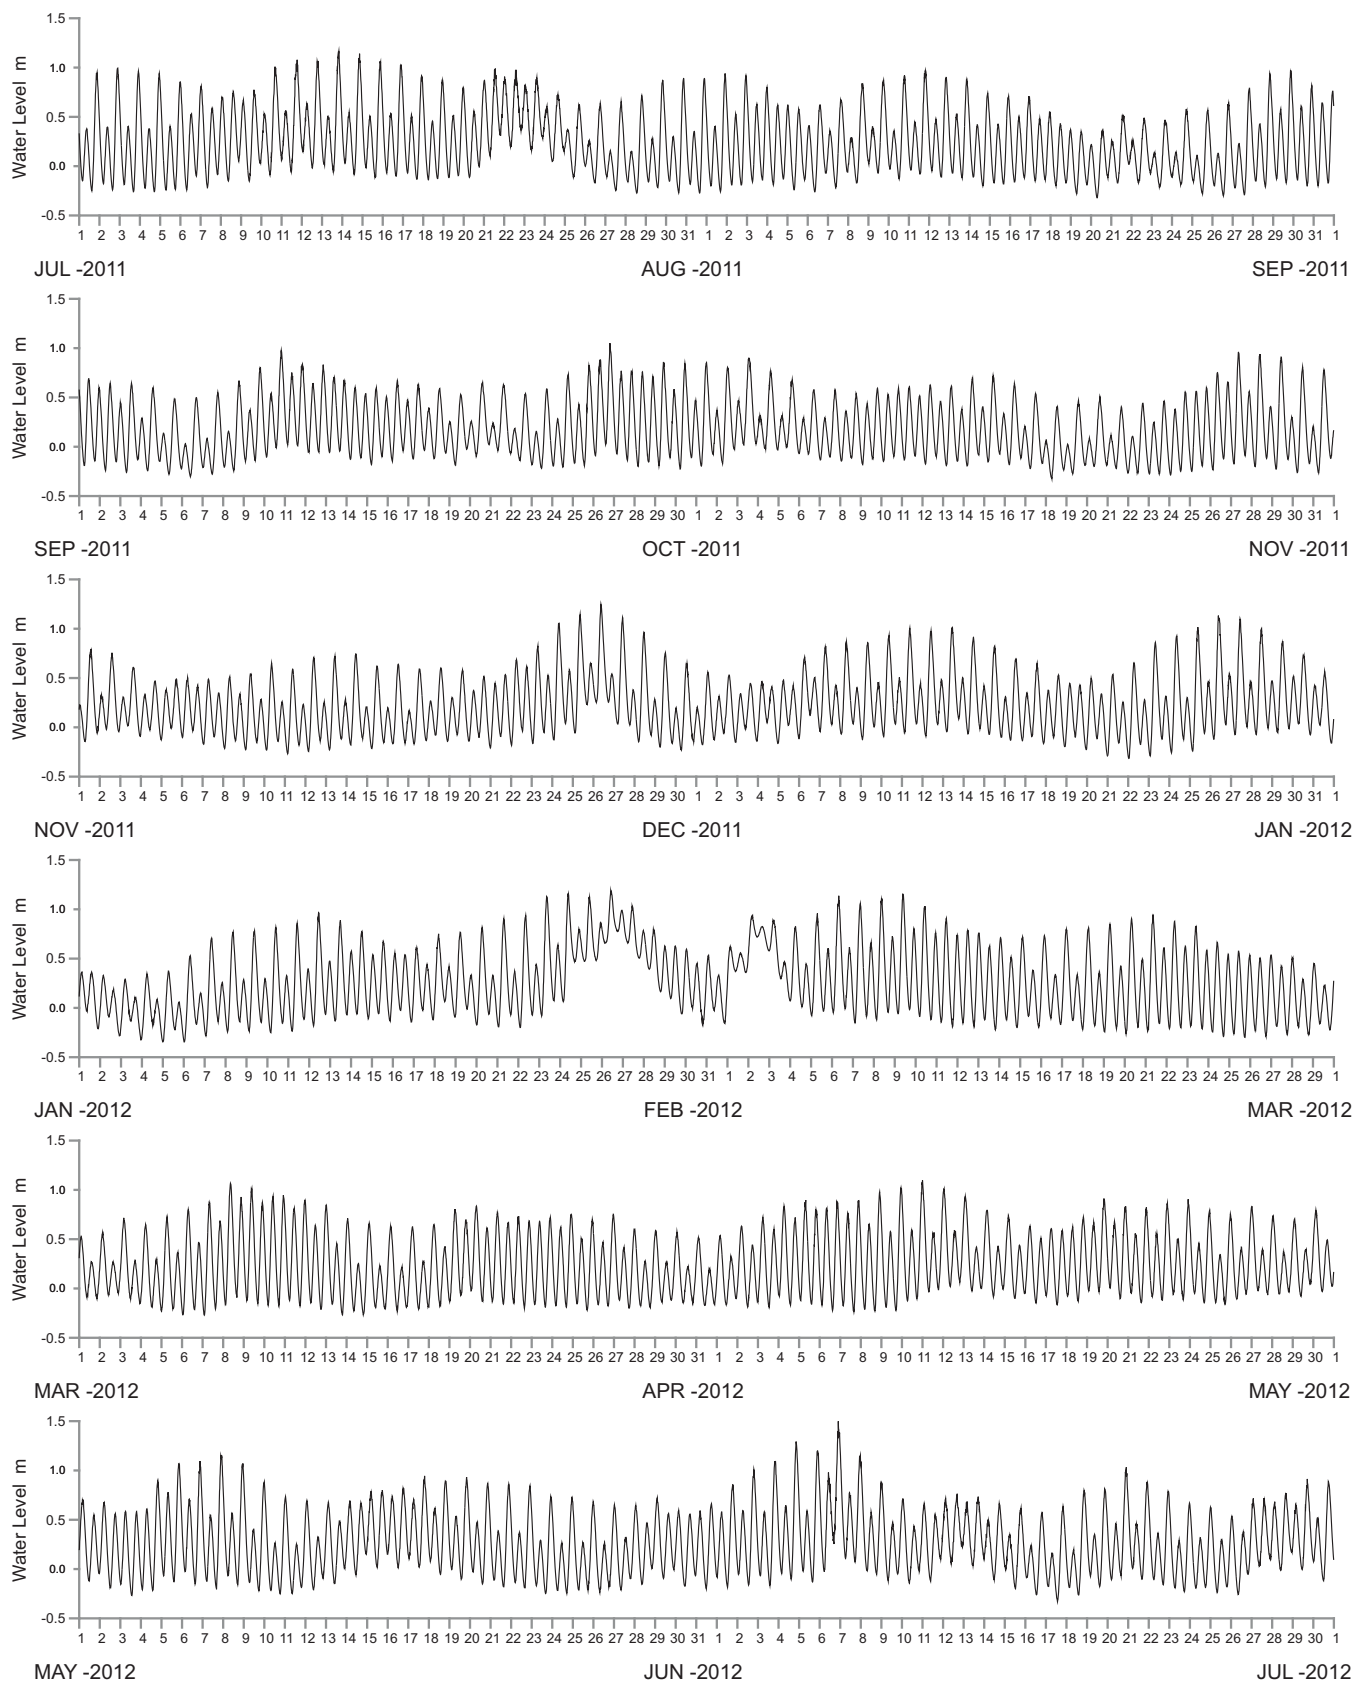
Figure  
**73**

WATER LEVEL REFERENCED TO AUSTRALIAN HEIGHT DATUM

**NAMBUCCA RIVER AT STUARTS ISLAND DOWNSTREAM**  
**2011-2012**

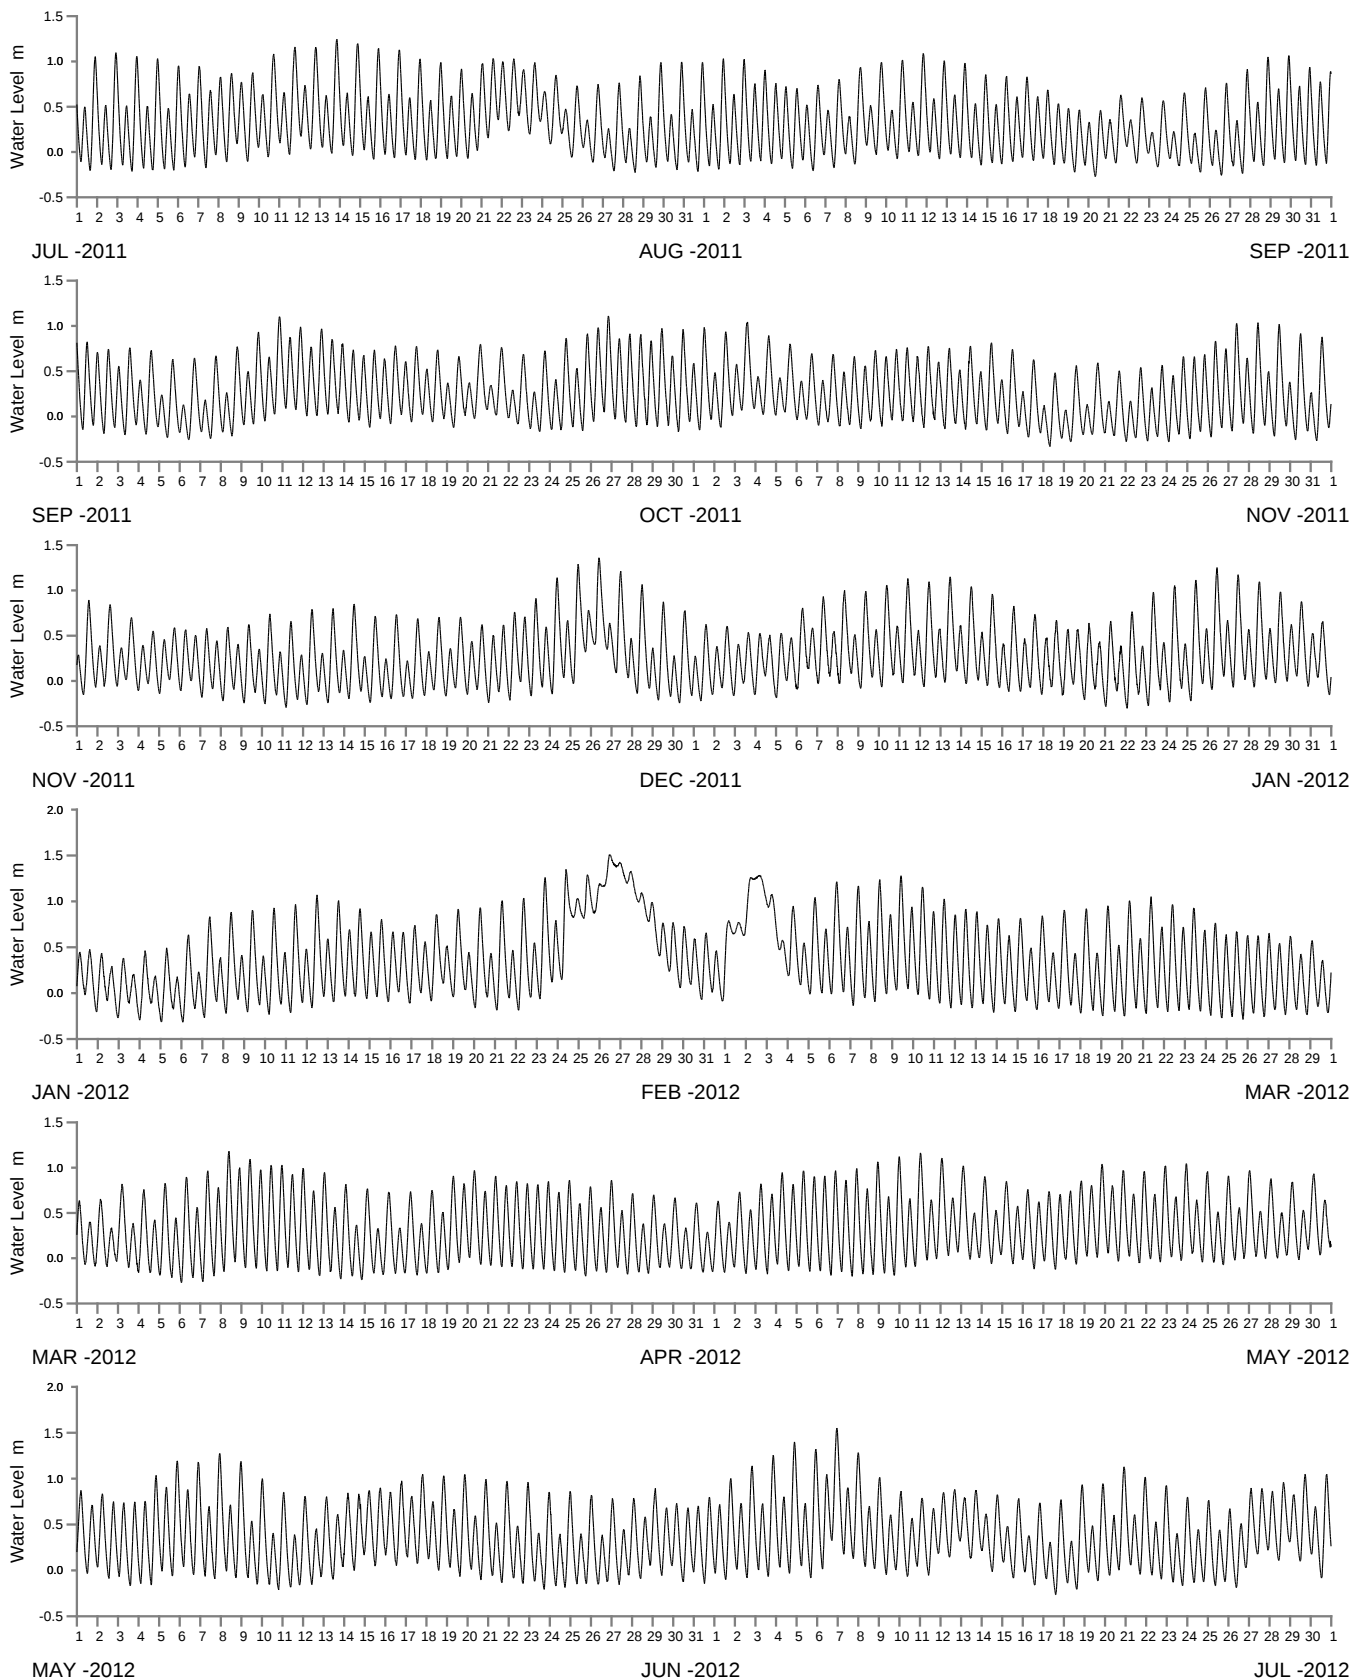
Figure  
**74**

WATER LEVEL REFERENCED TO AUSTRALIAN HEIGHT DATUM

# NAMBUCCA RIVER AT MACKSVILLE 2011-2012

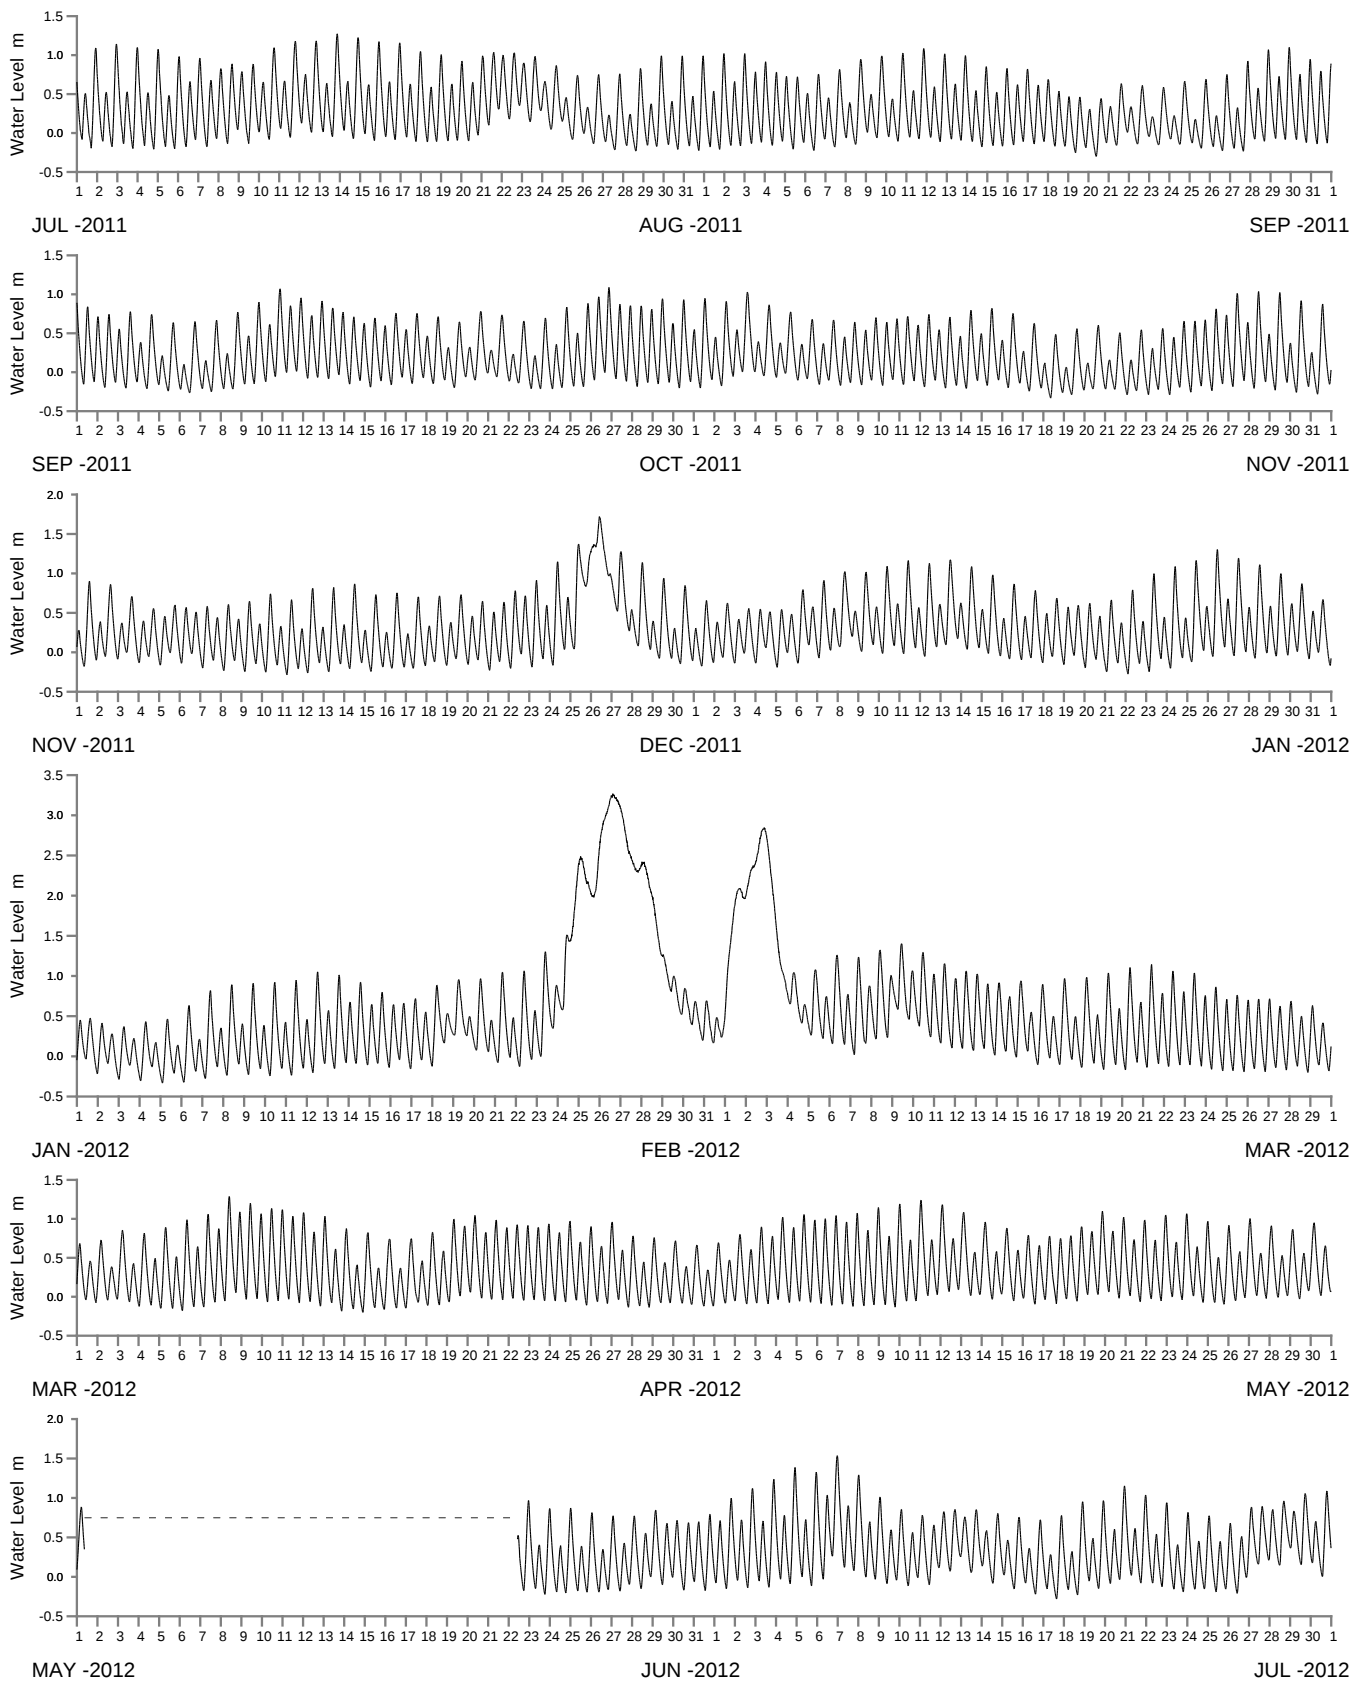
Figure  
**75**

WATER LEVEL REFERENCED TO AUSTRALIAN HEIGHT DATUM

**NAMBUCCA RIVER AT UTUNGUN**  
**2011-2012**

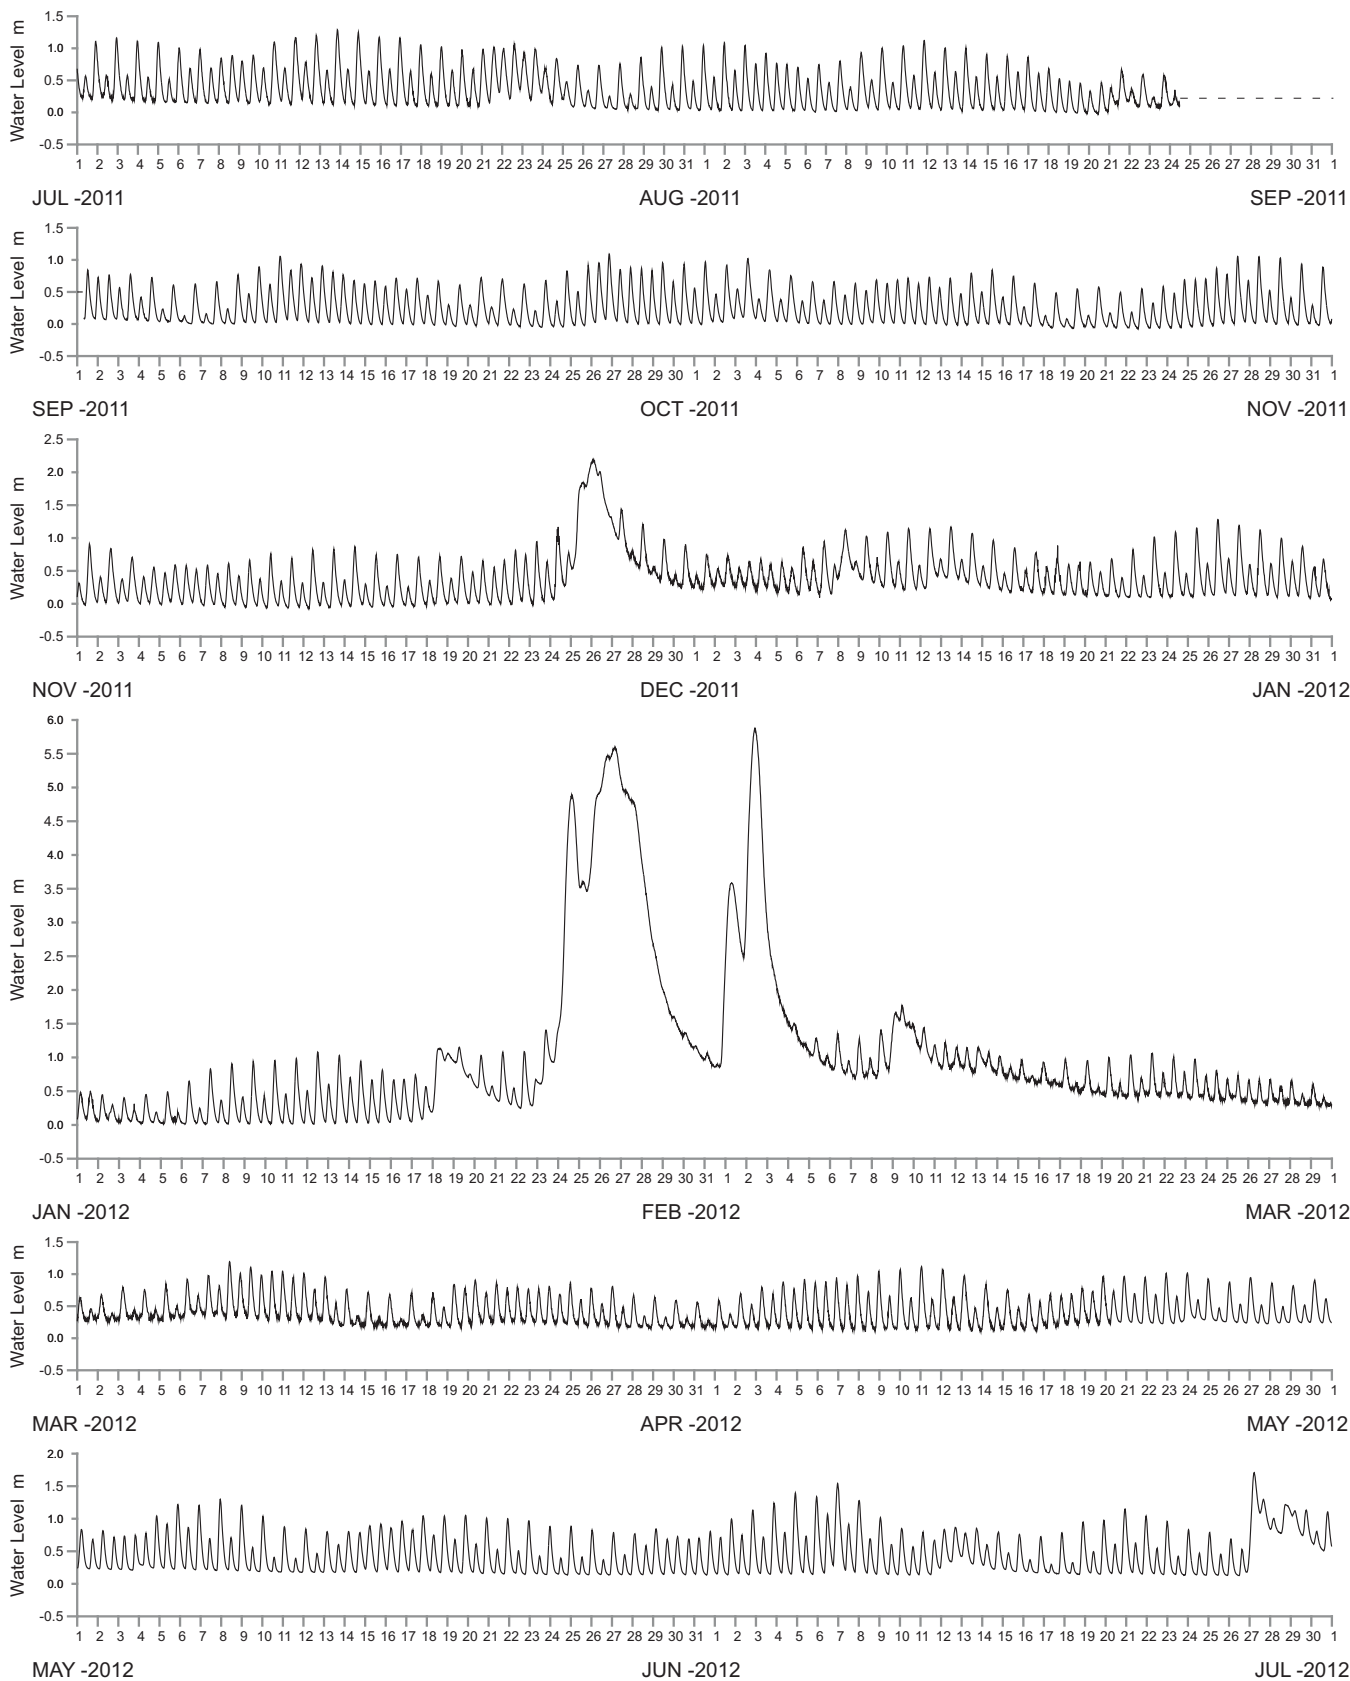
Figure  
**76**

WATER LEVEL REFERENCED TO ASSUMED DATUM

**NAMBUCCA RIVER AT BOWRAVILLE DOWNSTREAM**  
**2011-2012**

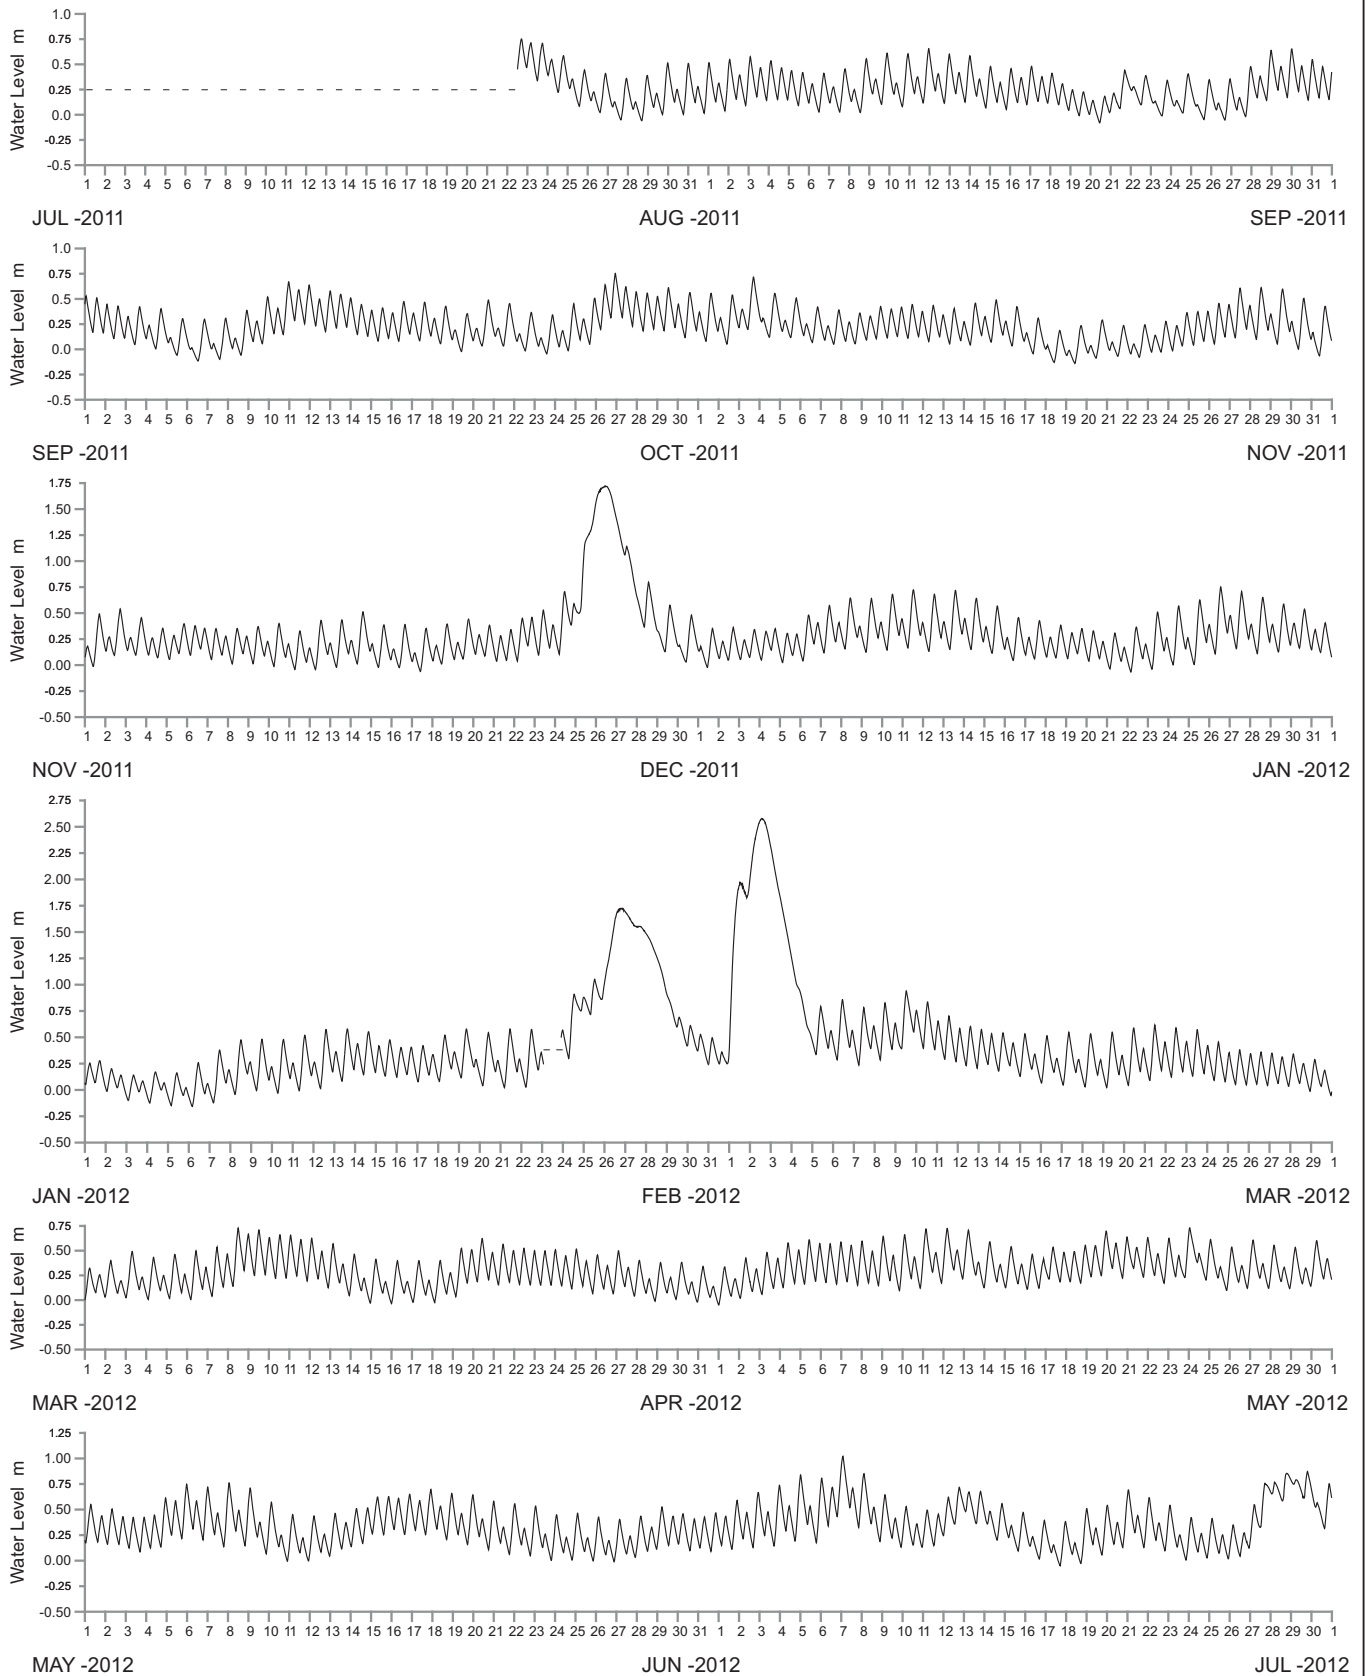
Figure  
**77**

WATER LEVEL REFERENCED TO AUSTRALIAN HEIGHT DATUM

**WARRELL CREEK AT WARRELL CREEK**  
**2011-2012**

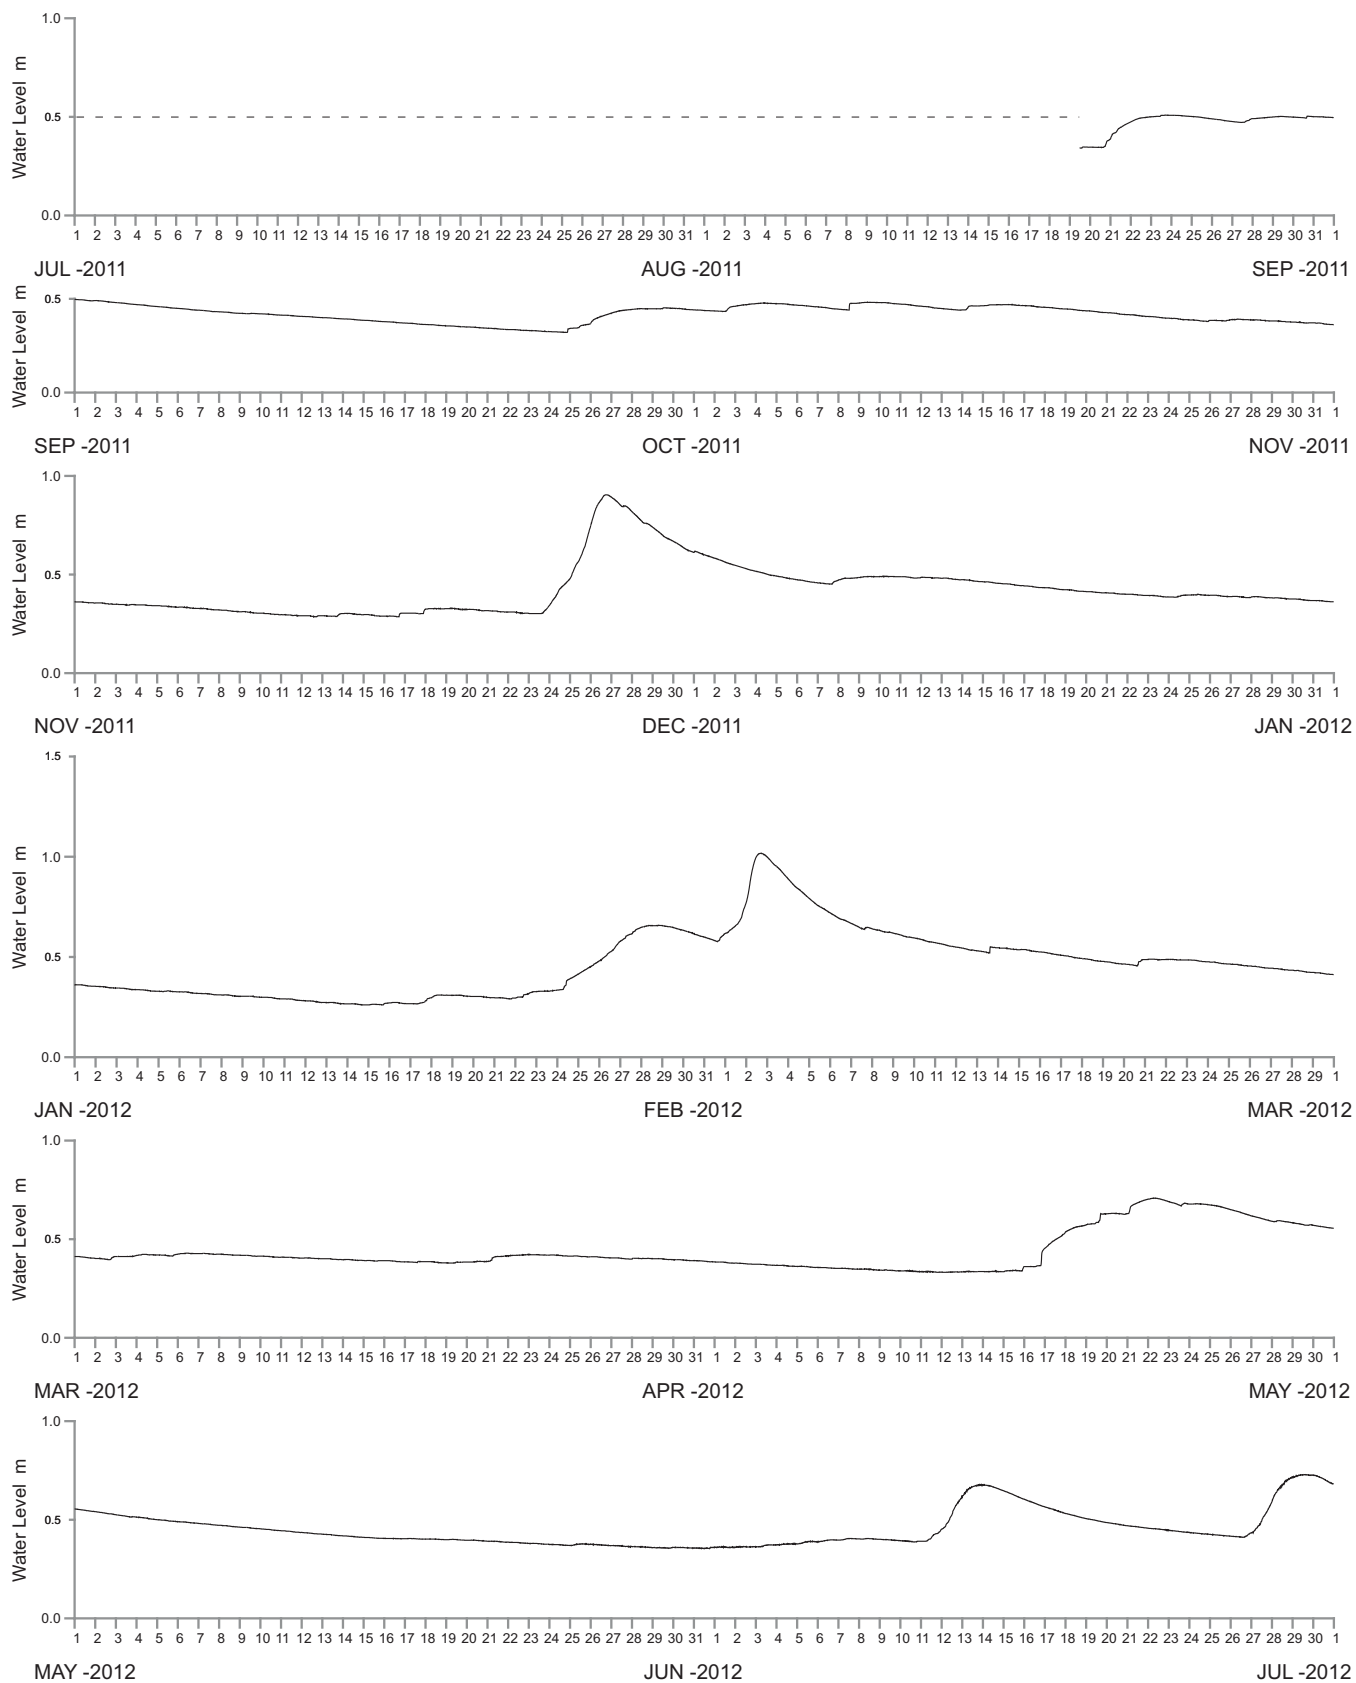
Figure  
**79**

WATER LEVEL REFERENCED TO AUSTRALIAN HEIGHT DATUM

**BORIRGALA CREEK AT BORIRGALA CREEK**  
**2011-2012**

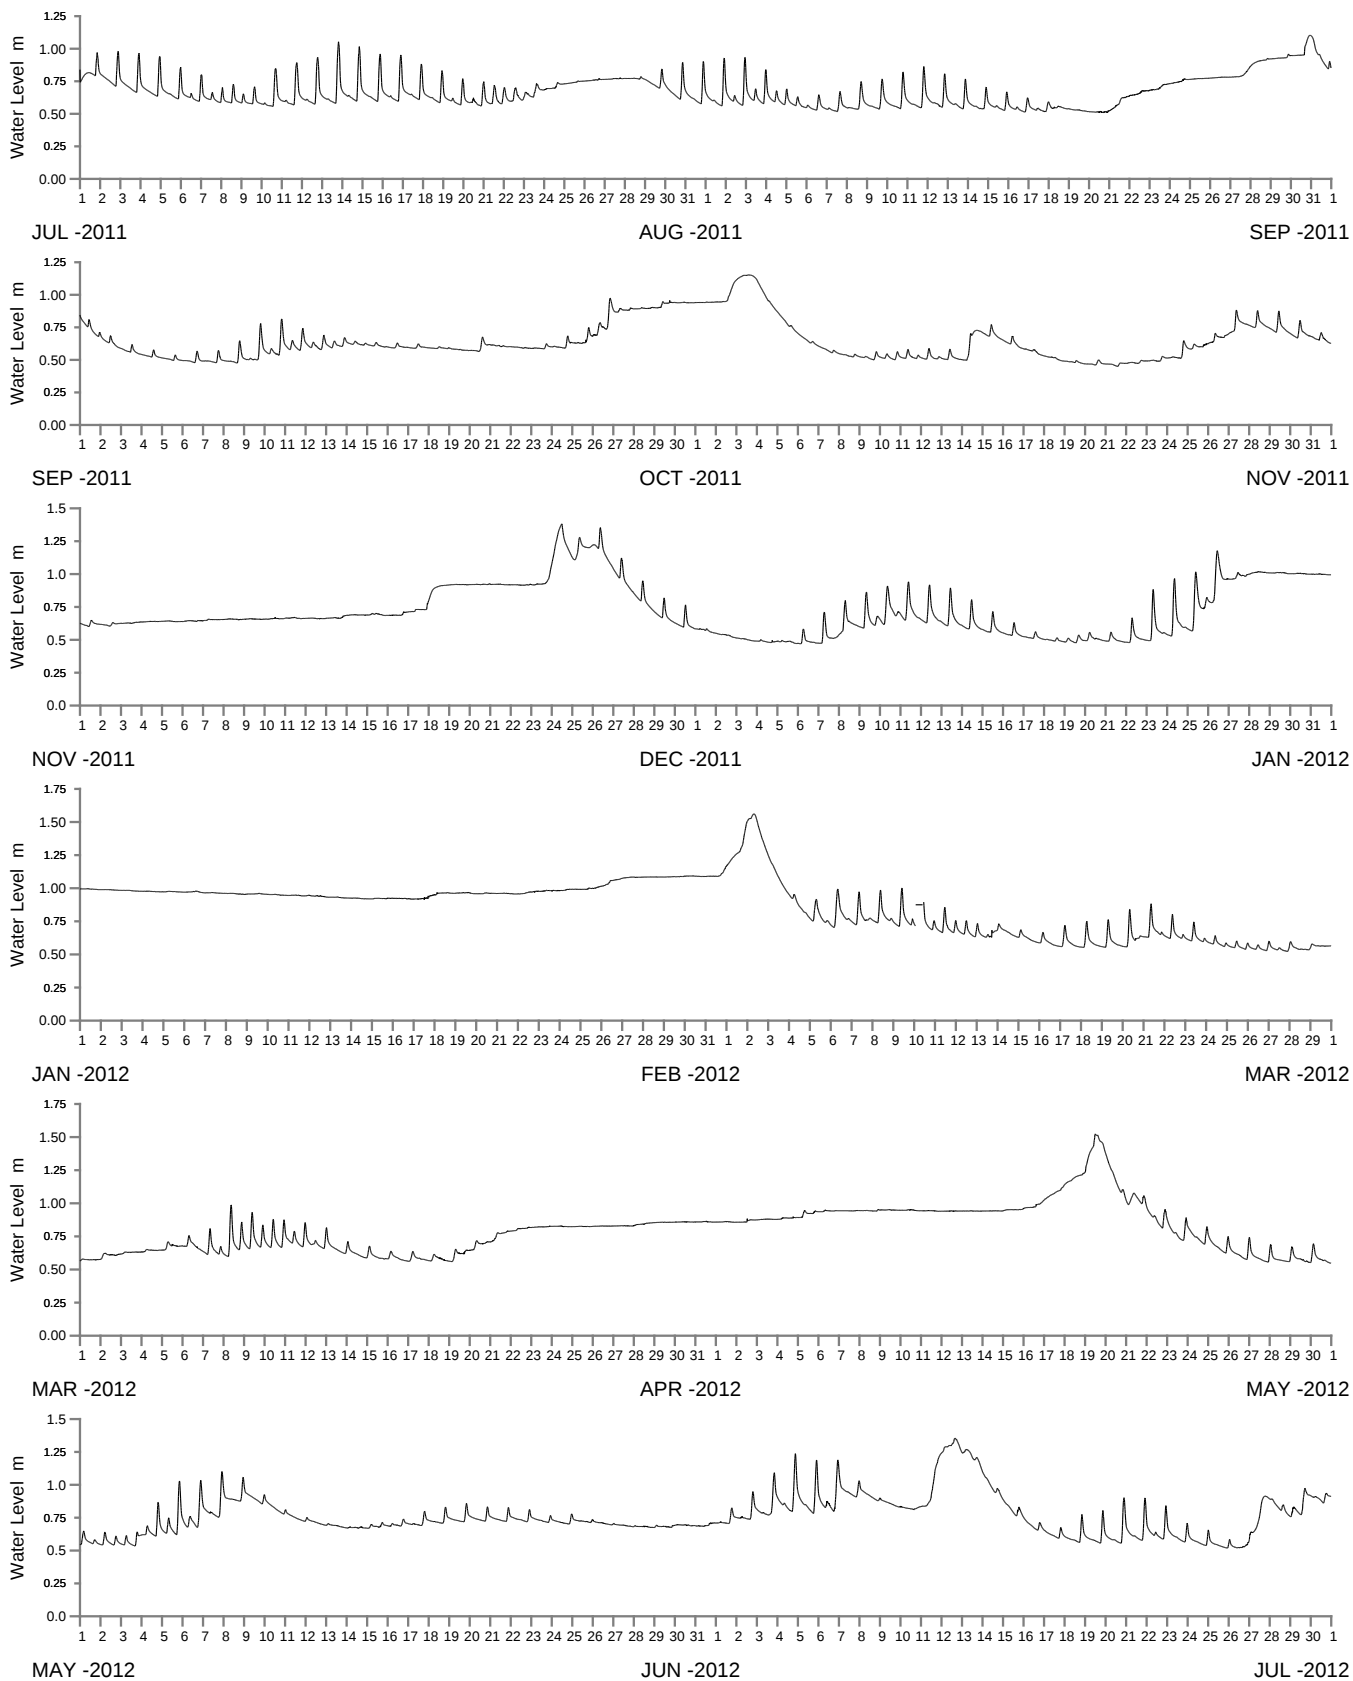
Figure  
**81**

WATER LEVEL REFERENCED TO AUSTRALIAN HEIGHT DATUM

**SALTWATER LAGOON AT SALTWATER LAGOON**  
**2011-2012**
